**Riparian Corridor Management Plan
Schoharie Creek
Grossman Property – Tannersville, NY**

November 19, 2009

**Laura Weyeneth
Catskill Streams Buffer Initiative Coordinator
Greene County Soil and Water Conservation District
Cairo, NY**

**Catskill Streams
Buffer Initiative**

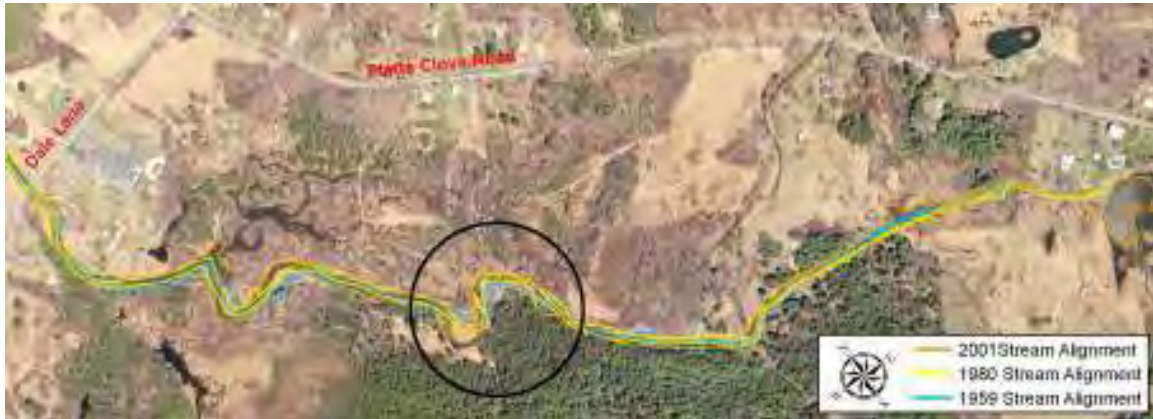
in the fall of 2009 is located in Management Unit 1. As seen from the historical stream channel alignments (below), with the exception of the meander bend in the middle of this management unit, the channel alignment has not changed significantly over the years.

Historic stream channel alignments with 2006 aerial photograph

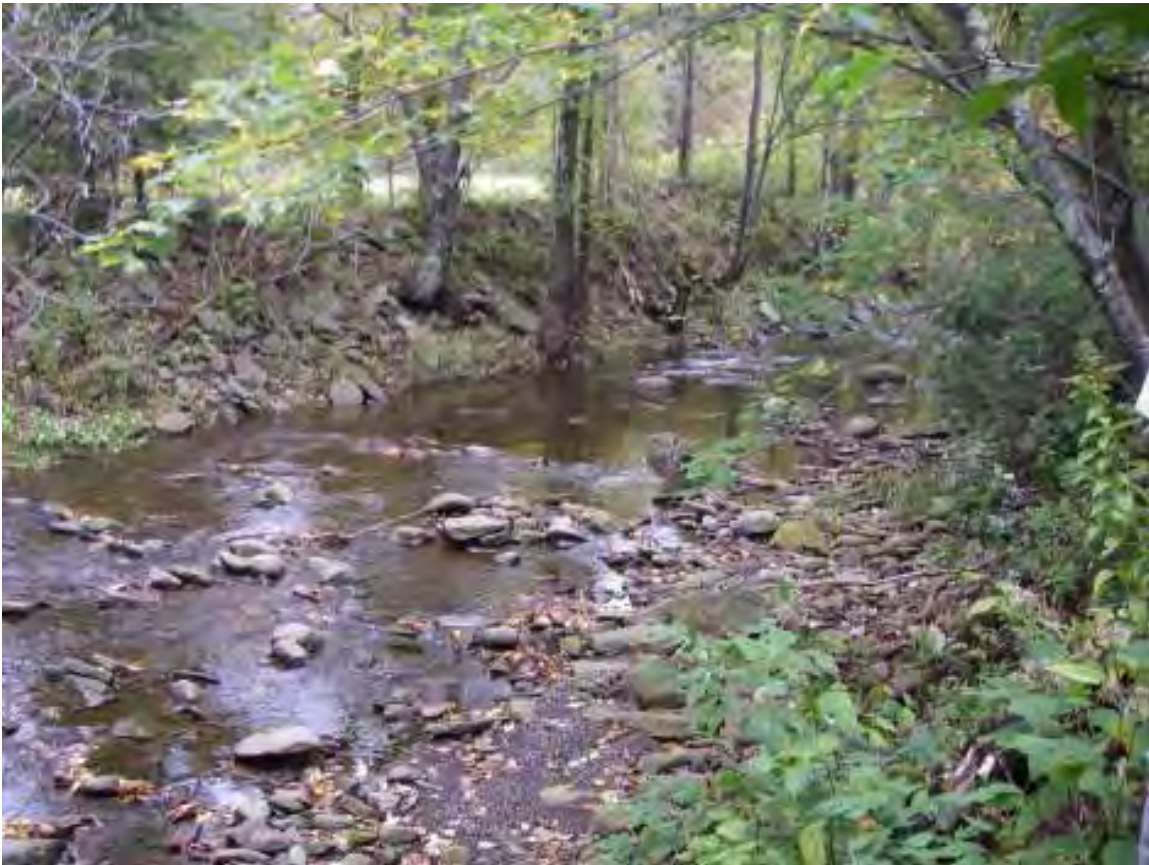
Localized erosion and gravel bars were noted at the site visit on the left streambank where Canda Creek has changed its course. The Grossman residence is located on an alluvial fan which forms on land where a stream emerges from a mountainous area and flows out onto a more gently sloping plain. The decrease in slope causes the stream to decelerate and deposit sediment, forming the alluvial fan. Flash floods will naturally occur as a direct result of the topography.

September 28, 2009 – Site Visit Photo showing upstream berm near residence

- 3) **Use vegetative treatments such as dormant posts and stakes to address minor localized erosion.** Bioengineering, the use of live vegetation to stabilize soils associated with streambanks, can be used at this location. Dormant cuttings from appropriate species, such as willows and dogwoods, quickly establish vegetation on the banks. Live posts and stakes are cut from living willow shrubs when the shrub is dormant (usually during the fall). The stakes, ranging from one to several feet long, are hammered or pushed into the stream bank where they will grow quickly and provide necessary bank stabilization where it is needed most. A dormant post detail drawing is attached. Onsite willows can be used for this treatment.

- 4) **Use live fascines.** Live fascines are a standard bio-engineering technique which involves the bundling and planting of dormant plant cuttings. The plant bundles sprout and develop a root mass that will hold the soil in place and protect the streambank from erosion. Onsite willows can be harvested and used for this treatment. A live fascine detail drawing is attached.

- 8) **Relocate fencing that is close to dynamic stream.** Horse pasture can be set back from stream to allow for riparian buffer.
- 9) **Continue to monitor reach stability through normal observations.** Take photographs from the same location each year to photo document erosion.

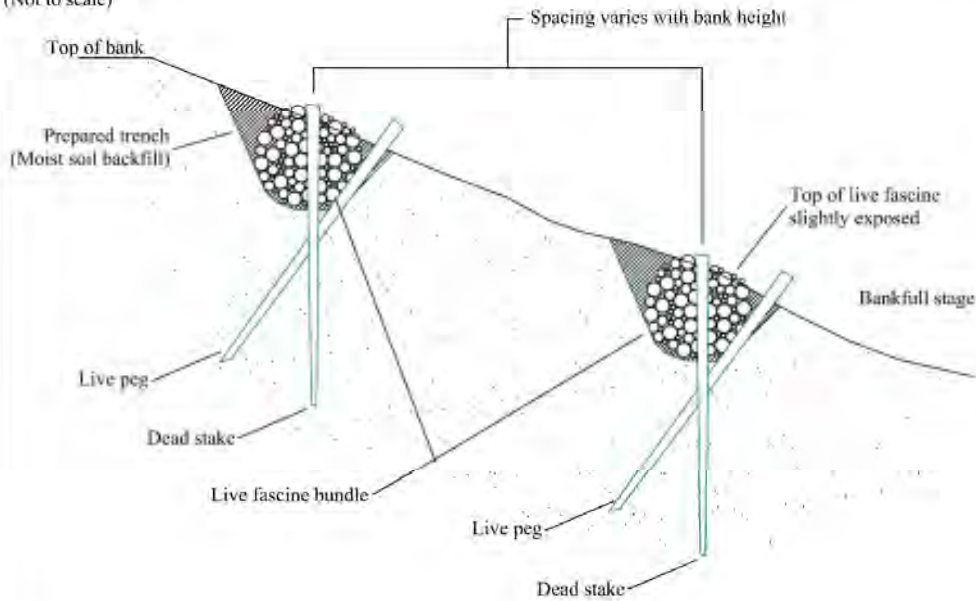
Cross Section
(Not to scale)

LIVE FASCINE DETAIL (VS-01)
