**Riparian Corridor Management Plan
East Kill
Rappleyea Property – Jewett, NY**

**Laura Weyeneth
Catskill Streams Buffer Initiative Coordinator
Greene County Soil and Water Conservation District
Cairo, NY**

**Catskill Streams
Buffer Initiative**

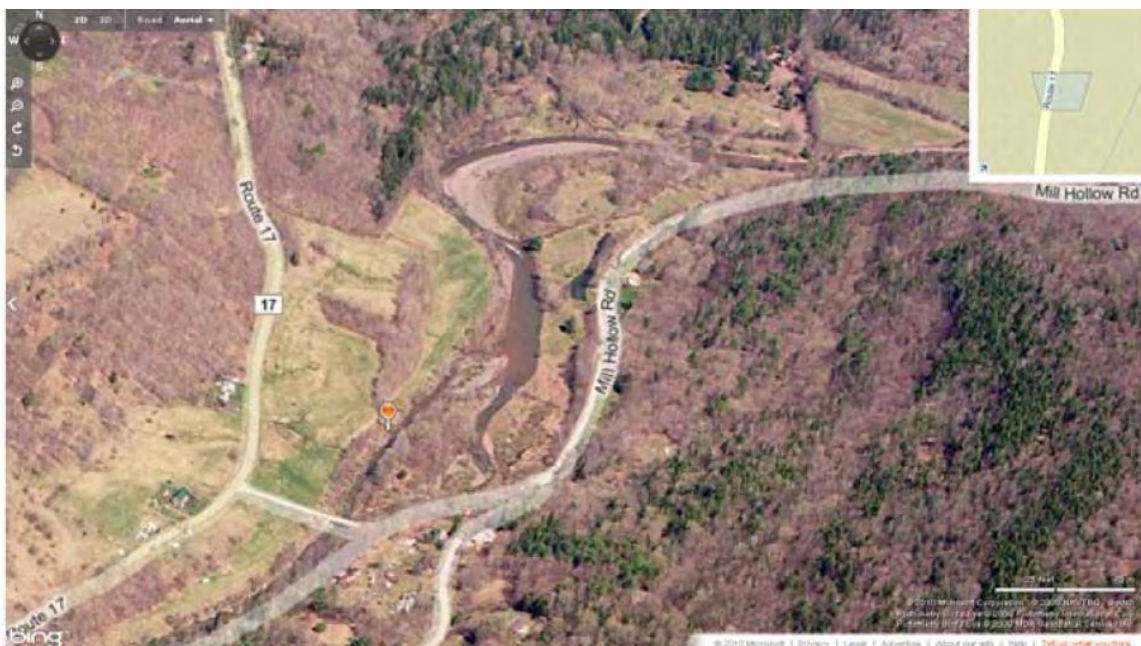
Aerial view of Rappleyea property between Route 17 and Mill Hollow Road

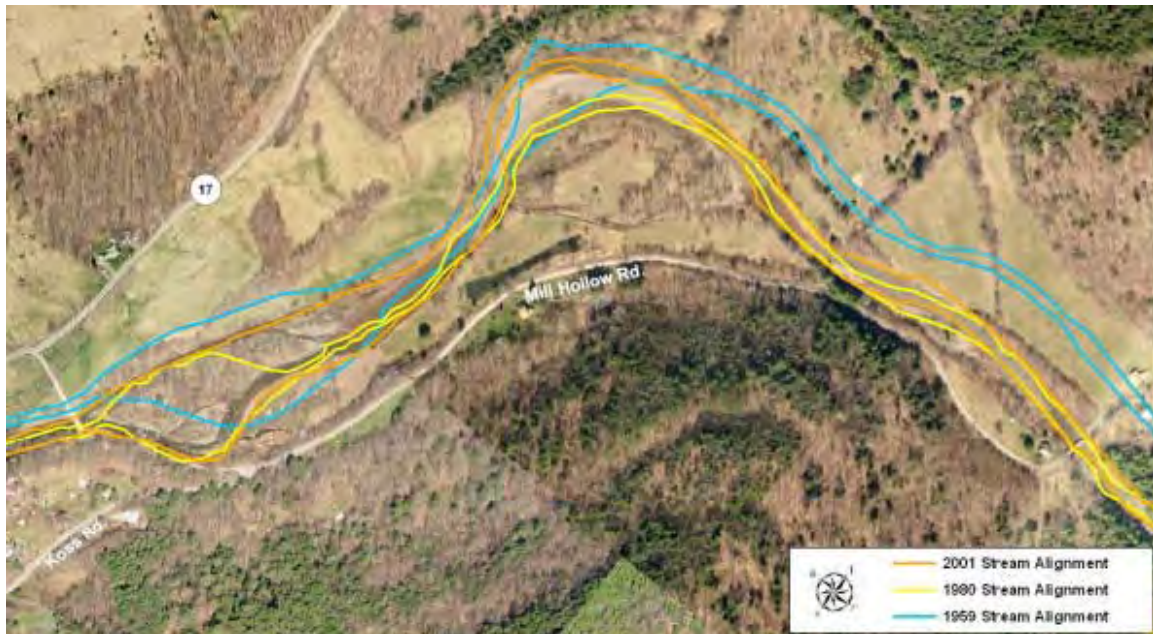
As seen from the historical stream channel alignments (below), the stream channel has experienced some lateral migration over the years. Lateral migration is the movement of a channel across its floodplain, which results in extensive bank erosion. The outside banks of meander bends tend to move laterally across the valley floor and down the valley. Generally, the planform of the channel alignment has not changed significantly over the years along this management unit; the channel has remained fairly stable.

Historic stream channel alignments with 2006 aerial photograph

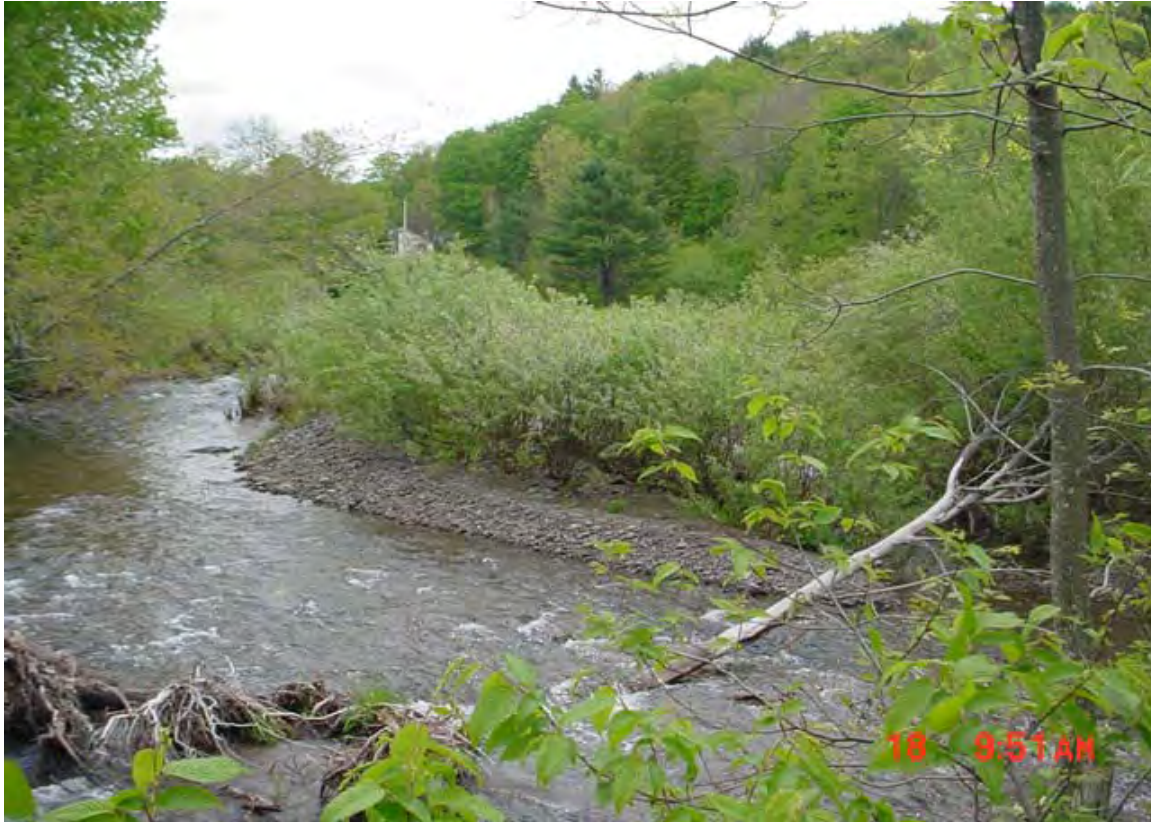
A 2006 Stream Feature Inventory documented channel divergence that had formed a secondary channel around an island of herbaceous and shrubby vegetation and an accumulation of gravel deposits and woody debris. Fallen woody debris appeared to have caused localized scour upstream and downstream of the debris, exacerbating the erosion along the right bank.

2009 site visit photo of willows on established gravel bar

- 1) **Apply** to CSBI for funding support to install one or more of the practices below.
- 2) **Establish a riparian buffer** of deep rooted woody vegetation to maintain bank stability. Planting and maintaining a healthy buffer of native trees and shrubs along streambanks and floodplains is one of the most cost effective and self-sustaining methods for landowners to protect streamside property. Planting additional native species already present on the property such as willow and alder can help restore the riparian buffer to
