Riparian Corridor Management Plan

Schoharie Creek

Silver Property – Elka Park, NY

November 19, 2009

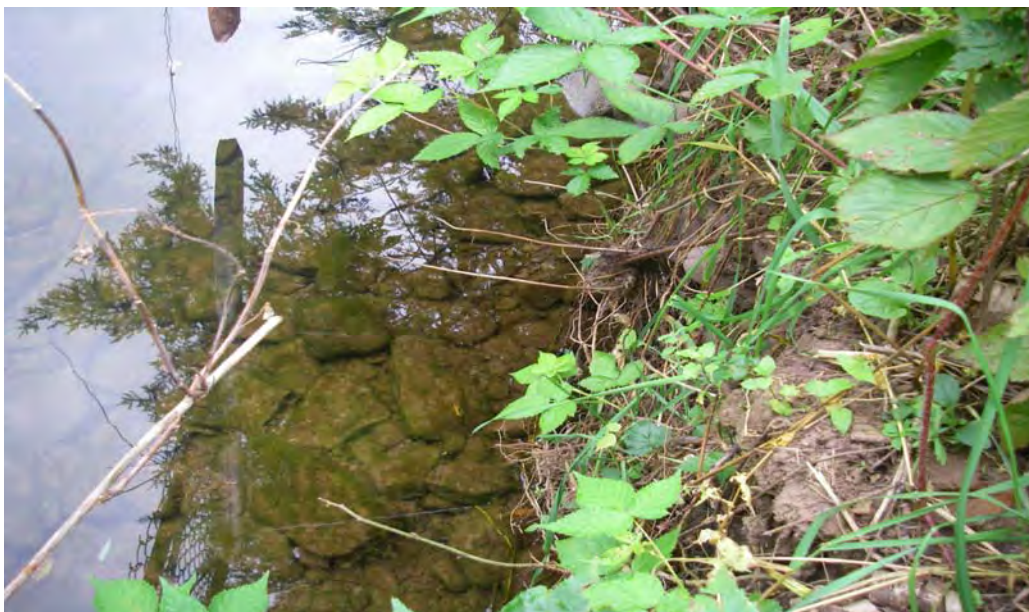
September 22, 2009 – Site Visit

Mr. Silver has expressed concerns about localized erosion on the right streambank where a fence is now hanging over the stream. The eroding streambank is 55 inches high. The owner has stopped mowing the lawn to the edge of the stream letting a small buffer area "go wild" to establish more roots. Goldenrod and Rubus species are now growing among the grass.

The landowner is concerned that the 70 ft. high dying tree behind the house could fall in the stream. This beech tree is 50 ft. from the streambank and is more likely a threat to the house. The owner would like to have the tree removed. It was also noted during the site visit that the propane tank by the house is in the floodplain.

- 3) **Use vegetative treatments such as willow stakes to address minor localized erosion.** Bioengineering, the use of live vegetation, either alone or in combination with harder materials such as rock or (dead) wood, to stabilize soils associated with streambanks can be used at this location. Dormant materials such as willows quickly establish vegetation on the banks. Willow stakes are cut from living willow shrubs when the shrub is dormant (usually during the fall). The stakes, ranging from one to several feet long, are hammered or pushed into the stream bank where they will grow quickly and provide necessary bank stabilization where it is needed most. A willow stake detail drawing is attached.

- 4) **Use live fascines.** Live fascines are a standard bio-engineering technique which involves the bundling and planting of dormant plant cuttings. The plant bundles sprout and develop a root mass that will hold the soil in place and protect the streambank from erosion. A willow fascine detail drawing is attached.

- 7) **Remove fencing that is close to dynamic stream.** Obstructions in the floodplain interrupt the flow of flood water on the floodplain, and can accumulate debris. Obstructions promote accelerated flow velocities and result in increased erosive power of flood flows.

10) Seek advice from your fuel supplier on proper anchoring of propane tank located in the floodplain to prevent flotation or lateral movement during a flood.
