# **Local Flood Analysis**

**Town of Shandaken Along Esopus Creek  
Hamlets of Phoenicia and Mt. Tremper  
Ulster County, New York  
June 2016**

MMI #4615-04-6

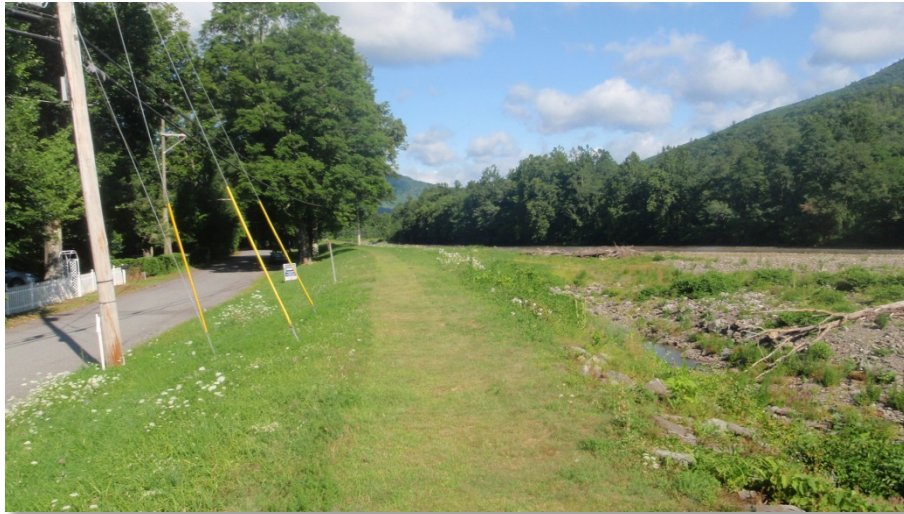
Esopus Creek is lined by a flood control levee as it flows through Mt. Tremper. According to information on the NYSDEC website and on signs placed on site, the levee project was authorized pursuant to Section 2 of the 1937 Flood Control Act as amended. The original project was operationally completed in 1952 and was modified in 1954 to provide for strengthening the riprapped toe of the spoil bank and for shoal removal. Emergency repairs of the flood-damaged spoil bank were made under authority of Public Law 84-99 in fall 1980 (NYSDEC website, 2015). The levee is not certified by FEMA, indicating that it does not meet FEMA's standards for design, operation, and maintenance. As a result, flood elevations indicated on the FIS and on FIRMs have been computed as if the levee did not exist.

**Flood Control Levee Along Esopus Creek in Mt. Tremper**

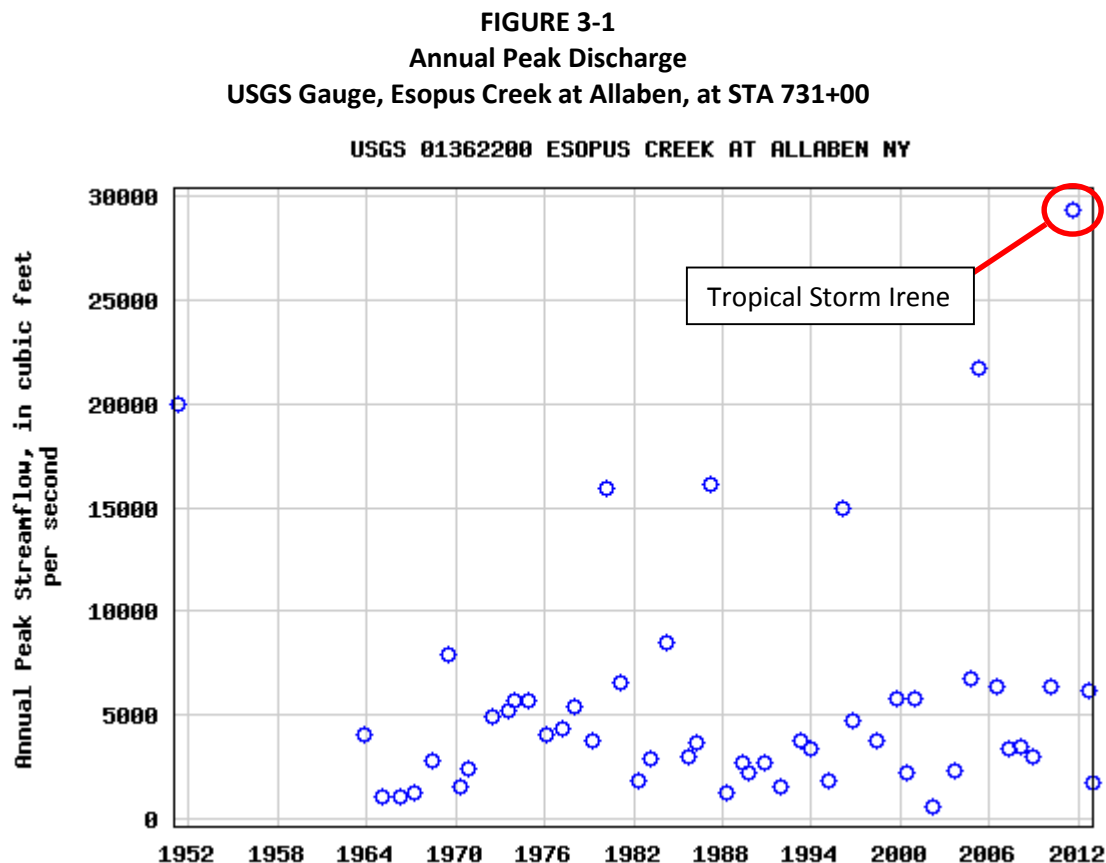
**FIGURE 3-2**  
**Annual Peak Discharge**  
**USGS Gauge, Esopus Creek at Cold Brook, at STA 123+50**

Figures 3-1 and 3-2 show annual peak flows recorded at the USGS gauges on Esopus Creek at Allaben and Cold Brook, respectively. These figures illustrate that Tropical Storm Irene produced the largest discharge ever recorded on Esopus Creek since the time that the gauges were first established (October 1963 at the Allaben gauge and October 1934 at the Cold Brook gauge).

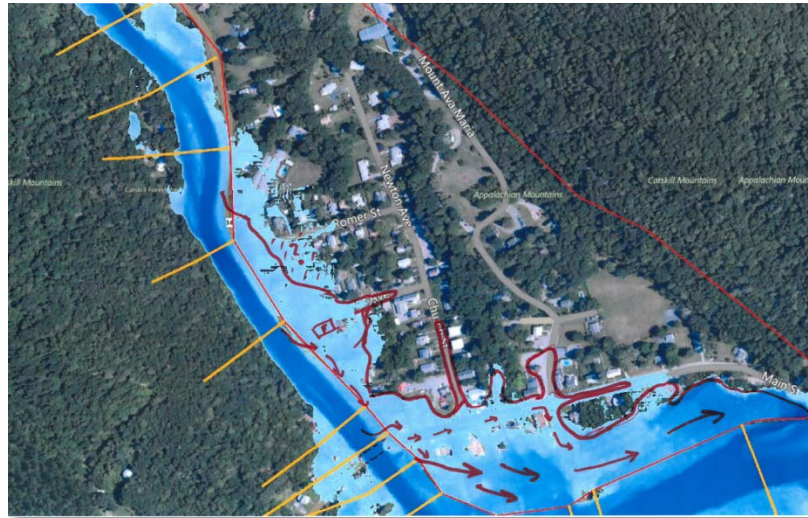
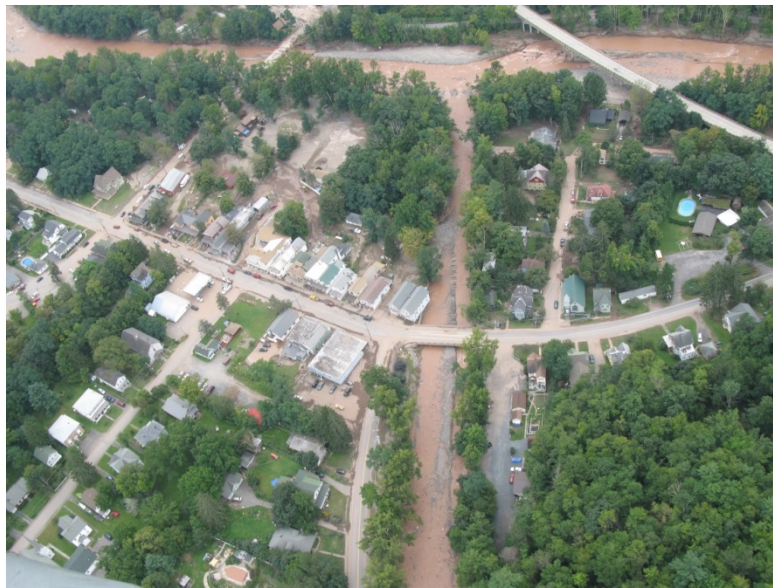
coefficients were adjusted. Water depths in the one-dimensional portions of the model are similar to FEMA modeled levels. The water depth and extent in the two-dimensional area is less than shown in the FEMA mapping for the Stony Clove. The extent of flooding along the Esopus matches FEMA modeling well.

**Example of Aerial Photographs Used for Hydraulic Model Calibration**

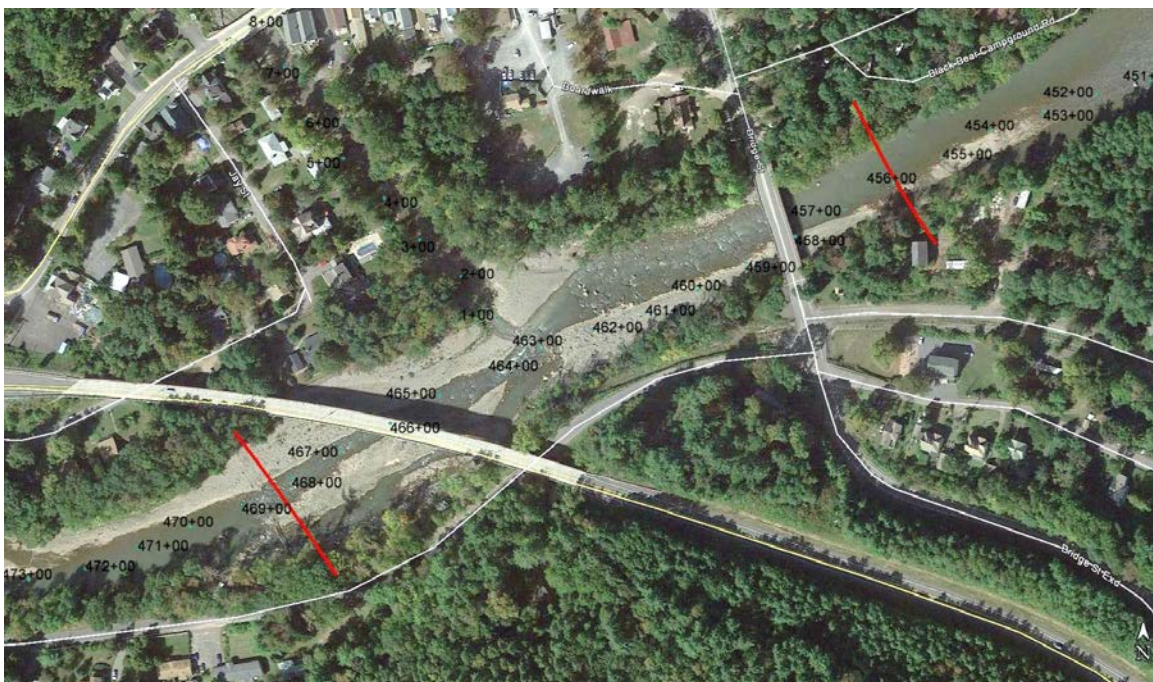
**Figure 4-6**  
**Location Along Esopus Creek Where Dredging of Channel Was Modeled**

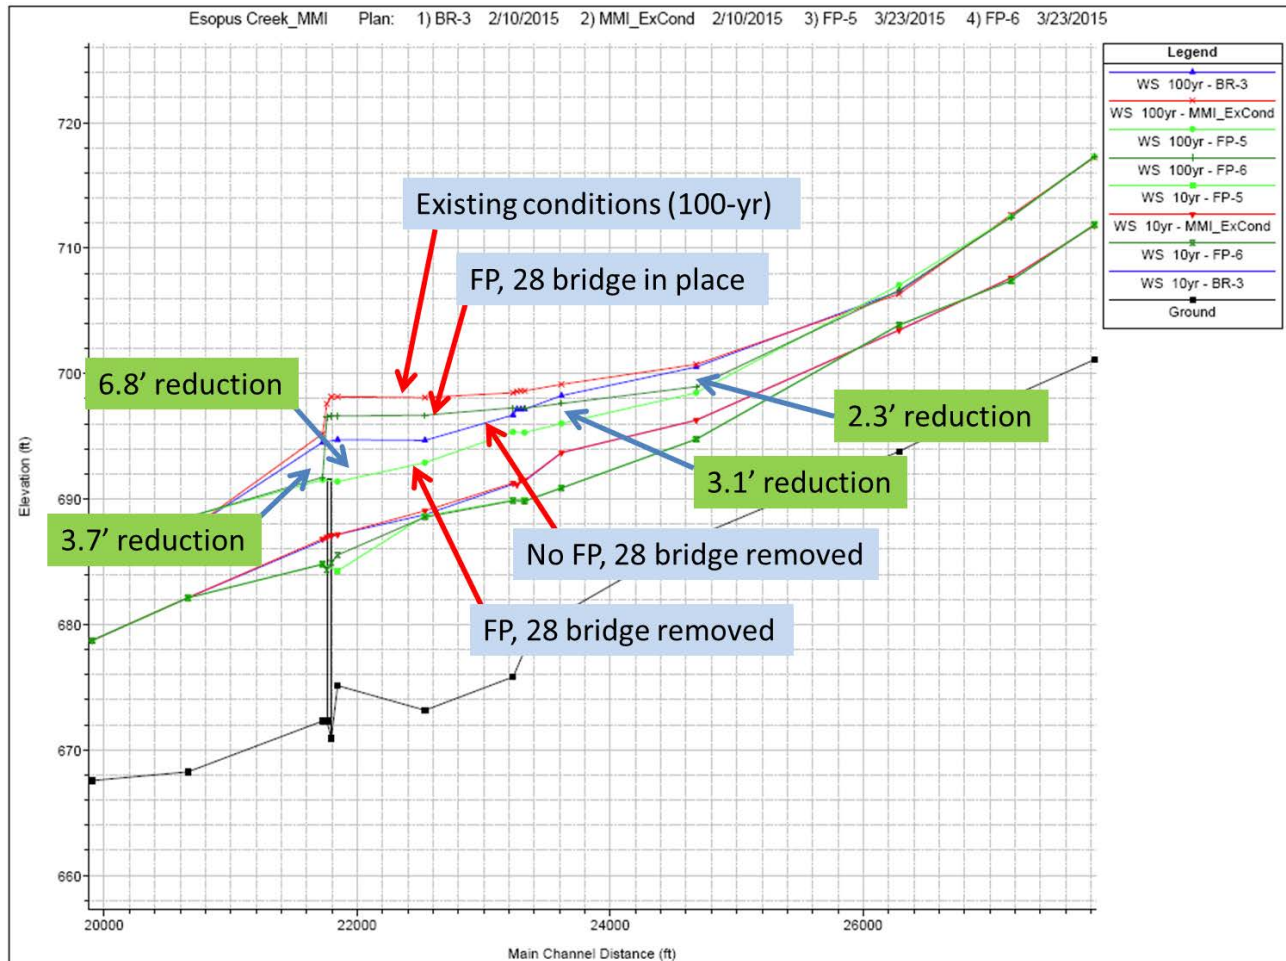
**Figure 4-17**  
**Water Surface Elevation Reductions – 100-Year Flood Event**  
**Mt. Tremper Floodplain Enhancement and Bridge Replacement Scenario**

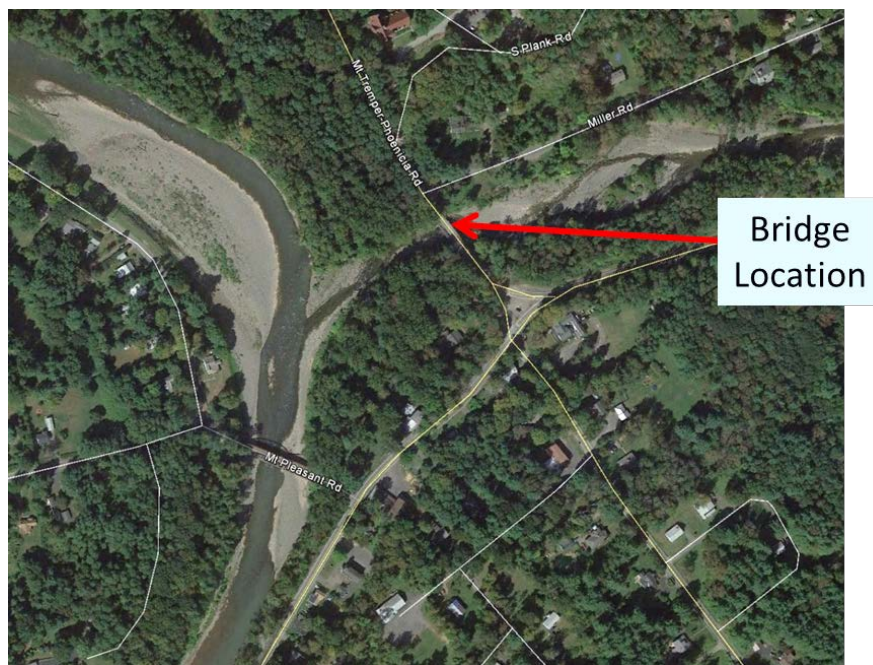
The Plank Road bridge crosses the Beaver Kill at STA 6+25 (Figure 4-20). The bridge is a steel truss design with abutments on each bank and connects Plank Road with State Route 212. Hydraulic modeling was conducted to determine the effect replacement of the bridge with a larger structure would have on floodwater elevations. Modeling indicates that replacement of the bridge with a hydraulically adequate structure would reduce water surface elevations immediately upstream of the bridge but with only marginal benefit to homes and roads in the vicinity. Water surface elevation reductions are shown on Figure 4-21 (water surface profile) and Figure 4-22 (flooding depth map). Replacement of the bridge with a new bridge with a larger hydraulic opening has potential for flood reduction and was, therefore, advanced as a flood mitigation alternative.

**Figure 4-20**  
**Plank Road Bridge Over Beaver Kill**

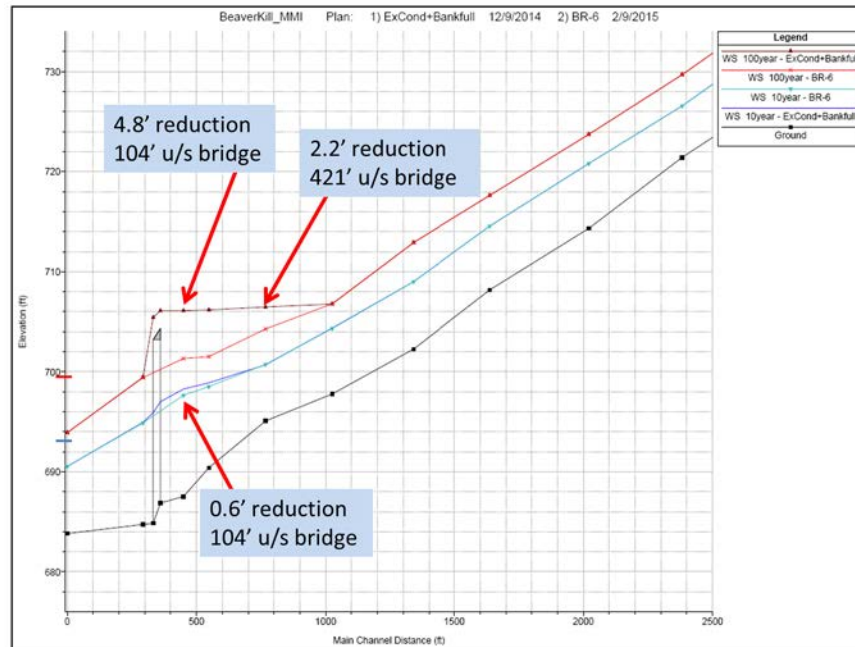
**Figure 4-21**  
**Water Surface Elevation Reduction Resulting From Replacement of Plank Road Bridge**  
**10-Year and 100-Year Flood Events**
