# *Upper Rondout Creek*

## *Stream Management Plan*

This document is a summary of the comprehensive Stream Management Plan document (374 pages), available as a downloadable PDF at [www.catskillstreams.org](http://www.catskillstreams.org). Hard copies are available at the Rondout Neversink Stream Program field office at Neversink Town Hall (2nd floor), Denning and Neversink Town Halls, Daniel Pierce Library in Grahamsville, and Sundown Church Hall.

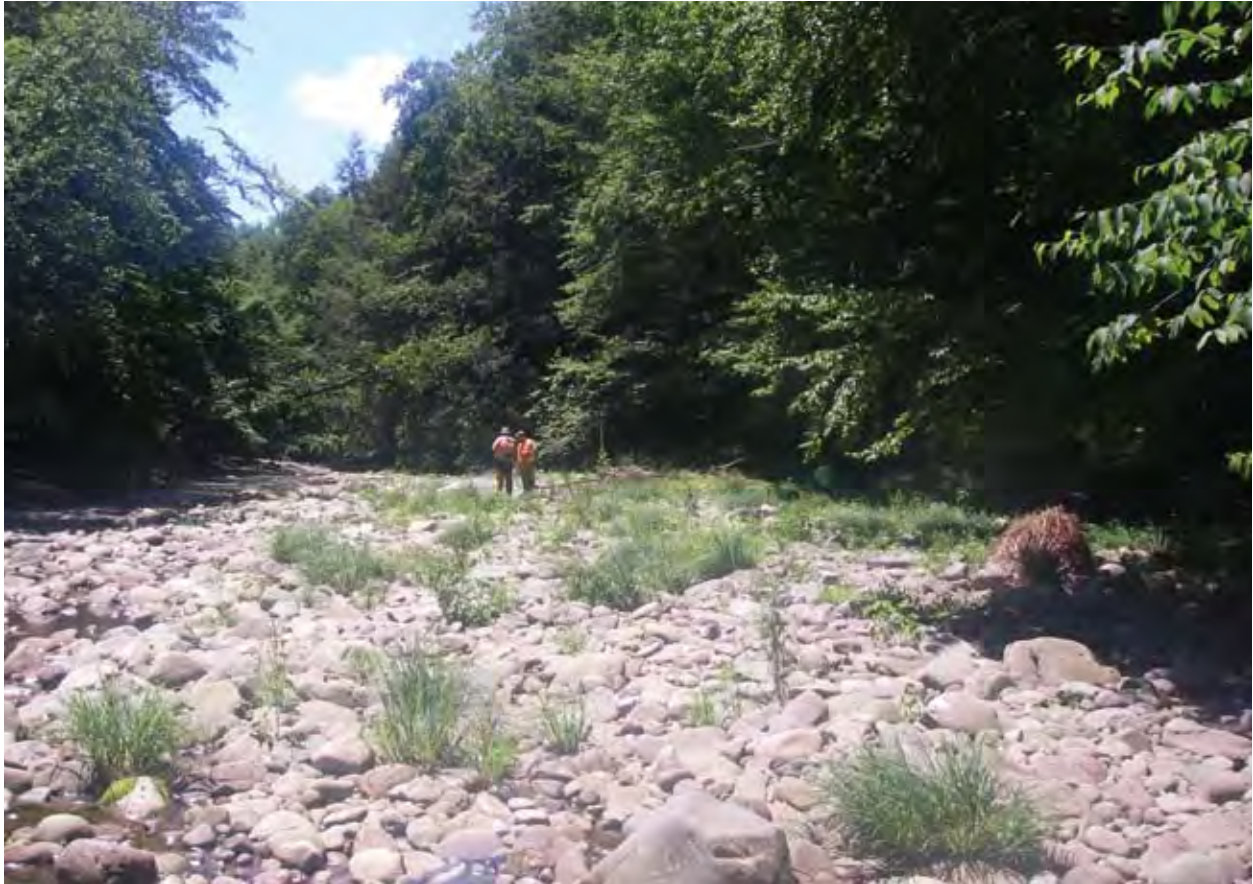
*An aggrading streambed builds up material because its slope or depth does not allow it to move downstream.*

*degrade* and, ultimately, to become *incised*, like a gully in its valley. Both situations — aggradation and degradation — mean that the stream reach has become unstable, and both can lead to rapid bank erosion, as well as impairment of water quality and stream health. Worse yet, these local changes can spread upstream and downstream, causing great lengths of stream to become unstable.

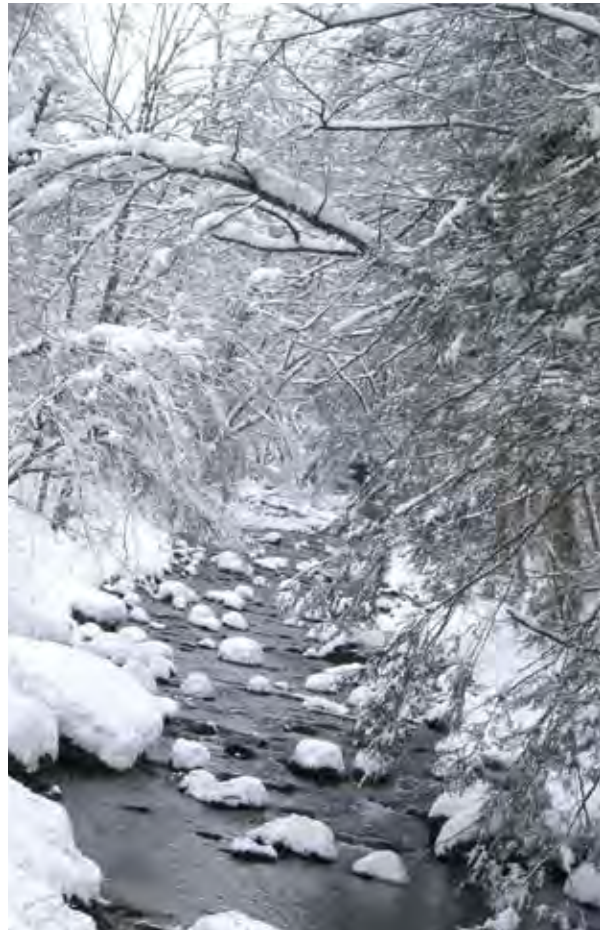
*Stable streams regain their previous form after both a small or large flood and are less likely to experience bank erosion, water quality or habitat problems.*

Stable streams are less likely to experience bank erosion, water quality and habitat problems. The management plans being developed for landowners by the Stream Management Program generally describe the current condition of the stream form and streamside vegetation throughout the watersheds they address, and then make recommendations for protecting healthy sections of stream and for restoring the stability of those sections that are at risk.

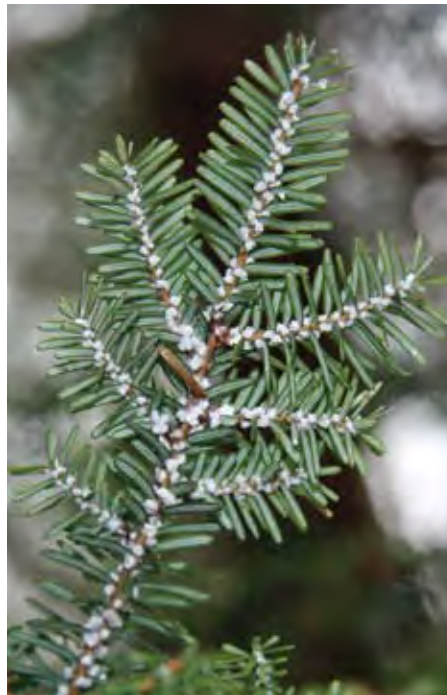
*Hemlock Woolly Adelgid, the invasive insect, attacks trees by feeding on sap at the base of the needles.*

The Olive Natural Heritage Society, Inc. is monitoring the advance of the hemlock woolly adelgid in the Catskills and is working in cooperation with NYS DEC on testing releases of *Pseudosymnus tsugae*. Due to the widespread nature of the infestation, the use of chemical pest control options such as dormant oil would most likely provide little more than temporary, localized, control. The use of pesticides to control adelgid is not recommended in the riparian area due to potential impacts on water quality and aquatic life.

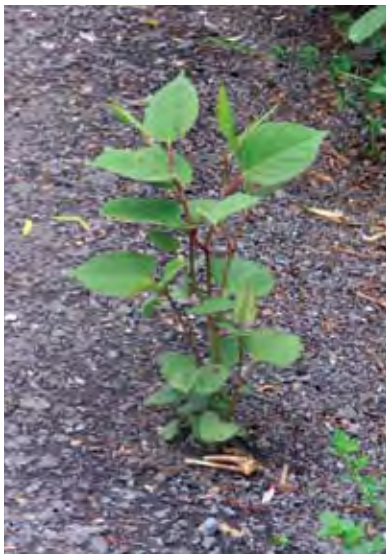
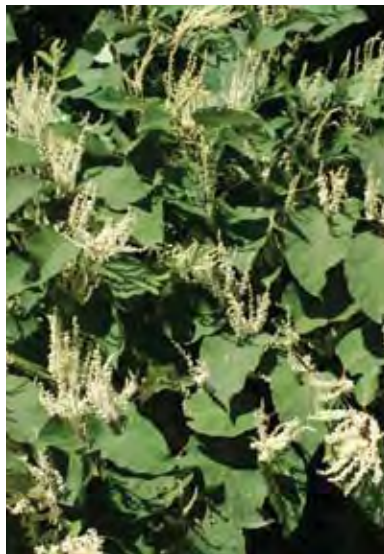
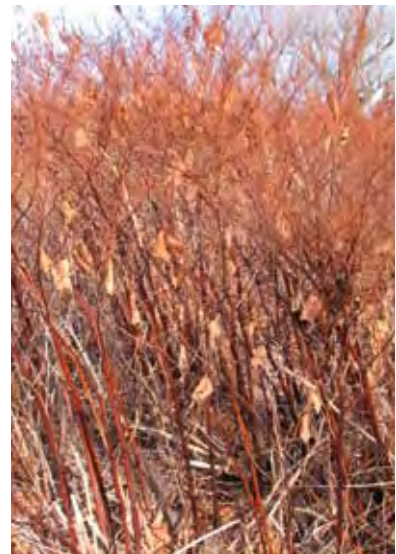
*Japanese knotweed: first shoots emerge (spring); full bloom (summer) and dried stalks (after killing frost).*

- Knotweed appears to be less effective at stabilizing streambanks than shrubs and trees with deeper roots, possibly resulting in more rapid bank erosion.
- The shade of its broad leaves and the cover by its dead litter limit the growth of native plants that provide food and shelter for associated native animals.
- Knotweed branches do not lean out over stream channels, providing little cooling from shade.
- Dead knotweed leaves (detritus) may alter food webs and impact the food supply for terrestrial and aquatic life.
- Large stands of knotweed impede access to waterways for fishing and streamside hiking.
- Knotweed may alter the chemical make-up of the soil, altering soil microfauna and soil properties.

- Japanese knotweed is very difficult to control. One small fragment of stem or underground root can start a whole new stand, often spread by floods or inadvertent transport through fill or cutting. The broad use of herbicides, while partially effective, is not a viable option due to the threat chemicals pose to water quality and the fragile aquatic ecosystem. Mechanical control, by cutting or pulling, is labor intensive and requires regular attention to remove any re-growth. Biological controls are untested. While Japanese knotweed colonizes nearly five continuous miles of stream banks in some areas of the Catskills, the Rondout Creek has primarily only one large stand and a few smaller, manageable stands.

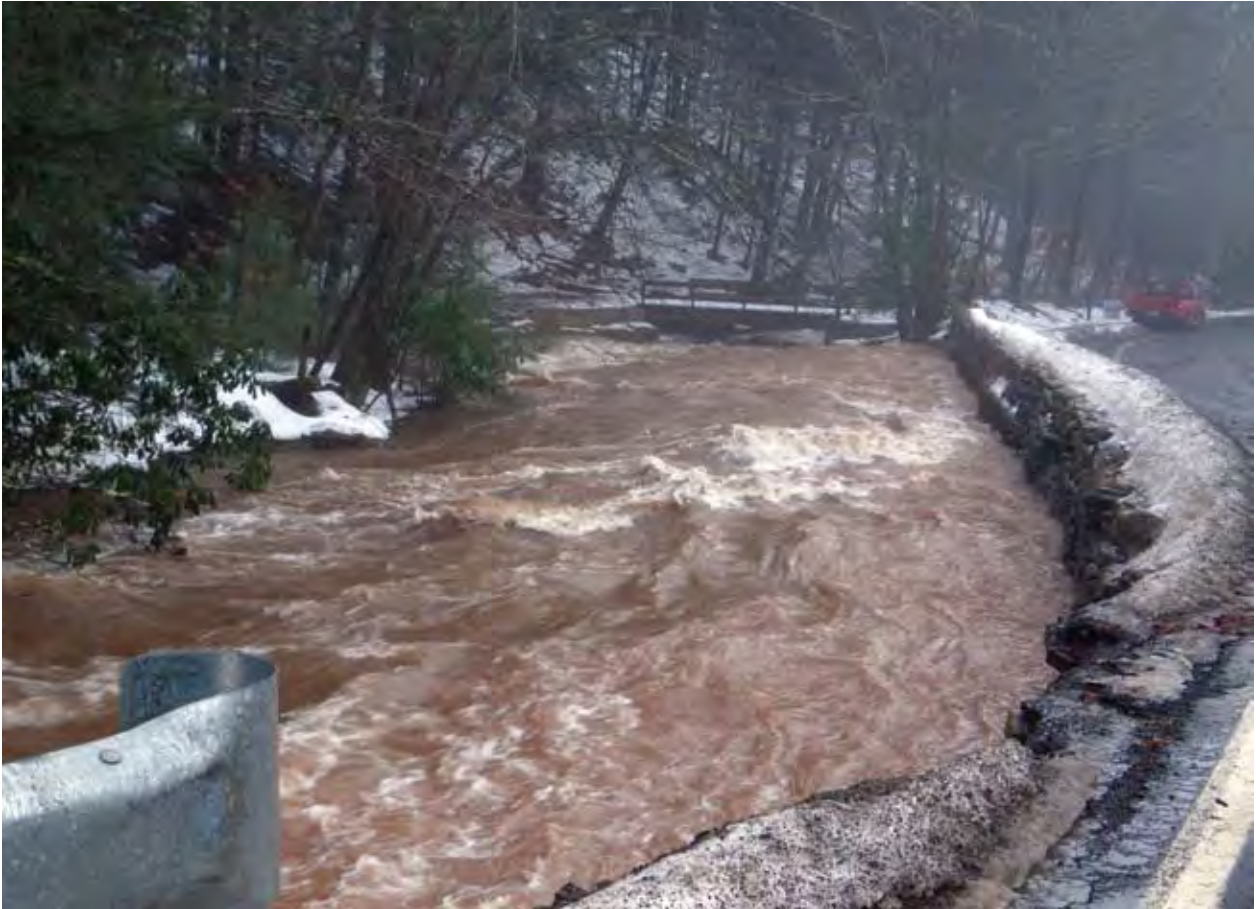
*Turbidity measures high during storm events when the Rondout Creek looks muddy because of escaping sediment from natural sources, January 2010.*

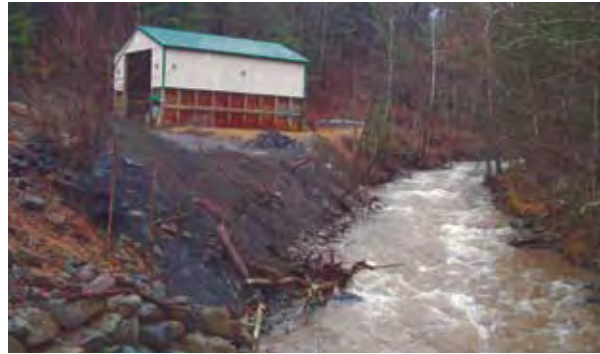
*Plan: provide a buffer for activities at highway garage storage yard.*

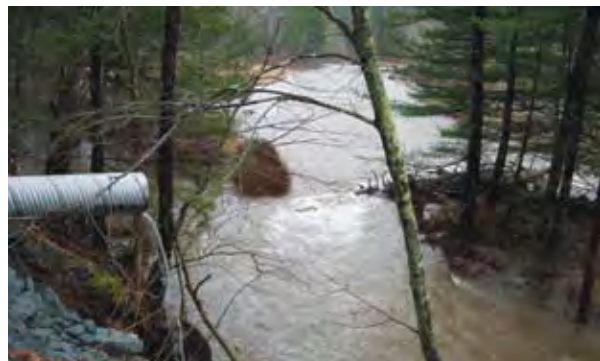
*Plan: Re-establish proper stream channel to protect a road embankment critical to the community.*

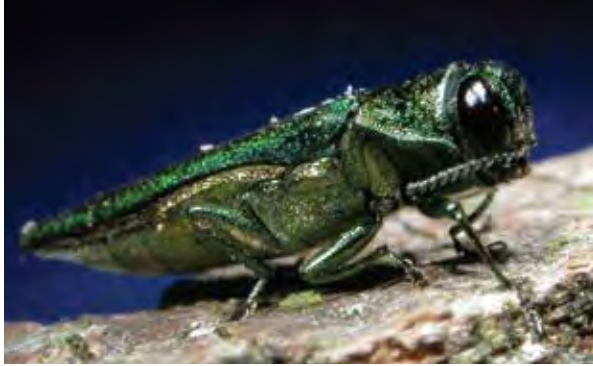
*Emerald Ash Borer*

*The Emerald Ash Borer, left and the katydid, right, shown at same life size scale.*
