IV-H: Riparian Vegetation

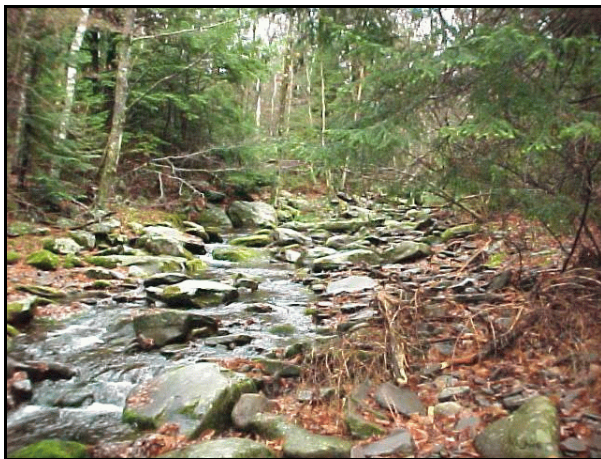
Figure IV-30: Riparian buffers provided stability, habitat and cooling benefits along the stream corridor.

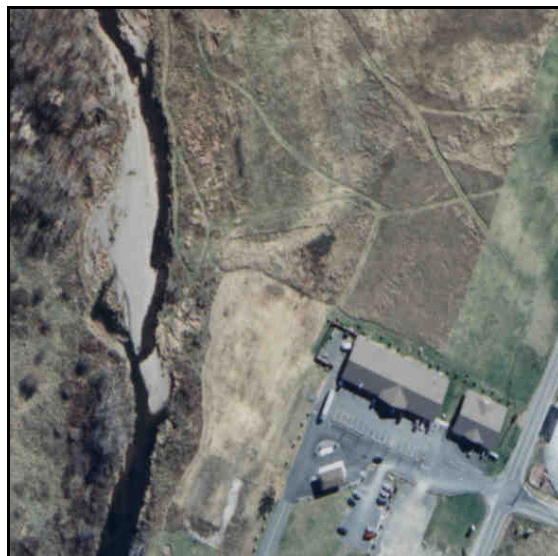
Figure IV-31: This reach behind Alpine Village complex exhibits poor riparian conditions and is highly unstable

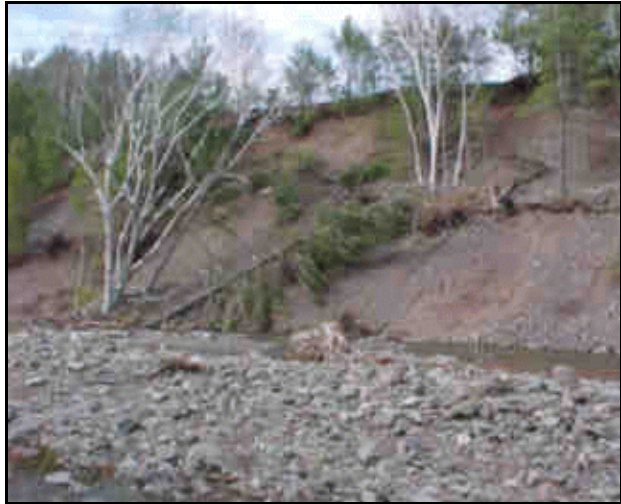
Figure IV-32: Under conditions of extreme stream instability, riparian vegetation can be ineffective in providing streambank stability as shown in this eroded terrace in Big Hollow.

The presence of a riparian buffer does not always ensure stability of the stream system. If the geomorphic form of the stream becomes unstable and is undergoing adjustments, even a mature forest buffer can be lost or seriously damaged as the stream undergoes changes. In the flood event associated with Tropical Storm Floyd in 1999, the GCSWCD observed erosion of streambanks in areas with good buffers, with some banks moving as much as 50-75 feet in the flood event and the loss of hundreds of mature trees. Consequently, the planting of stream riparian buffers should only be undertaken when the stream’s geomorphic condition is basically stable and major changes in the stream channel are not actively underway.

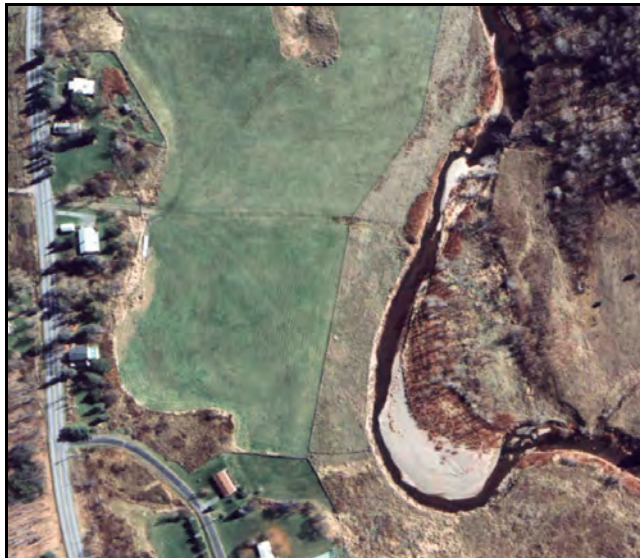
Figure IV-33: In this field in Ashland behind Carrington Road, note the absence of riparian vegetation along the fields. The GCSWCD has measured migrations of this meander bend of over 40 feet in a single storm event.

In this reach, agricultural operations, road construction, and other human activities as well as stream instability processes have significantly degraded the riparian zone and there are numerous areas where streambank erosion and lack of shade cover are impacting the stream. Ironically, in this section of the Batavia Kill stream system, the presence of loose, unconsolidated alluvial soils and “C” type streams makes the presence of vegetation critical to long-term stream stability.

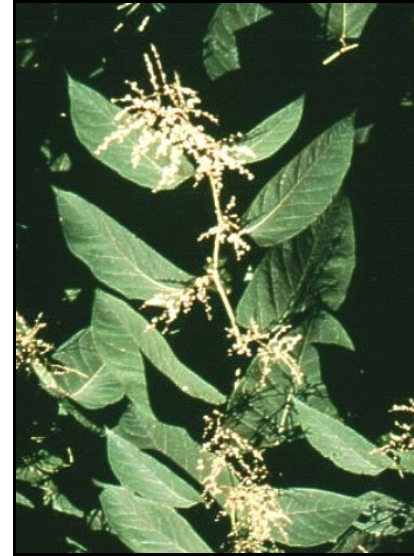
Figure IV-34: Japanese Knotweed has distinctive broad leaves, large hollow stems and small white flowers in the fall.

Knotweed can grow to an average of 8' in height and it is characterized by a stout, round, hollow stem and broad leaves (Japanese Knotweed Manual, 1998). It grows in very dense clumps. The plant is generally associated with areas of disturbance, where it quickly colonizes open ground and disturbed soils. The plant’s primary method of reproduction is rhizomes, which can regenerate a plant population from small fragments that are easily transported through the stream system by flood flows. The aggressive growth habit of

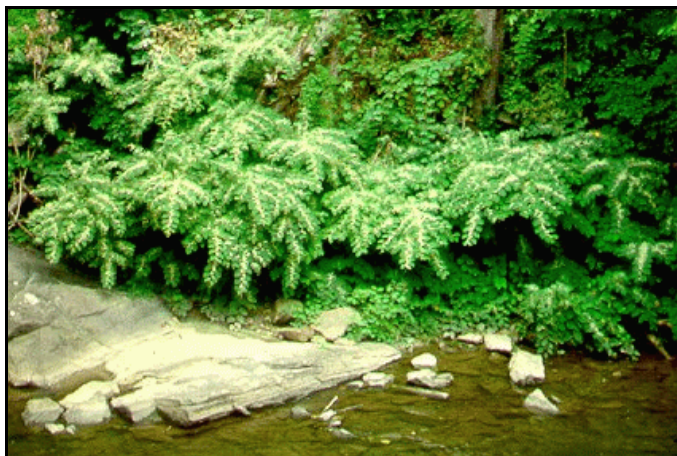
Figure IV-35: The aggressive growth habit of knotweed forms dense clumps which overshadow more beneficial species of riparian vegetation.

knotweed allows it to out compete native vegetation for nutrients and sunlight. Most clumps of knotweed are so dense that little or no sunlight penetrate its leaf cover. This slows the native plant growth under its canopy and in most cases, knotweed quickly out competes native plants, resulting in a monoculture vegetative community.
