UPPER ESOPUS CREEK MANAGEMENT PLAN

Volume III

Watershed and Stream Characterization

Prepared by
New York City Department of Environmental Protection
US Army Engineer Research Development Center
Cornell Cooperative Extension – Ulster County
January 2007

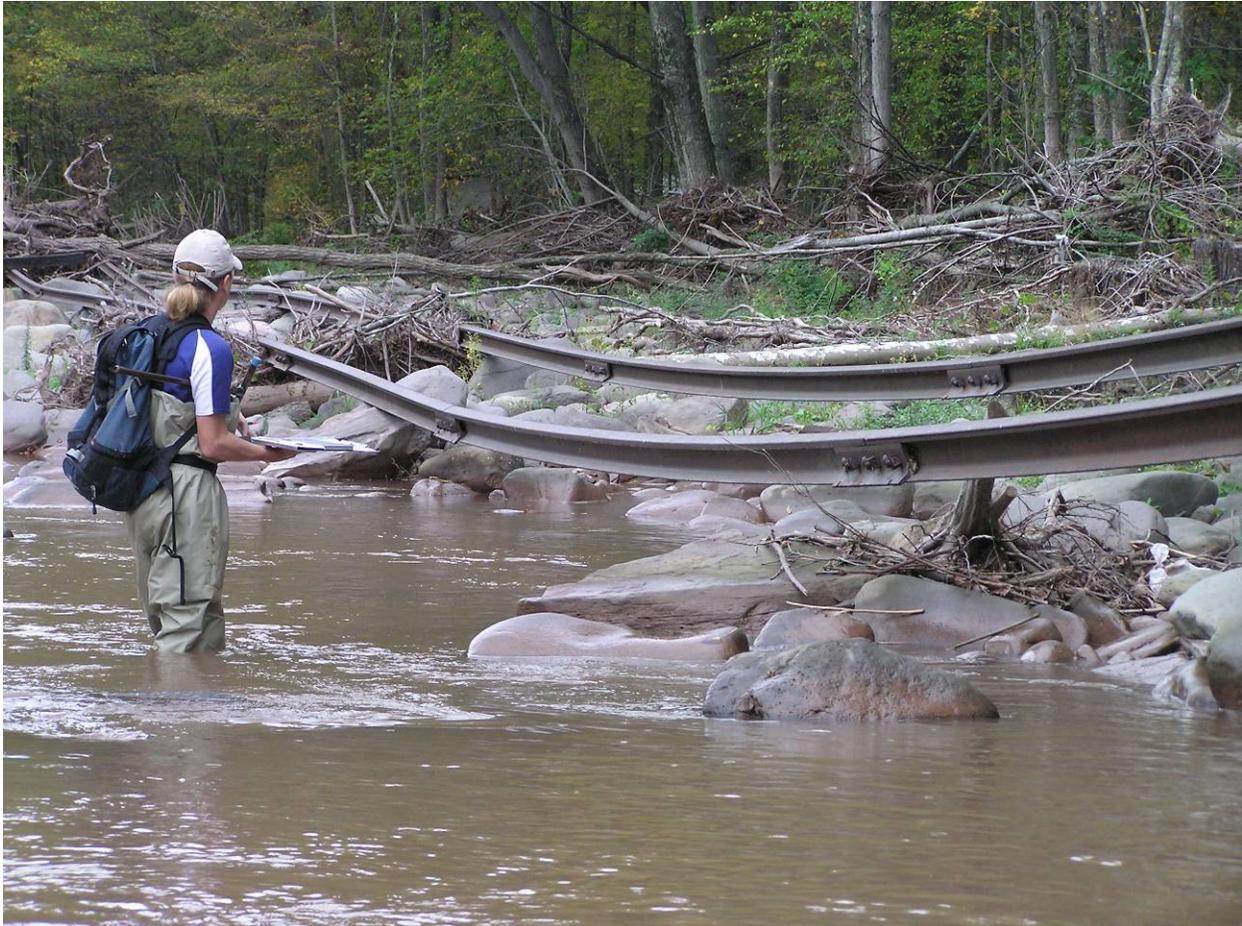
Photo 1.1 Inventorying stream erosion, damage to infrastructure, and woody debris along Upper Esopus Creek. October, 2005

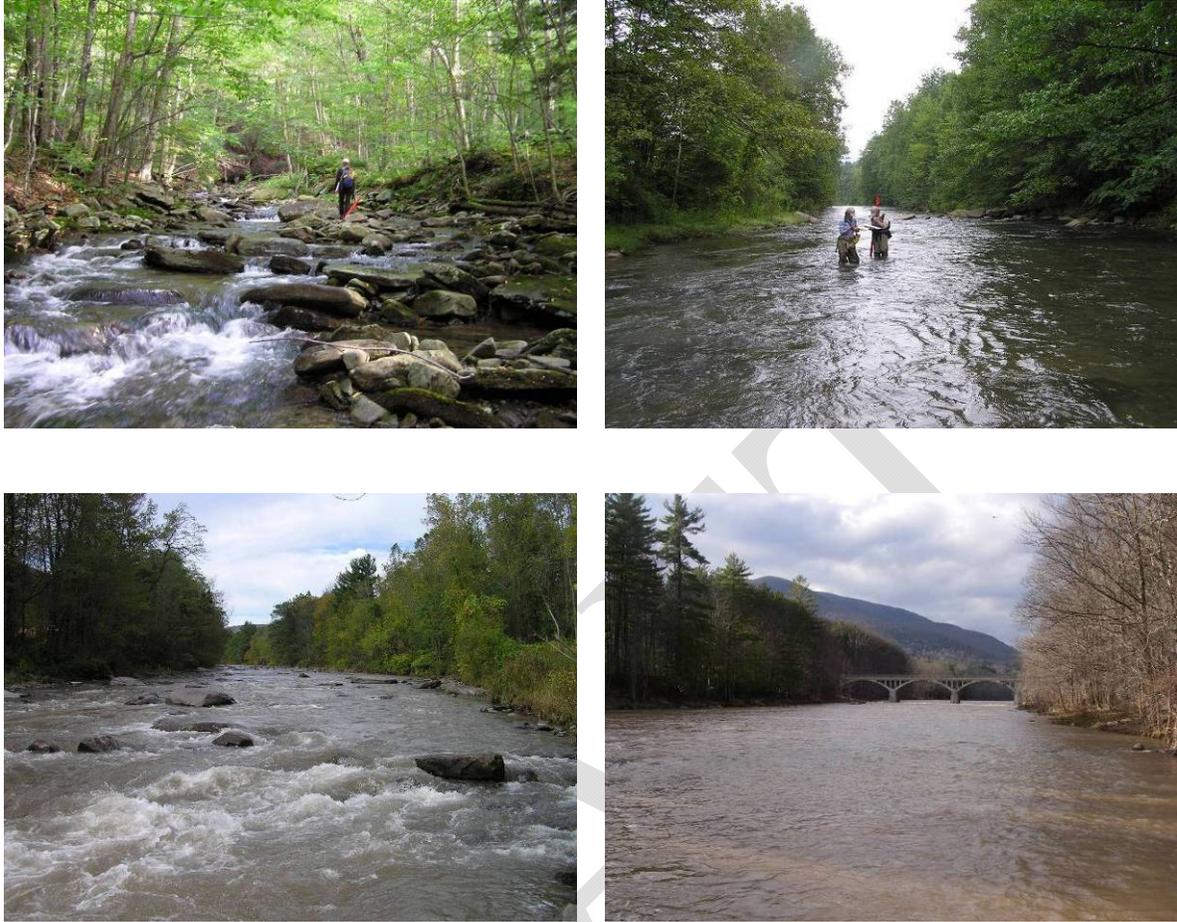
Photo 2.2 Varying stream slope from headwater reaches to just above Ashokan reservoir

Figure 2.3 graphs the stream's slope from Winnisook to Ashokan Reservoir. The slope along Esopus Creek ranges from 13% in the cascading headwater reaches down through 3% – 0.5% as the stream descends to Boiceville. (**Photo 2.2**). The average slope, or gradient, for Esopus Creek along this course is 1.5%. Any stream with an average slope greater than 0.2% is classified as a mountain river or stream. This is significant because management of mountain streams is considerably different than for lower gradient streams given differences in stream condition.

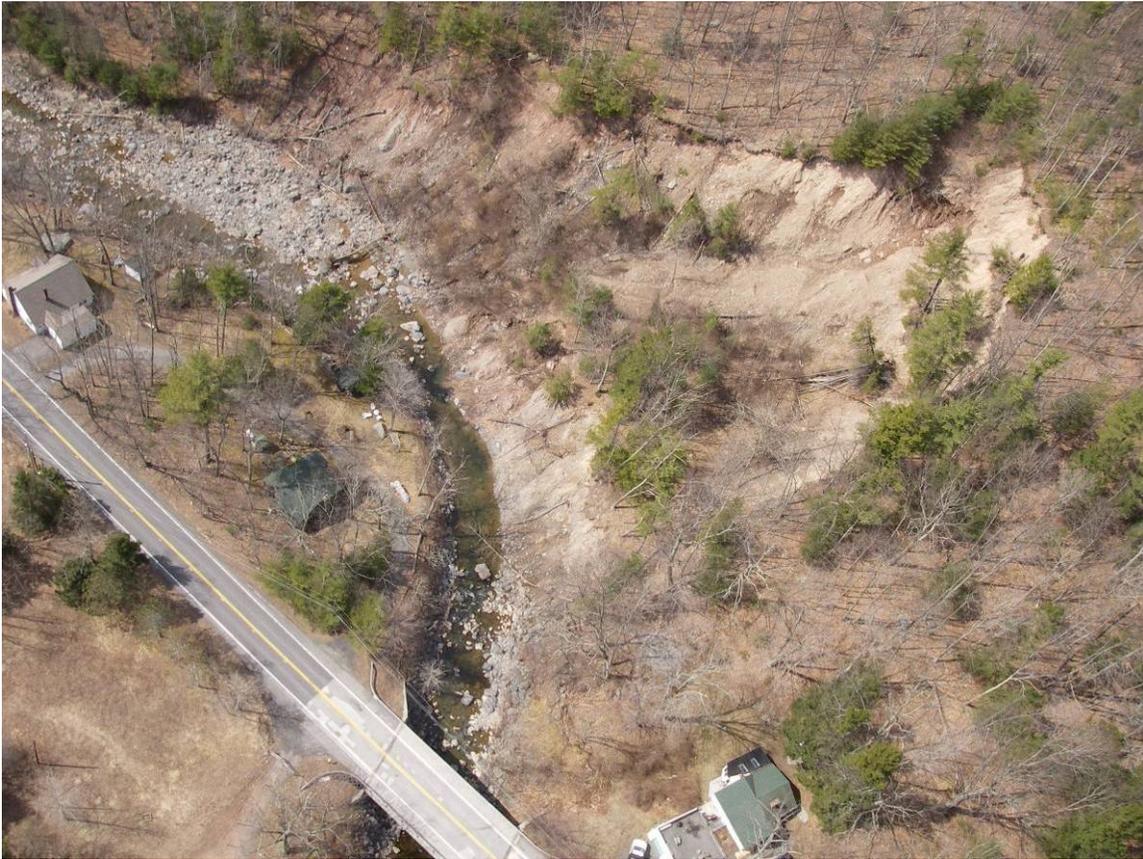
Photo 2.6 Landslide next to Beaver Kill just upstream of Esopus Creek confluence. The hill slope failure exposes glacial deposits

The most recent ice ages – the time that spanned the last 30,000 years or so – had giant continental-sized ice sheets flowing across the northern landscape (**Figure 2.9a**). The ice sheet covering Greenland (**Figure 2.9b**) is a modern day analog to those Pleistocene conditions. The continental glaciers scoured and moved vast amounts of sediment across the landscape. Once the ice sheet started melting back into the Hudson River valley and to the north, smaller alpine glaciers formed in the mountains and further sculpted the landscape. The glaciers left a legacy that still profoundly influences hill slope and stream channel stability and water quality (**Photos 2.6 and 2.7**).

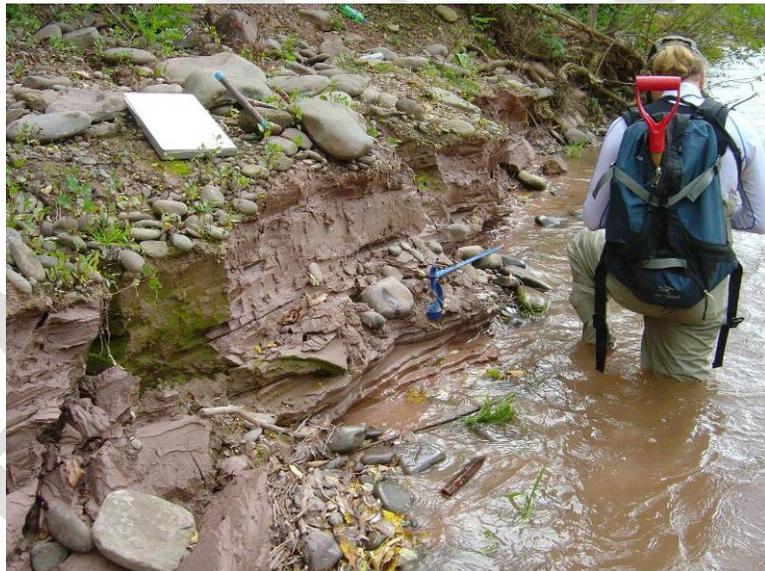
Photo 2.7 Stream channel and stream bank sediment derived from Catskill bedrock

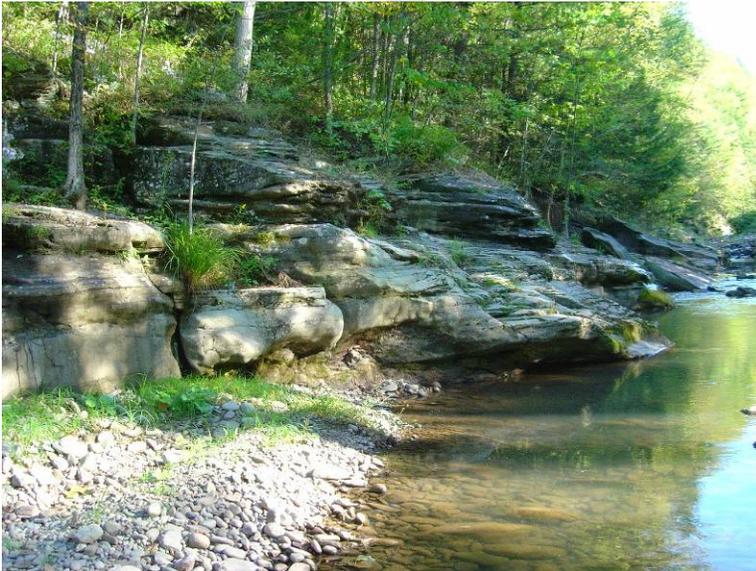
Photo 2.8 Outcrop of Oneonta Fm sandstone along Woodland Valley Creek

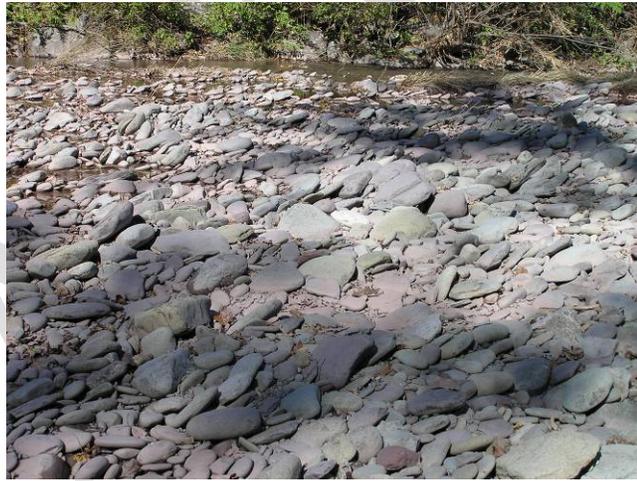
Photo 2.9 Example of imbricated Catskill stream sediment

Imbricated streambeds are thus generally more stable or “locked up”, and all other things being equal, generally require a larger flow to mobilize the bed material than nonimbricated beds. However this same platy shape can also, under the right conditions, act like an airplane wing and be lifted by the streamflow more readily than would a spherical particle of similar weight. Once this occurs for even a few particles, the imbrication is compromised and significant portions of the streambed become mobile.

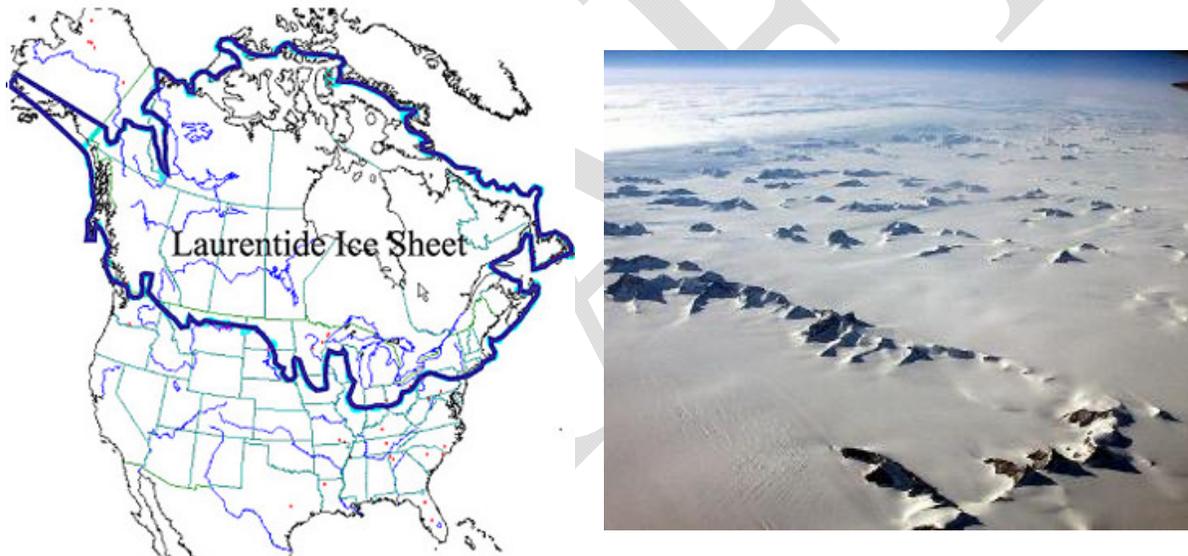
Figure 2.9 (a) map of Laurentide ice sheet. (b) Photo of Greenland ice sheet in mountainous terrain.

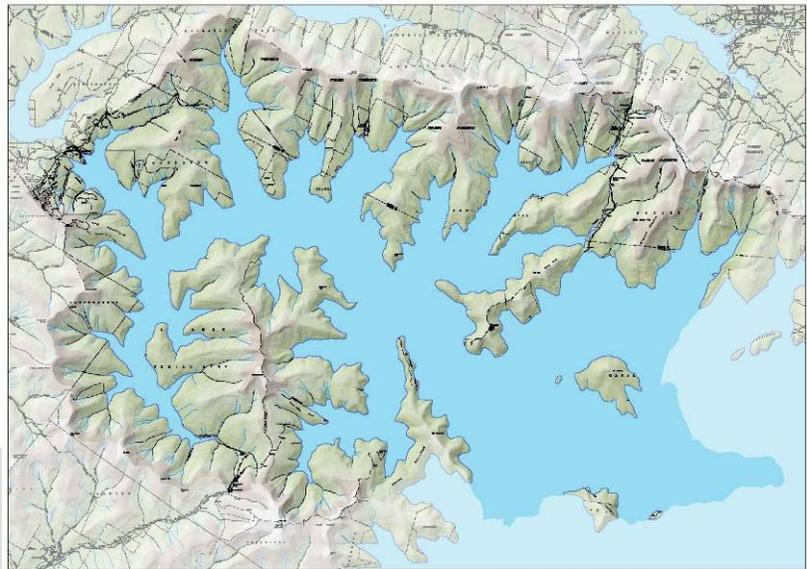
Figure 2.10. Map of hypothetical Lake Peekamoose based on Rich (1935)

“Fossil” deltas from meltwater streams pouring into large valley filling lakes occur at an elevation up to 564 m (Rich, 1935), exposing a large proportion of the catchment to the accumulation of layered fine sediment. As climate fluctuated during the period of deglaciation, temporary re-advances of ice from ice sheet lobes or alpine glaciers would leave till and other meltwater deposits on top of the earlier glacial material, resulting in the complex lateral and vertical distribution of glacial deposits observed today. After the ice fully retreated north, rainfall-runoff returned as the predominant sculptor of the landscape.

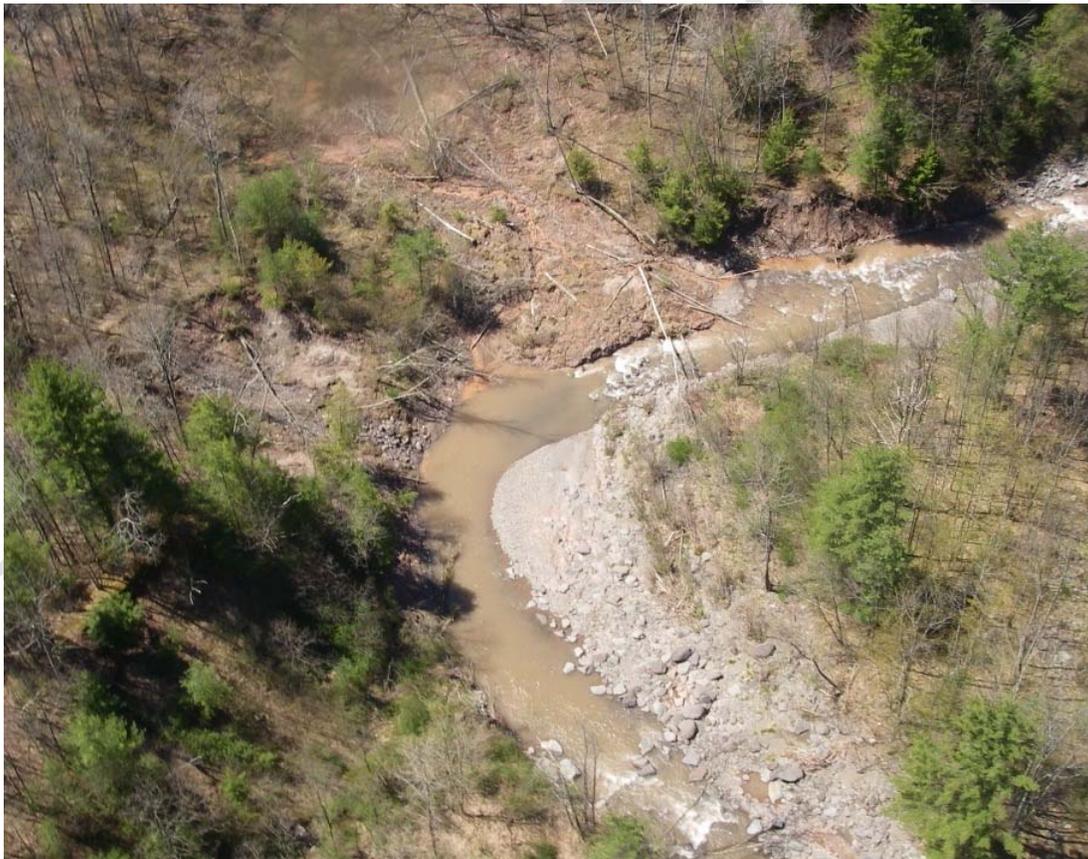
Photo 2.10 Hillslope failure and debris flow on Stony Clove

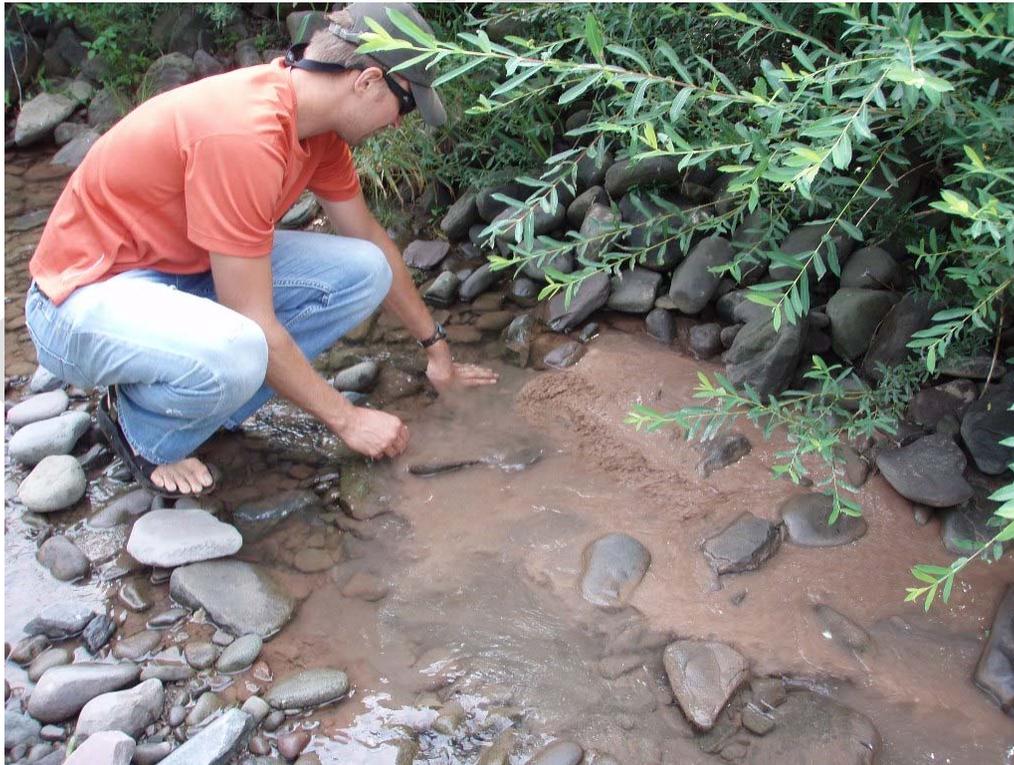
Photo 2.11 Artesian “mudboil” in Broadstreet Hollow stream bed. June, 2006

Groundwater flow through the complex glacial stratigraphy on the hill slopes is a major factor in the massive hill slope failures that impact stream channel conditions and water quality (**Photo 2.10**). The combination of stream erosion at the toe of the hill slope, fluctuating groundwater levels, differential seepage from the slopes and saturated sediment can result in very long-lasting, deep-seated slope failures. Examples abound throughout the watershed. Every major rainfall-runoff event seems to generate new slope failures or reactivate older failures. Some of the chronic turbidity sources in the tributary streams are from these hill slope failure sources, such as in Stony Clove, and the unique artesian “mud boil” condition that is recurrent in a reach of Broadstreet Hollow (**Photo 2.11**). The Broadstreet Hollow reach has been managed repeatedly through the years – first through traditional riprap revetment, then in 1999 by combined use of natural channel design (NCD) techniques and hill slope dewatering employed by Greene County Soil and Water Conservation District (UCSWCD, 2003). The April, 2005 flood that ravaged the Esopus Creek watershed caused significant erosion in this reach which helped reactivate the hill slope hydraulics leading to a reoccurrence of the artesian mud-boil.

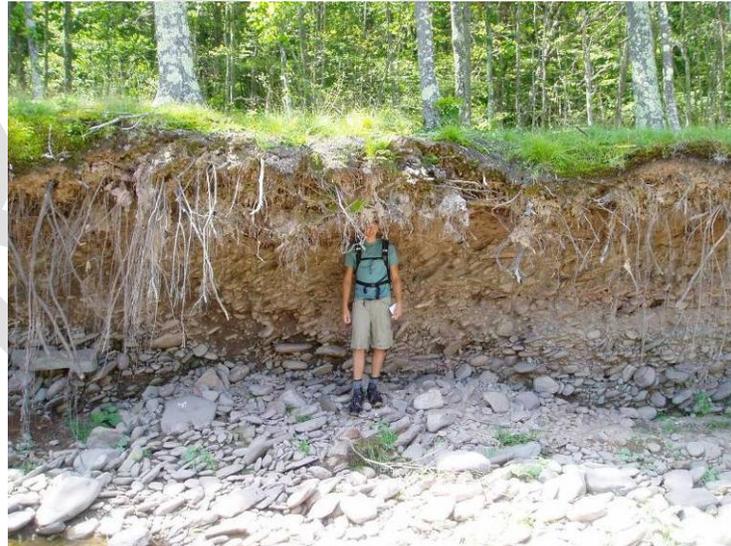
Photo 2.12 Coarse fluvial sediment comprises most of Upper Esopus Creek stream banks

This general term is applied to all unconsolidated deposits regardless of whether they were deposited directly as post-glacial stream deposits, glacial *outwash* (proglacial fluvial sediments), reworked outwash, *kame terrace* deposits, *melt-out till*, *moraine* deposits or reworked *lodgement till* (**Photo 2.12**).

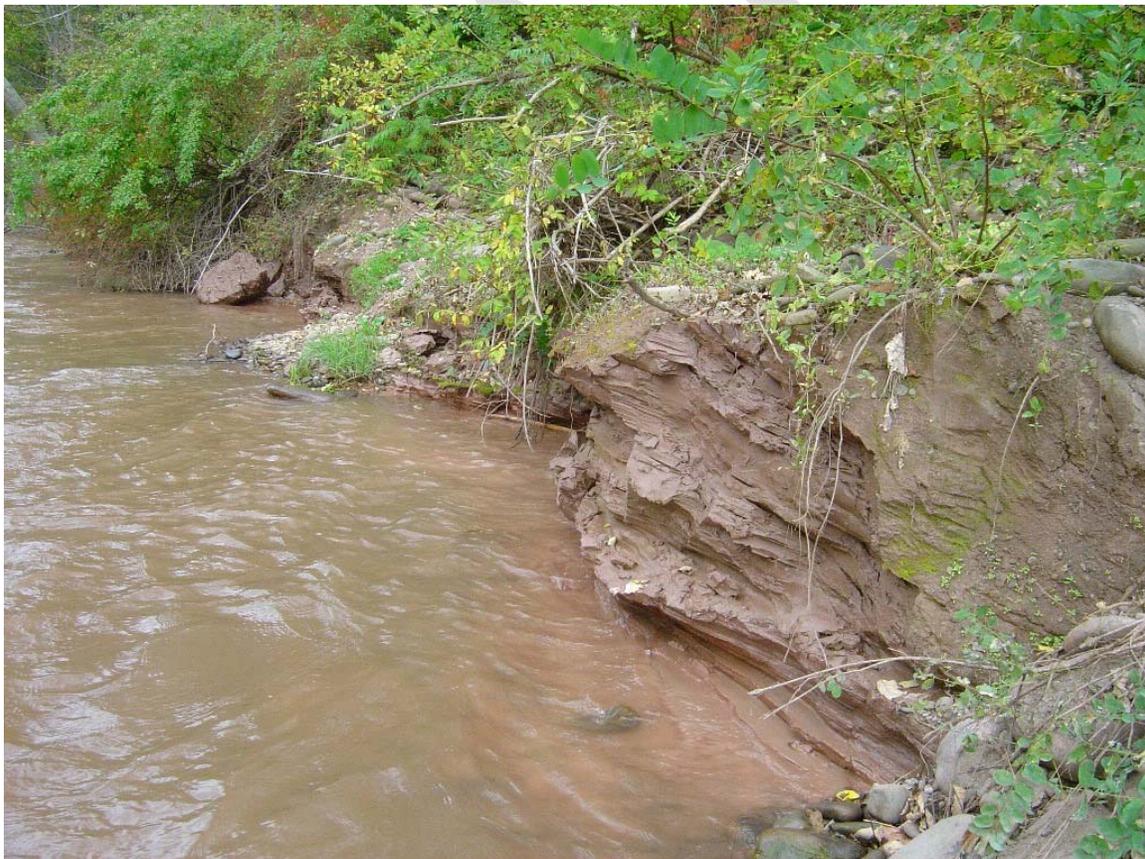
Photo 2.13 Esopus Creek streambank exposure of lacustrine silt/clay layers deposited in a proglacial lake that once filled the Upper Esopus Creek valley

sand sometimes occur, creating the potential for piping and associated mechanical failures. When saturated, it tends to be extremely soft and in this physically- and chemically-weakened condition is susceptible to creep and erosion.

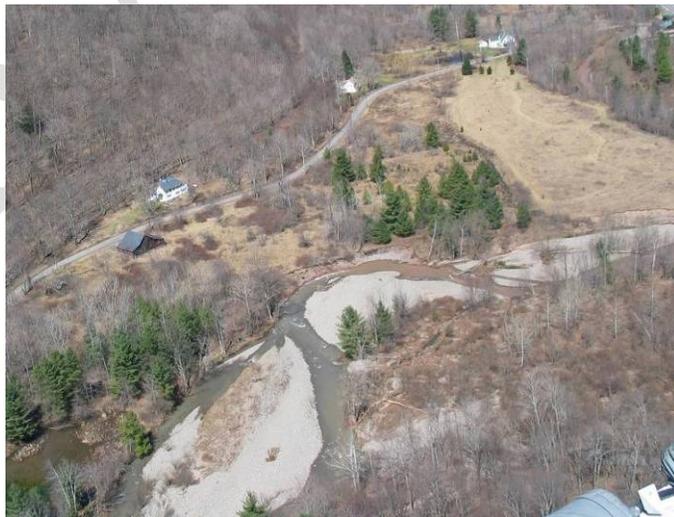
Photo 2.14 Esopus Creek above Birch Creek with exposed glacial lake deposits causing turbidity

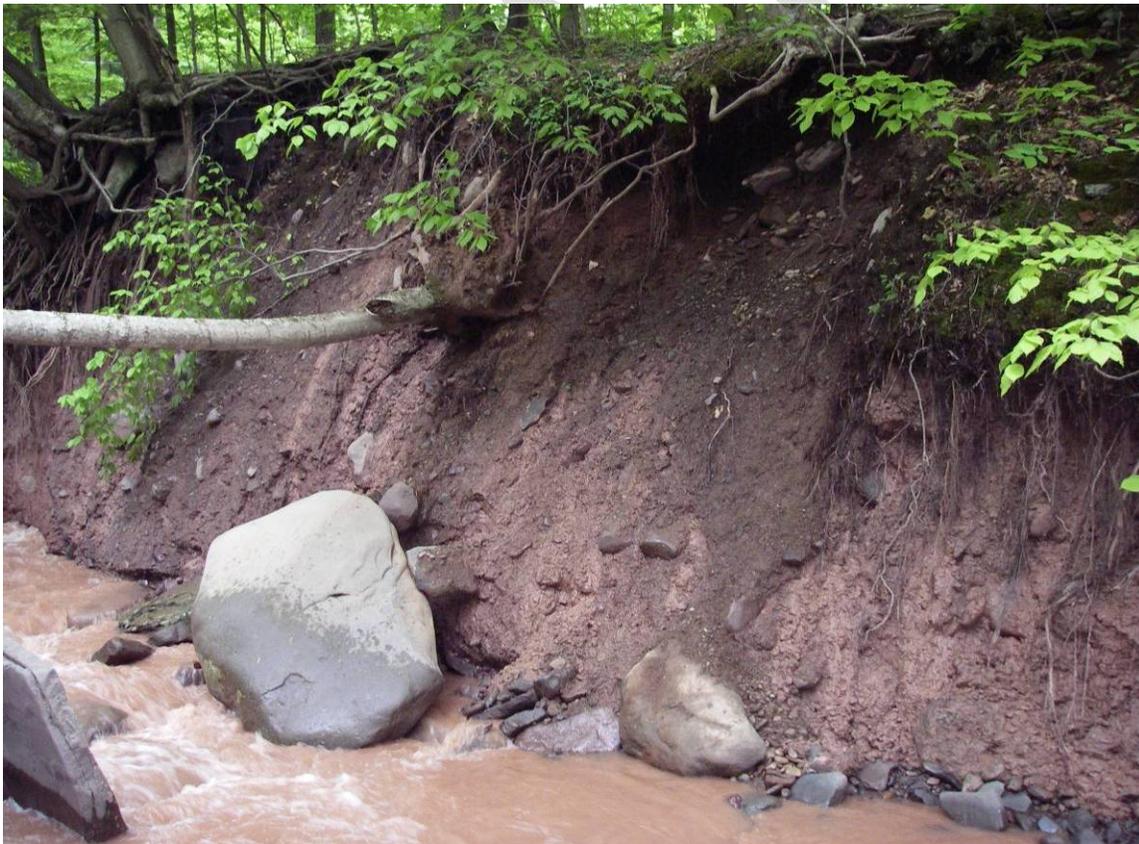
Photo 2.15 Glacial till exposed in Fox Hollow stream bank. Turbid water is from contact with glacial till.

This is an over-consolidated (very dense), clay-rich, reddish brown deposit that is prevalent in the Upper Esopus Creek watershed (**Photo 2.15**). This hard-packed silty clay with embedded pebbles, cobbles and boulders forms a number of steep banks in the drainage basin. Its dense, consolidated character is distinguished from the looser assemblage of mixed sediment sizes (silty sand-boulder) that comprises melt-out till found in moraines and along mountain sides. It is typically exposed in stream channels where overlying lake clay deposits have been removed by erosion, where streams have scoured into valley wall deposits or where they have breached morainal ridges.

It's relatively competent nature, especially compared to disturbed lacustrine sediment; make it significantly more resistant to hydraulic erosion. It is however, susceptible to mechanical erosion by mass failure of fracture bound blocks during saturation/desaturation and freeze/thaw cycles. This failed material is subsequently eroded by streamflows. Under conditions of high stream velocities and discharges, lodgement till is a contributor of sediment. However, where the stream (particularly in tributary valleys) is against the valley wall and the hill slope composed of lodgment till is saturated, long-lasting exposures can be chronic sources of suspended sediment into the

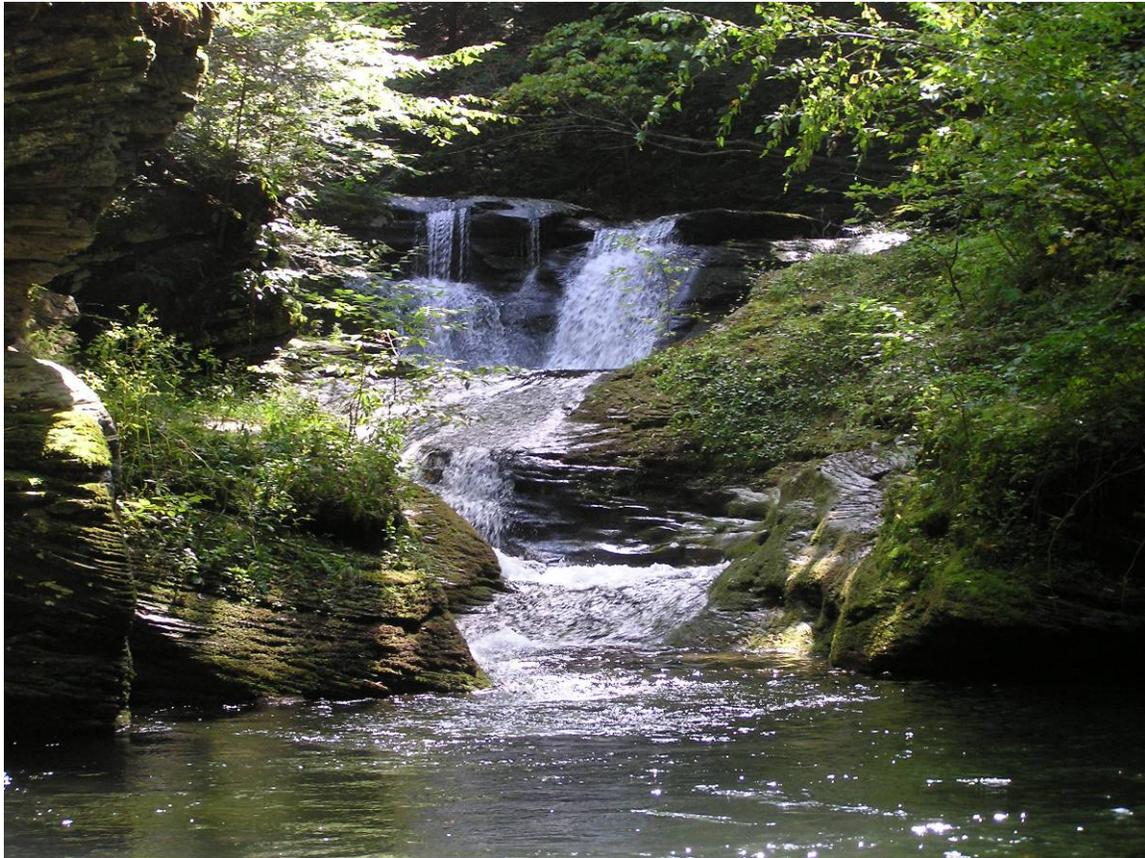
Photo 2.16 Otter Falls in the headwater reaches of Upper Esopus Creek

The presence of bedrock sills and banks is an additional geologic unit equally important in characterizing geology for stream corridor management. These hydraulic controls can represent natural limits to changes in the stream channel system caused by incision or lateral migration. Examples include the falls in the headwater reaches above Oliverrea (**Photo 2.16**), and occasional bedrock stream banks along the Upper Esopus Creek course.

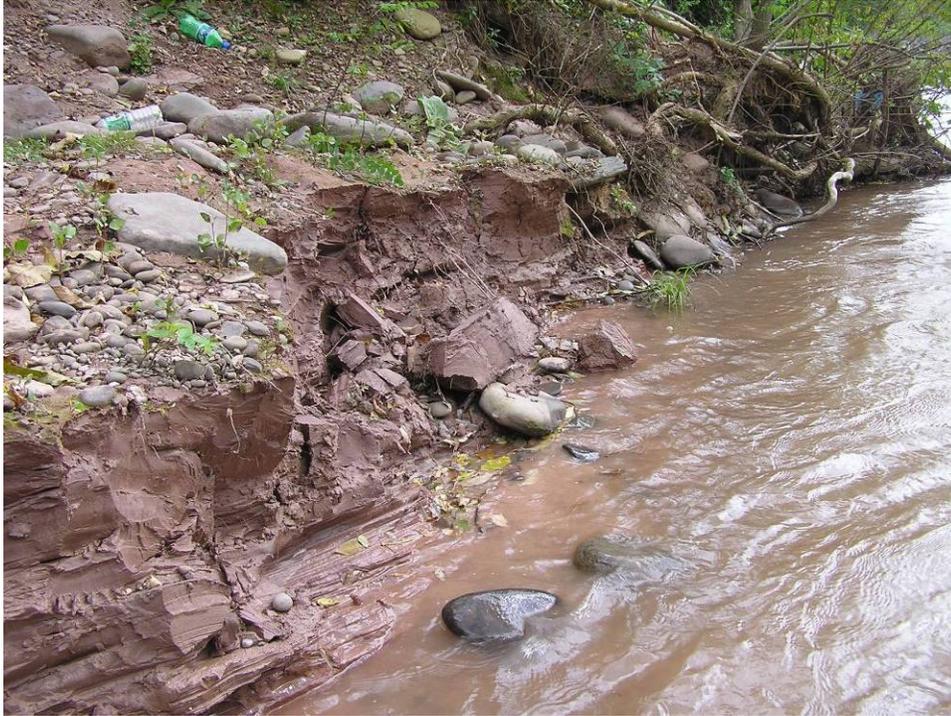
Photo 2.17a. Stream bank erosion into lacustrine silt/clay overlain by unconsolidated fluvial sediment. October, 2005

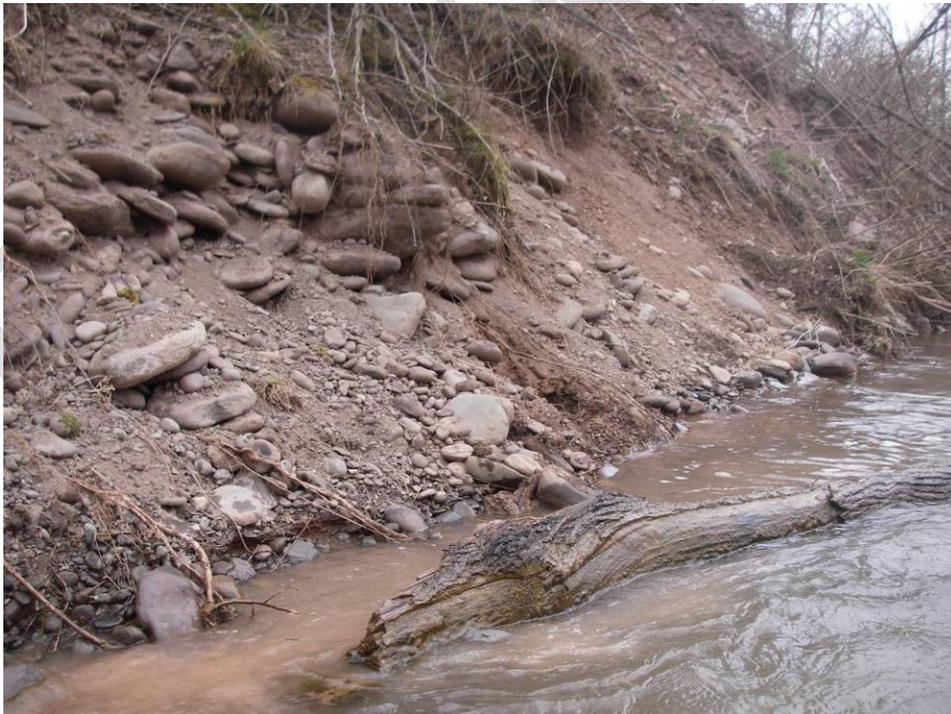
Photo 2.17b. Same location as 2.17a in April, 2006. Unconsolidated sediment has draped over lacustrine sediment removing exposure of fine sediment source.

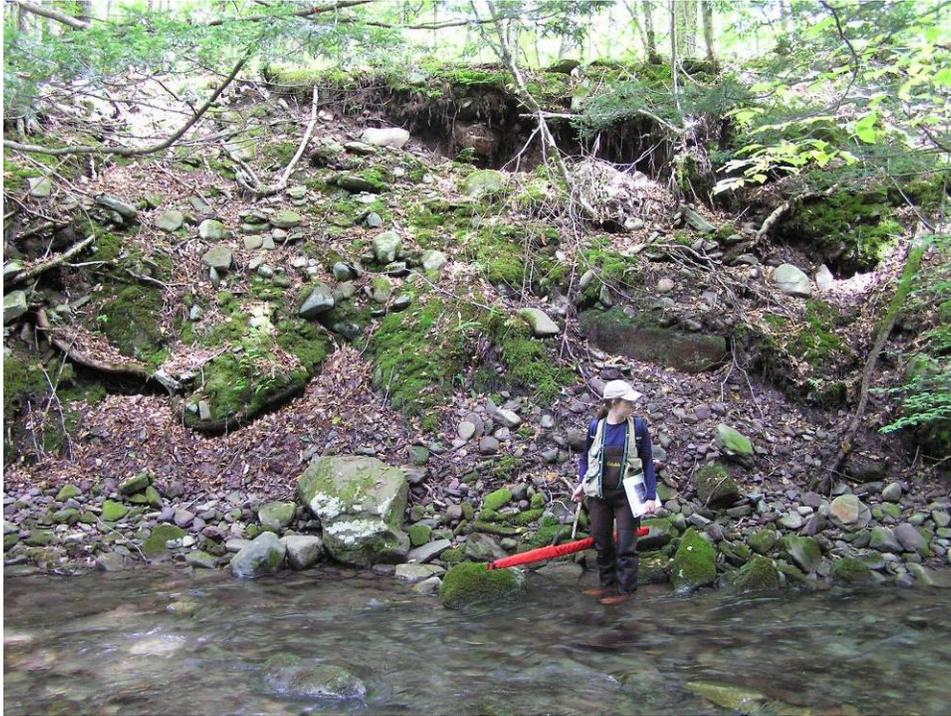
Photo 2.17c. Slumping glacial till in headwater reach of Upper Esopus Creek

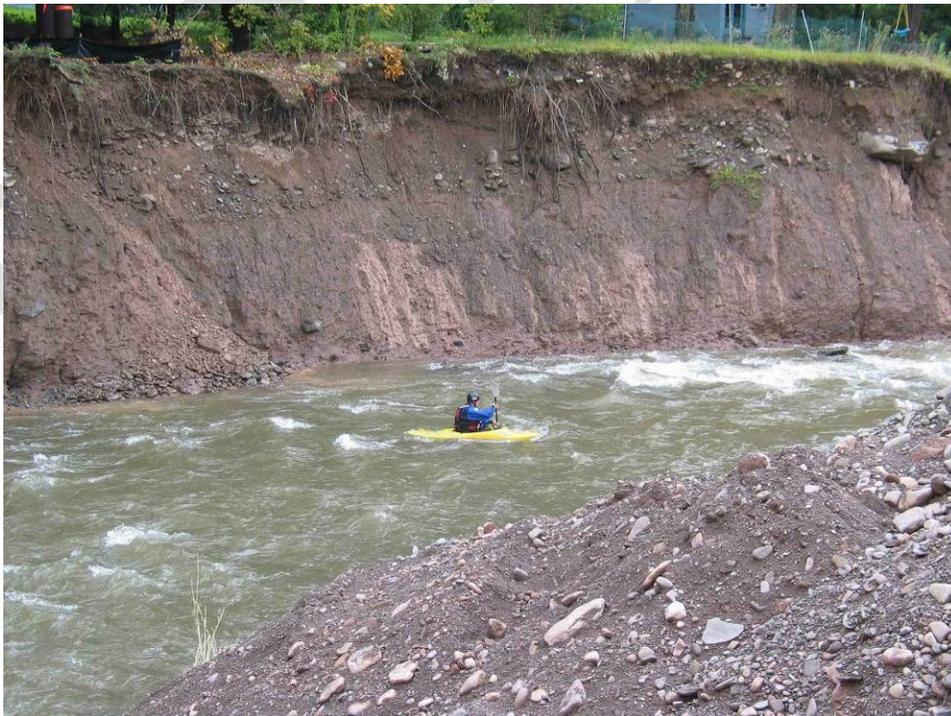
Photo 2.17d. Steep eroding bank of glacial till overlain by unconsolidated fluvial sediment.

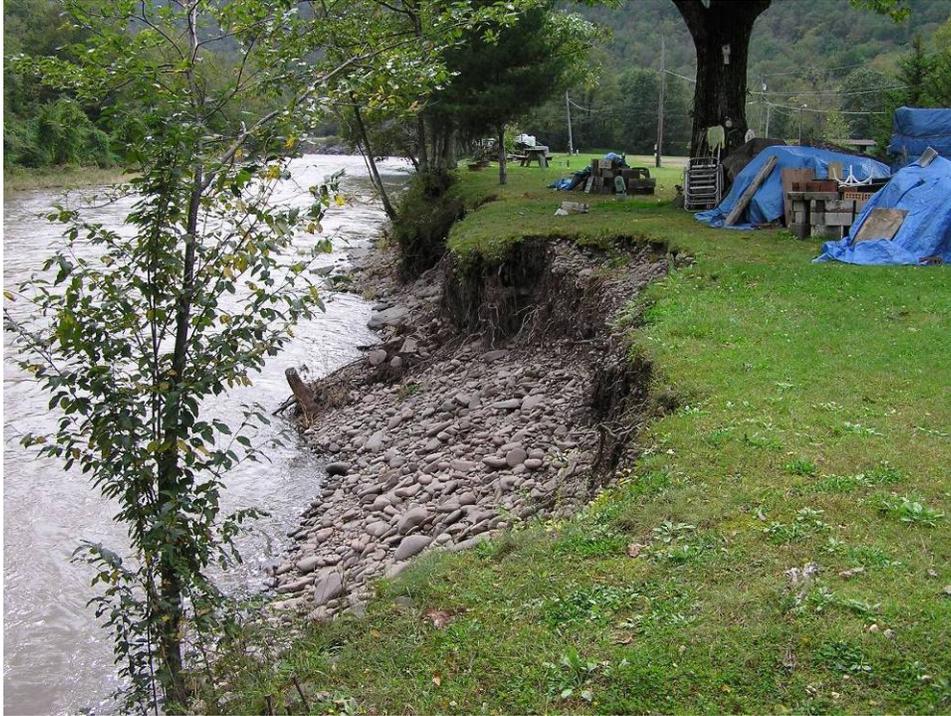
Photo 2.17e. Stream bank erosion into unconsolidated fluvial sediment with limited riparian buffer protection. A very narrow strip of woody vegetation can exacerbate bank retreat as the individual trees are uprooted.

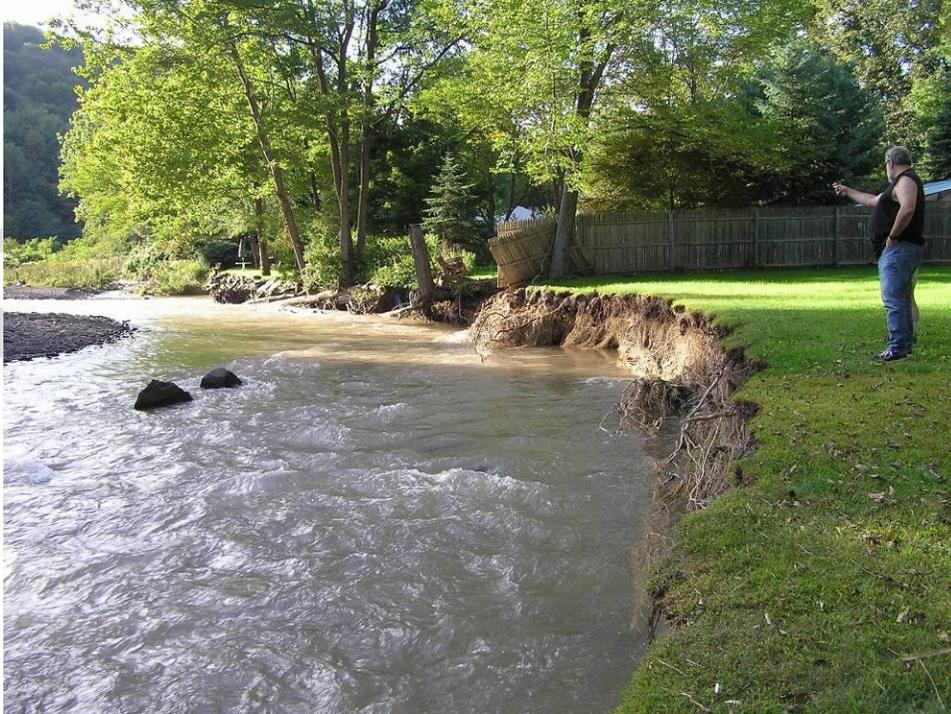
Photo 2.17d. Stream bank erosion into unconsolidated fluvial sediment with no riparian buffer. Boulders in stream are approximate position of bank line before Tropical Storm Ivan flood significantly adjusted channel alignment. Non-keyed riprap was flanked and washed away.

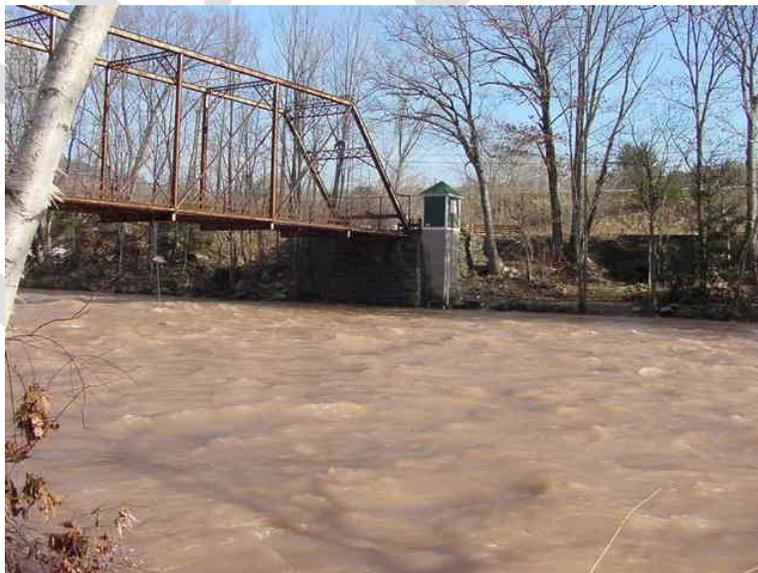
Photo 2.19 USGS stream gage Esopus Creek at Coldbrook, NY (01362500)

The United States Geological Survey (USGS) through a contract with NYCDEP maintains ten continuously recording stream gages in the Upper Esopus Creek watershed (**Table 2.5; Figure 2.15; Photo 2.19**) and one crest stage gage on the Bushnellsville Creek. There are two gages on Esopus Creek: Esopus Creek at Allaben (established in 1963, drainage area 63.7 mi²; USGS ID# 01362200) and Esopus Creek at Coldbrook (established in 1931, drainage area 192 mi²; USGS ID# 1362500). **Figure 2.16** is a hydrograph for 25 years of the 75 years of record available for the Coldbrook gage. The real-time and historic data for these gages (and others in the watershed) is available online at the USGS website <http://nwis.waterdata.usgs.gov/ny/nwis/rt>.

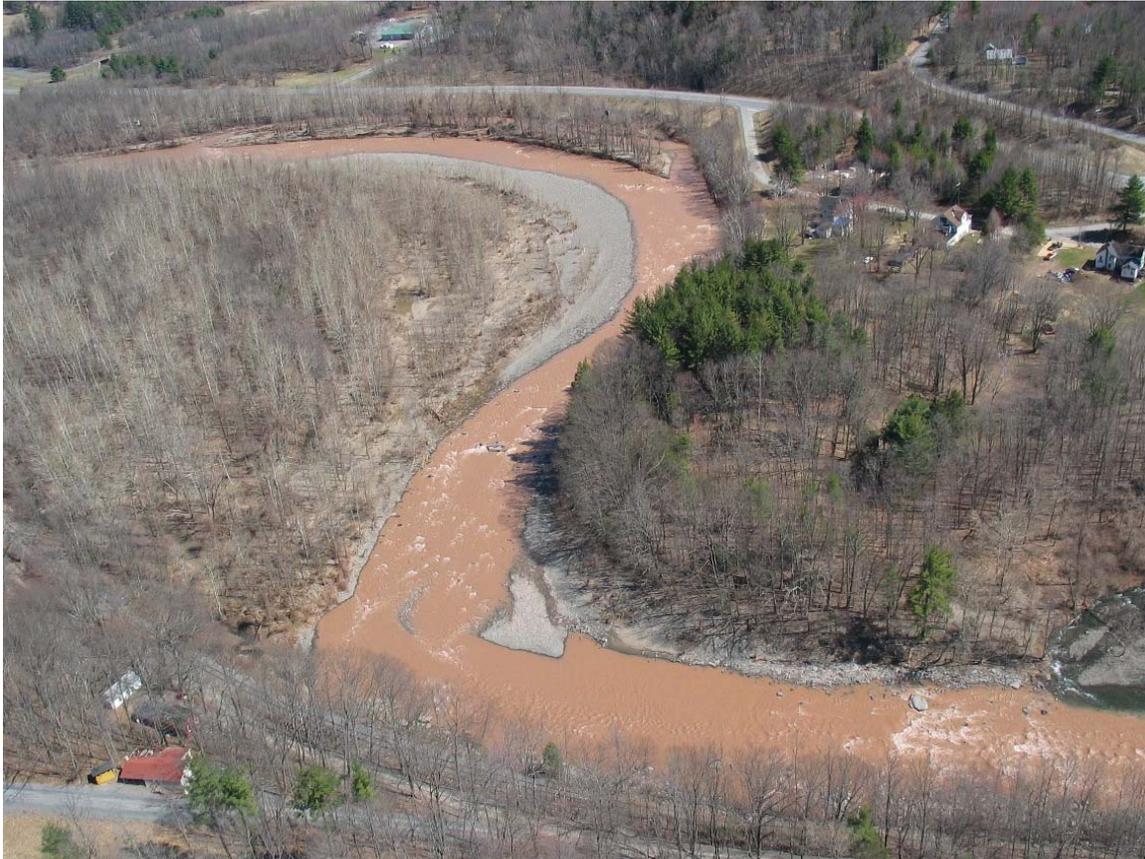
Photo 2.20 Esopus Creek just above Little Beaver Kill after the April 2-3, 2005 flood. During this time the Shandaken Tunnel was turned off.

system. Silt and clay – buried in ice age deposits – are easily eroded into the stream and often, after a major storm, the streams run with a characteristic reddish brown color (**Photos 2.19** and **2.20**). As explained below, from all perspectives the resulting turbidity is considered the number one water quality concern in the watershed.

Suspended solids in Catskill streams are predominantly fine sediment. It does not take much suspended sediment to reduce the clarity. The water clarity can range from clear to an opalescent red-brown following a significant high water event (**Photo 2.20**). Sediment gets in the stream from three sources: (1) runoff from the landscape carries fine sediment (silt and clay) into the stream through ditches and culverts (**Photo 2.21**); (2) from entrainment in the stream (**Photo 2.22**); and (3) from the Shandaken Tunnel (**Photo 2.23**). We believe that it is the stream channel, and not the landscape, that is the primary source of sediments. The contribution of turbidity (as a surrogate for suspended sediment) from the Shandaken Tunnel relative to the Esopus Creek is known and shown in **Figure 2.32**.

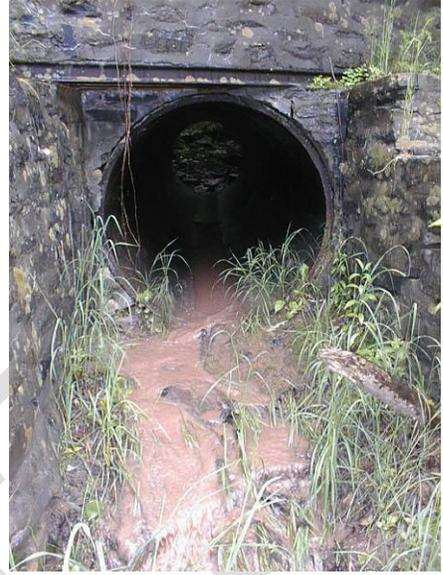
Photo 2.21 Turbid discharge from a culvert draining a road ditch

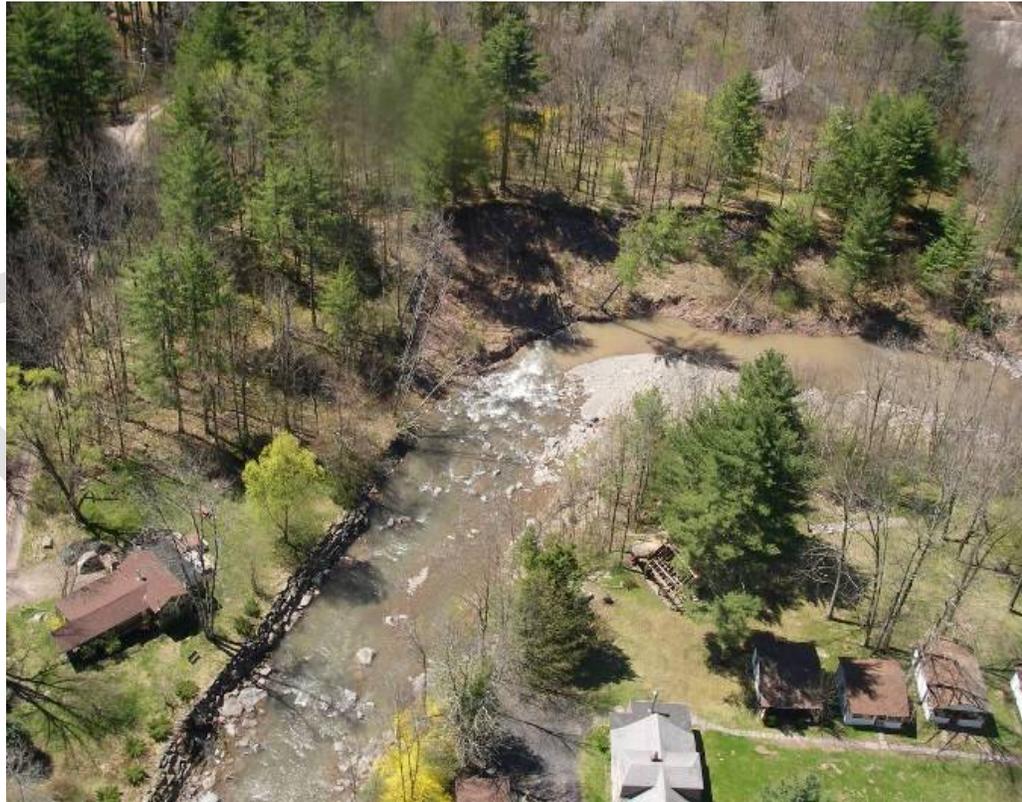
Photo 2.22 Stream flow entraining fine sediment along an eroding section of Stony Clove Creek. April, 2006

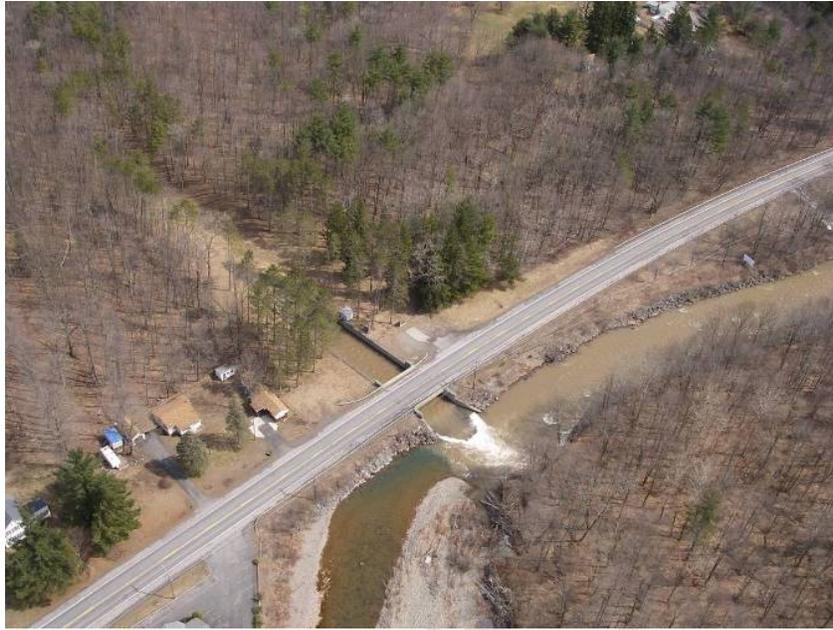
Photo 2.23 Turbid discharge from Shandaken Tunnel (March 28, 2006)

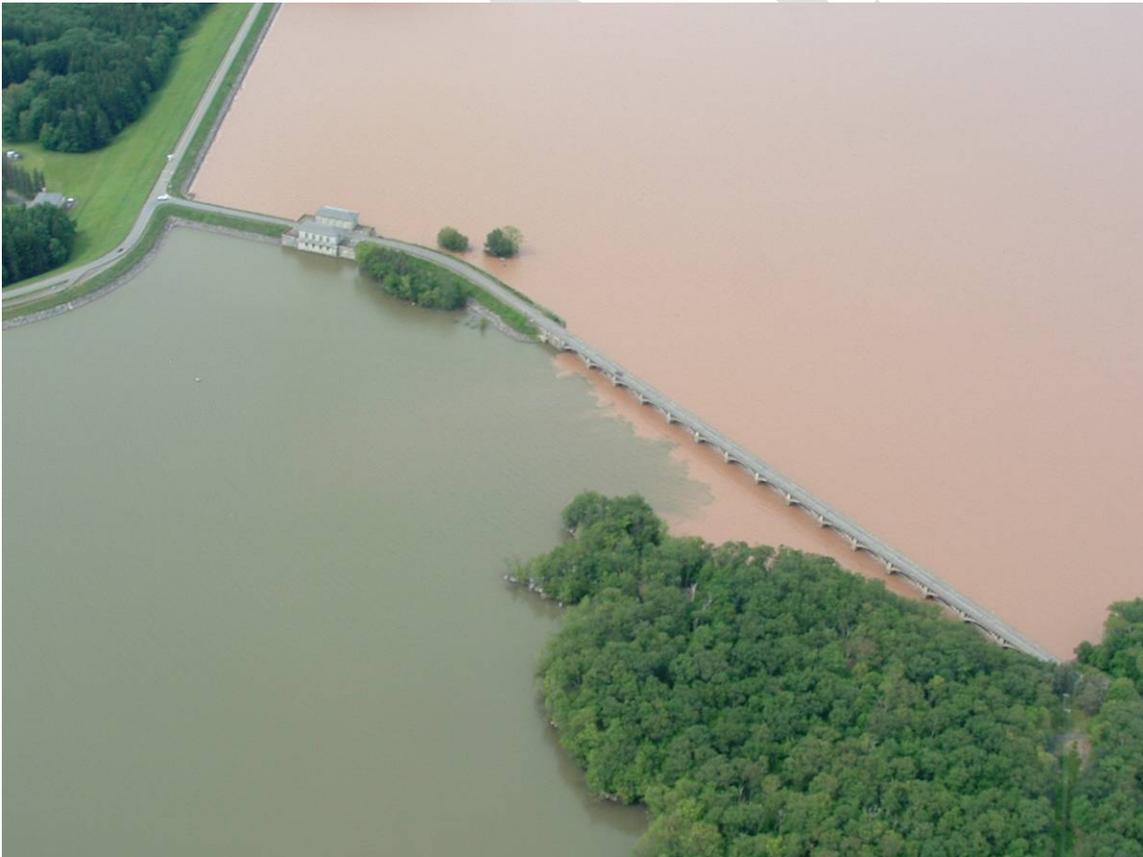
Photo 2.24 Dividing weir at Ashokan Basin (June, 2006)

Turbidity in Upper Esopus Creek is not a new phenomenon. The design of the Ashokan Reservoir itself reflects concern for turbidity on the part of the design engineers. Two basins separated by a dividing weir were created in order to allow time for suspended particles to drop out as the water flows from the mouth of the upper Esopus on the West basin to the spillway outlet on the East basin (**Photo 2.24**). In addition to the partitioned basins, the West basin includes a diverting “waste channel” that can release water into the

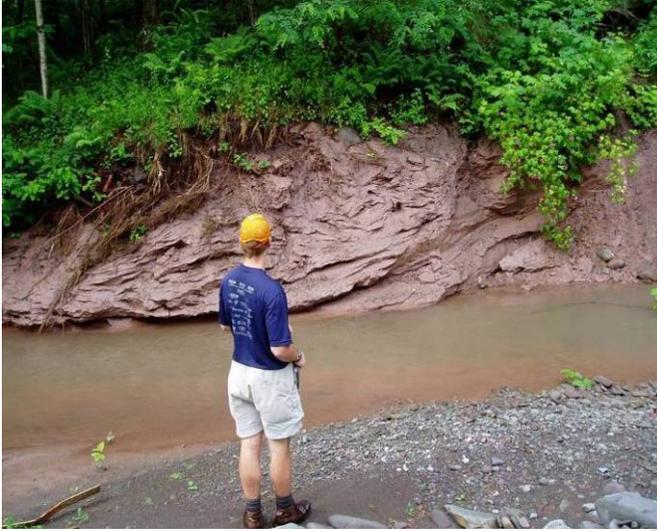
Photo 2.25 Layered glacial lake silt and clay exposed in streambank on Bushnellsville Creek

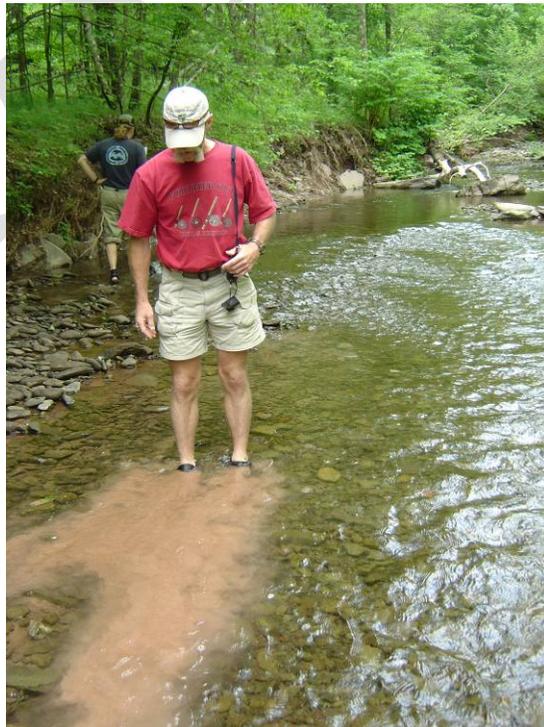
Photo 2 Photo 2.26 Clays and fine silts in the streambed are easily disturbed and contribute to turbidity throughout the basin.
