UPPER ESOPUS CREEK MANAGEMENT PLAN

Volume III

Watershed and Stream Characterization

Prepared by
New York City Department of Environmental Protection
US Army Engineer Research Development Center
Cornell Cooperative Extension – Ulster County
January 2007

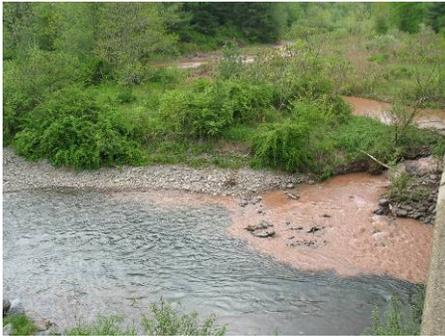
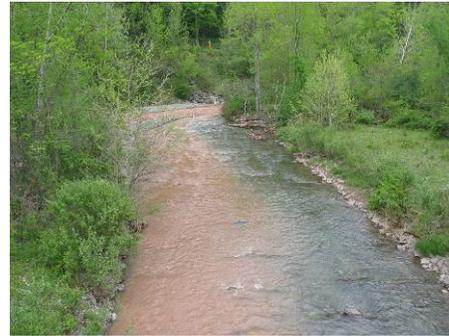
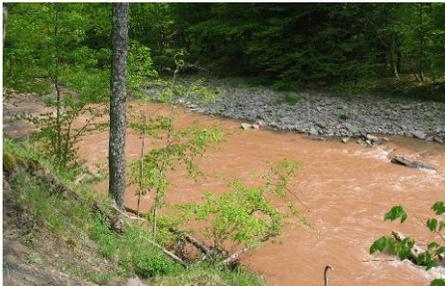
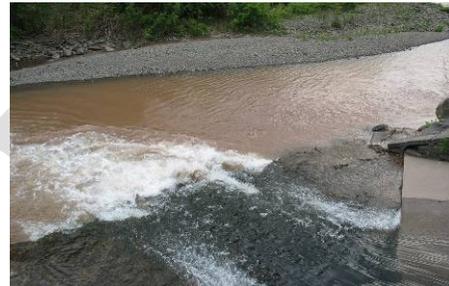
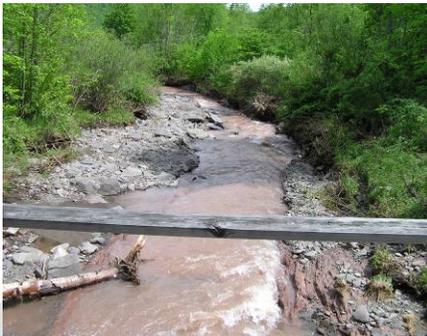
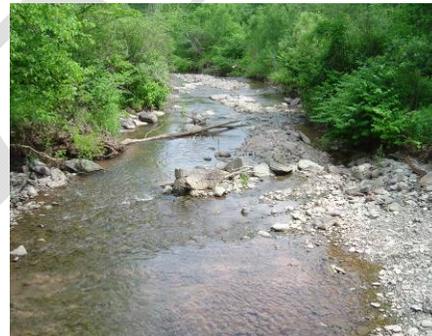
Figure 2.34 Flash flood impact and recovery on Birch Creek and Esopus Creek

Birch Creek confluence May 15, 2004

Just below Birch Creek May 15, 2004

Esopus Creek along CRT 47 May 15, 2004

Esopus Creek at Shandaken Tunnel May 15, 2004

Birch Creek at WMR bridge May 19, 2004

Birch Creek at WMR June 13, 2005

Clearly the sources of fine sediment are systemic and difficult if not impossible to manage. There is hope though. The case of Birch Creek following an extreme localized thunderstorm over Pine Hill in May, 2004 is an excellent example of how these streams can “heal” (at least temporarily) without the help of active management. On May 14, 2004, 2.5 inches of rain fell in under 3 hours causing Birch Creek to swell from under 10 cfs to over 800 cfs. The flash flood scoured the streambed incising into the underlying glacial lake clays starting behind the Pine Hill WWTP and continuing down to within a half mile of the confluence with Esopus Creek. Seven extensive exposures of glacial lake clay were mapped following the flood. Those seven exposures turned the Esopus Creek red-brown all the way to the reservoir. **Figure 2.34** shows the impact of the flash flood on Esopus Creek and follows one of the source sites (Winding Mountain Road bridge) for a period of one year. At the depicted location, the scour was so severe that the stream abandoned its former bed and occupied a trench cut into the clay. There was a lot of concern raised by DEP, TU and others about the need to address the problem. Within a year, after a few more floods the trench filled in with coarse sediment and the stream reoccupied its former channel. The devastating April 2005 flood did not cause further damage to this site, as it was sufficiently “armored” by that time. However, other exposures developed elsewhere along the stream and throughout the watershed.

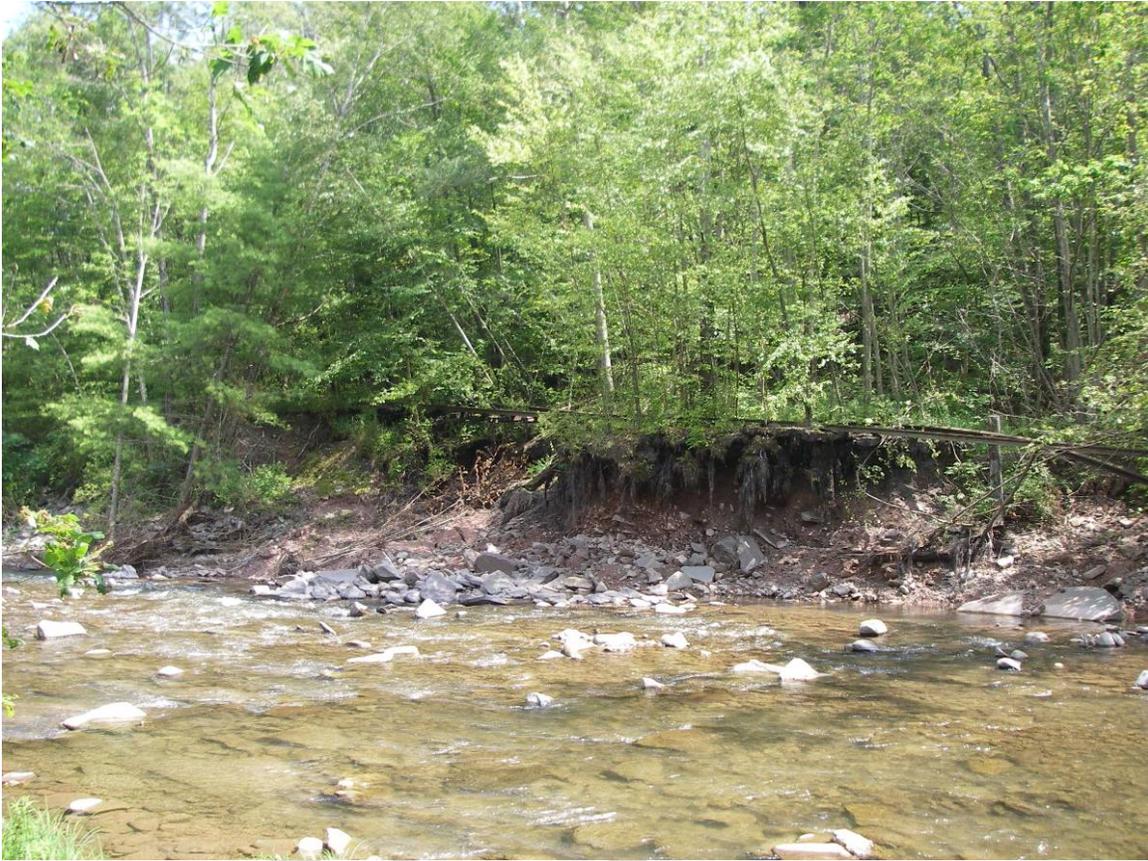
Photo 3.1.1 Washed out Catskill Mountain Railroad Tracks and stream eroded exposure of slumping pro-glacial lake silts and clays about 1,000 feet upstream of Fox Hollow

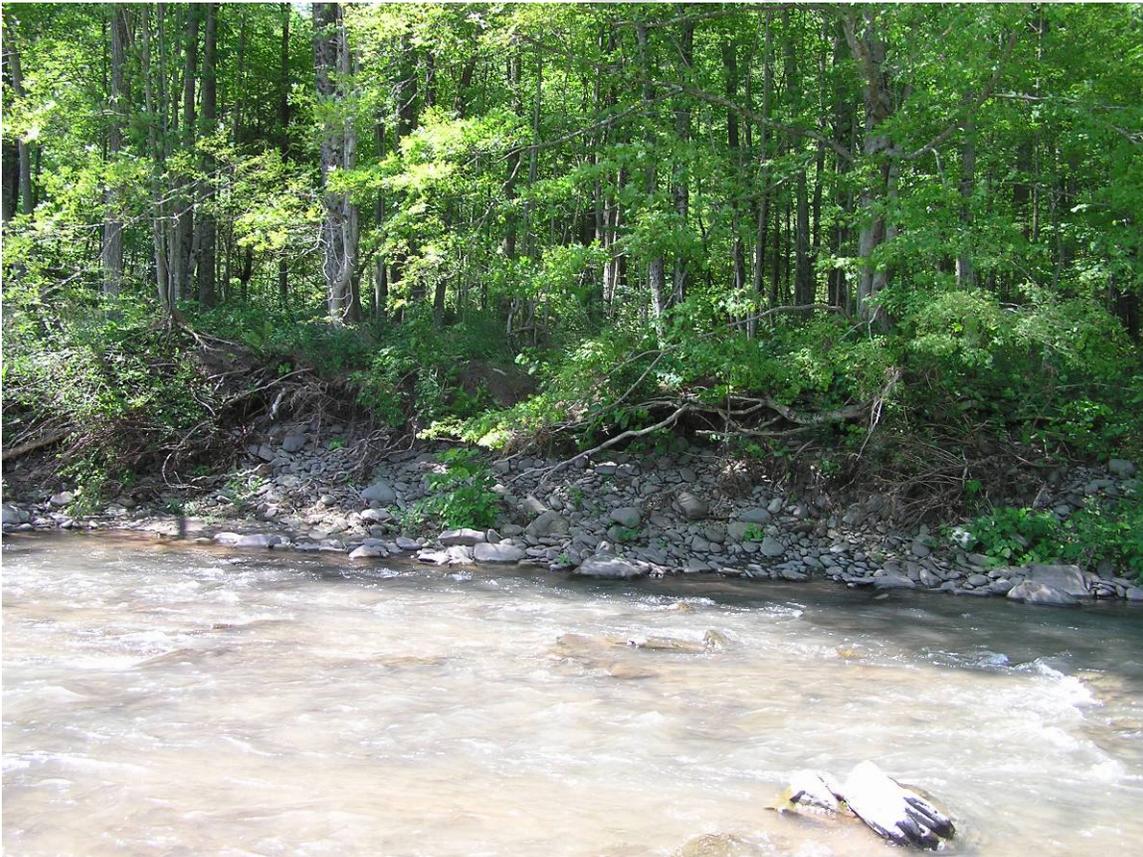
Photo 3.1.2 Non-persistent erosion caused by major flood events was excluded from classification as an eroding bank.

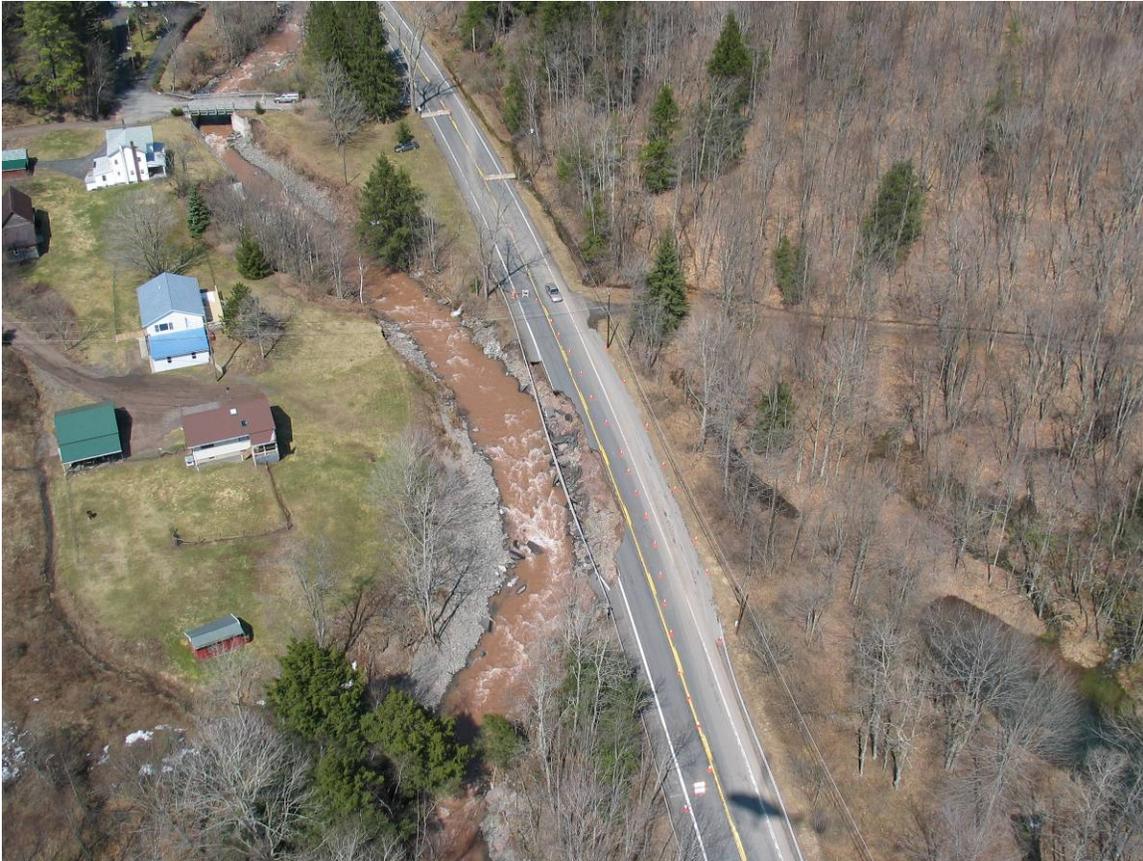
Figure 3.1.8. Factors included in the erosion hazards model include the lack of a healthy riparian corridor, high or over-steepened banks, areas located on the outer bank of meanders, and infrastructure located close to the stream corridor.

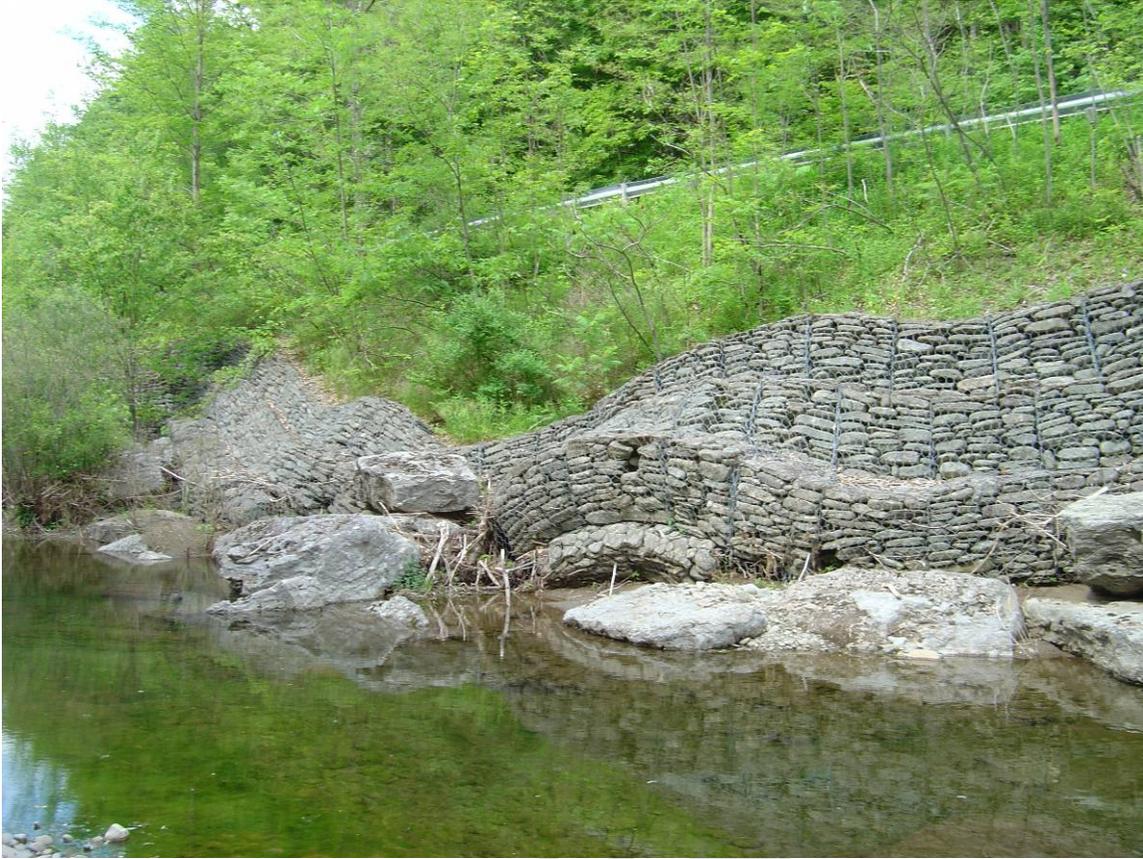
Photo 3.1.3. Bank protection measures that are inappropriate for a site or are not properly keyed into the bed and banks of the channel and may be ineffective were nevertheless given a weighting factor of 0.25 in the Erosion Hazard Model.

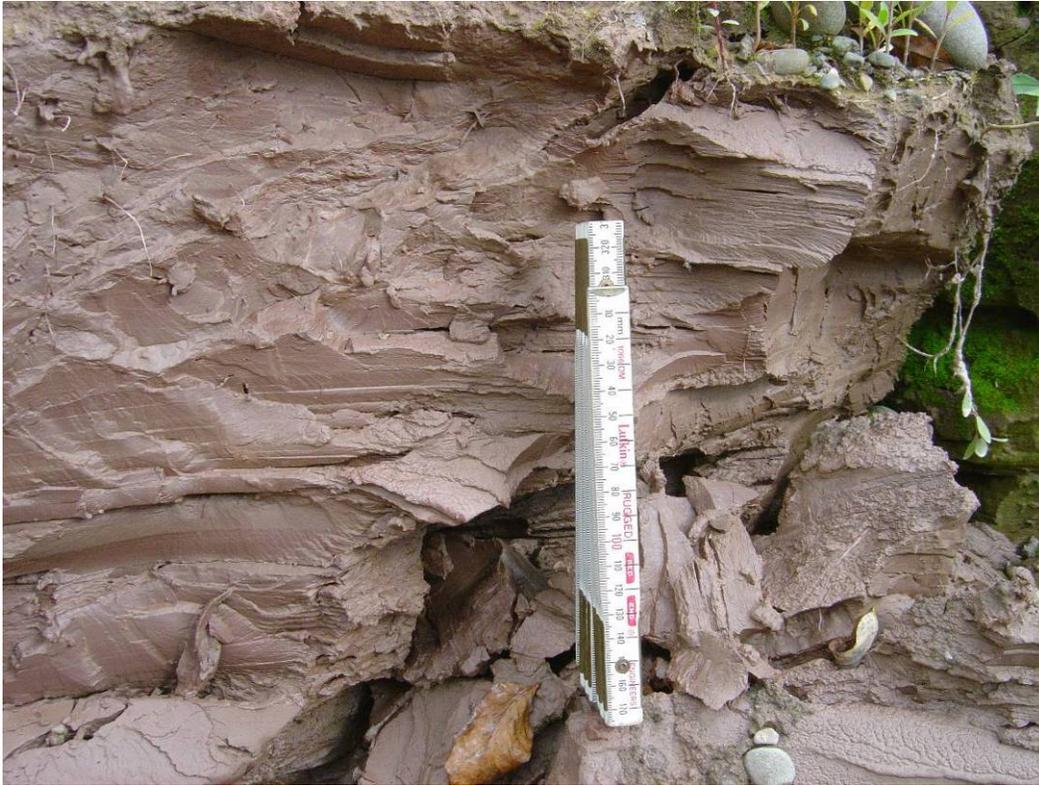
Photo 3.1.4 Typical clay exposure with the surface cleaved to expose bedding planes. Sample site M9-S02

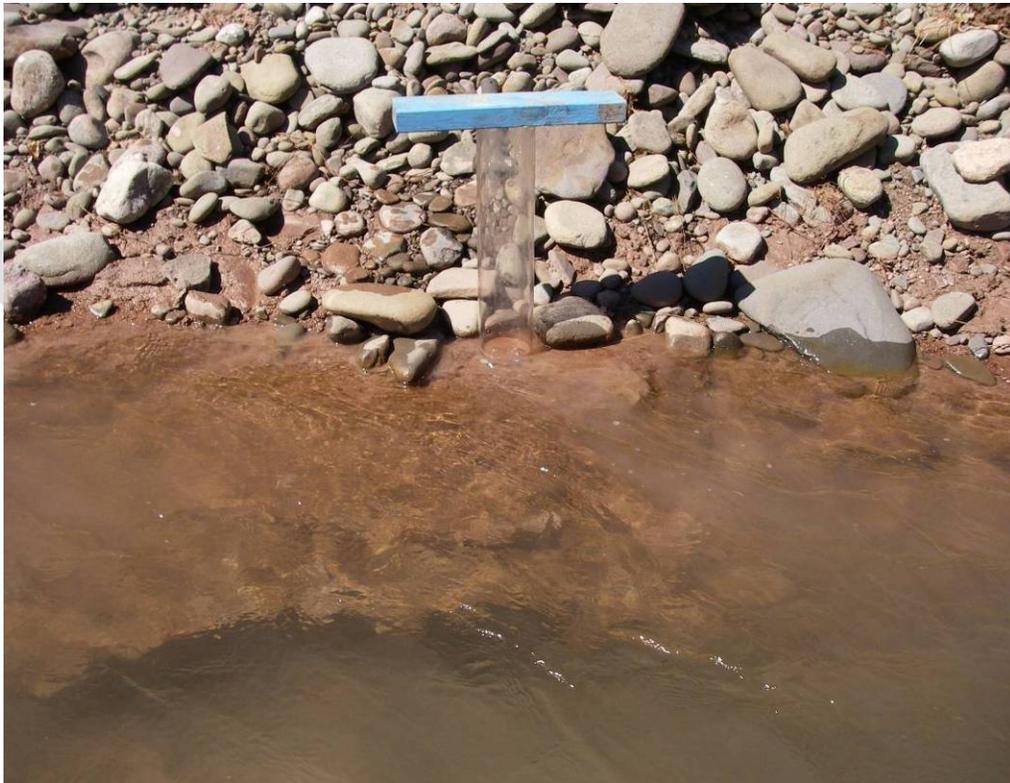
Photo 3.1.5 Acquisition of a sample from the streambed. Sample M16-S01

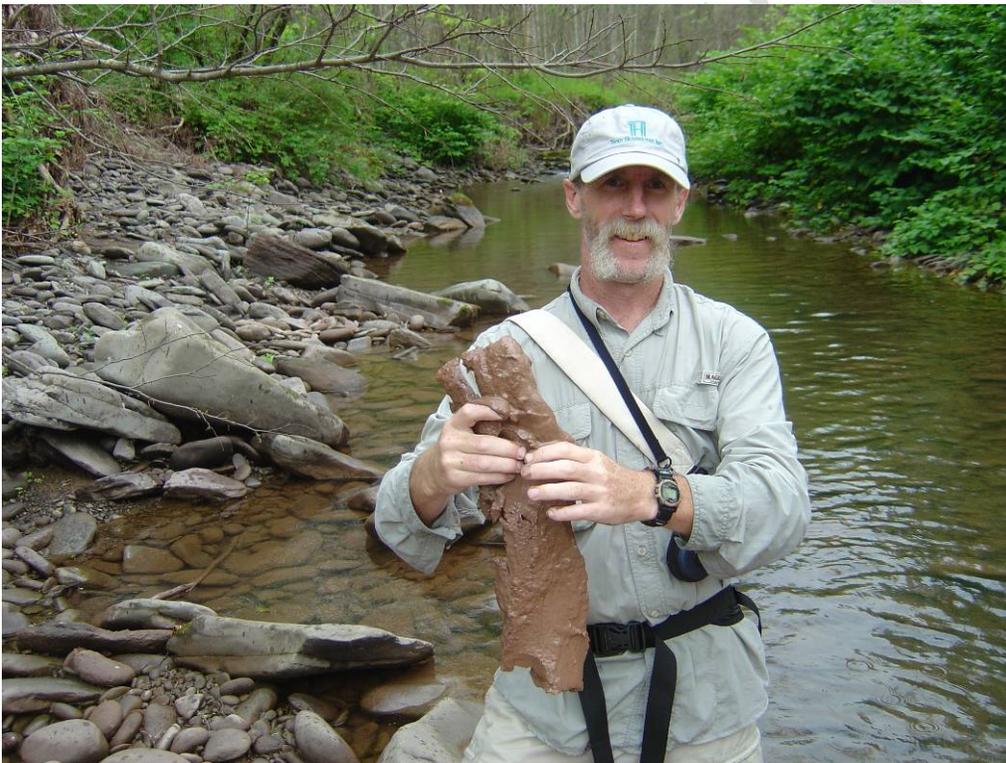
Photo 3.1.6. Exposed “glacial clay deposits” were one of several sources of fine sediment investigated in the study.

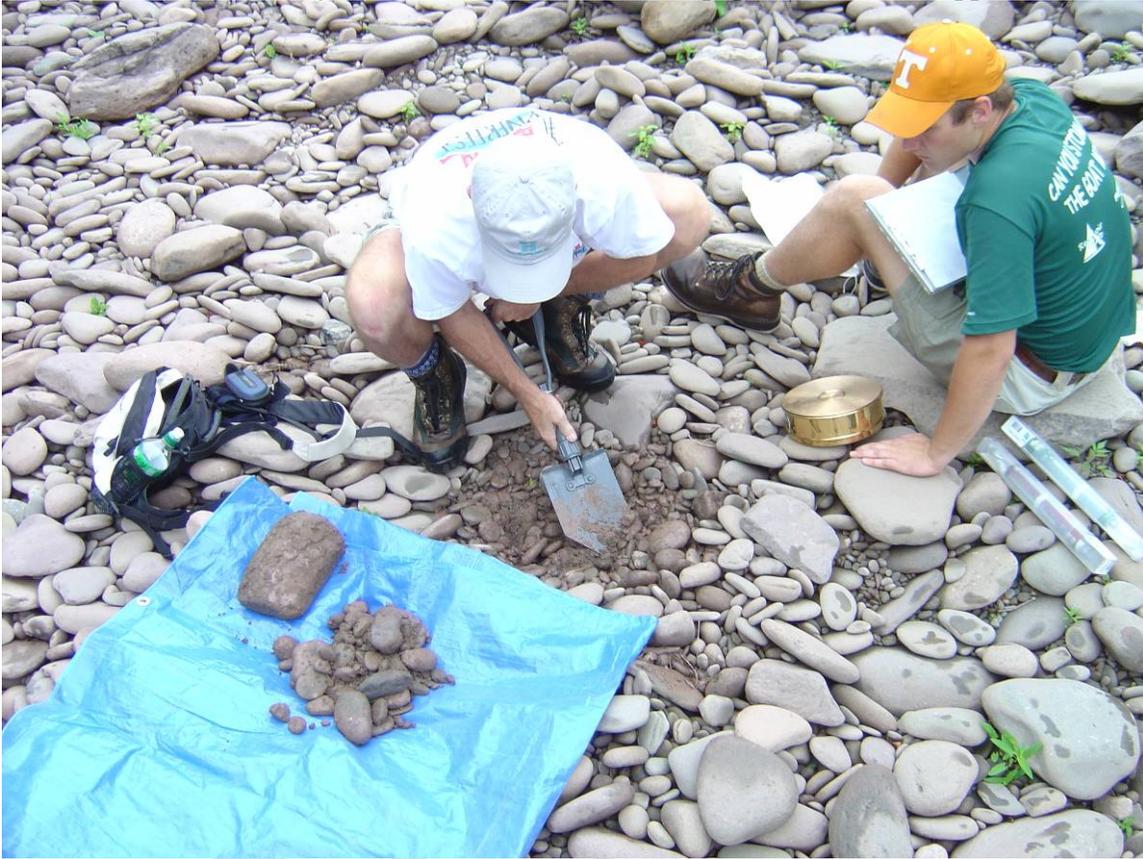
Photo 3.1.7. Samples of the bed material were collected and evaluated to determine the volume of silts and clays present at various points along the channel.

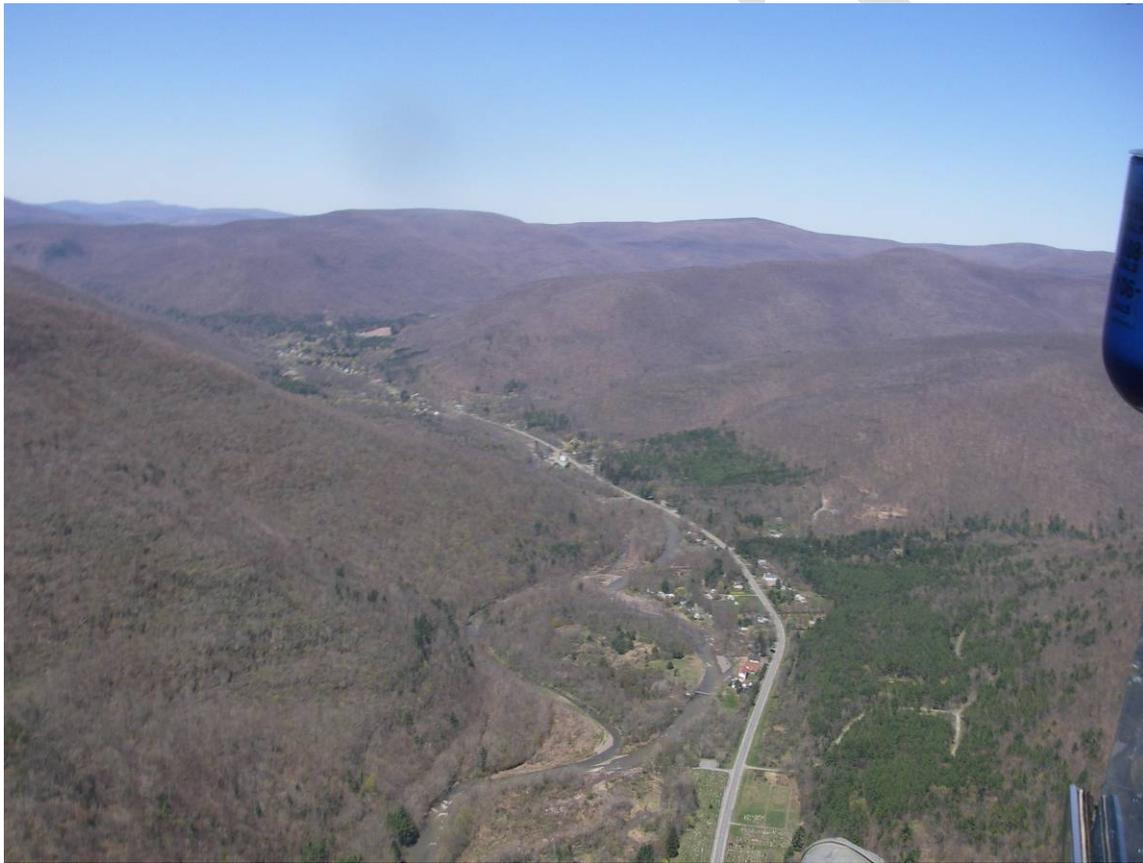
Photo 3.1.8 Reach 9/10 BMP Assessment Site: Looking west upstream through bifurcation. June, 2006

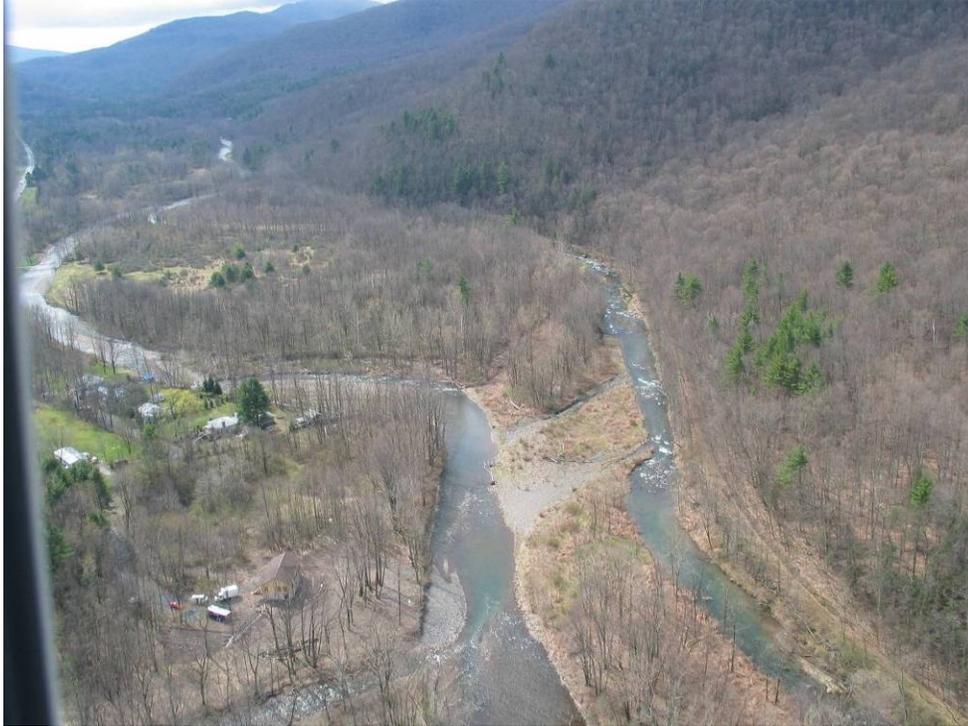
Photo 3.1.9 Reach 9/10 BMP Assessment Site: Looking east downstream through bifurcated channel. Broadstreet Hollow confluence in lower left corner. April, 2004

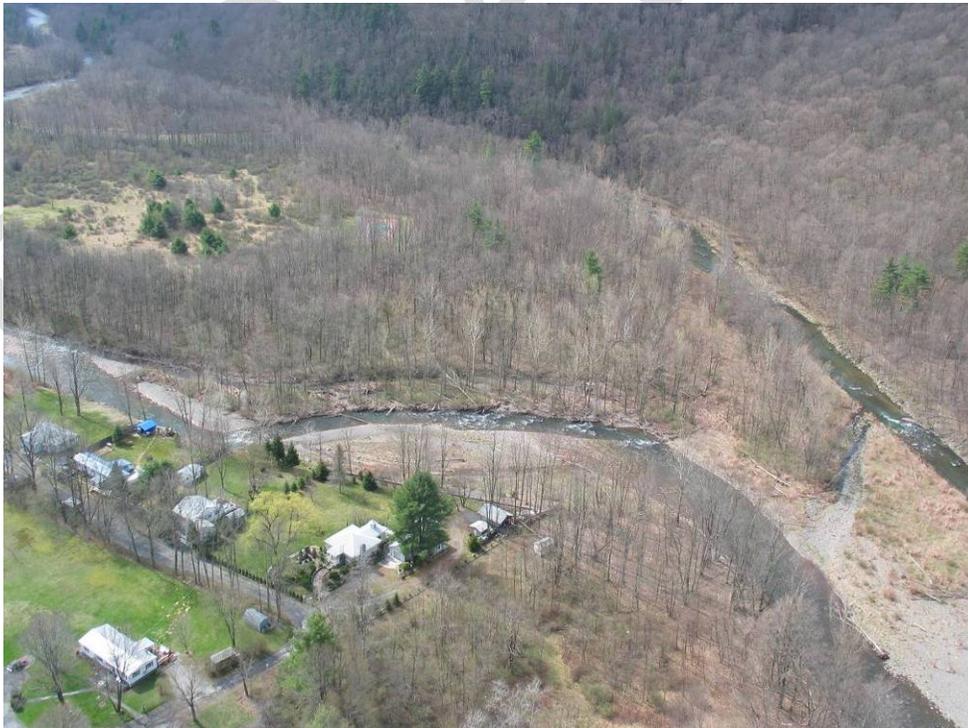
Photo 3.1.10 Reach 9/10 BMP Assessment Site: (1) hazardous-debris catching meander bend, (2) blue shed subsequently eroded away, (2) avulsion across bar connecting bifurcated channel. April, 2004

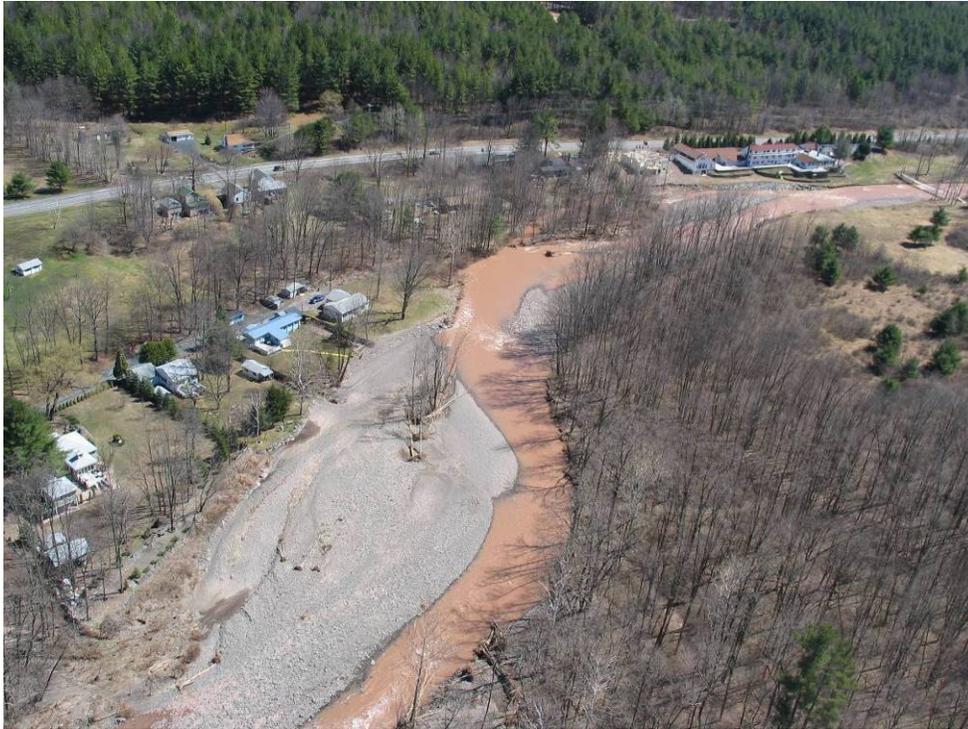
Photo 3.1.11. Reach 9/10 BMP Assessment Site: North channel following April, 2-3, 2005 flood. Note (1) alignment adjustment from 2004 condition ,(2) absence of blue shed, (3) line of trees in point bar is remnant of downstream end of meander bend shown in Photo 3.1.10.

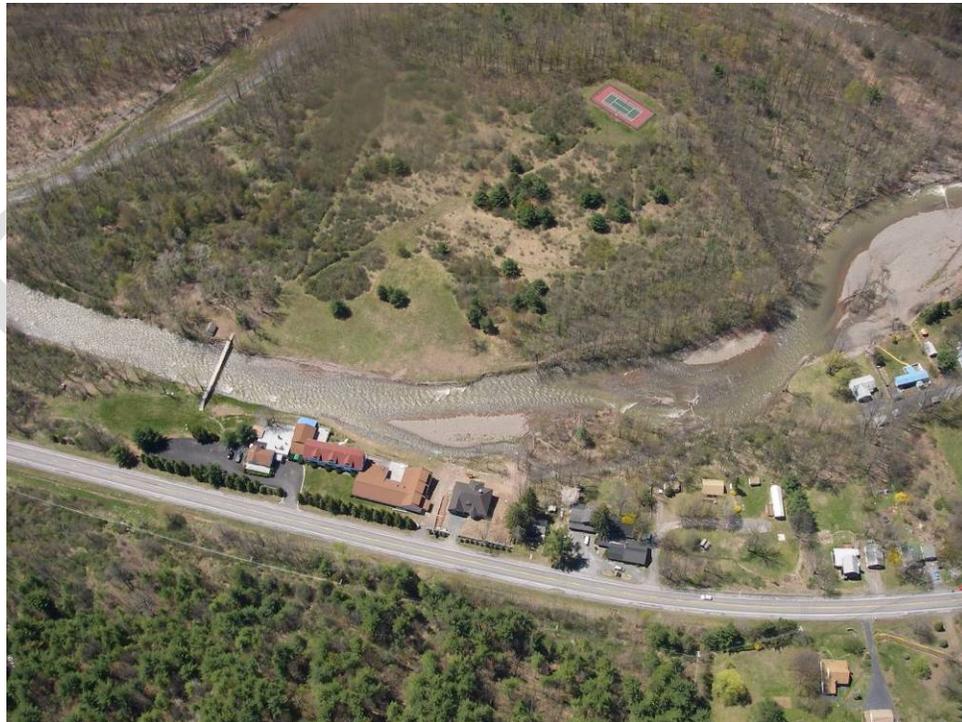
Photo 3.1.12. Reach 9/10 BMP Assessment Site: Zone of active erosion adjacent to private property and businesses. June, 2006

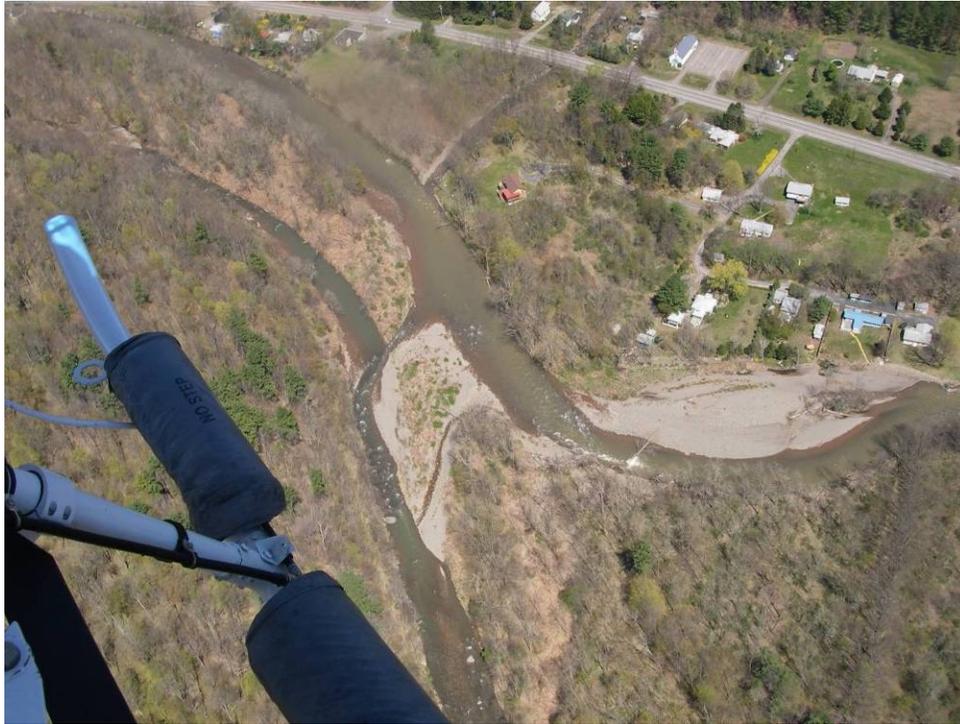
Photo 3.1.13. Reach 9/10 BMP Assessment Site: Location of cobble bar separating north and south channels just below Broadstreet Hollow confluence. June, 2006

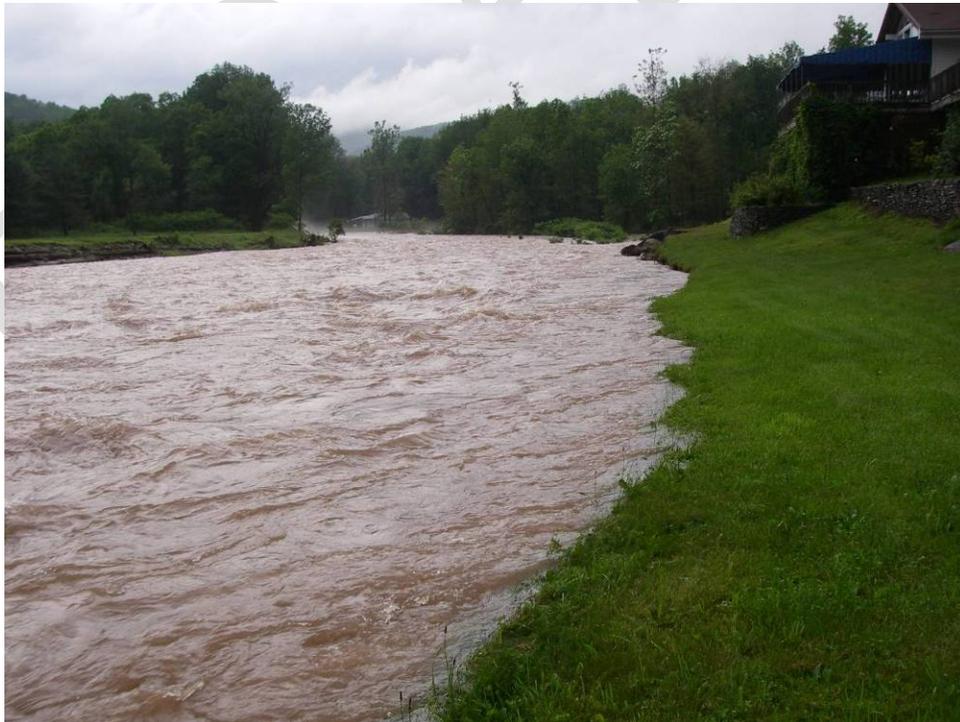
Photo 3.1.14. Reach 9/10 BMP Assessment Site: Looking upstream alongside Copperhood Inn. Note eroding bank and lack of woody riparian buffer on outside of adjusting meander bend. Previous riprap revetment failed in April, 2005 flood. June, 2006

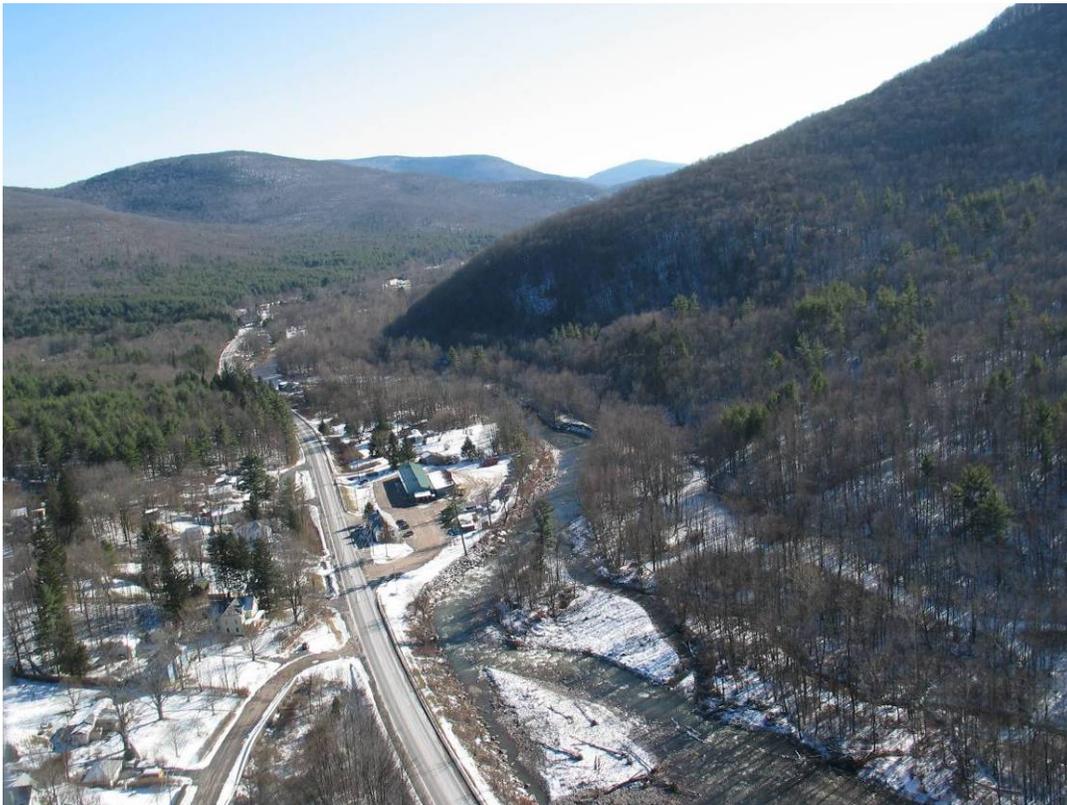
Photo 3.1.15 Reach 11 BMP Assessment Site: Looking downstream toward Shandaken Town Hall (12/08/05). Former meander bend is on left side of Route 28. Energy from cut-off meander increases shear against the bermed bank bordering the Town offices.

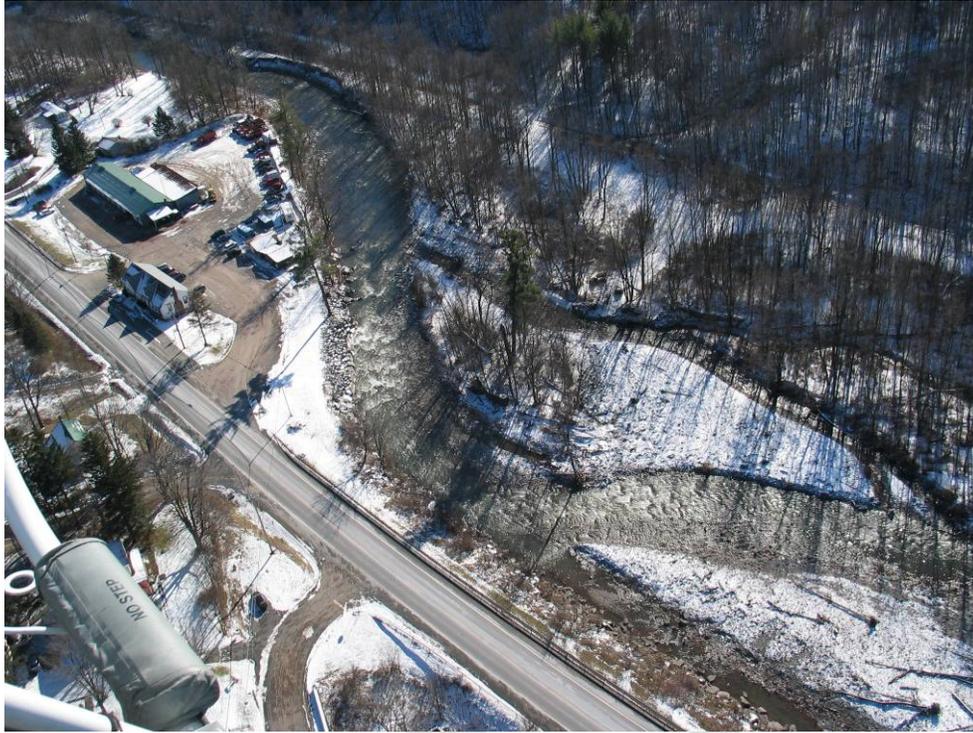
Photo 3.1.16 Reach 11 BMP Assessment Site: Channelized section with very erosive meander bends and a large depositional wedge above. The challenge will be to ...

Erosion along the left bank of the Esopus Creek is threatening an existing stabilization project at the Shandaken Town Hall (**Photos 3.1.15 – 3.1.17**). Velocities at bankfull flows are about 7 feet per second, and exceed 12 feet per second under flood flow conditions. The condition is exacerbated because the bank is on the outside of a bend where secondary flows can increase scour at the toe of the revetment. The existing bank protection is for a berm that affords protection to the Town Hall for flows up to about the 25-year event. Failure of the berm would subject the Town Hall to flooding at less than the 10-year flow level. A channel avulsion is pending along the right bank at this location, and a large sediment lag is progressing into the reach from upstream. The floodplain is constrained by the railroad grade along the right bank, and this reach was adversely impacted by the realignment of NYS Route 28 in the early 1960's. The current road alignment cut off a meander bend just upstream of the Town Hall location.

Two alternatives were evaluated for the site. Both are predicated on the belief that the channel avulsion will occur, and are intended to capitalize on its further development to reduce erosion impacts on the left bank. The alternatives differ primarily in the means of implementation: Alternative 1 involves equipment mobilization one time and full construction would occur in a single season. Alternative 2 involves a phased construction effort wherein the creek's response to actions taken in the first phase are observed and the remaining phases adjusted accordingly. Costs for the two alternatives are roughly the same, the additional mobilization costs for Alternative 2 being offset by reductions in excavation and pollution prevention costs for Alternative 1.

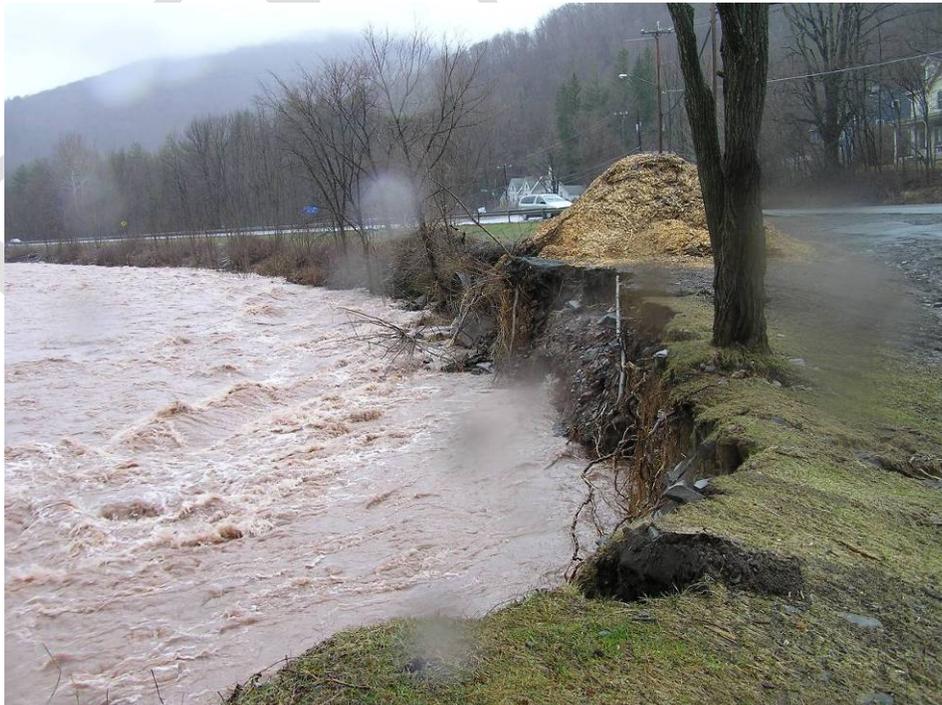
Photo 3.1.17 Reach 11 BMP Assessment Site: April 3, 2005 - significant bank erosion nearly breached the berm protecting the Town Hall

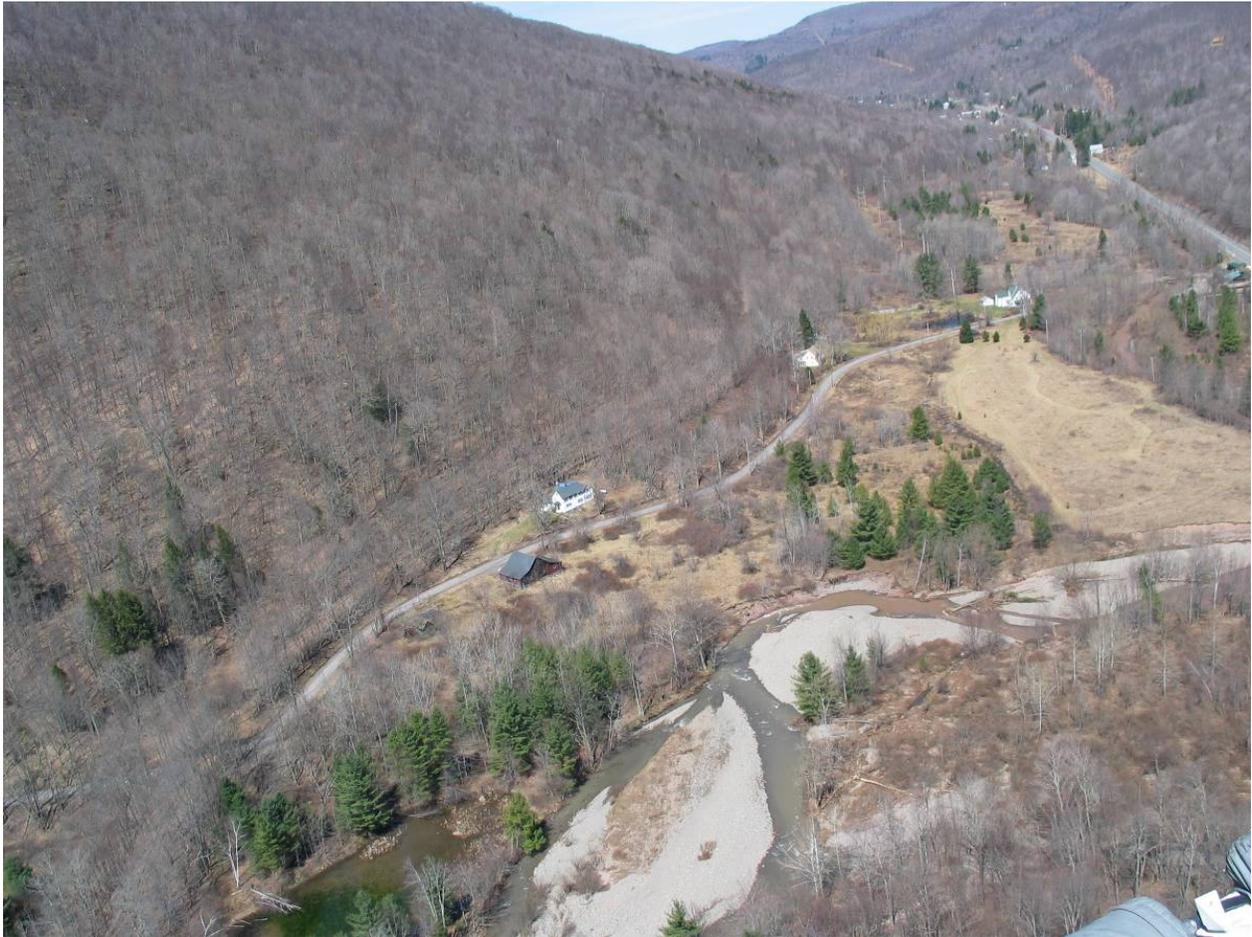
Photo 3.1.18 Reach 16 BMP Assessment Site: Looking downstream toward Birch Creek valley. Esopus Creek water entrains fine sediment at the contact with exposed glacial deposits in this eroding terrace. April, 10, 2005

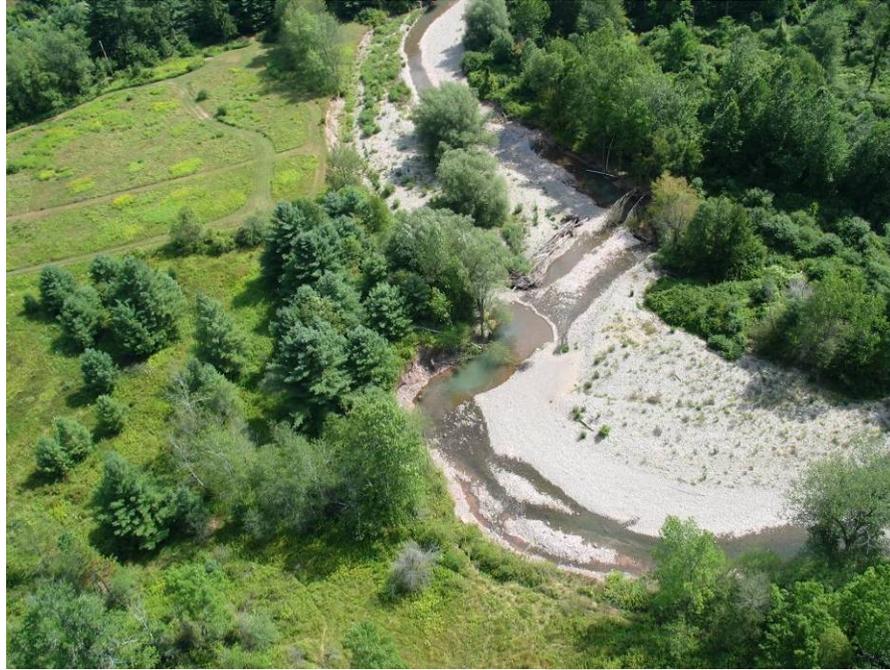
Photo 3.1.19 Reach 16 BMP Assessment Site: Looking downstream from the actively eroding channel margin composed of complex glacial stratigraphy. The small mid-channel gravel bar near the bottom of the picture is a thinly covered mound of deformed glacial lake clay.

Rapid bank retreat is occurring along the left bank in two locations. A 200-ft segment of the bank is experiencing erosion associated with both hillslope failures (along an old terrace) and has exposed a significant glaciolacustrine deposit that periodically contributes to turbidity. Just downstream, a 400-ft segment of bank with no riparian buffer has retreated from hydraulic erosion. The current channel alignment does not pose further hydraulic erosion potential, though a return to former conditions is very possible. Rapid bank retreat is also occurring along the right bank mid-way through the effected reach and has exposed a glaciolacustrine deposit in the stream bed and bank.

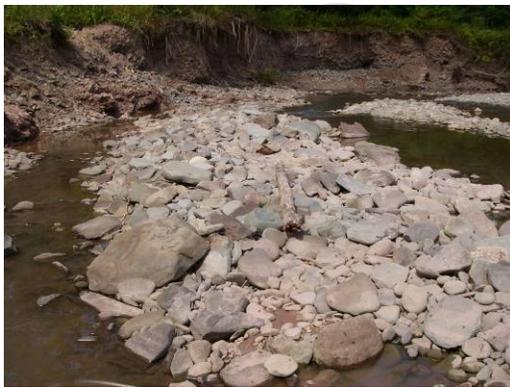
Photo 3.1.20 Reach 16 BMP Assessment Site: Cobble-covered "push-up" structure of glacial lake clay formed from series of rotational failures in adjacent terrace.

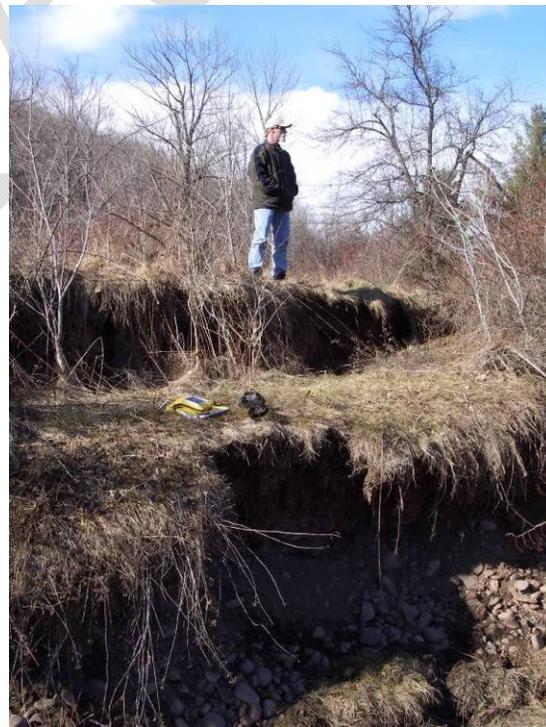
Photo 3.1.21 Reach 16 BMP Assessment Site: scarps from rotational failures in left terrace adjacent to creek.

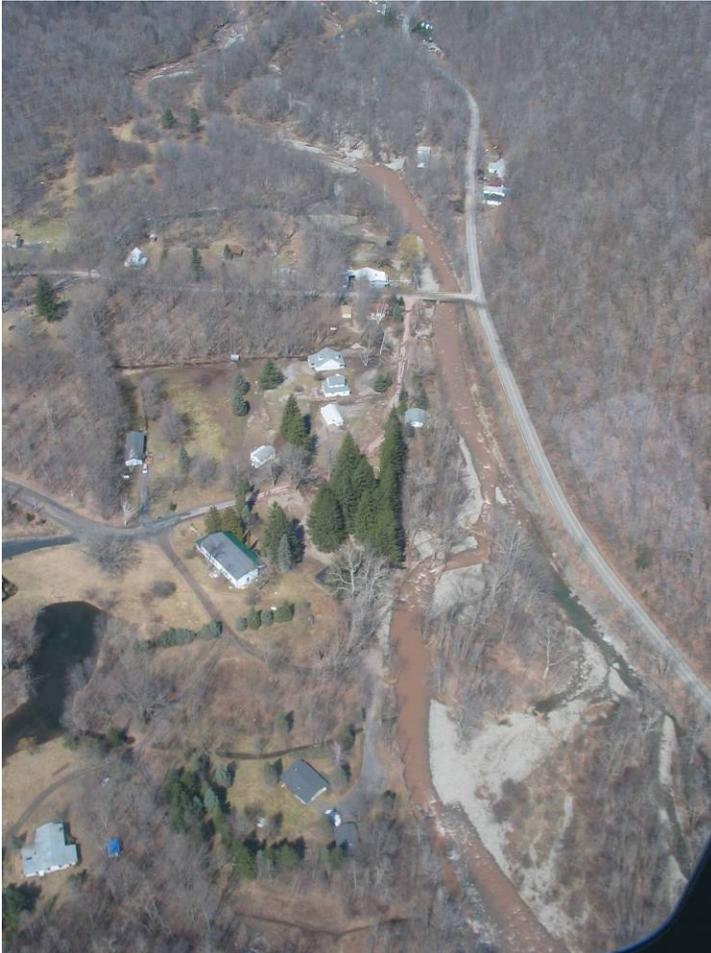
Photo 3.1.22 Reach 18 BMP Assessment Site: Looking downstream along "Brown Rd Reach" with McKenley Hollow Rd bridge. April 5, 2005

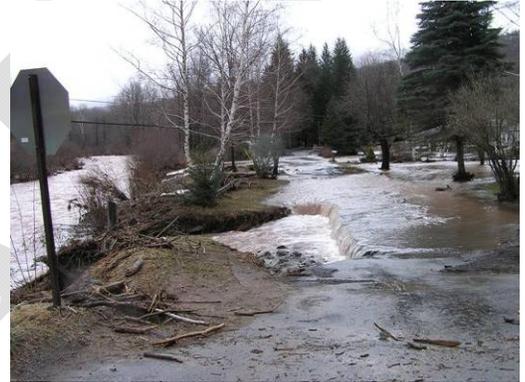
Photo 3.1.23 Reach 18 BMP Assessment Site: wash-out of Brown Road following April 2-3, 2005 flood.

Flooding in the last two years has caused a section of Esopus Creek just upstream of the McKenley Hollow bridge to experience excessive deposition and channel avulsion (**Photos 3.1.22 – 3.1.24**). During the April, 2005 flood Brown road was “washed out” and several homes were inundated. Subsequent flooding has caused additional channel shifting. Adjacent landowners hired a local contractor to install a berm of stream bed material in the channel to serve as a temporary channel block, diverting stream flow toward CRT 47 and an alternative channel. This reach was not assessed for BMP alternatives as part of this study; however UCSWCD and NRCS have extensively surveyed the reach and have prepared a conceptual design employing natural channel design and traditional engineering. UCSWCD has approached NYC DEP to help provide local cost share for the further design and implementation of this project considered high priority by the Town of Shandaken.

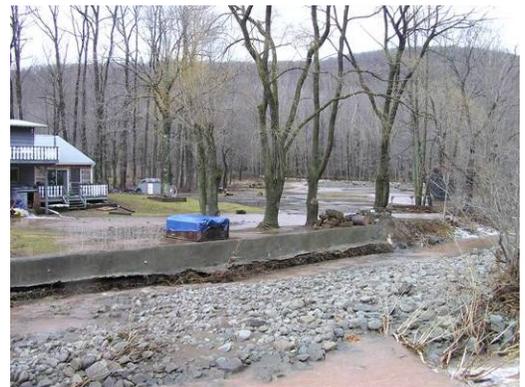
Photo 3.1.24 Reach 18 BMP Assessment Site: Flood damage on stream adjacent property. April 3, 2005

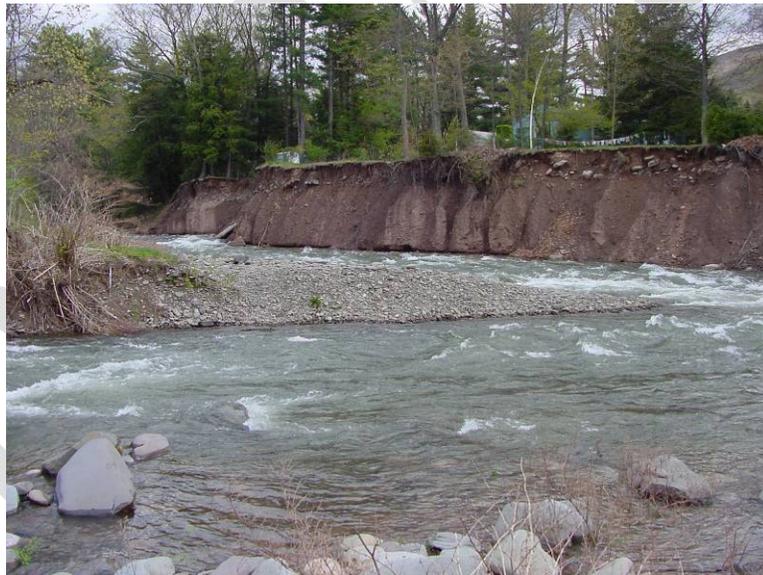
Photo 3.1.25 Eroding streambank composed of glacial till overlain by stream deposits. May 2003

Appendix C contains several resources documenting the ECRP. **Figure 3.1.16** is a site map. In 2000 NYCDEP contracted with FISCH Engineering to complete a BMP assessment for this site that was experiencing excessive erosion and periodic water quality impairment from exposed glacial clays (**Photo 3.1.25**). In 2002 NYCDEP
