UPPER ESOPUS CREEK MANAGEMENT PLAN

Volume III

Watershed and Stream Characterization

Prepared by
New York City Department of Environmental Protection
US Army Engineer Research Development Center
Cornell Cooperative Extension – Ulster County
January 2007

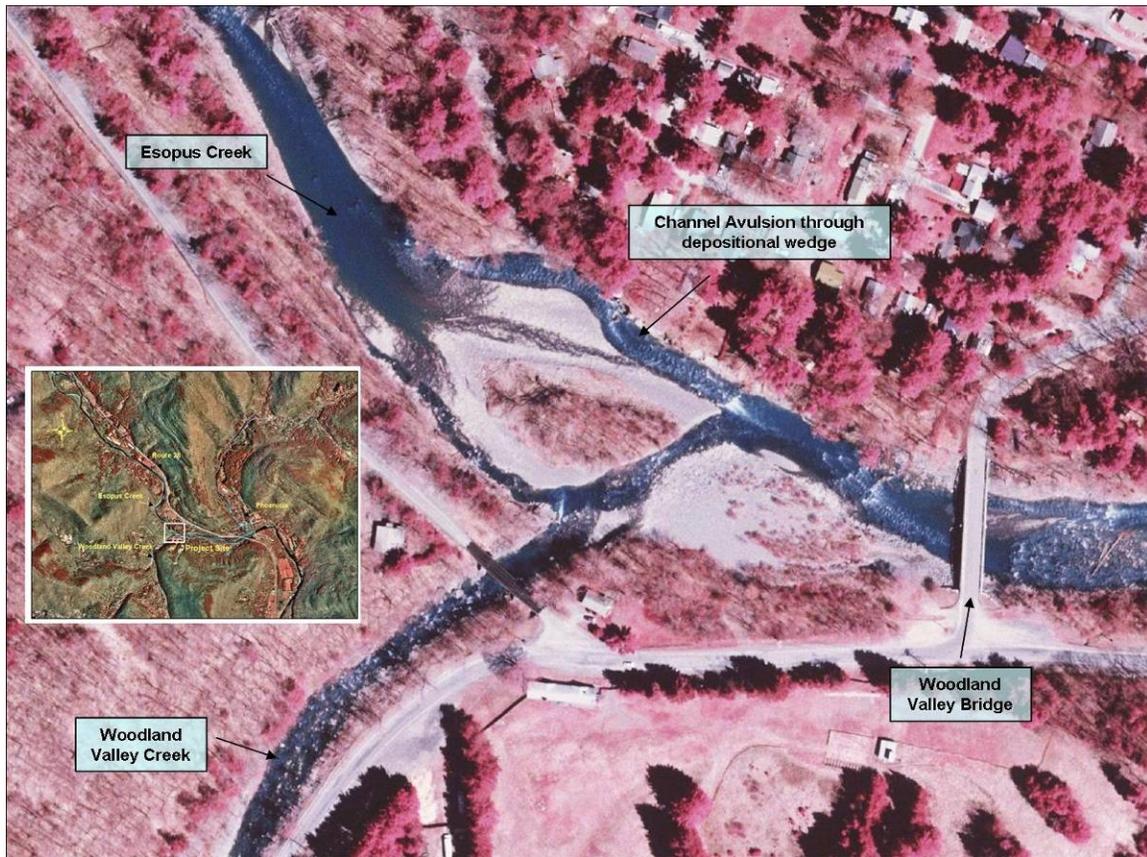
Figure 3.1.16 Location of Esopus Creek restoration demonstration project at Woodland Valley confluence. Digital aerial photo taken in April, 2001

Appendix C contains several resources documenting the ECRP. **Figure 3.1.16** is a site map. In 2000 NYCDEP contracted with FISCH Engineering to complete a BMP assessment for this site that was experiencing excessive erosion and periodic water quality impairment from exposed glacial clays (**Photo 3.1.25**). In 2002 NYCDEP

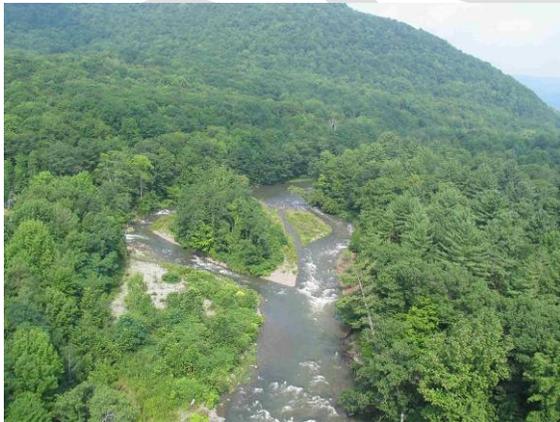
Photo 3.1.26 ECRP site pre-construction. August 2003

contracted with UCSWCD to oversee the construction of a restoration project that employed a combination of natural channel design techniques, traditional engineering (riprap revetment) and bioengineering (**Figure 3.1.17** and **Photos 3.1.26 – 3.1.30**). The project design used a bankfull flow of 3,400 cfs and 4,200 cfs upstream and downstream of the Woodland Valley confluence, respectively. A reconstructed flood

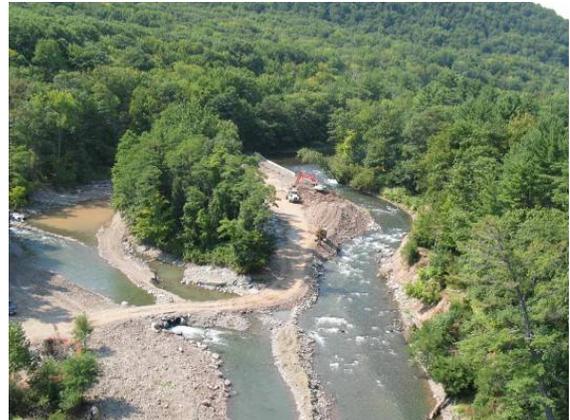
Photo 3.1.27 ECRP site during construction. September 2003

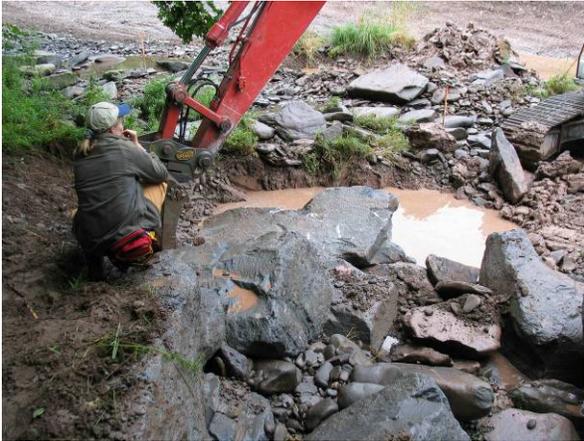
Photo 3.1.28 Construction of rock vane arm of upper boulder weir. Glacial lake clay just below stream sediment.

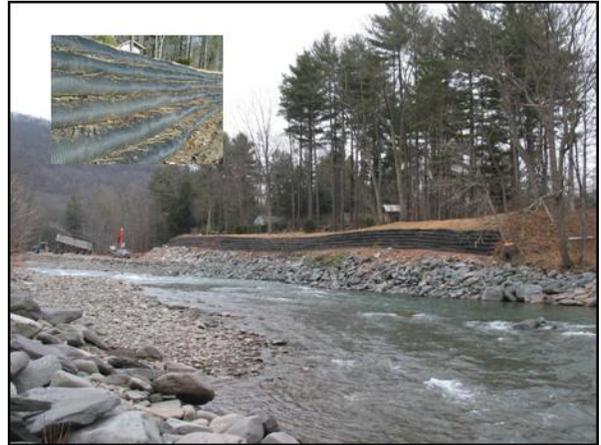
Photo 3.1.29 Construction of VRSS: 7 layers of soil partially wrapped in geotextile fabric with ~25,000 willow whips.

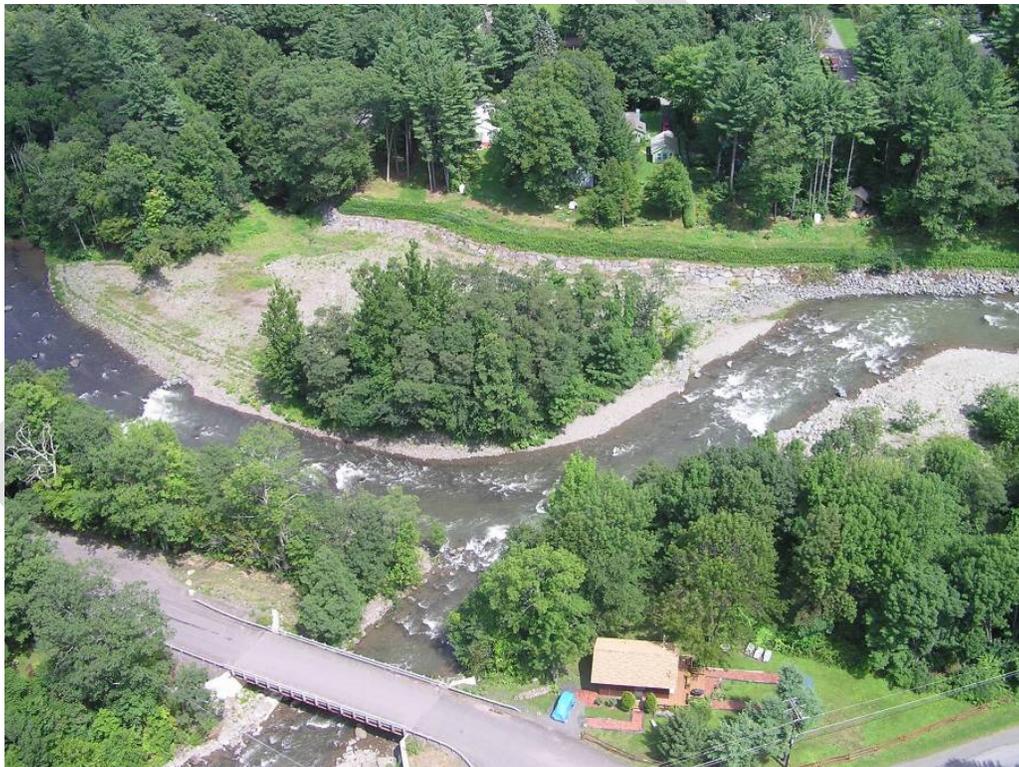
Photo 3.1.30 ECRP site one year after construction. August 2004

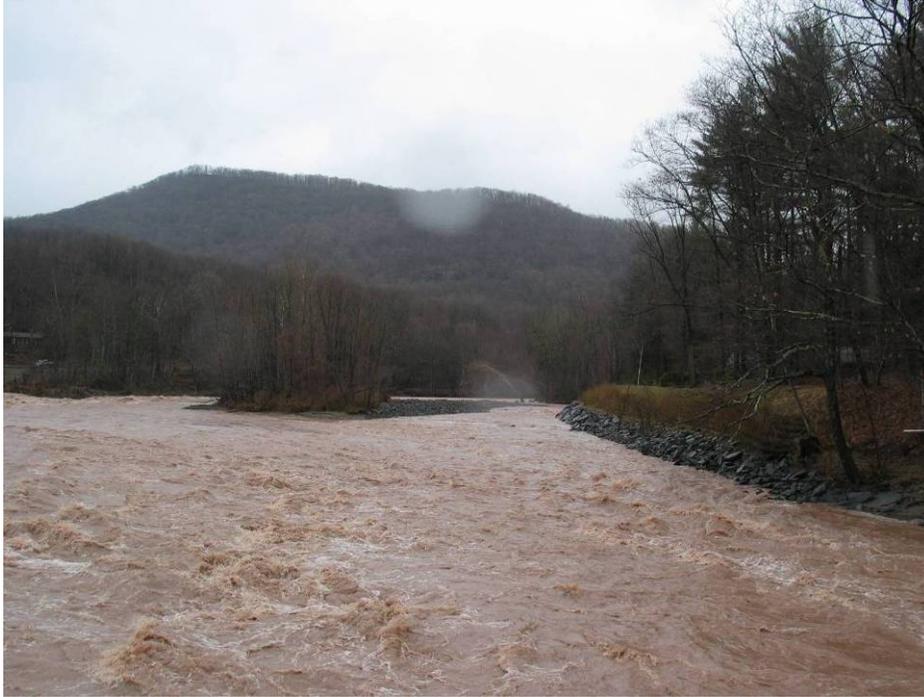
Photo 3.1.31 ECRP site day after peak of April 2-3, 2005 flood. Flood stage was reportedly level with Woodland Valley bridge and above riprap along left descending bank.

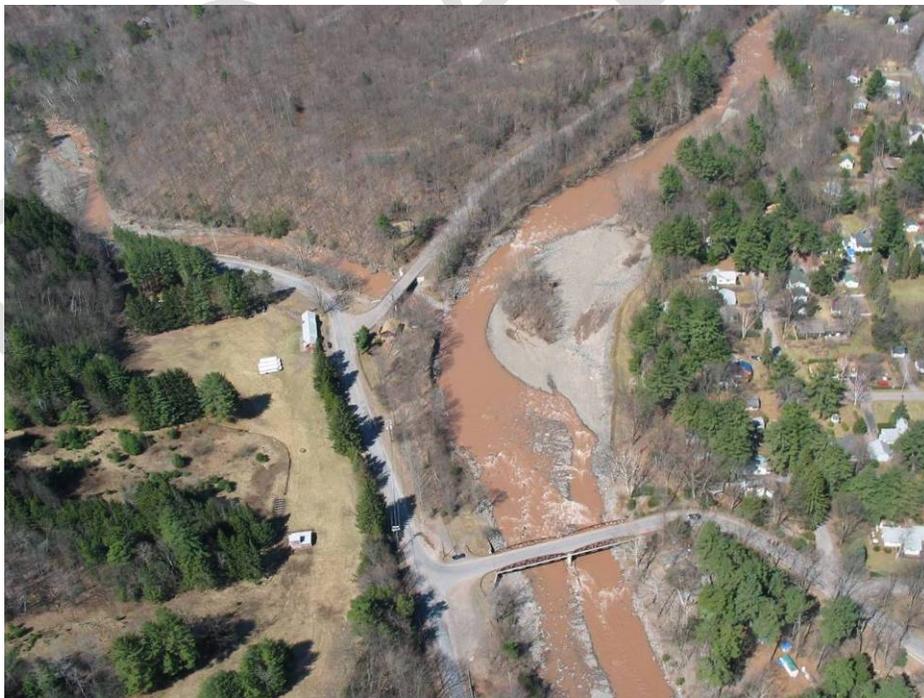
Photo 3.1.32 ECRP site two days after April 2-3, 2005 flood. Note significant change below Woodland Valley and protection of left bank and reconstructed floodway with scour between channel blocks.

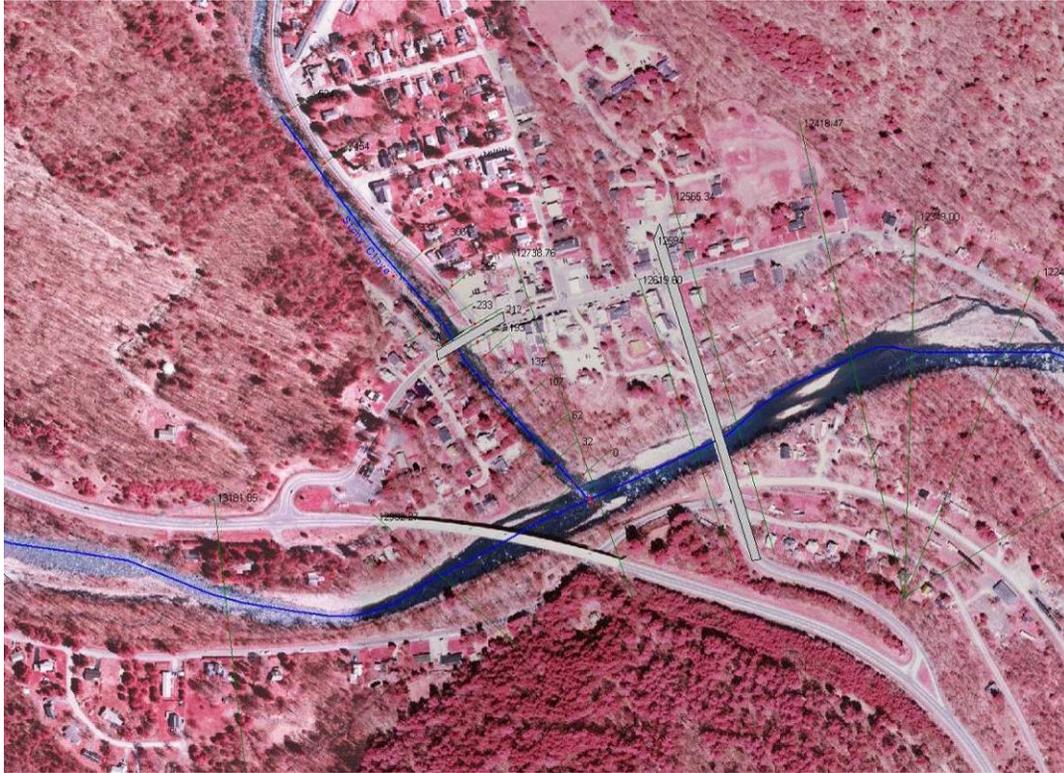
Figure 3.1.20. Graphic showing study area (Stony Clove Creek entering Esopus Creek Mainstem) with 2001 DOQQ backdrop. Blue lines are stream centerlines; green lines are model cross sections; and numbers denote cross section distance (in meters) upstream from the confluence.

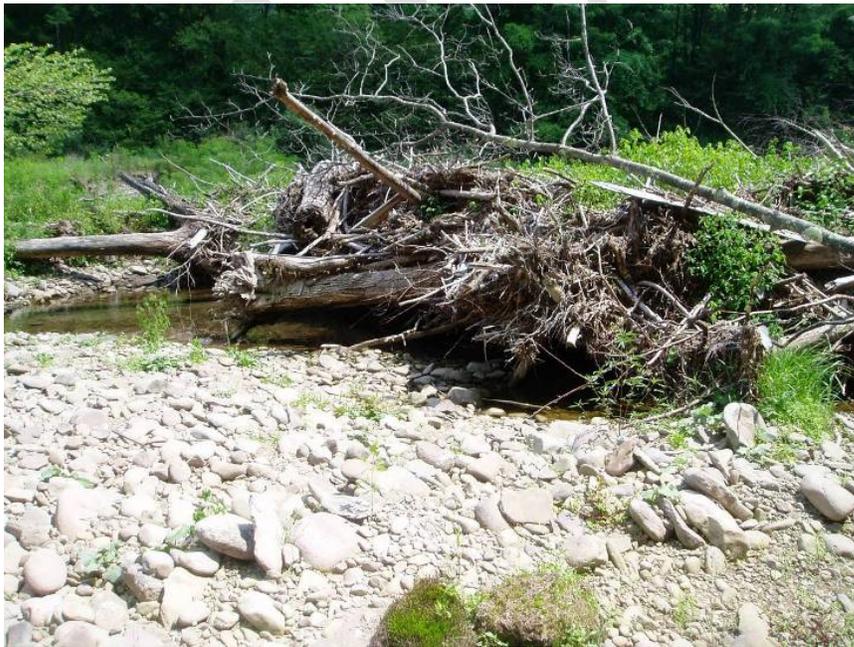
Photo 3.2.3. Woody debris partially blocking a channel in Reach EC18

The effect of flooding on healthy streamside vegetation is generally short term and the recovery/ disturbance regime can be cyclical. Following a large flood, the channel and adjacent floodplains can be littered with everything from woody debris to downed live trees (**Photo 3.2.3**). In following years, much of the vegetation recovers. Trees and shrubs flattened by floodwaters re-establish their form. In stable streams, gravel bars and sites disturbed in previous flood events become seedbeds for natural regeneration of grasses and forbs. However, if significant flood or ice floe events occur too frequently to allow adequate vegetation re-establishment, large trees do not have the opportunity to establish.

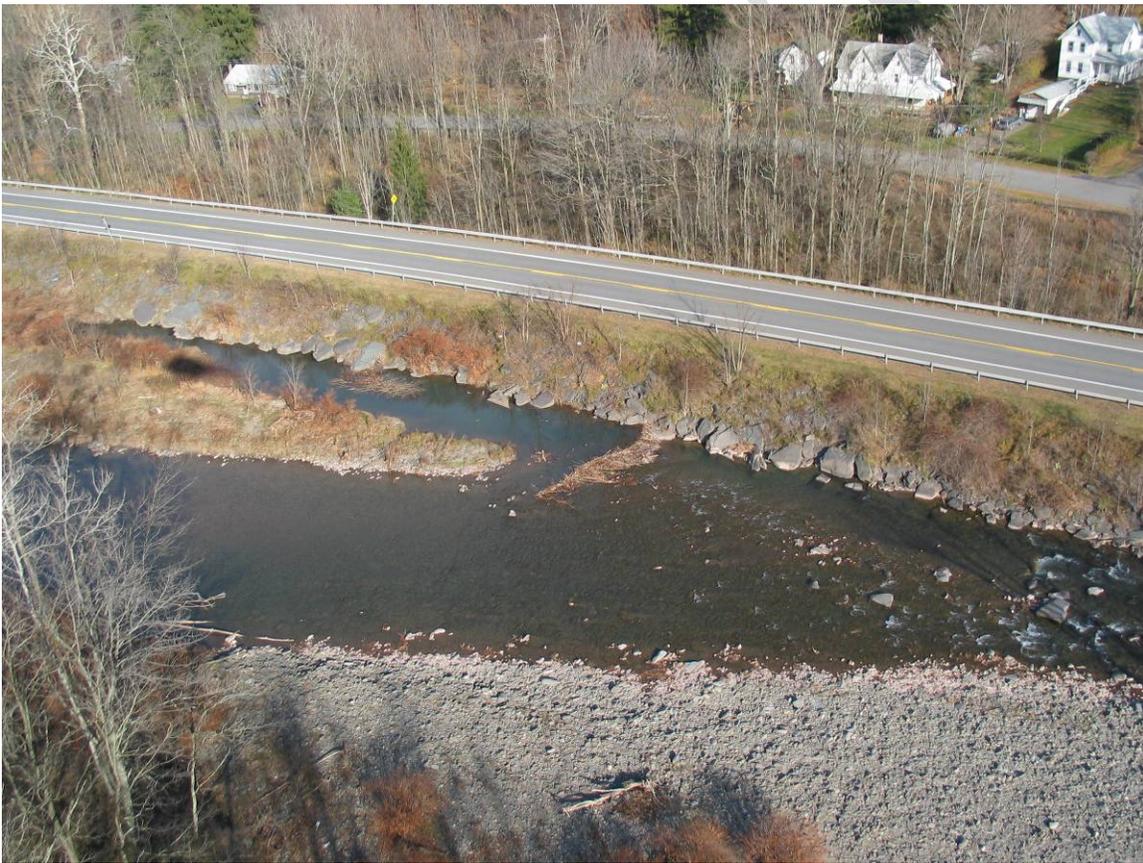
Photo 3.2.4 NYS Route 28 impact on riparian buffer (Reach 11)

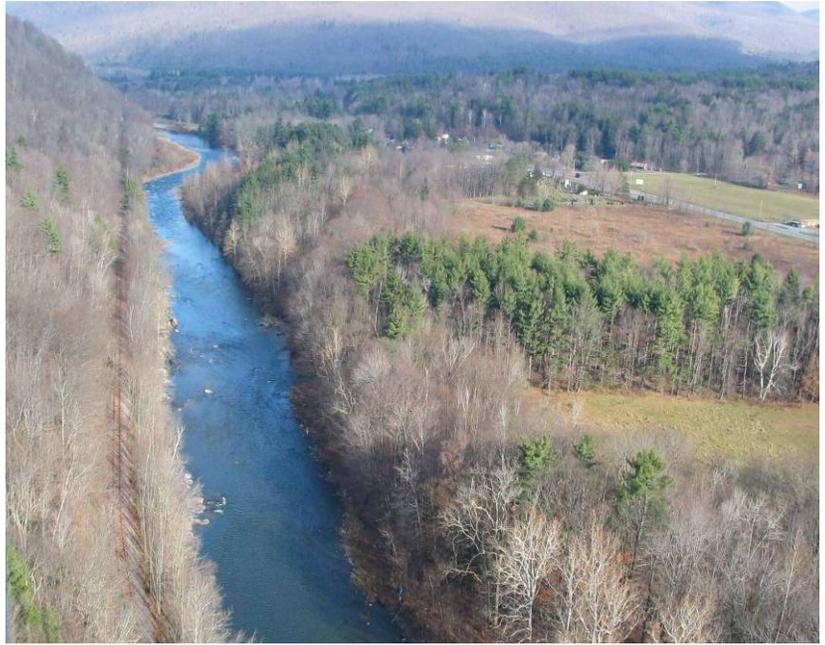
Photo 3.2.5 Maintained railroad grade along reach M2 resulting in riparian buffer break.

the streambank in these locations. Highway maintenance activities that regularly disturb the soil along shoulders and cut banks can welcome undesirable *invasive plants*. The presence of the Catskill Mountain railroad line that approximately parallels the course of the Esopus for several miles has a significant influence on the continuity of riparian vegetation coverage between the Ashokan Reservoir and Birch Creek. Where the railroad is in active use and maintained (Esopus Creek reaches 1-5) it is a clear break in the riparian buffer (**Photo 3.2.5**). In areas where public utility lines parallel or cross streams, riparian areas are disturbed by the practice of keeping vegetation trimmed to near ground level. This practice of vegetation suppression is another contributor to accelerated runoff and increased streambank erosion.

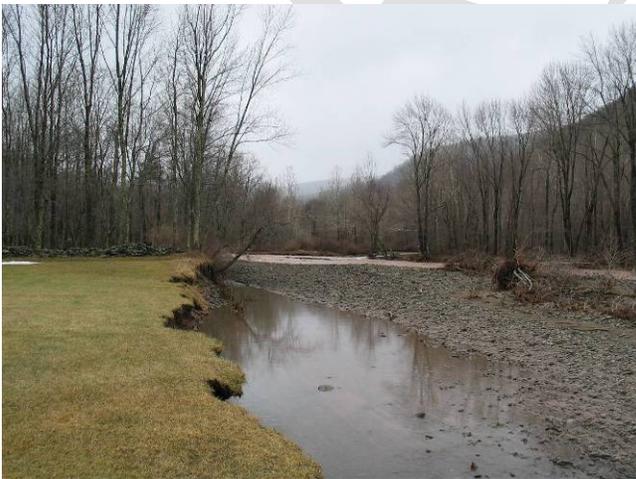
Photo 3.2.6 Streambank erosion and mowed lawn

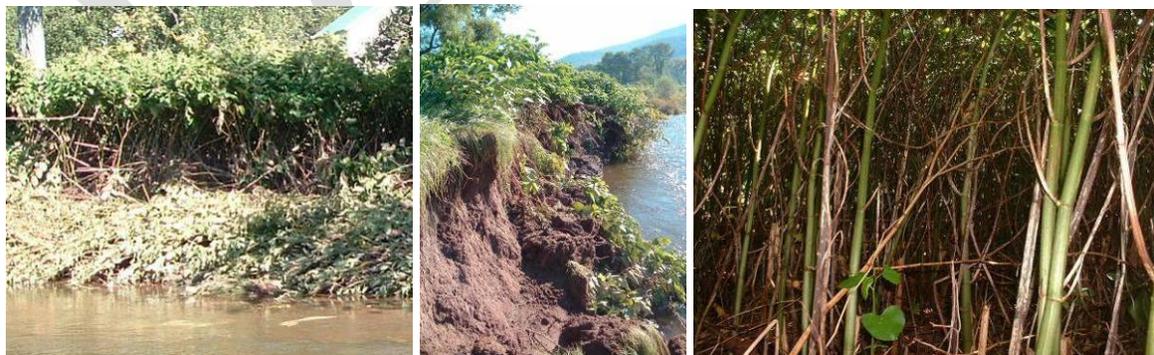
Figure 3.2.3 From left to right: knotweed flattened by high flow event in Greene County, a stream bank *slump* where only grass and knotweed bordered streambank, and the shade created by dense canopy of broad knotweed leaves.

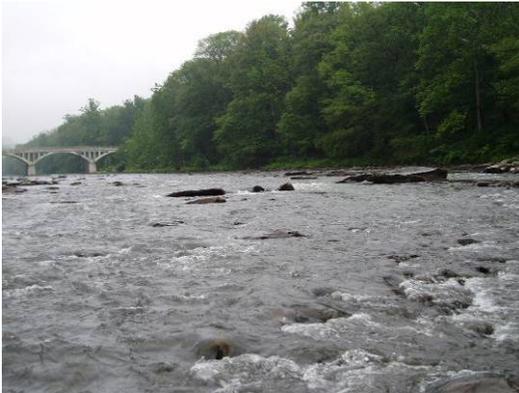
Valley and Stream Slope

Figure 2.3 graphs the stream's slope from Winnisook to Ashokan Reservoir. The slope along Esopus Creek ranges from 13% in the cascading headwater reaches down through 3% – 0.5% as the stream descends to Boiceville. (**Photo 2.2**). The average slope, or gradient, for Esopus Creek along this course is 1.5%. Any stream with an average slope greater than 0.2% is classified as a mountain river or stream. This is significant because management of mountain streams is considerably different than for lower gradient streams given differences in stream condition.

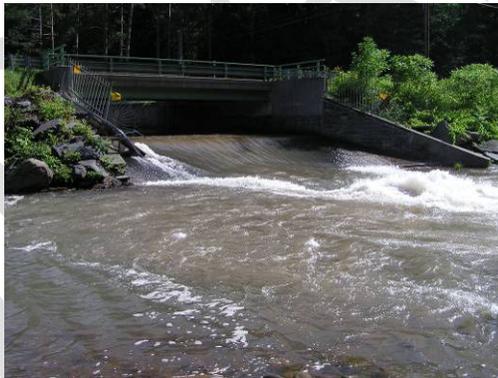
The climate, or the long-term weather pattern for a region delivers the water that the stream system conveys. The Southeast Catskill region, with its high relief/ high elevation stream-dissected landscape captures a lot of water (**Photo 2.4**). A map of precipitation prepared by Jerome Thaler for his book **Catskill Weather**, shows that there is a “bulls eye” of increasing precipitation amount around Slide Mountain (**Figure 2.5**). In fact the average rain fall measured at Slide Mountain is the highest for New York State. The amount, rate, and timing of water that the climate delivers to the landscape affect the size and type of streams that evolve to convey the range of water. This “bulls eye” of precipitation over Upper Esopus Creek watershed means the streams need to be larger than other streams with similar sized watersheds in adjacent areas to accommodate the larger volume of water.

Climatologists classify the Catskill region as humid continental. This means that cool, dry air masses move generally eastward throughout the year, and warm, humid maritime air masses from the south move northeastward during the summer (Lumia, 1991). The

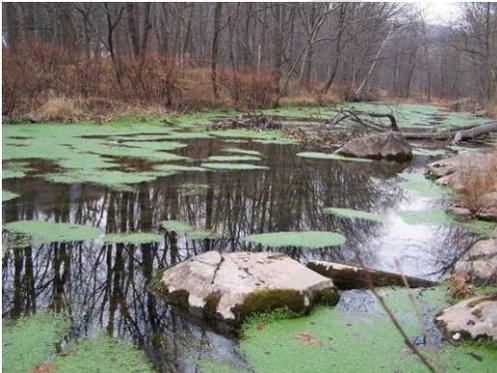
Agricultural Land	Cropland, pastures, hay, orchards, groves, vineyard and nurseries
Brushland	Bushland, successional species, herbaceous species (grass, etc.) and shrubs (woody veg., saplings)
Built Up	Urban and commercial land. For example: shopping centers, office parks, sewage treatment plants, junkyards and landfills, industrial lands, airports and roads
Forested	Deciduous, coniferous and mixed forests, including those that have been burned or logged
Residential	Single or multi-family units, apartment complexes, residential hotels and mobile home parks
Turf	Managed turf, golf courses, parks, cemeteries
Water	Water
Wetland	Wetland

Anderson Level 2 classification for the 23 reaches. The Phase 1 Assessment Report in **Appendix C** contains a river corridor map of LU/LC.
