# Long Road Stream Restoration Project

## *Assessment, Design & Implementation Report*

*Town of Lexington, Greene County, New York*

*Report Date: February 2010*

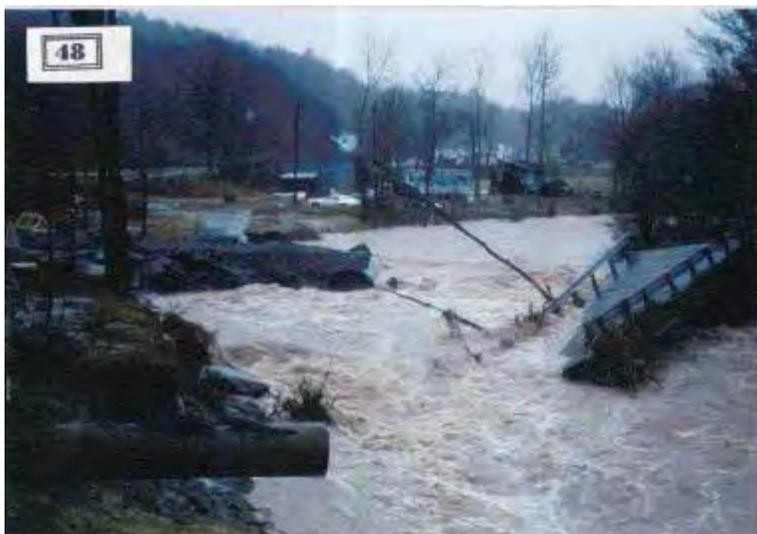
**Long Road Bridge during a 1996 flood event.**

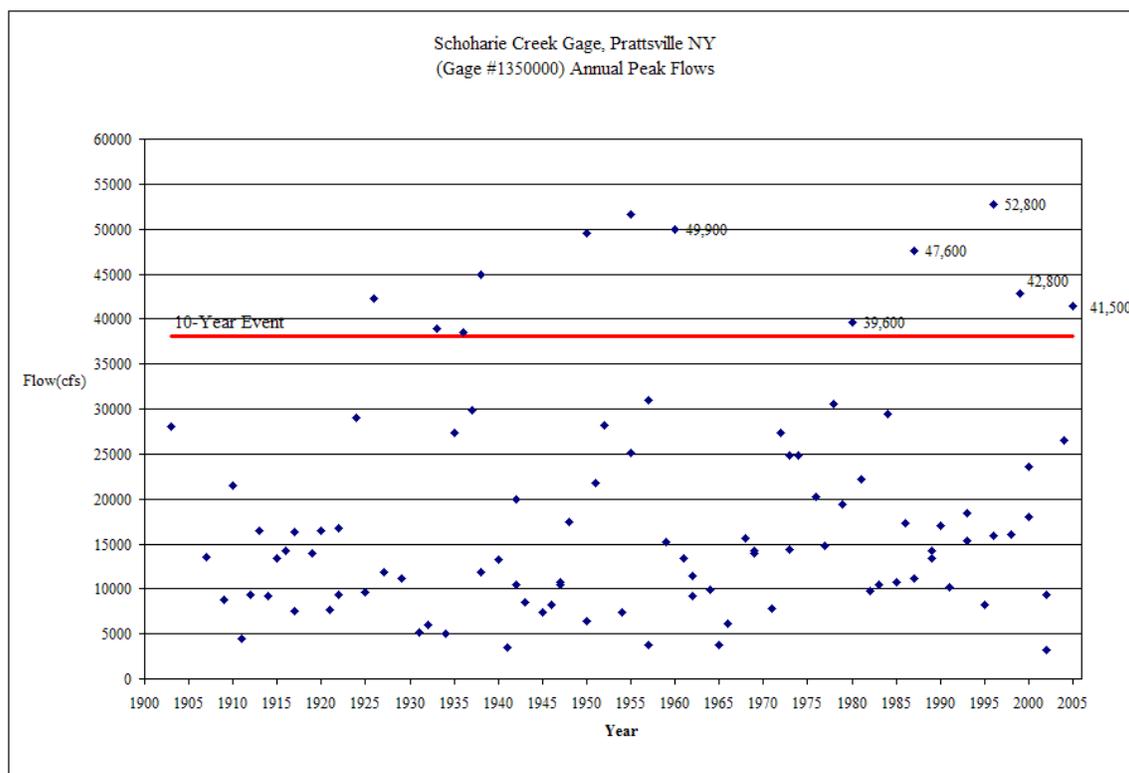
**Figure 1. Historic annual peak events at nearby Schoharie Creek at Prattsville (1903-2005).**

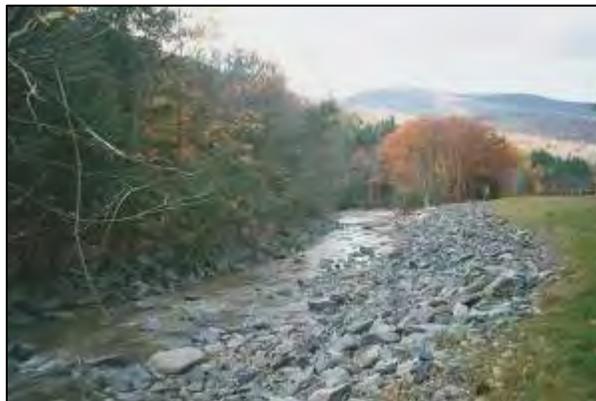
**Planform constrained by infrastructure and landform.**

The existing sinuosity of the project reach was 1.09, considered low within Rosgen classification system for natural “F” or “B” stream reaches. The average wavelength was 1,600 feet and measures of radius of curvatures were 337, 954, and 587 feet respectively in a downstream direction. The average meander beltwidth through the reach was 312 feet with a meander width ratio of 4.33.

In general the existing beltwidth was truncated through the lower reach due to impingement of the south valley wall and the road embankment to the north. The condition had caused the reach to be historically prone to bank erosion and failure as the channel had attempted to expand its beltwidth. The imposed restriction of the corridor had caused the channel to incise into the landscape. This had resulted in increased bank heights leading to widespread failure of both the road embankment and the valley wall.

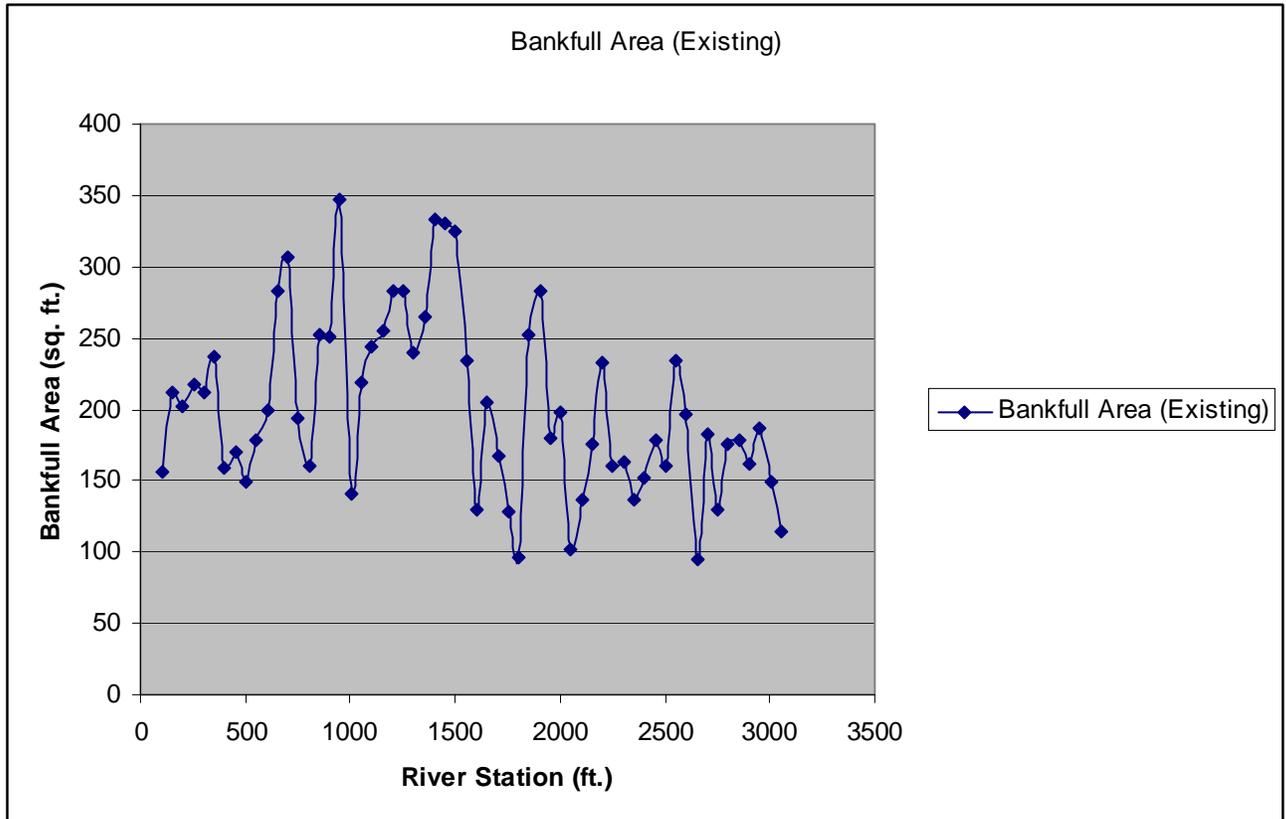
Figure 2. Bankfull existing cross sectional area through the project reach.

Bankfull flow areas for the reach averaged 201 square feet, and were highly variable, ranging from 95 to 348 feet<sup>2</sup>. Bankfull width averaged 67 feet and hydraulic depth was 3.1 feet. Channel width to depth ratios averaged 25 indicating relatively normal width conditions under this flow condition. It is suspected that these values were heavily influenced by confinement of the channel width, and may result in sediment transport over competence considering the steep slope of the project reach.

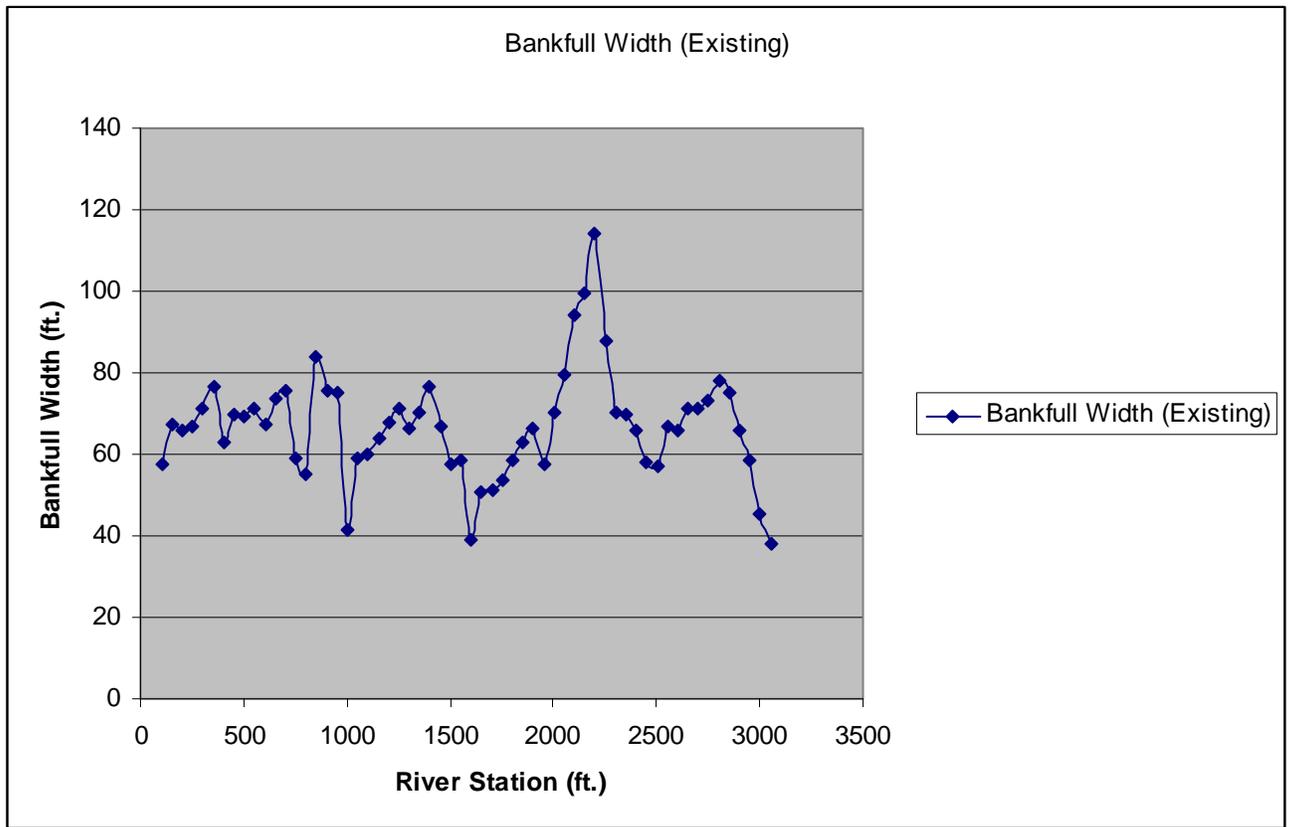
Figure 3. Bankfull channel existing width through the project reach.

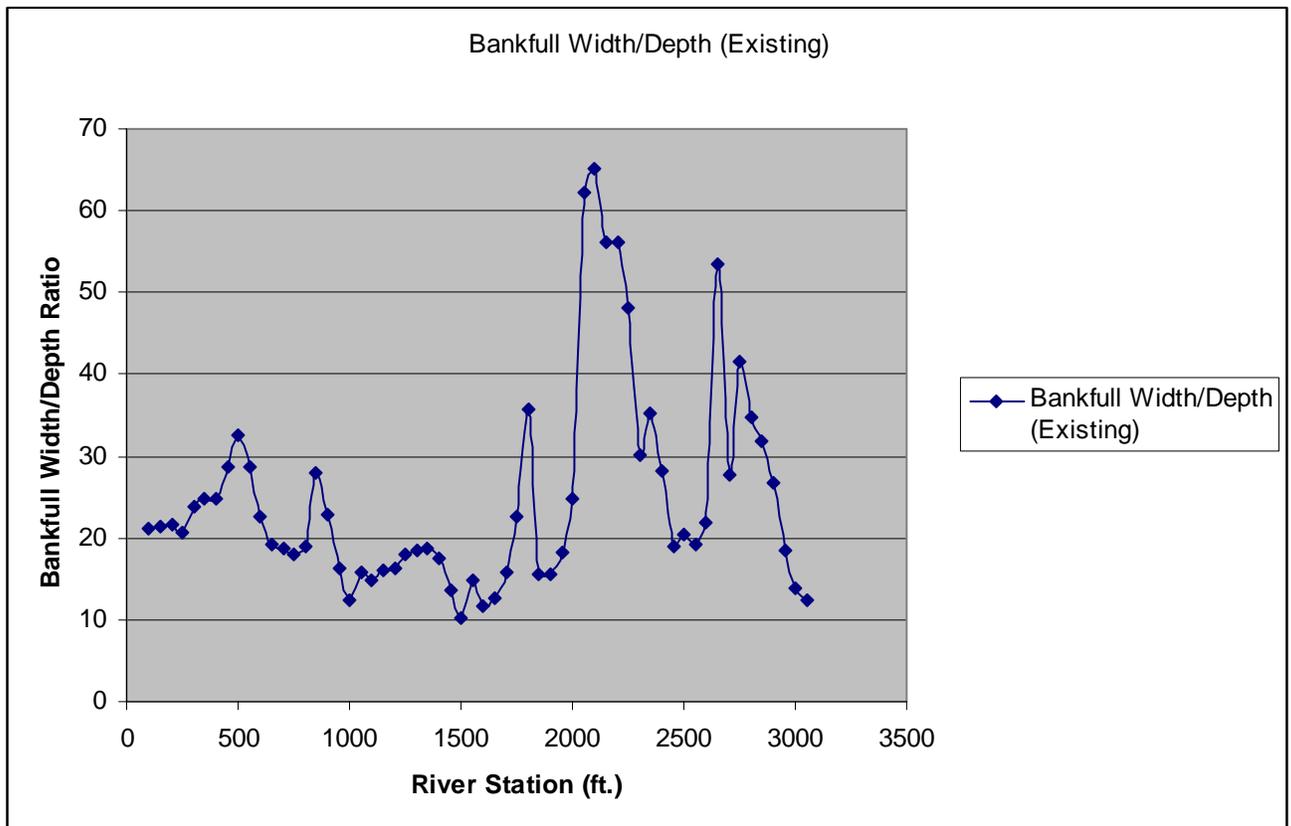
Figure 4. Bankfull channel existing width to depth ratio through the project reach.

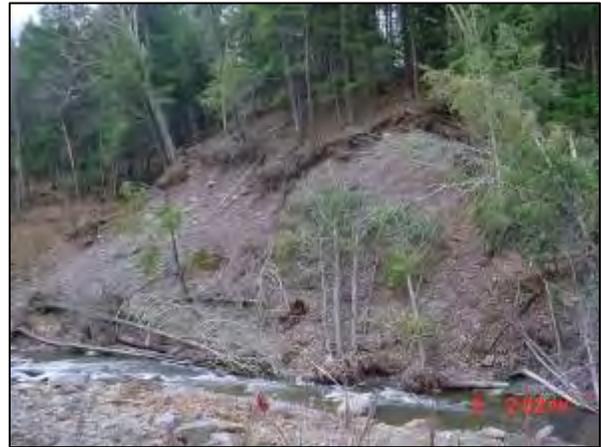
Erosion and failure of high bank.

Shallow, planar and cantilever failures were all identified within the project reach. These failures were addressed by the installation of stable bank geometry achieved through bank slope and/or height reductions.

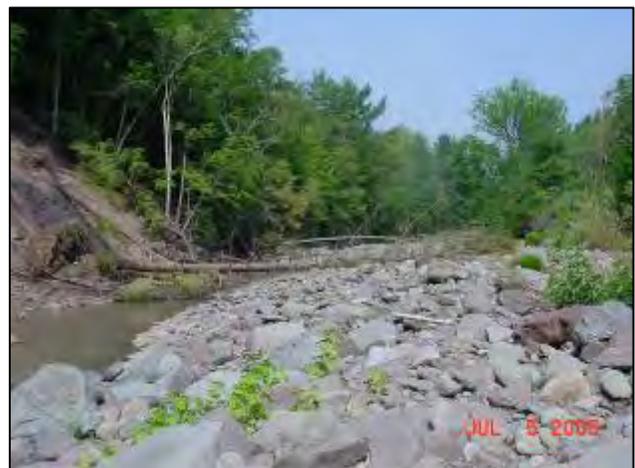
View looking downstream at bank failure and cobble bar.

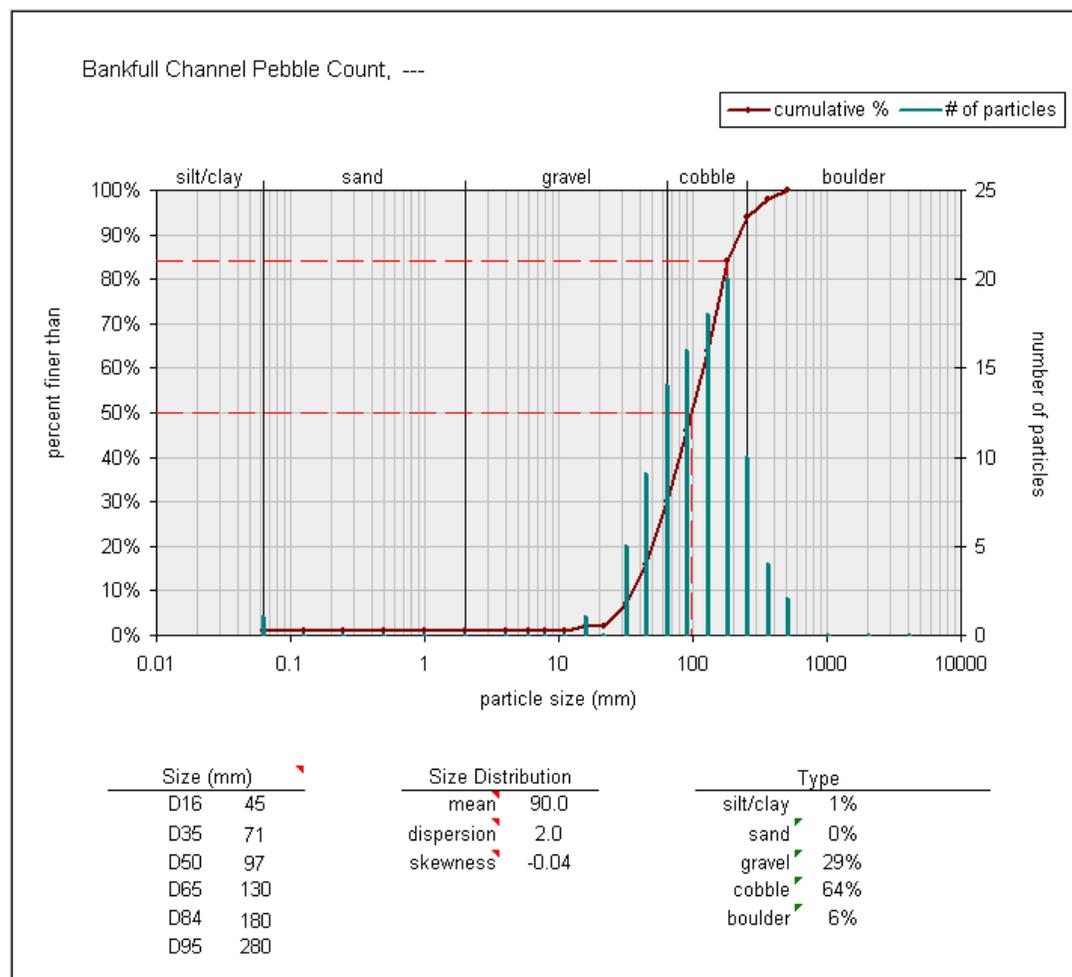
**Figure 5. Representative bankfull sediment distribution at a riffle section.**

The pebble count distribution in **Figure 5** reveals the predominant material found in the riffle was in the medium cobble size range (D50=97mm) with large portion of the sample in the large cobble class. 6% of materials were boulders and 84% of the sample was estimated to be smaller than 180 mm. The gradation of materials was moderately well sorted containing a large portion of grain sizes in the cobble class (dispersion 2.0). The distribution was considered normal and negatively skewed with a geometric mean of 90 mm and a D50 of 97 mm. Sample materials were generally well rounded and not well imbricated.

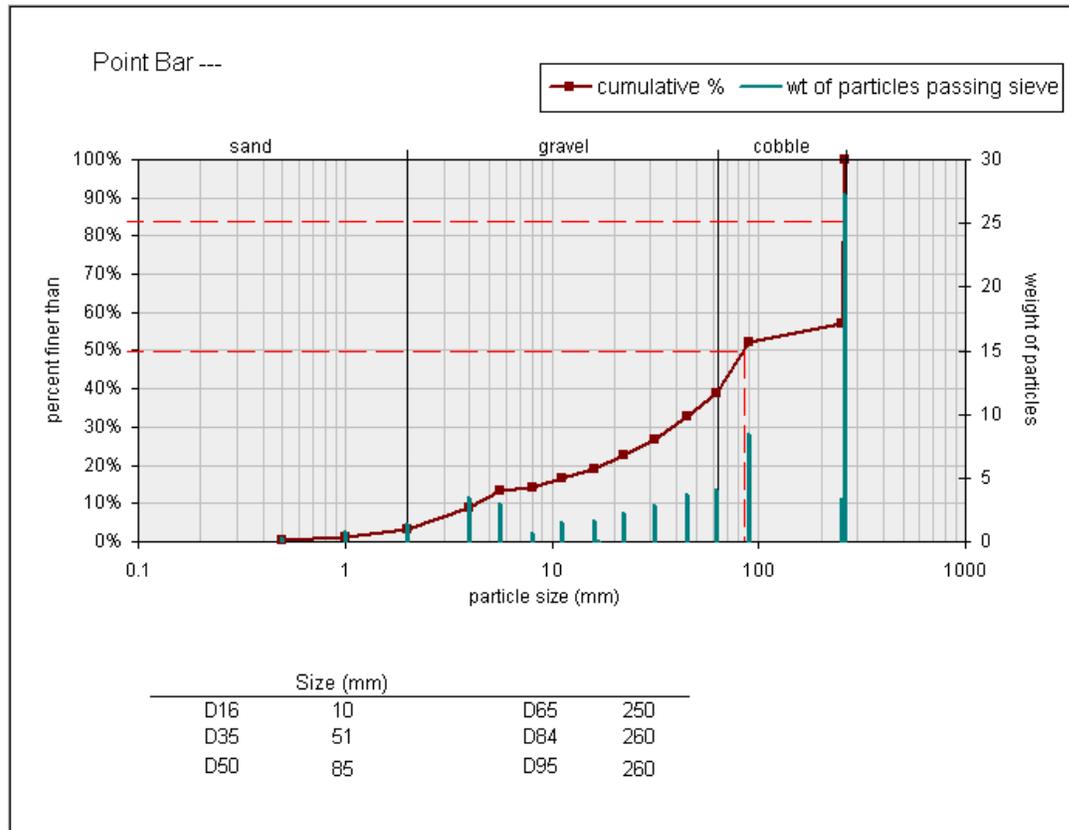
Figure 6. Point bar sediment distribution sampled near the bottom of the project reach.

Point bar sampling was performed at a bar formation at the downstream project extent. **Figure 6** represents the sieve analysis distribution depicting consistently smaller materials than the

pavement sample, dominated by gravels and small cobble. These materials were well embedded by finer gravel and sand material. Several larger particles were found on the bar near the sample site characterized as very large cobbles generally measuring approximately 250 mm.

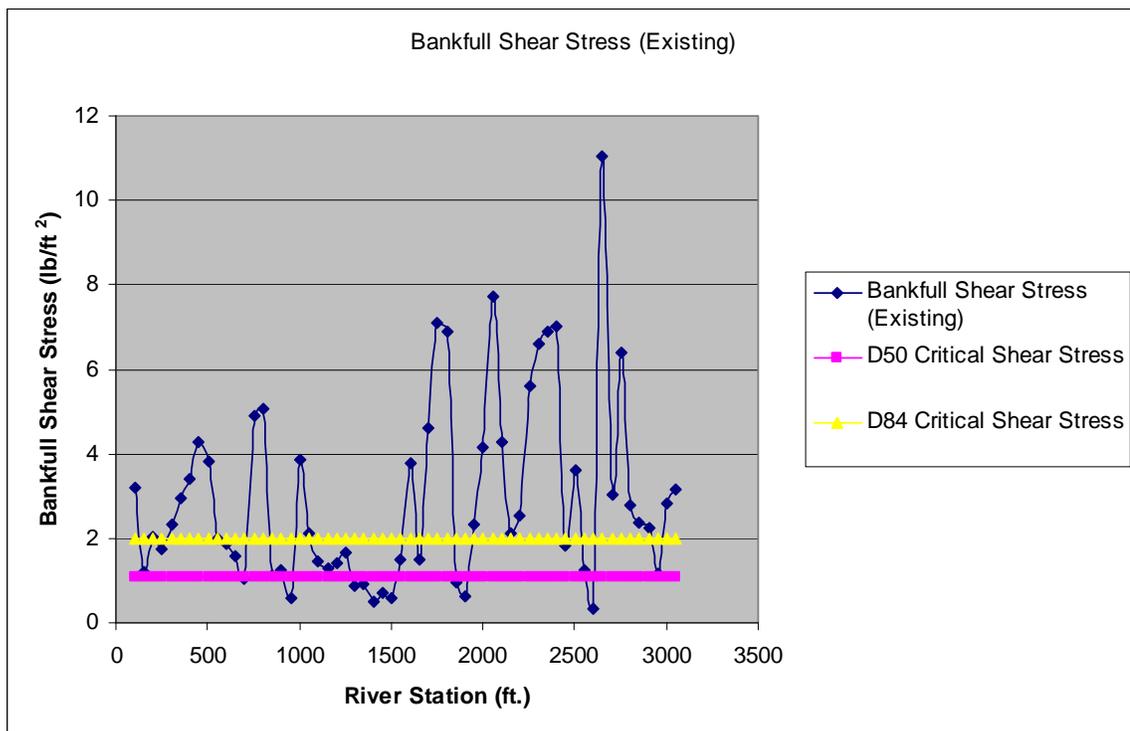
Figure 7. Channel average shear stress and channel armor threshold values.

Shear stress is a function of slope and depth and is commonly used to describe a reaches hydraulic condition. The initial step in a sediment transport analysis is evaluation of the mobility of the channel bed material. Commonly this is accomplished through comparison of the hydraulic shear stress and the critical shear stress of the bed material. It should be noted that there are many paradigms for sediment and channel armor mobility. **Figure 7** displays the average shear stress through the reach during bankfull flow and critical shear stress values corresponding with the bed material D50 and D84. The model indicated that the critical shear stress for both the D50 (97 mm) and the D84 (180 mm) particle sizes were mobile during bankfull flow condition throughout much of the project reach.

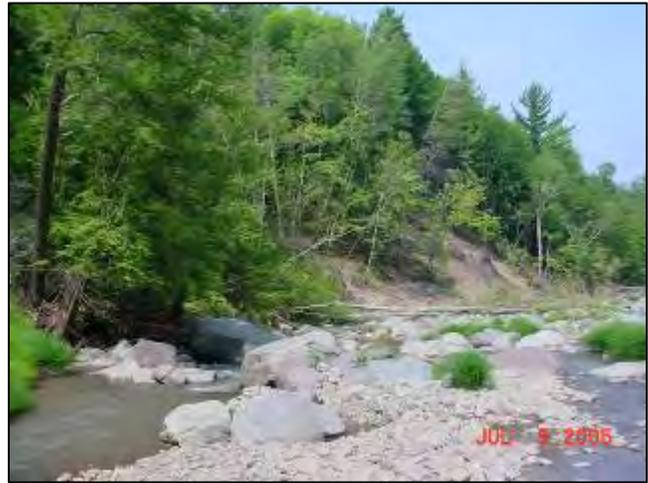
**Bank erosion and failure in project reach.**

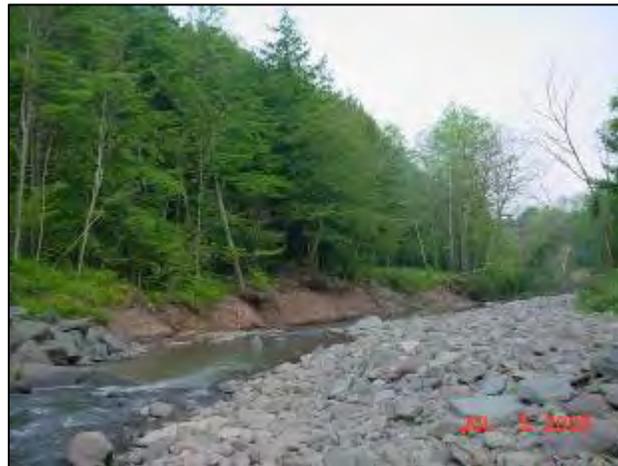
Image of bank erosion and associated cobble bar.

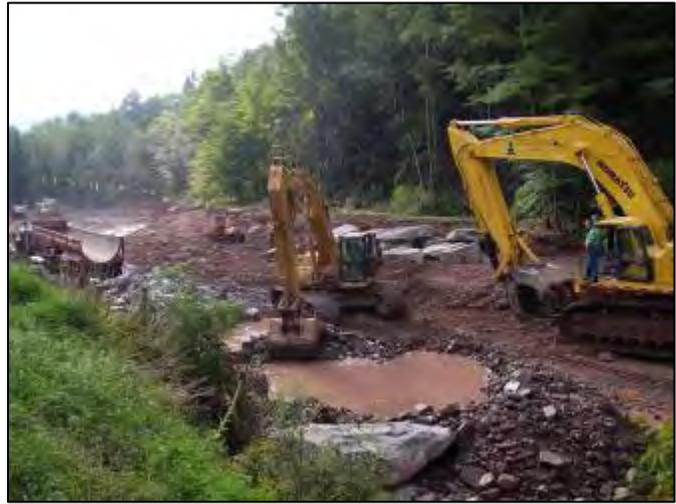
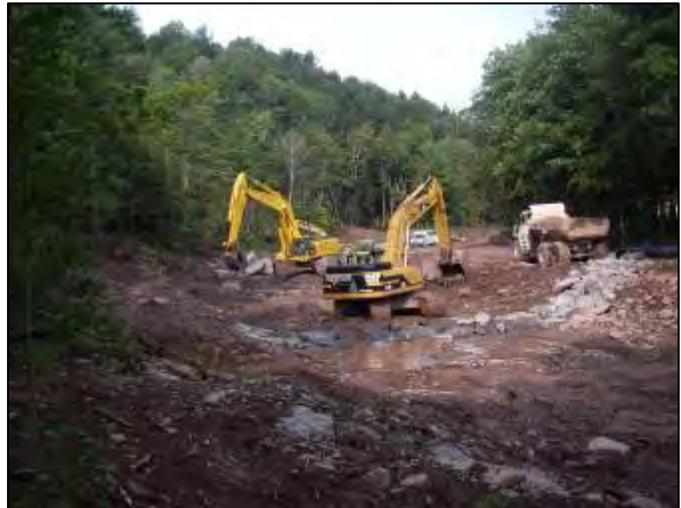
**Phase I stream channel excavation.**

Stream channel excavation results in disturbance of significant land area. This portion of the project implementation was scheduled in phases to minimize the land area vulnerable to erosion at all times. The phased approach to the excavation work was an effective

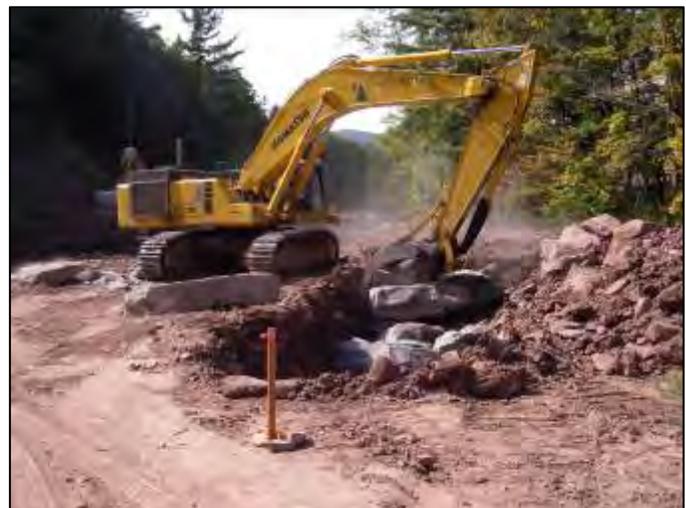
**Excavation and construction of a cross vane arm near the center of project reach.**

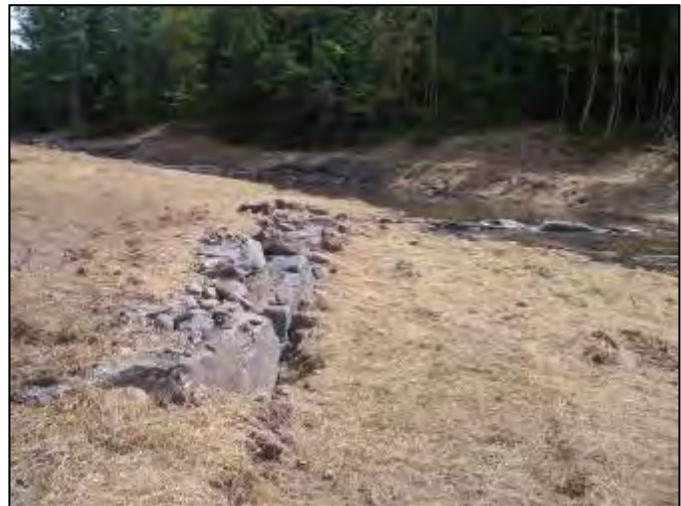
**Completed cross vane in upper reach of project.**

The final count of structures installed on the project included twelve cross vanes, 6 drop structures and three rock vanes.

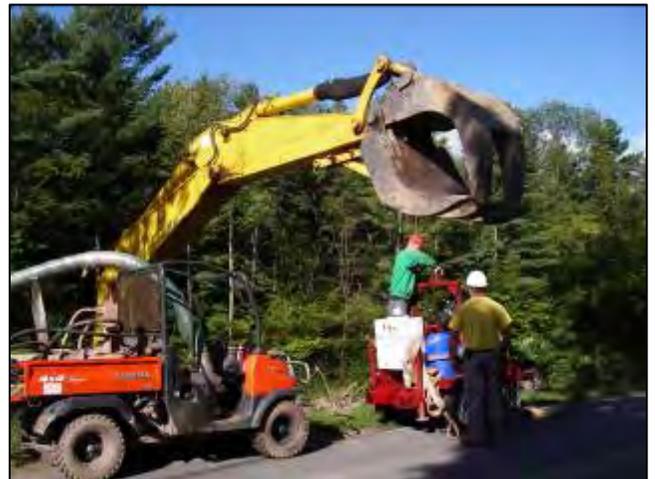
**Installation of turbidity control equipment.**

Dewatering for the project was provided by GCSWCD. Installation of the provided equipment was completed on a time and materials basis according to the equipment and labor rates provided by the contractor as a component of the bidding process. This included assembly of the dewatering pipeline, installation of the pumping equipment, relocation of the equipment as necessary to complete the project, and removal of the equipment and pipeline upon completion of the project.
