Section 5.3 Proposed Rondout Creek Demonstration Project

As part of the 2007 Filtration Avoidance Determination for the NYC Water Supply, it was agreed to construct, by 12 February 2012, a demonstration restoration project for the Rondout Creek. After completing the watershed assessment and mainstem stream feature inventory, and following discussions with highway superintendents and engineers from the towns and counties in the watershed regarding their priority infrastructure issues related to stream management, a site was selected in the lower reaches of Management Unit 6 as a potential demonstration project site. In 2009 and early 2010, preliminary discussions between DEP and the Sullivan County Soil and Water District (DEP's contract partner on the Rondout Basin Stream Management Plan and Project), Sullivan County Department of Public Works, the owner of the property on which the restoration work will occur, and NYSDEC permitting biologists for Region 3, a general consensus was made to develop the project described below, contingent on receipt of permits.

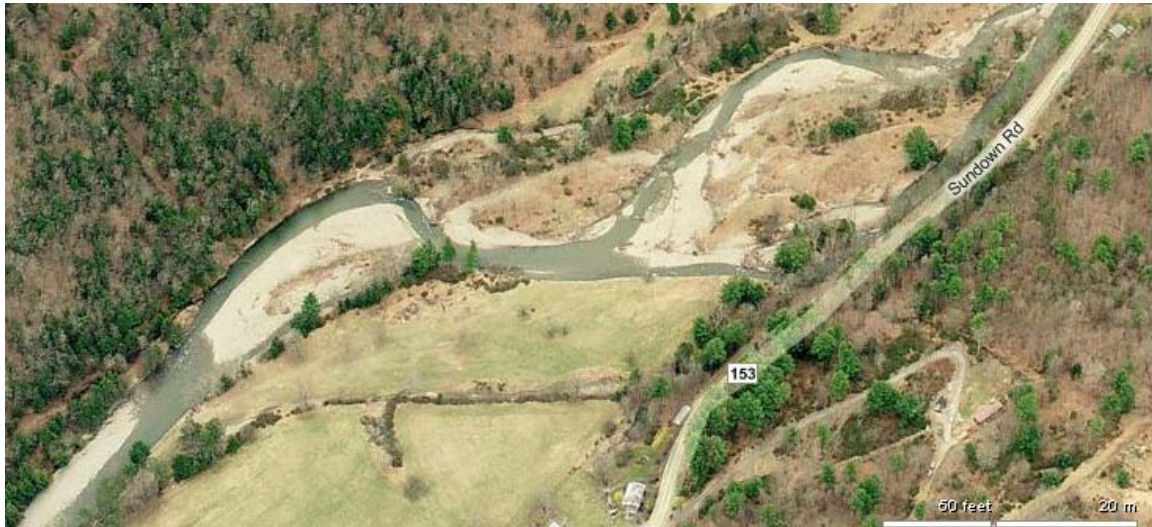
Figure 1 Proposed Rondout Creek Demonstration Restoration Project, looking downstream

At the downstream end of Management Unit 6, the Rondout Creek becomes braided, aggraded and collects large woody debris (Figs. 1-7). A major new channel thread has developed as a result of debris jams carrying a significant proportion of the total bankfull channel flow; eroding a hay field (Figure 8); threatening the road embankment along a stretch of Sundown Road (Sullivan County Route 153); undermining a piped outfall carrying road runoff (Figs. 9-10); and entraining fine sediment, increasing turbidity (Fig. 8-10).

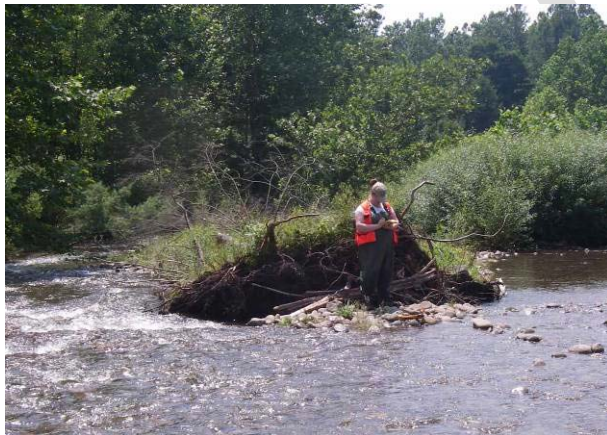
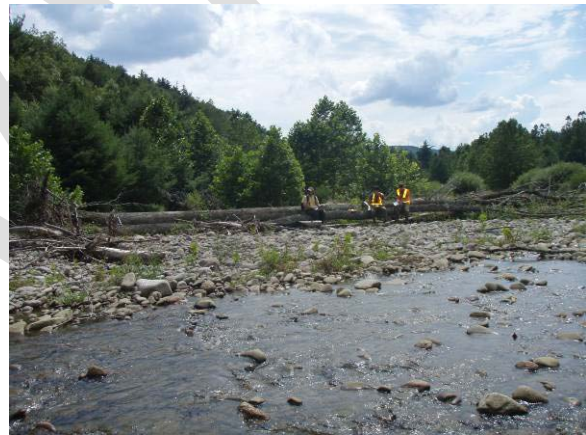
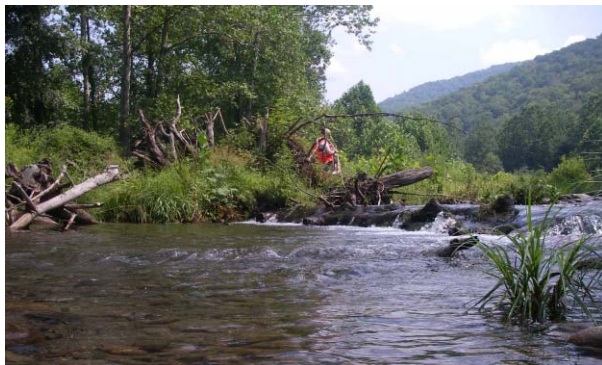
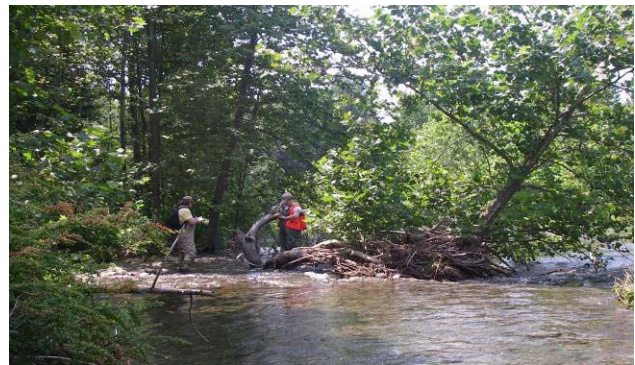
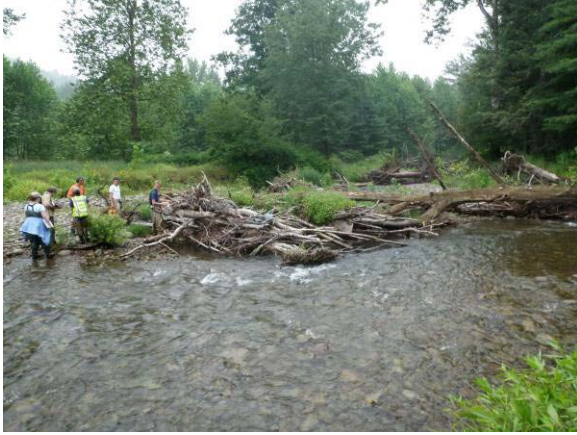
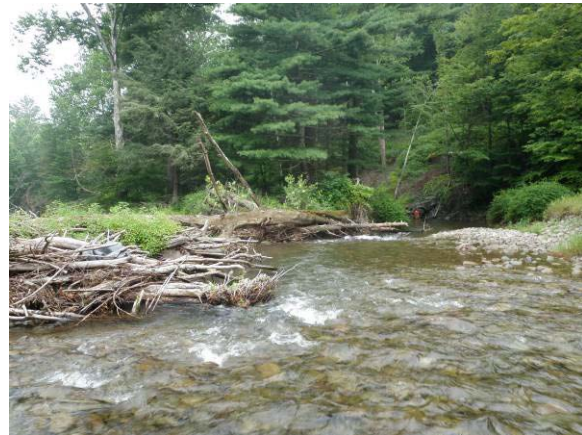
Figure 2 Woody debris accumulation

Figure 3 Woody debris accumulation

Figure 4 Woody debris accumulation

Figure 5 Woody debris accumulation

Figure 6 Woody debris accumulation

Figure 7 Woody debris accumulation

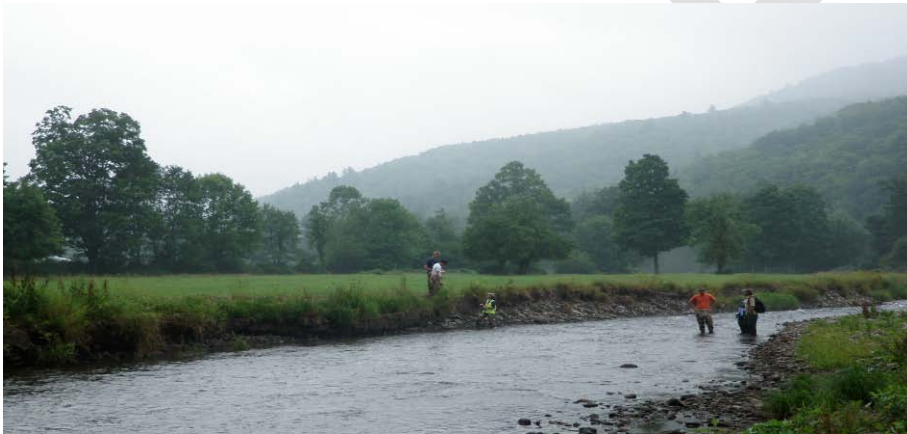
Figure 8 Eroding bank at hayfield

During the watershed assessment, the Sullivan County Department of Public Works identified this site as priority for protection of public safety, as the road is a primary artery for emergency services for a significant population. The road embankment is not protected by ledge here; rather is composed of highly erodible glacial till deposits; which include a significant fraction of entrainable fine clay sediment and represent a source of turbidity and thus a water quality concern for the NYCDEP. Additional fine sediment is entrained from the eroding bank at the hayfield.

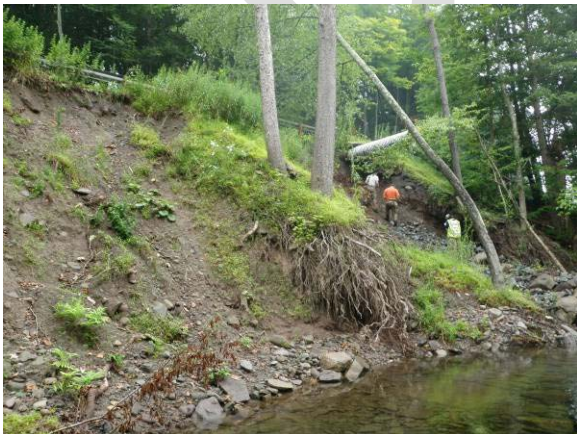
Figure 9 Eroding embankment along SC Rte 153
