2.6 Riparian Vegetation Issues in Stream Management

General Concepts of Riparian Vegetation Ecology and Management

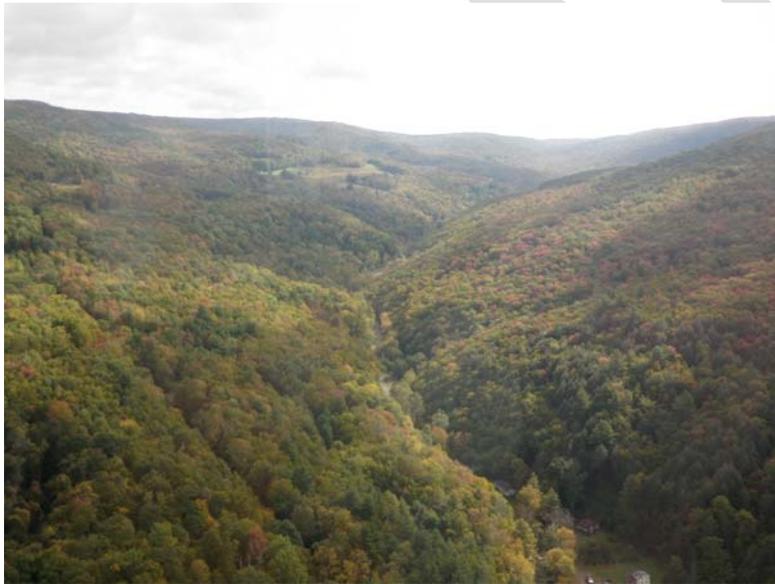
Figure 3 Primarily forested upper Rondout watershed

Previous land uses have had a significant role in determining the type of vegetation found along the stream. Due to the steepness of the sides of the valley, the most intensive development activities were confined to the valley floor along the stream. Pastures and fields were created from cleared, forested floodplains. Abandoned, old fields have experienced a consistent pattern of recovery, with primary-colonizer species dominating the initial regrowth including sumac, dogwoods, aspens, hawthorns, and white pine. These species are succeeded by other light loving hardwood tree species such as ash, basswood and elm or in lower parts of the watershed, hickories, butternut, and oak. Hemlocks are largely confined to steeper stream banks and slopes where cultivation or harvesting of hemlocks for bark was impossible. More recent housing construction has re-intensified activity along the stream and been accompanied by the introduction of non-native vegetation typical of household lawns and gardens. While today the upper Rondout watershed is largely forested, agriculture and development activities are concentrated along the valley floor, leaving the riparian area predominantly herbaceous.

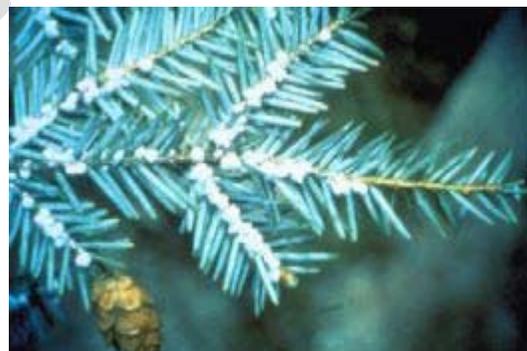
Figure 4 Hemlock woolly adelgid on the underside of a Hemlock branch

The hemlock woolly adelgid (*Adelges tsugae*) is an insect, which feeds on the sap of hemlocks (*Tsuga spp.*) at the base of the needles causing them to desiccate and the tree to take on a grayish color (Fig. 4). Stress caused by this feeding can kill the tree in as little as 4 years or take up to 10 years where conditions enable the tree to tolerate the attack (McClure, 2001). This native insect of Japan was first found in the U.S. in Virginia in 1951 and has spread northward into the Catskills (Adams, 2002).

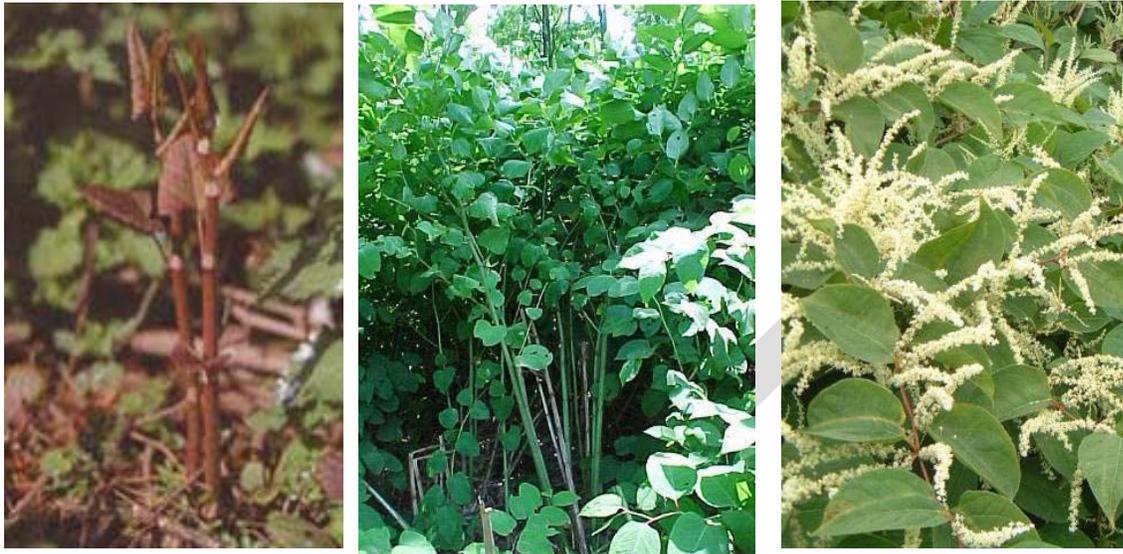
Figure 5, (a), (b), and (c) Stages of Japanese knotweed's growth throughout the growing season

The spread of Japanese Knotweed (*Fallopia japonica*), an exotic, invasive plant gaining a foothold in many streams in the Catskills, is an example of a plant causing such a disruption. As its common name implies, Japanese knotweed's origins are in Asia. It shades out existing vegetation and form dense stands along the bank (Fig. 5 a-c). Although the impact of a Japanese knotweed invasion on the ecology of the riparian area is not fully understood, the traits of Japanese knotweed pose several concerns. Some of these concerns include:
