2.7 Riparian Vegetation Issues in Stream Management

Riparian Vegetation in Schoharie Creek

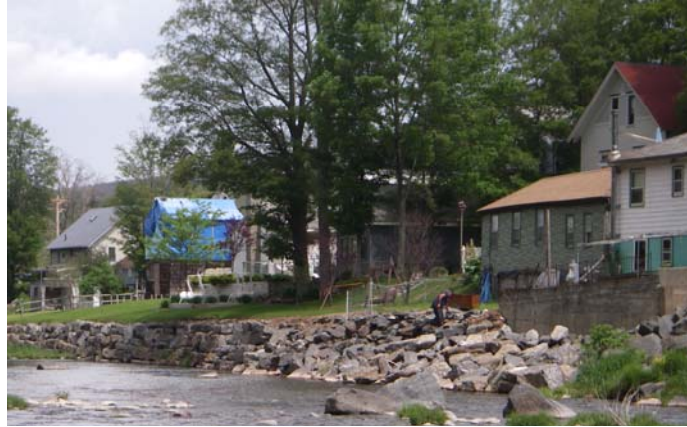
Streamside development and mowing to the edge of the stream leads to bank failure. This bank has been reinforced with riprap and concrete.

and views of the stream. Following this clearing, the stream bank begins to erode, the channel over-widens and shallows. The wide, shallow condition results in greater bedload deposition and increases stress on the unprotected bank. Eventually stream alignment may change and begin to cause erosion on the property of downstream landowners. Catskill stream banks require a mix of vegetation such as grasses and herbs that have a shallower rooting depth, shrubs with a medium root depth, and trees with deep roots. Grasses alone are insufficient to maintain bank stability in steeply sloping streams such as the Schoharie Creek.

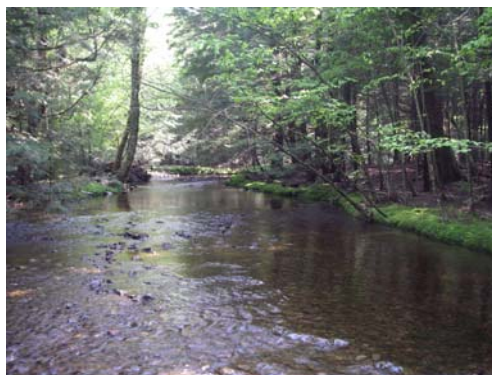
Figure 13 Riparian vegetation (closed deciduous), protects stream banks and water quality, and provides habitat and food sources for fish and wildlife.
