Watershed Overview

The Delaware County Soil and Water Conservation District together with the County Planning Department are preparing a stream management plan for the basin due for final release in December 2007.

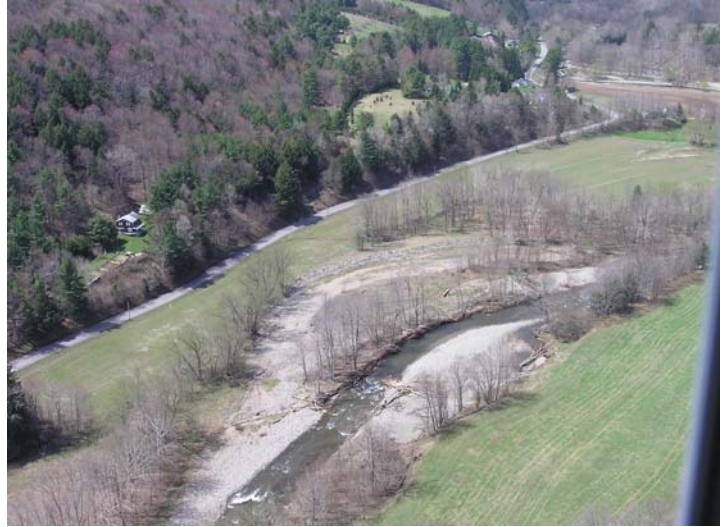
An example of channel migration and gravel deposition on a tributary.

Stream stability and sediment transport processes are a significant issue for landowners and managers of the resource in the basin. While the mainstem of the East Branch Delaware River has a stream bed that is composed largely of gravel and fine sediments, the tributaries are cobble bed streams that often move large amounts of bedload during high flows. The mobilization and deposition of this bedload in large gravel bars is a significant management concern for stream managers, highway superintendents and landowners in the basin.

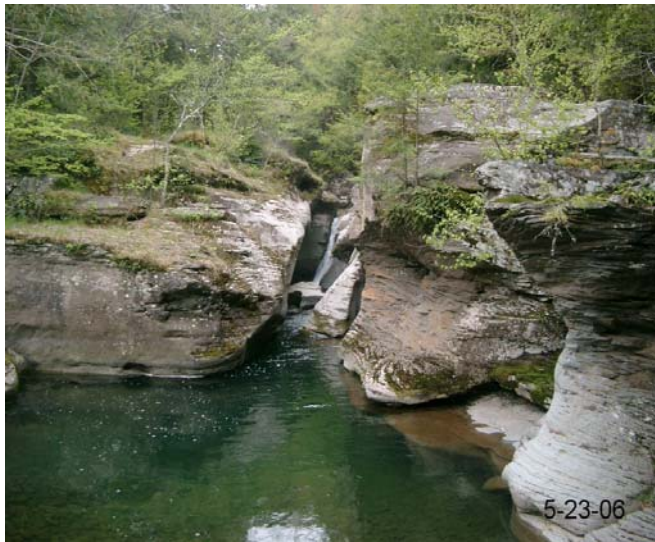
An example of a stream down-cutting through a bedrock outcrop.

The occurrence of bedrock also directly affects streams wherever the stream channel contacts bedrock instead of stream deposits. In such places, rates of stream channel downcutting, bank instability and lateral migration are dramatically reduced.
