Conine Stream Restoration Project

Design and Implementation Report

Town of Prattsville, Greene County, New York

December, 2007

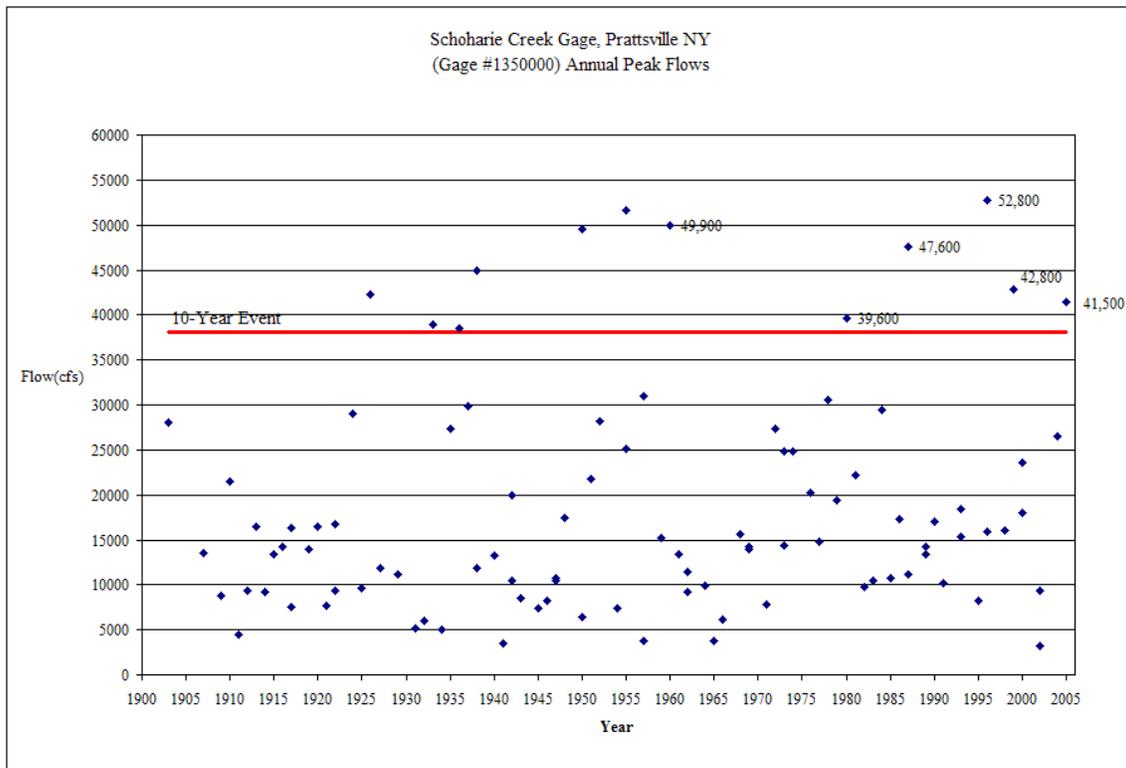
Figure 1. Historic annual peak events at nearby Schoharie Creek at Prattsville (1903-2005).

Annual monitoring from 1997-2000 of nine cross sections, streambed profile, and channel materials assisted in verifying more recent processes, erosion rates, and potential of the reach to naturally recover. Although the monitoring data provides a limited time span of 3 years, each year in the monitoring period an event above bankfull flow conditions occurred, as well as the major event associated with Hurricane Floyd in 1999 (16,800 cfs at the upstream Red Falls Gage).

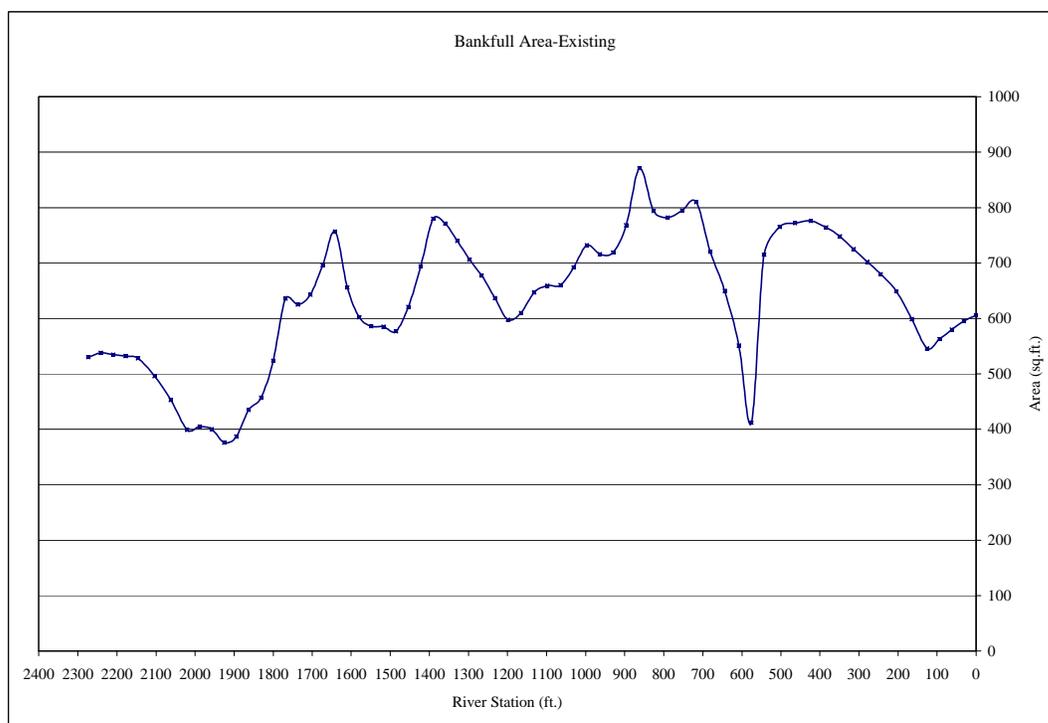
Figure 2. Bankfull cross sectional area through the project reach.

Bankfull flow areas for the reach averaged 632 square feet, and are highly variable, ranging from 376 to 871. Bankfull average area is considered high varying considerably from adjoining reaches and other regional reference data. Bankfull width averaged 188 feet and hydraulic depth was 3.5 feet. Channel width to depth ratios averaged 59 indicating an over widened condition during this flow condition. It is suspected that these values are increased due to the general complexity of the reach containing multiple channels at bankfull stage and have historically led to the continued instability and sedimentation evident in the project reach.

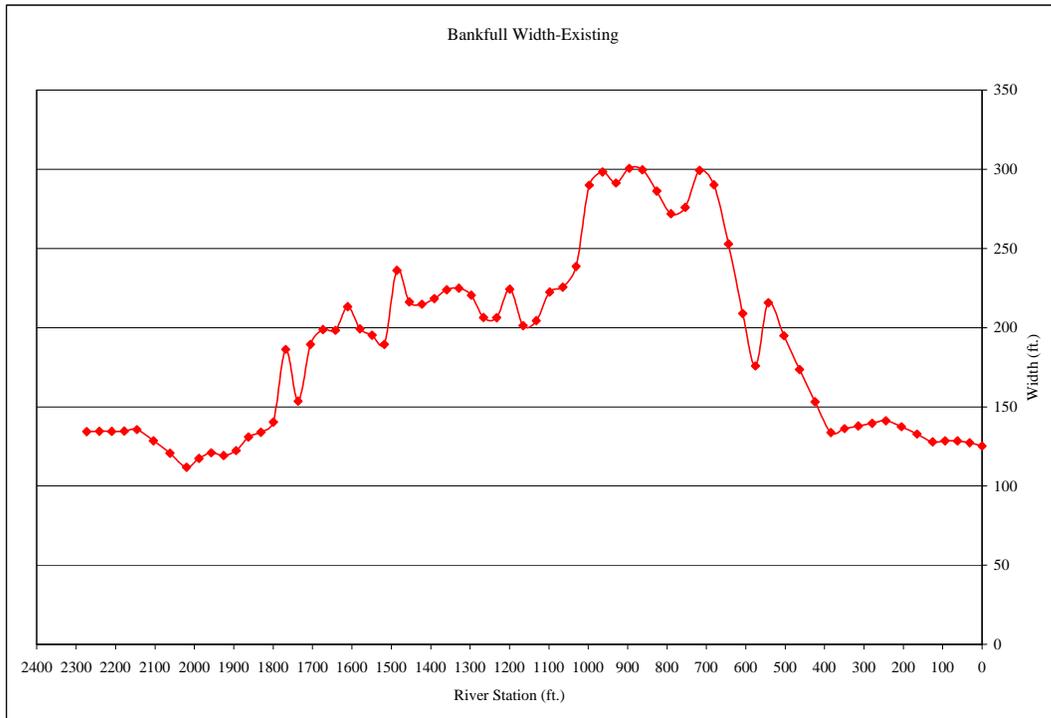
Figure 3. Bankfull channel top width through the project reach.

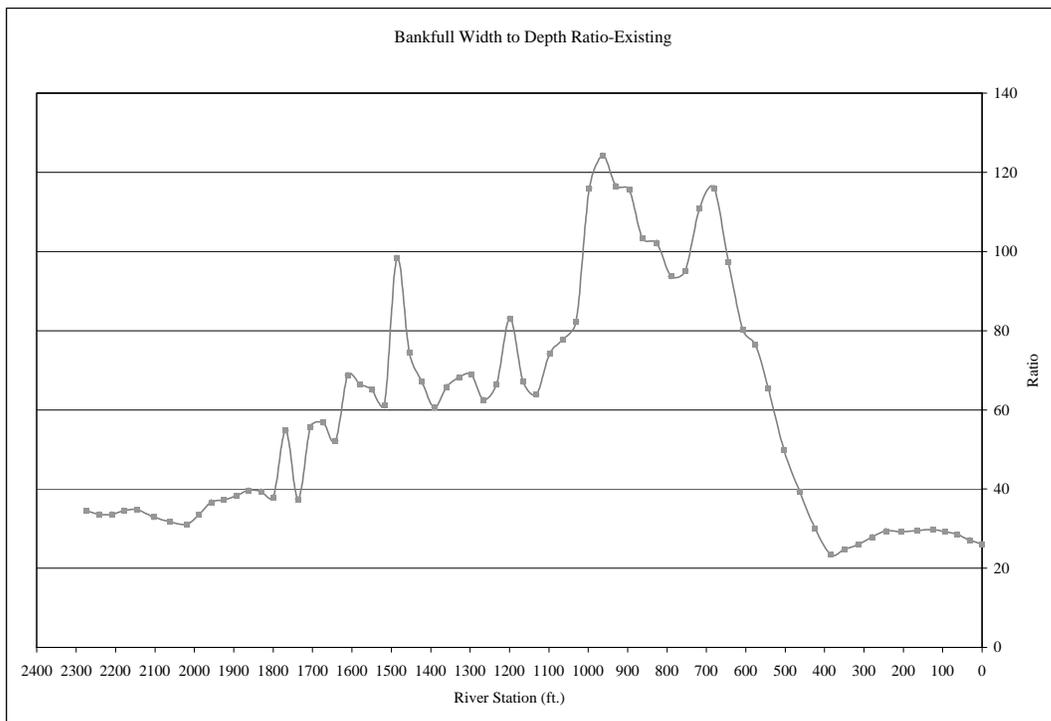
Figure 4. Bankfull channel width to depth ratio through the project reach.

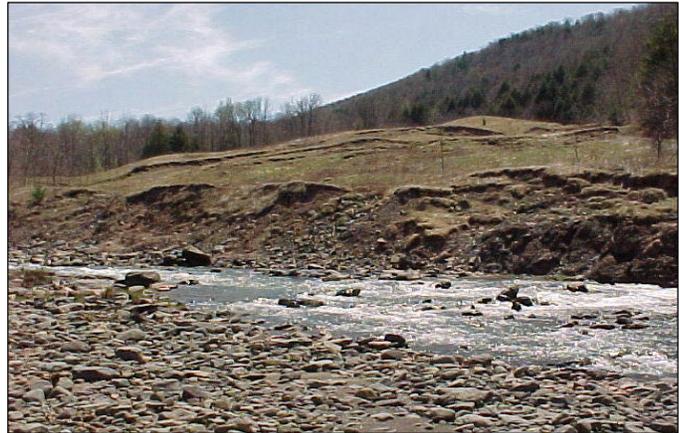
Erosion and failure of upstream high bank in 2001.

Two high stream banks within the project reach were identified as unstable during the assessment. Due to the scale and condition of the upstream large bank, a geotechnical investigation was initiated in 2005 to evaluate bank mechanics, and risk for future failure and provide recommendations for any necessary monitoring and stabilization. The Geotechnical Report is attached as **Appendix B**.

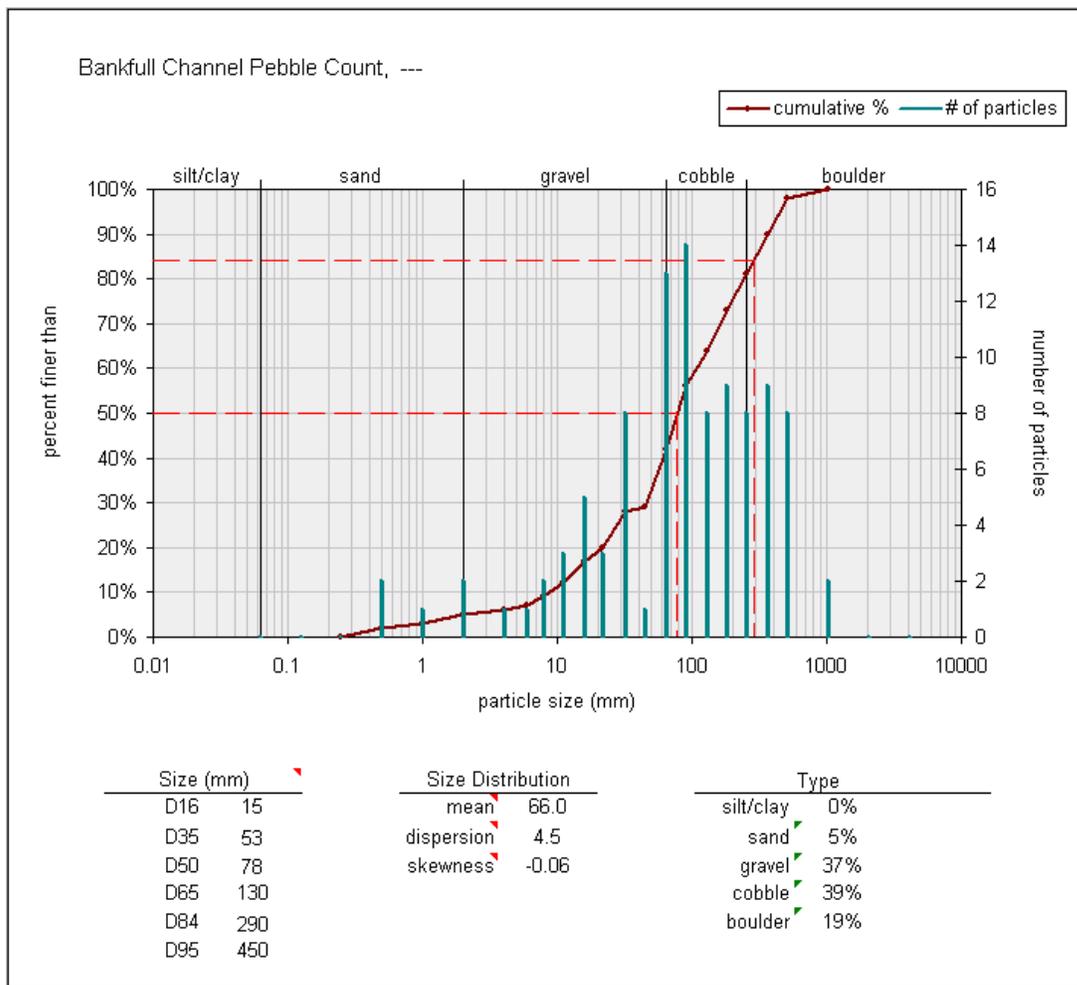
Figure 5. Representative bankfull sediment distribution at a riffle section.

The pebble count distribution in **Figure 5** reveals the predominant material found in the riffle is in the small cobble size range ($D_{50}=78\text{mm}$) with large portion of the sample in the gravel class. Nearly 20% of materials were boulders and 84% of the sample is estimated to be smaller than 290 mm. The gradation of materials is “poorly sorted” containing a wide range of grain size (dispersion 4.5) considered normal and negatively skewed with a geometric mean of 66 mm and a D_{50} of 78 mm. Sample materials were generally well rounded and not well imbricated.

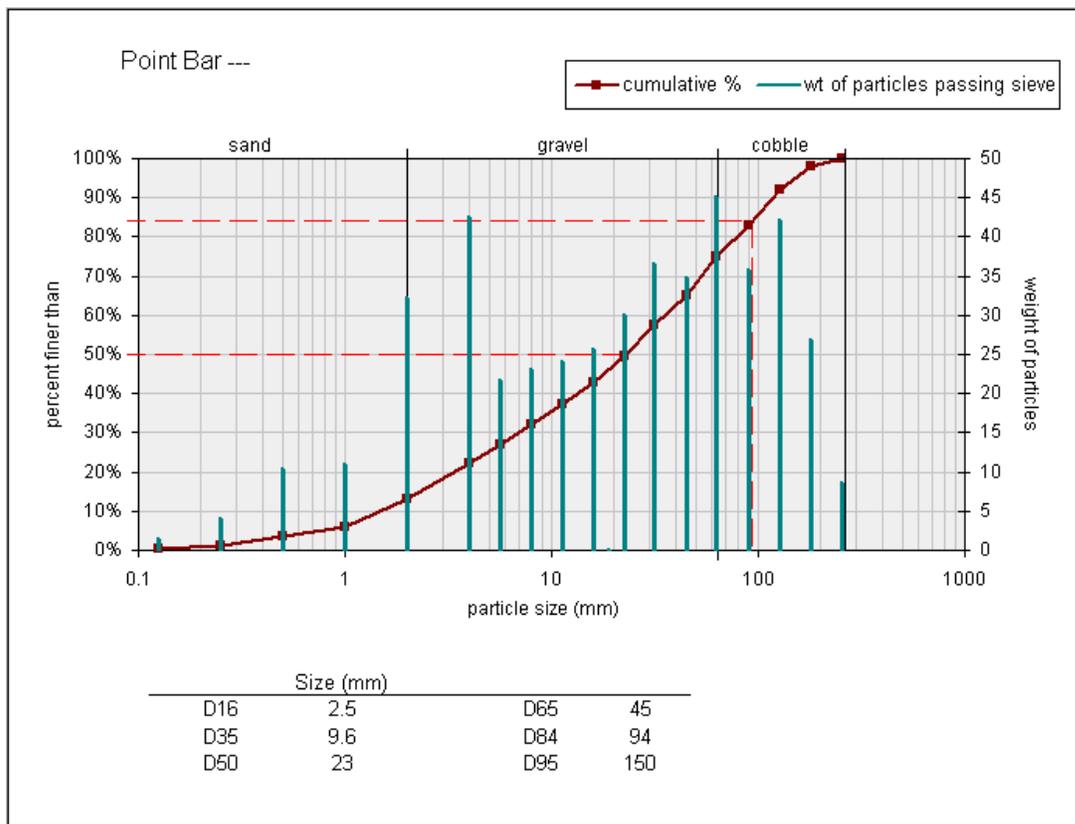
Figure 6. Point bar sediment distribution sampled near the bottom of the project reach.

Point bar sampling was performed at a bar formation at the downstream project extent. **Figure 6** represents the sieve analysis distribution depicting consistently smaller materials than the pavement sample, dominated by gravels and small cobble. These materials were well embedded by finer gravel and sand material. Several larger materials were found on the bar near the sample site characterized as small boulders measuring approximately 300 mm and greater.

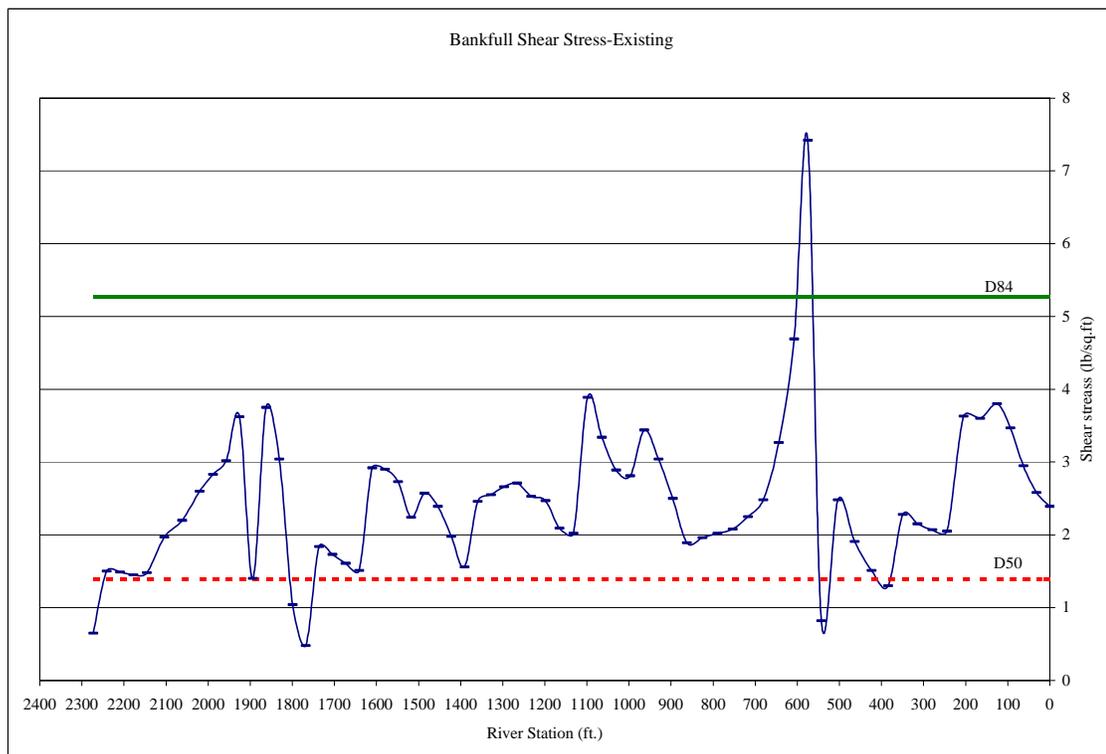
Figure 7. Average shear stress and channel armor threshold values.

Shear stress is a function of slope and depth and is commonly used to describe a reaches hydraulic condition. The initial step in a sediment transport analysis is evaluation of the mobility of the channel bed material. Commonly this is accomplished through comparison of the hydraulic shear stress and the critical shear stress of the bed material. It should be noted that there are many paradigms for sediment and channel armor mobility. **Figure 7** displays the average shear stress through the reach during bankfull flow and limiting shear stress values corresponding with the bed material D50 and D84. The model indicates that D50 (78 mm) is typically mobile during bankfull condition, and D84 (280 mm) would generally remain stable through the reach.

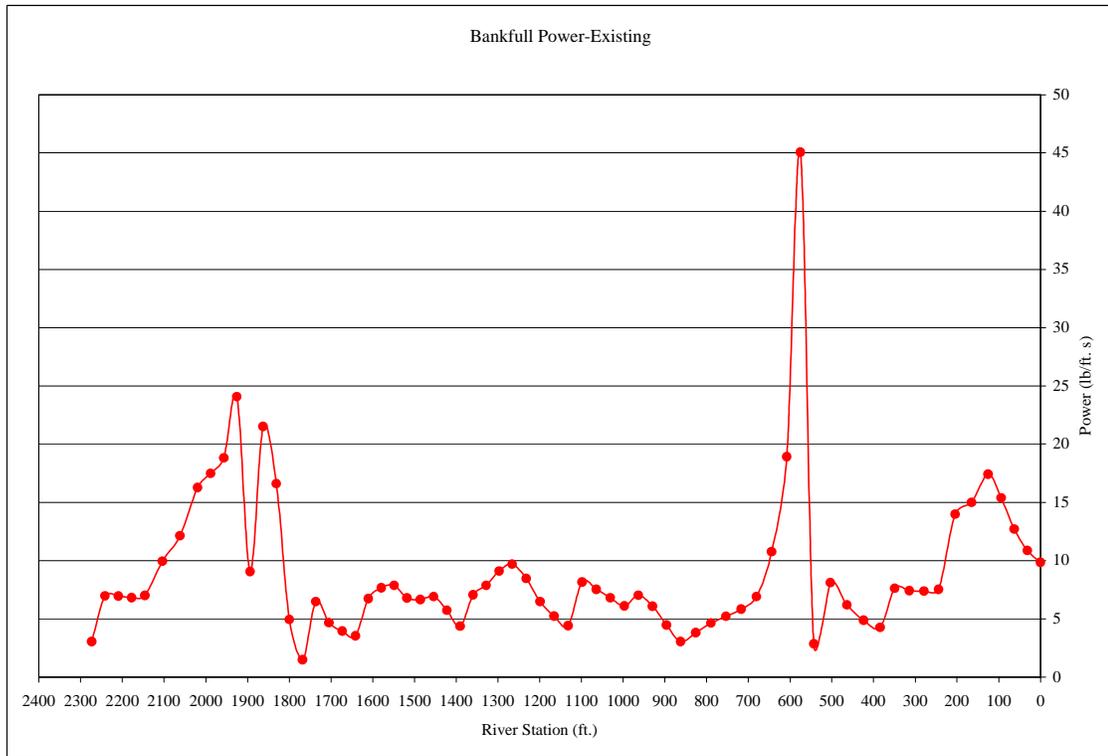
Figure 8. Stream power during bankfull conditions.

Sediment transport capacity was further evaluated using the hydraulic model to compute stream power, a function of discharge and slope, and bedload transport capacity, using Meyer-Peter Muller Equation (1948). **Figures 8 and 9** display the output of this analysis under bankfull flow conditions. Both techniques indicate a high degree of variability suggesting the potential for future instability.

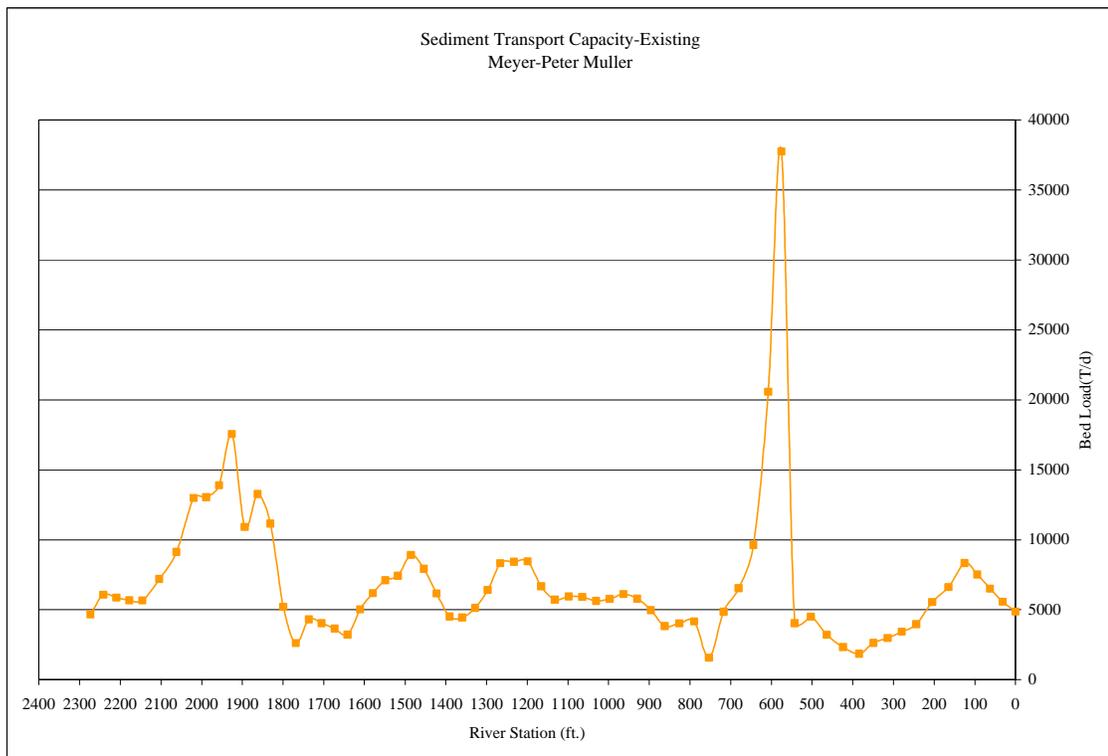
Figure 9. Bedload transport capacity using Meyer-Peter Muller equation through the project rea

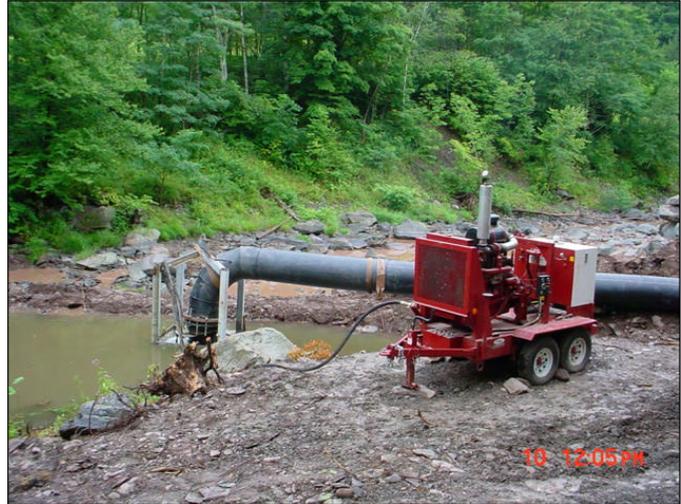
Phase I dewatering pump intake and pipeline.

Stream channel construction was required to be completed in a dry condition in order to meet the requirements of various regulatory agencies. During all construction in the existing or proposed stream channel, the contractor was required to divert the entire stream flow around the work area. Dewatering was maintained 24 hours per day, 7 days per week during the construction period and was accomplished by a pump and pipeline scenario. Dewatering was performed in two phases and required the excavation of a sump and construction of a gravel coffer dam across the existing channel at both the top and bottom of each phase. Upon completion of the construction of the phase all areas were restored as soon as possible to preconstruction conditions. Pumping specification **CS-4 in Appendix H** and construction drawings **CR-10 and 11 in Appendix I** display the location, extents and details of the dewatering plan.

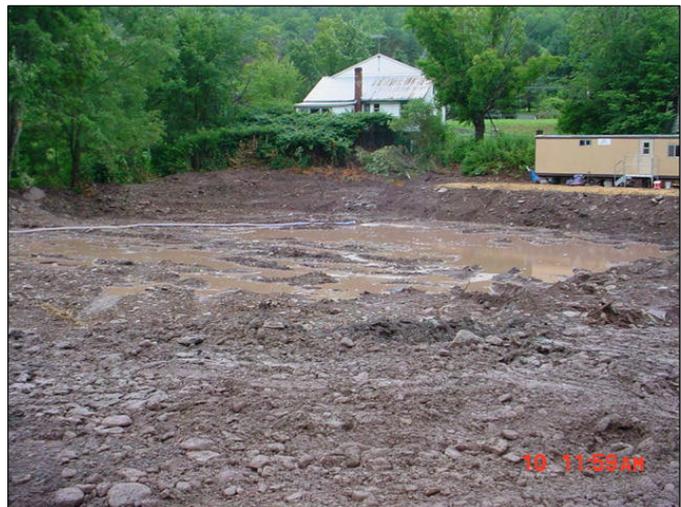
Phase I turbidity control basin.

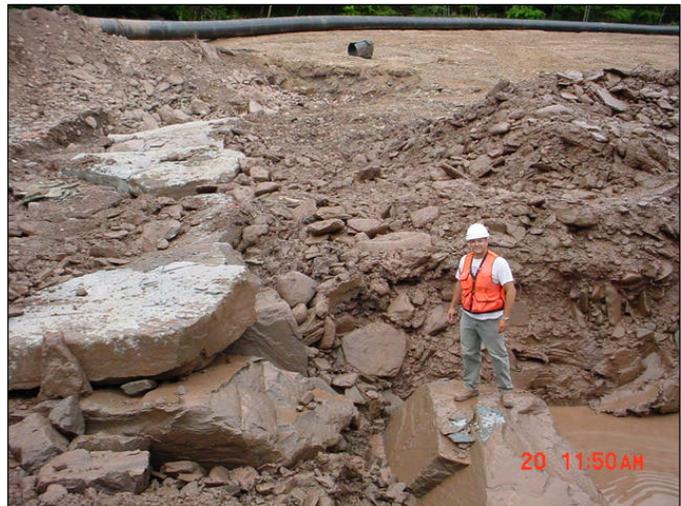
Excavation and construction of a cross vane sill near the center of project reach.

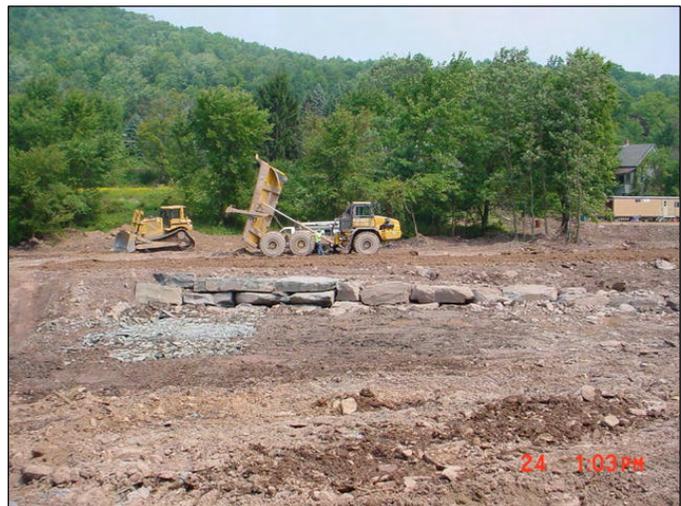
Completed arm of the downstream cross vane.

The rock tonnage applied to this project is somewhat larger than projects of similar character due to the installation of long subsurface floodplain grade control sills. These grade control sills were installed at the request of the NYCDEP Stream Management Program, with the concurrence of GCSWCD, in response to channel avulsions and floodplain scour observed at the Big Hollow Stream Restoration Project following an out-of-bank flow event in 2004. These portions of the rock structures accounted for approximately 17% of the overall

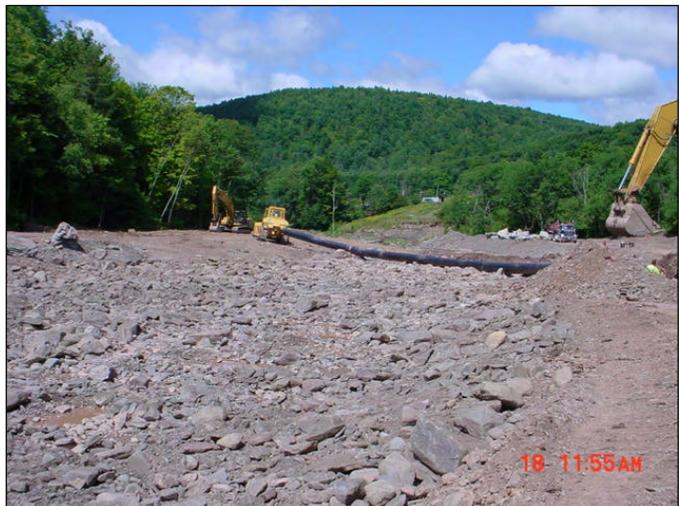
Section of the constructed riffle displaying salvaged and seeded coarser substrate.

A constructed riffle was proposed as a component of the channel design. Construction of the riffle required that select coarse material be collected from the existing stream channel and installed to grade in the location of the proposed riffle. The riffle materials were collected and hauled to the riffle location on a time and materials basis according to the equipment and labor rates provided by the contractor as a component of the bidding process. The materials were then installed to the design grades and elevations as a component of Primary Bid Item #3 – Stream Channel Excavation.

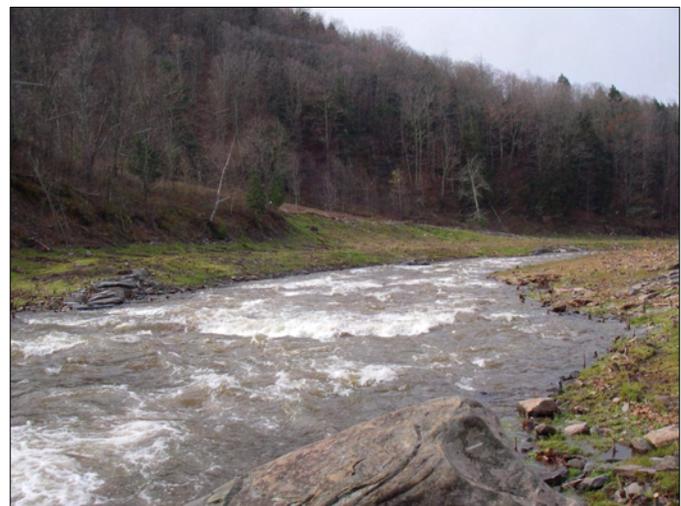
Upstream cross vane during high flow event.
