**New York City Department of Environmental Protection  
Bureau of Water Supply**

**Stream Management Program**

**Stony Clove Watershed Suspended Sediment and Turbidity Study:  
Turbidity Reduction Project Nomination Report**

**January 2019**

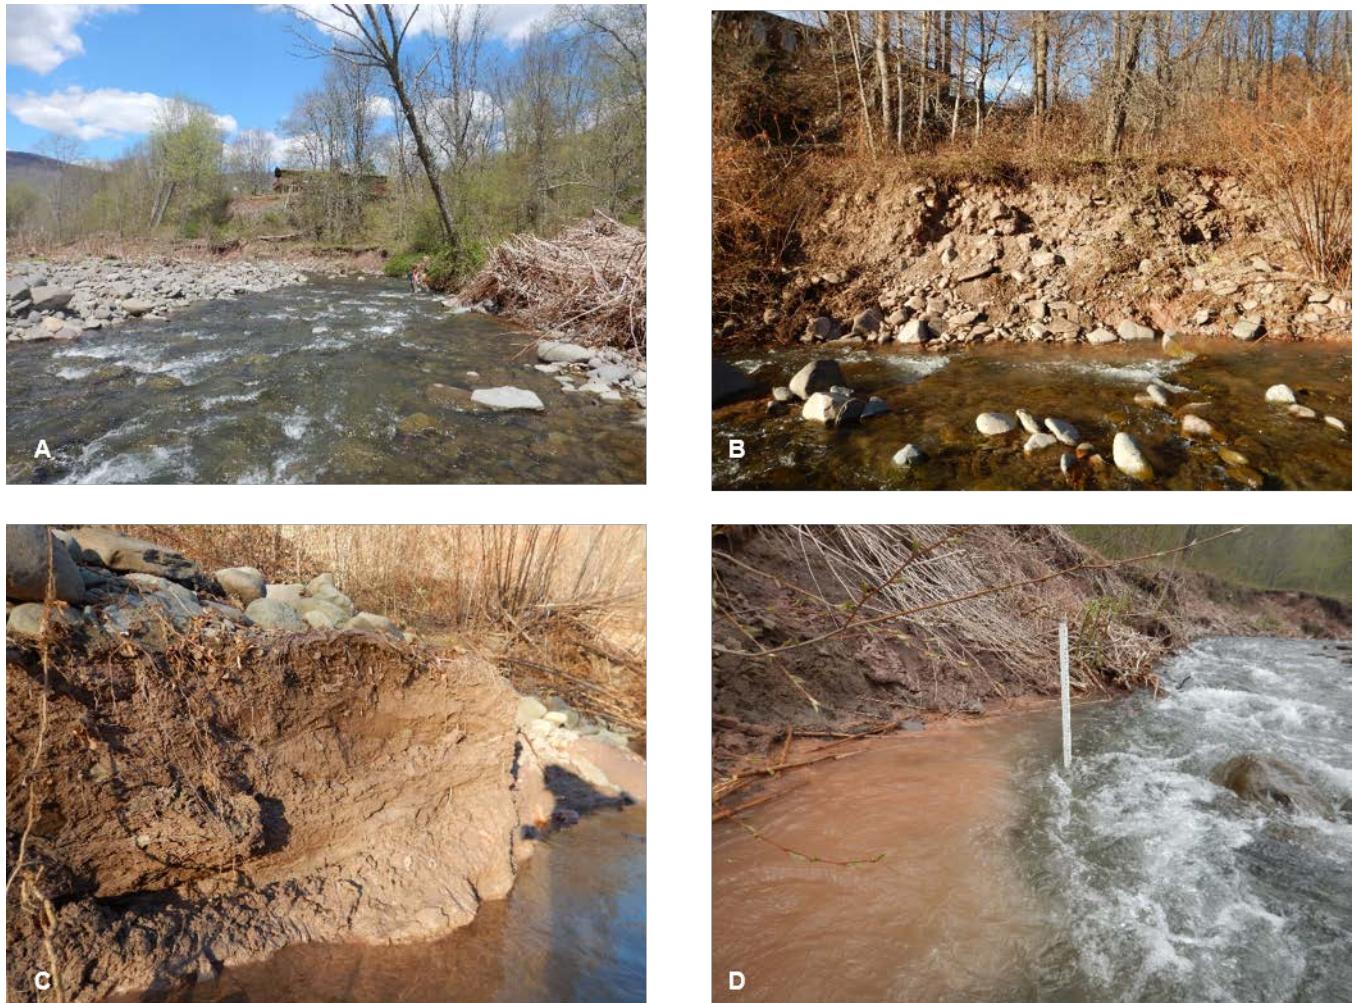
Figure 5. Documentation of SCC1 site at SC-BEMS-03 on Stony Clove Creek. Photo A depicts the mass failure of glacial lake sediment and high terrace alluvium. Photo B depicts terrace alluvium collapsed over underlying glacial lake sediment. Photo C Provides a close-up of view of mass-wasted glacial lake sediment on the channel margin. Photo D illustrates water quality impact of glacial lake sediment in bank toe and streambed at outside of meander bend.

The stream has extensive erosional contact with glacial lake sediment (silt and clay) along the right channel margin and in the streambed (Figure 5). Active hydraulic and geotechnical erosion were mapped here in 2013 and again in 2018, following a flood-induced avulsion in August 2011. STRP treatment at this site is expected to have a measurable reduction in turbidity by removing the channel from erosive contact with the glacial lake sediment.

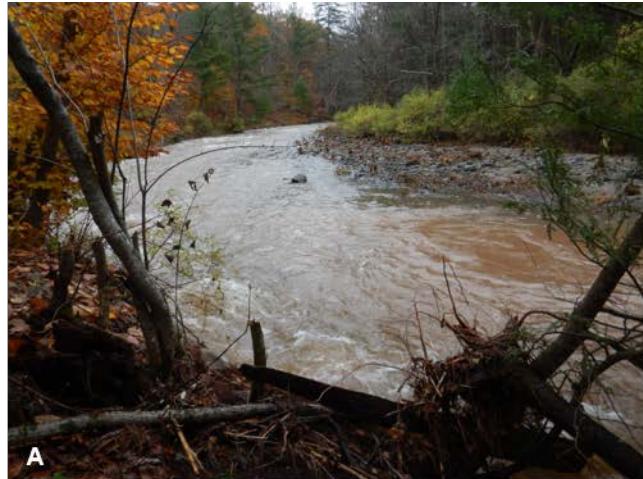
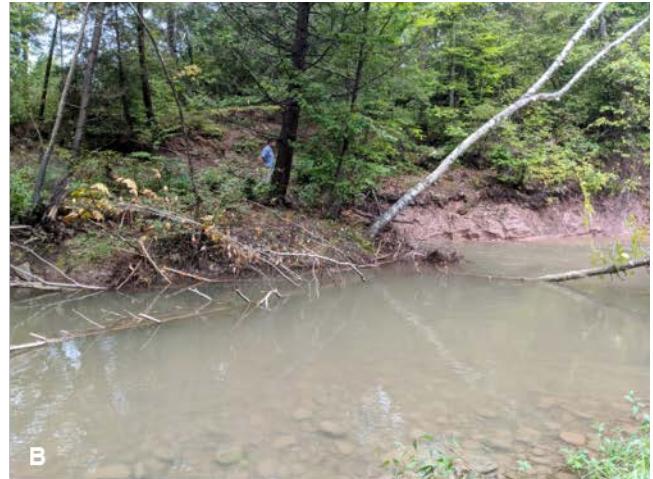
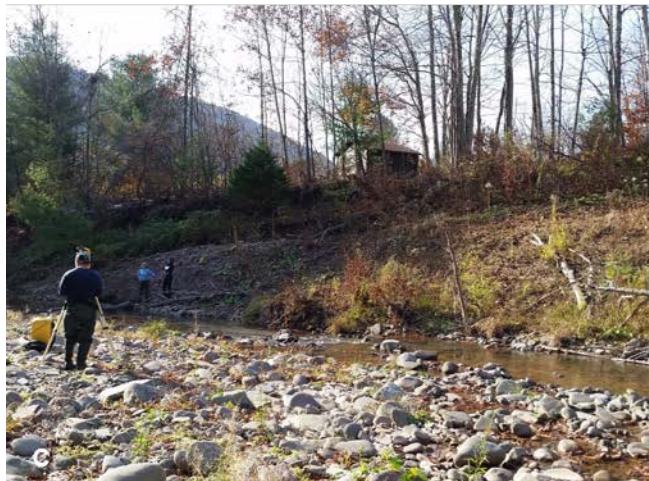
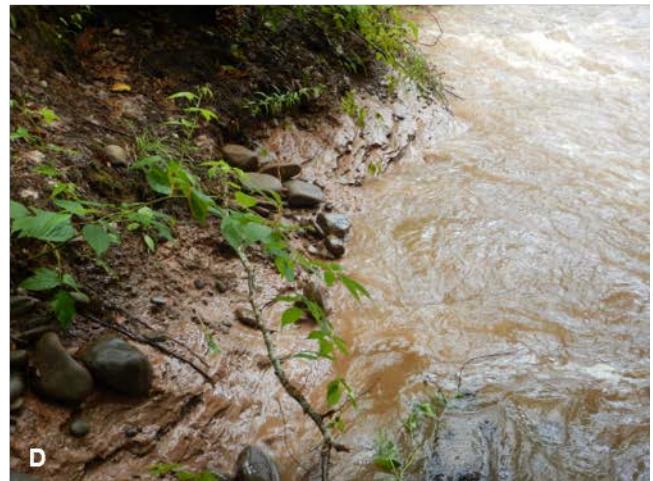
Figure 7. Documentation of WC1 site at WC-BEMS-01 on Warner Creek. Photo A depicts turbid scour pool into glacial lake sediment on outside of meander bend. Photo B depicts exposed glacial lake sediment along bank. Photo C depicts mass wasting glacial lake terrace capped by alluvium. Photo D provides a close-up of stream-turbidity source contact.

The stream has extensive erosional contact with glacial lake sediment along the right channel margin and in the streambed (Figure 7). Active hydraulic and geotechnical erosion have been repeatedly mapped here since 2010. STRP treatment at this site is expected to have a measurable reduction in turbidity by removing the channel from erosive contact with the glacial lake sediment. In addition to turbidity source reduction, the site is impacting a residential property and has the potential to impact Silver Hollow Road through mass wasting encroachment on the road.

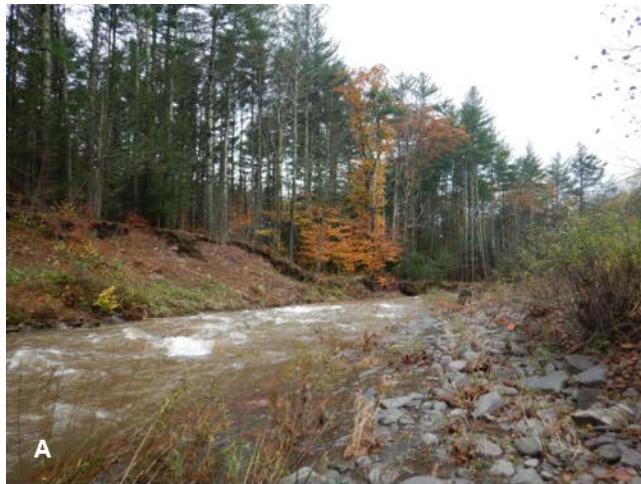
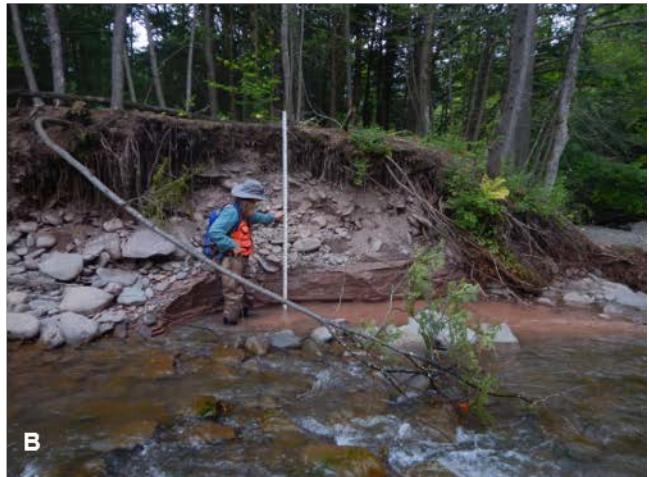
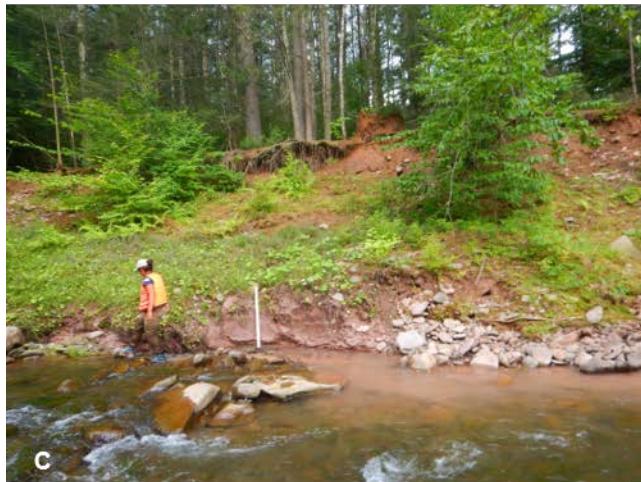
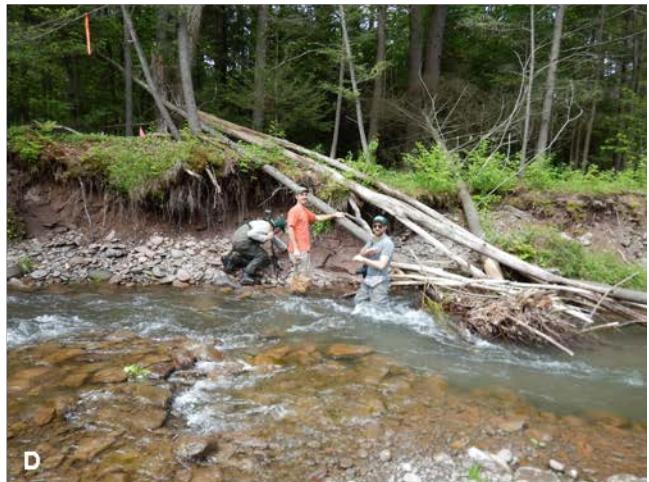
Figure 8. Documentation of WC2 site at WC-BEMS-02 on Warner Creek. Photo A depicts mass failure of glacial lake sediment and terrace alluvium. Photo B depicts where the stream is eroding into glacial lake sediment. Photo C illustrates the mass wasting terrace with glacial lake sediment exposed in the channel margin. Photo D illustrates headcut into glacial lake sediment in streambed.

The stream has extensive erosional contact with glacial lake sediment along the left channel margin and in the streambed (Figure 8). Active hydraulic and geotechnical erosion have been repeatedly mapped here since 2010 following a flood-induced avulsion in January 2010. STRP treatment at this site is expected to have a measurable reduction in turbidity by removing the channel from erosive contact with the glacial lake sediment.

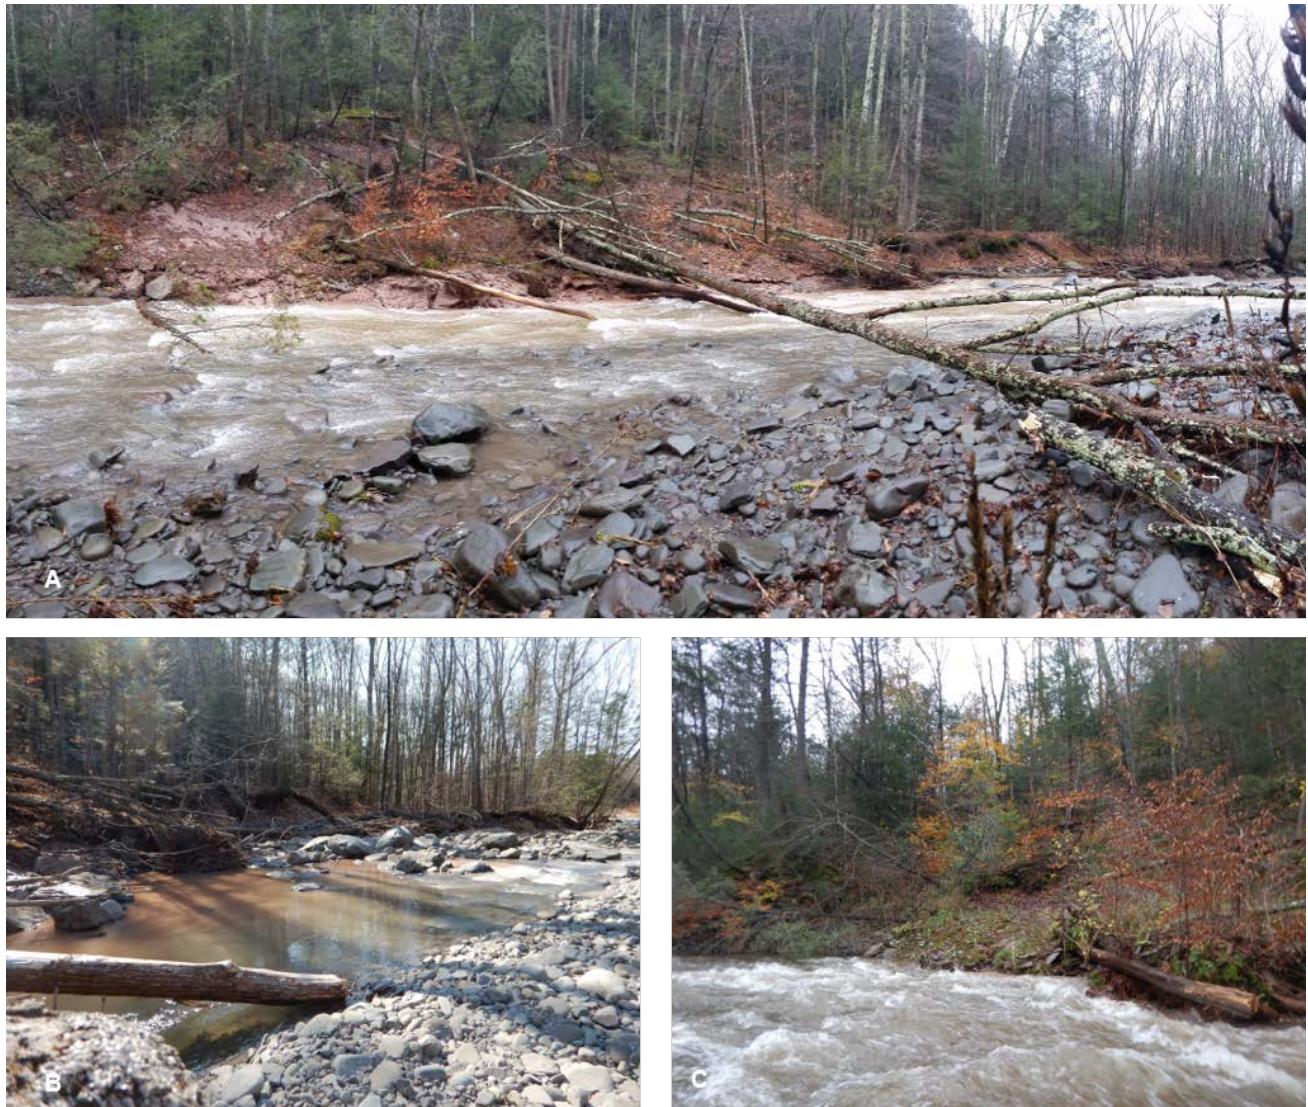
Figure 10. Documentation of WC3 site located at WC-BEMS-03 on Warner Creek. Photo A depicts mass failure of glacial lake sediment, glacial till and terrace alluvium. Photo B illustrates where the stream becomes turbid from contact with glacial lake sediment. Photo C illustrates mass wasting slope on outside of meander bend with high near bank shear stress.

The stream has erosional contact with glacial lake sediment (silt and clay) along the left channel margin and in the streambed associated with a mass failure triggered by hydraulic erosion on the outside of a meander bend (Figure 10). Active hydraulic and geotechnical erosion have been repeatedly mapped here since 2010. This is the known upstream most source of chronic turbidity in Warner Creek at this time. STRP treatment at this site is expected to have a measurable reduction in turbidity by removing the channel from erosive contact with the glacial lake sediment.

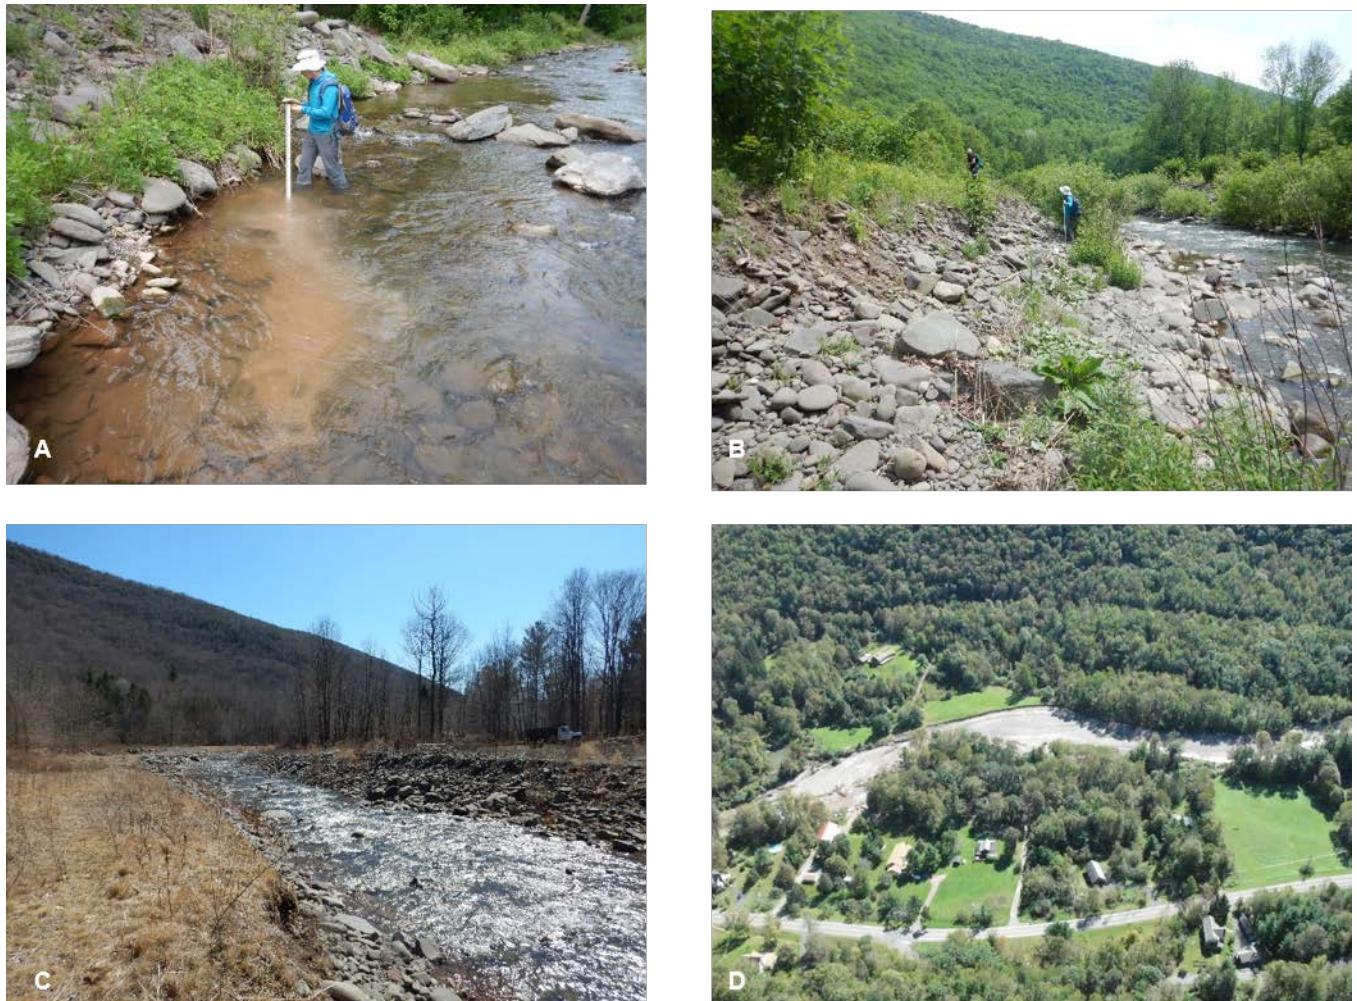
Figure 12. Documentation of SCC2 site on Stony Clove Creek. Photo A depicts a bed exposure of glacial lake sediment. Photo B depicts the entrenched channelized channel. Photo C depicts channelized channel. Photo D was taken after Tropical Storm Irene flooding but before post-flood channelization.

This reach of stream between the monitoring stations has intermittent erosional contact with glacial lake sediment in the streambed at the upstream extent and along the left channel margin in the downstream extent (Figure 11 and Figure 12). Extensive post-flood modification of approximately 1200 feet of the channel about 650 feet downstream of the Jansen Road bridge occurred following Tropical Storm Irene flooding in 2011. This work resulted in several exposures of glacial lake clay in the streambed that have transiently recurred. Based on the water quality monitoring so far, STRP treatment at this site is expected to have a measurable reduction in turbidity by removing the channel from erosive contact with the glacial lake sediment. The site is not one of the eight BEMS in the Stony Clove watershed. The only assessment work completed to date has been the repeated stream feature inventory (SFI) mapping, so further investigation is needed to better characterize suspended sediment source conditions.
