Hamlet of Lanesville

Local Flood Analysis

Town of Hunter, New York

SLR Engineering, Landscape Architecture, and Land Surveying, P.C.

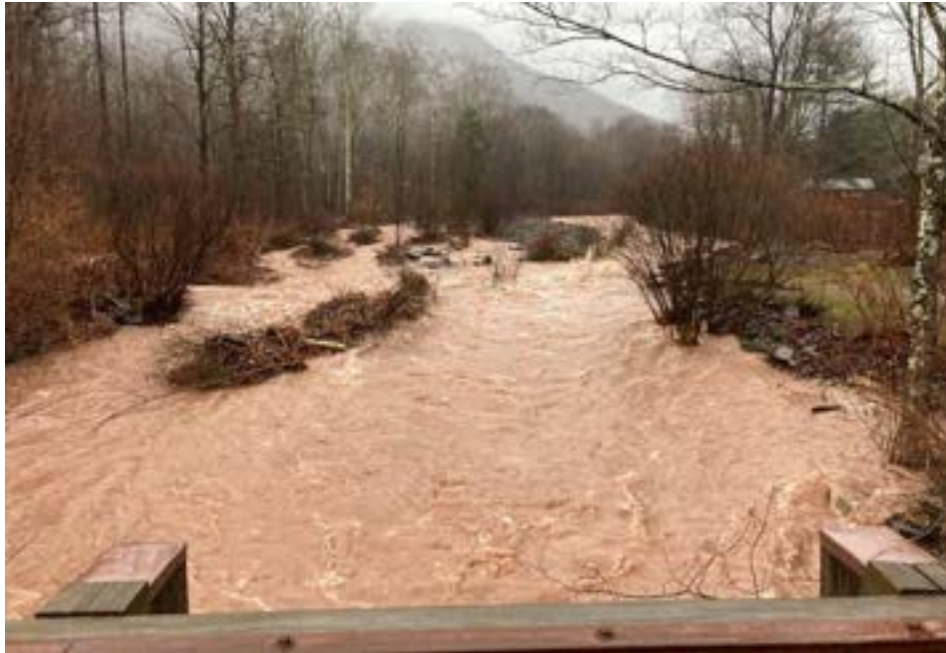
Photo 2-1 Turbid flows on Stony Clove Creek at the Jansen Road bridge in December 2020. Photo provided by Kachadourian family.

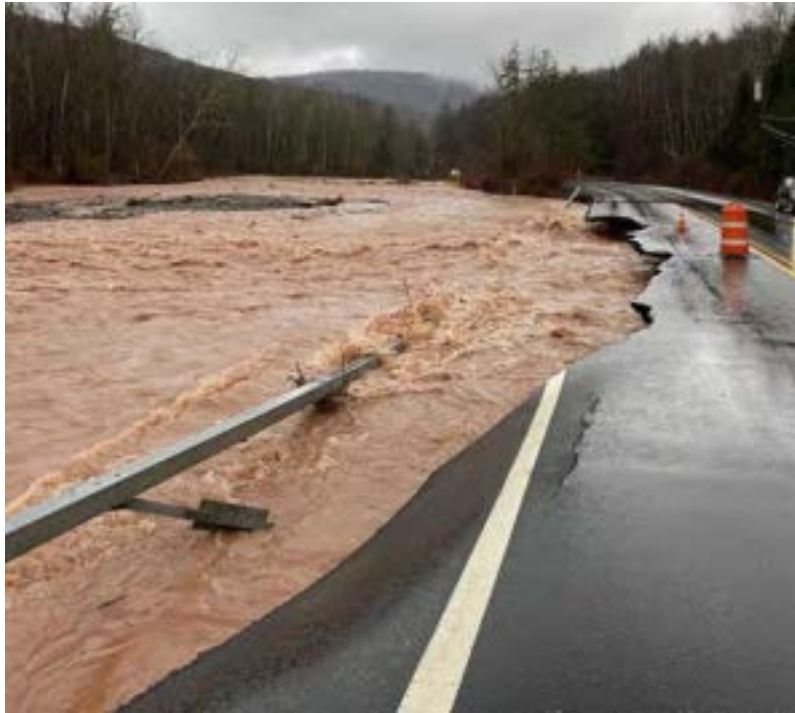
Photo 3-1 December 2020 flood damage to NY-214. Photo provided by AWSMP.

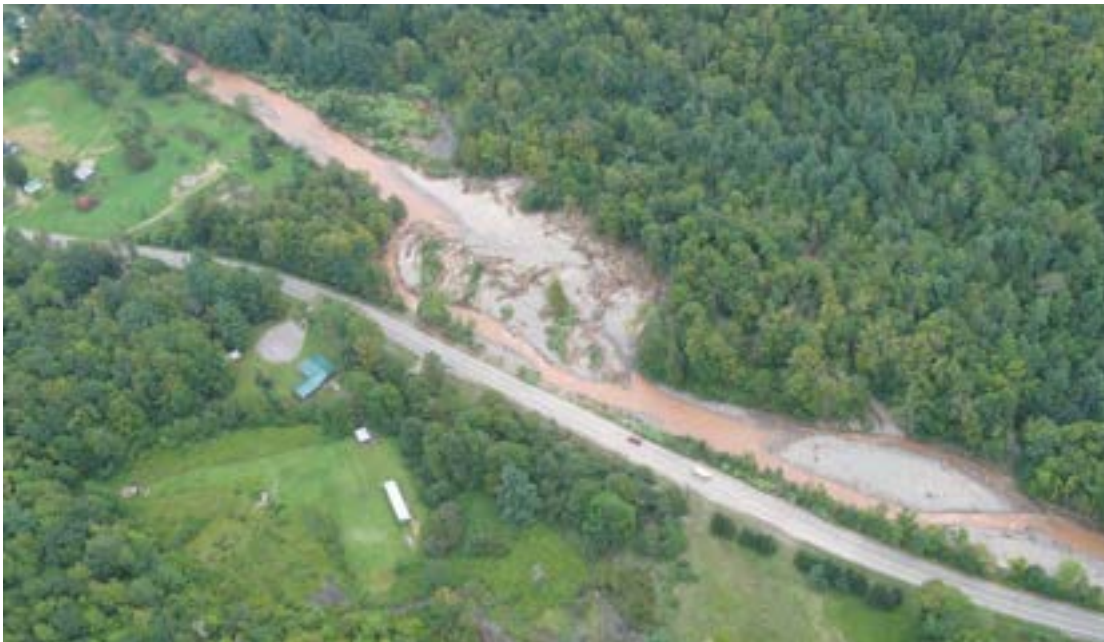
Photo 3-2 Large wood accumulation and lateral channel adjustment along flood-prone section of NY-214 after Tropical Storm Irene in 2011. Photo provided by NYCDEP SMP.

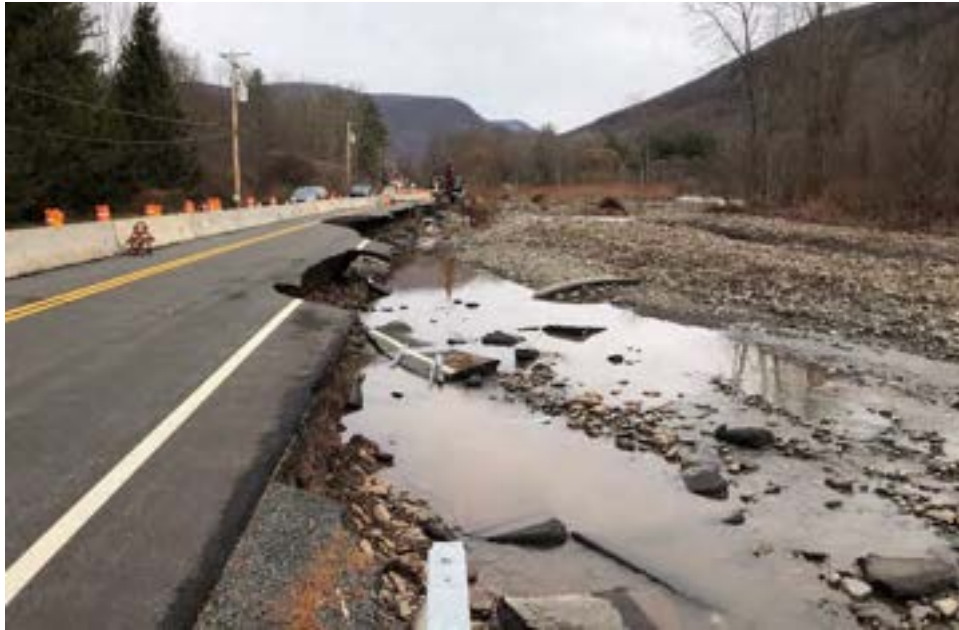
Photo 3-3 Damage to NY Route 214 in December 2020

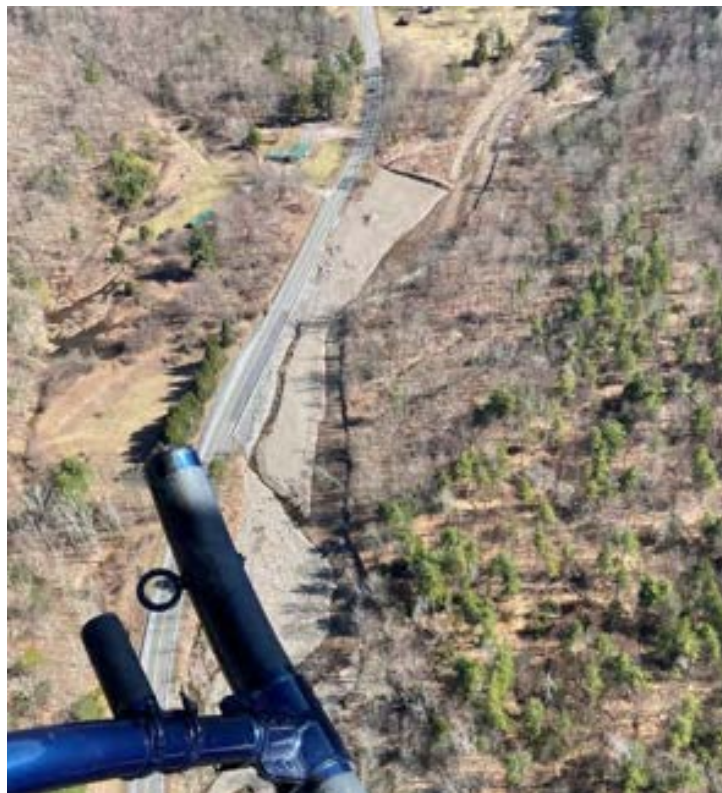
Photo 3-4 Repairs to NY-214 following damage in December 2020. Stony Clove Creek was relocated farther from the road. Photo provided by NYCDEP SMP.

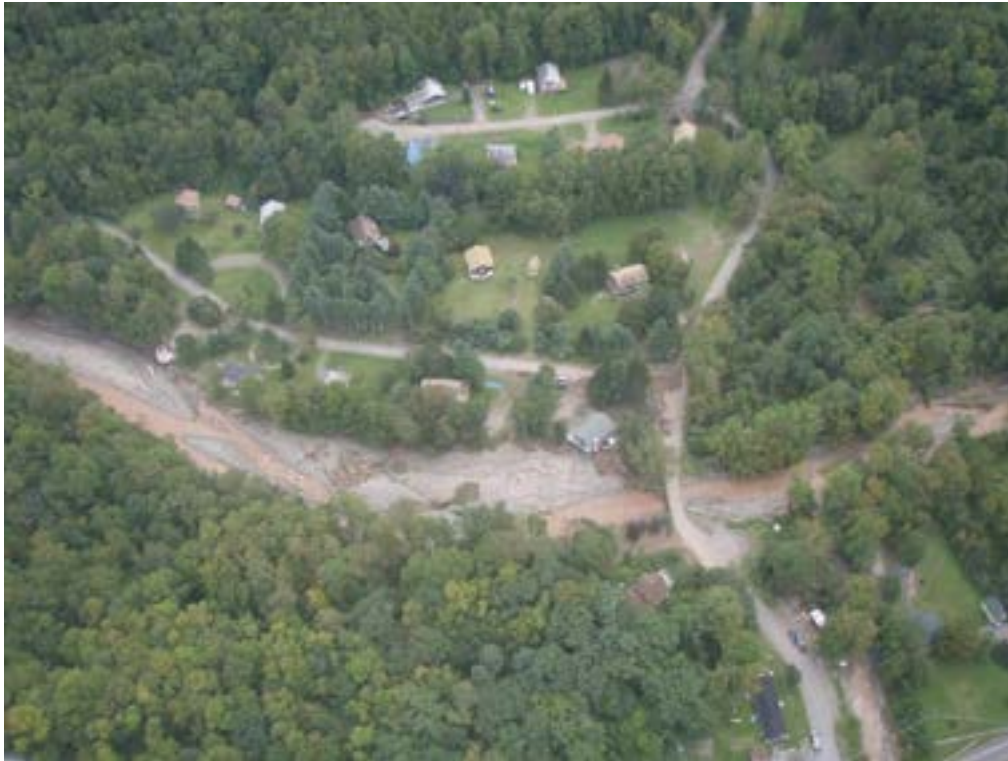
Photo 3-5 Post-Irene damage near the Jansen Road bridge, 2011. Photo provided by NYCDEP SMP.

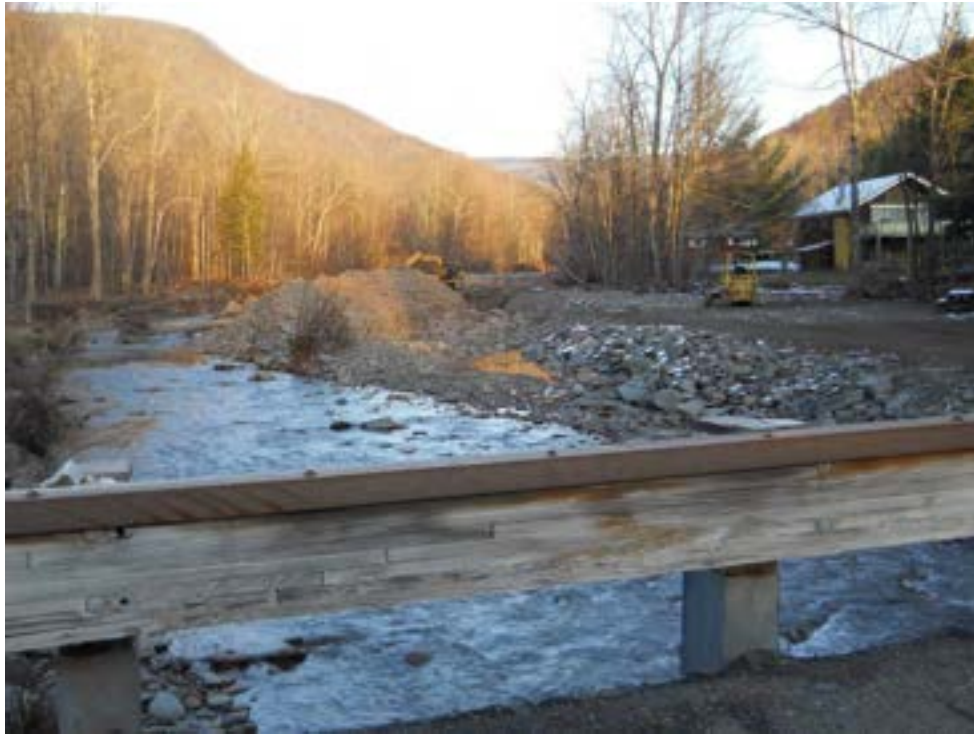
Photo 3-6 Post-Irene recovery work at the Jansen Road bridge, 2011. Photo provided by AWSMP.

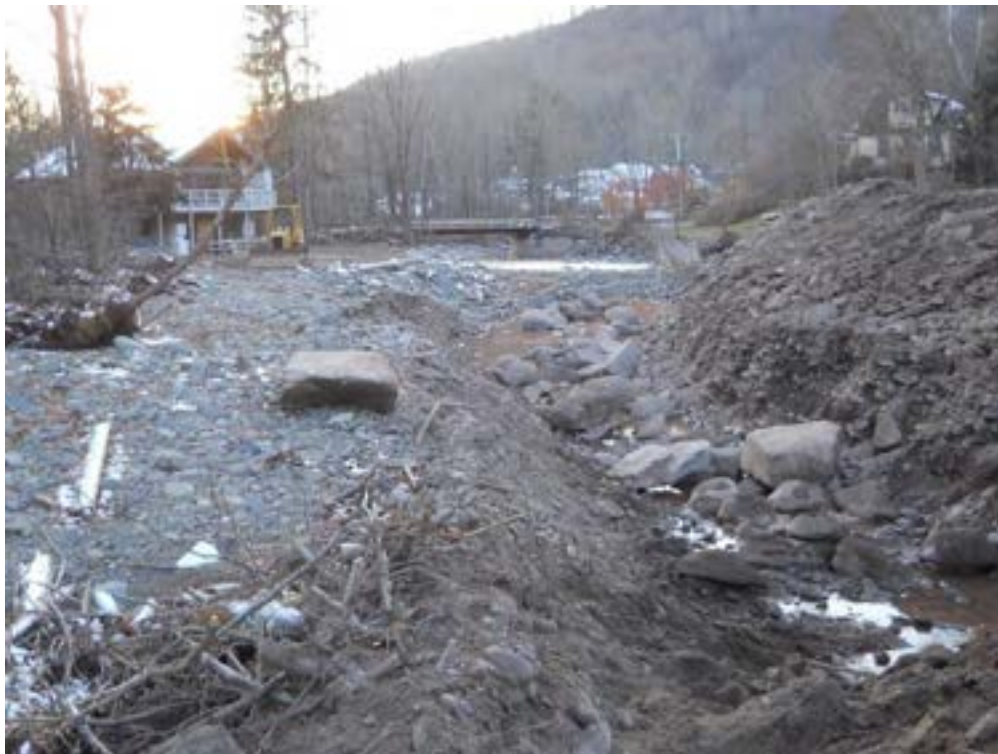
Photo 3-7 Post-Irene recovery work at the Jansen Road bridge, 2011. Photo provided by AWSMP.

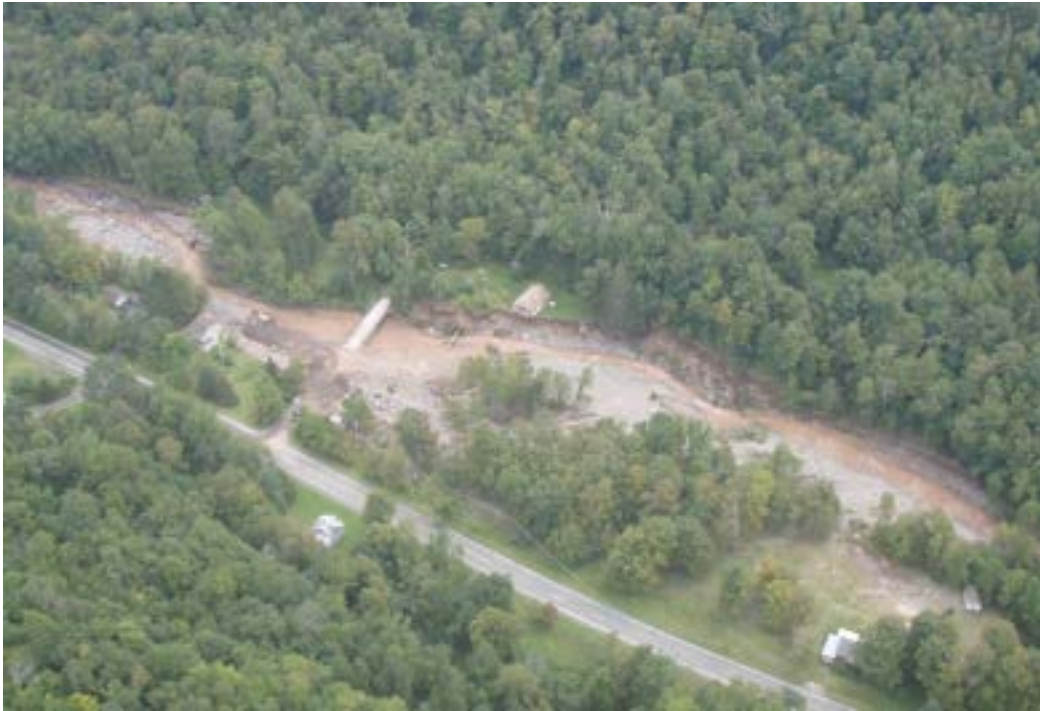
Photo 3-8 Erosion damage at the Wright Road bridge during Tropical Storm Irene in 2011. Repairs to approach roadway embankment are underway. Photo provided by NYCDEP SMP.

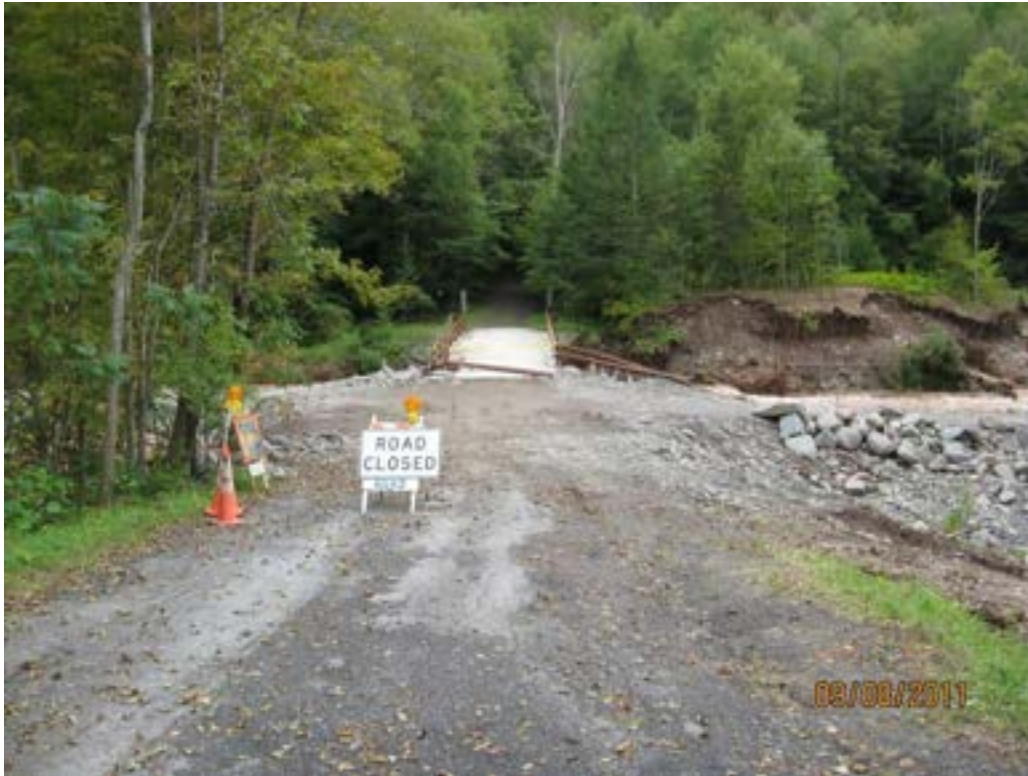
Photo 3-9 Damage to Wright Road bridge in 2011 flooding. Photo provided by HLFRC.

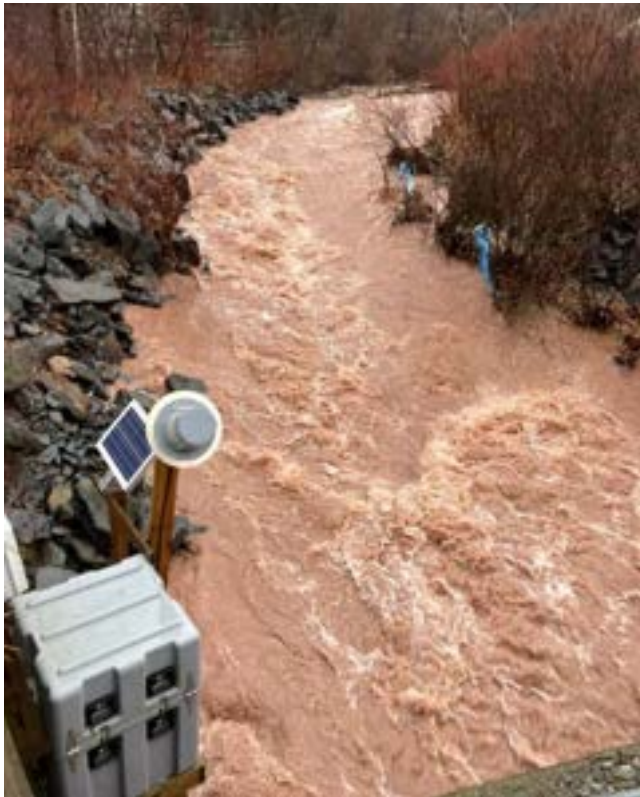
Photo 3-10 Elevated flows on Hollow Tree Brook at the NY-214 bridge in December 2020. Photo provided by Kachadourian family.

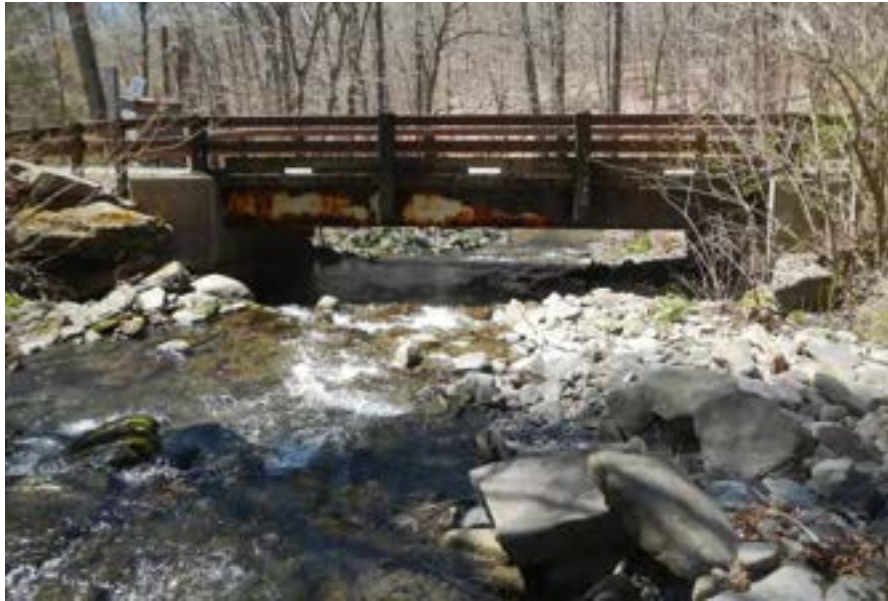
Photo 3-11 Diamond Notch Road bridge over Hollow Tree Brook

Diamond Notch Road Bridge	
Area Served	Three Properties, NYSDEC Trailhead
Available Detours	None
Road/Bridge Impassable in Flood	25-Year
Replacement Priority	High

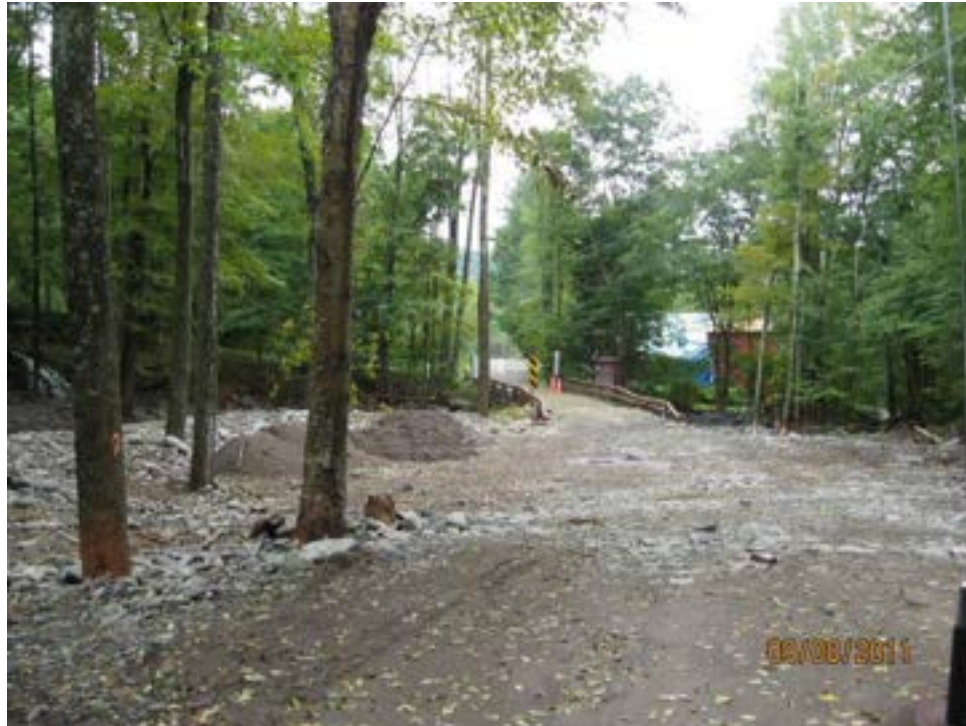
Photo 3-12 Diamond Notch Road bridge over Hollow Tree Brook following 2011 flooding. Note damage to roadway from overtopping. Photo provided by HLFRC.

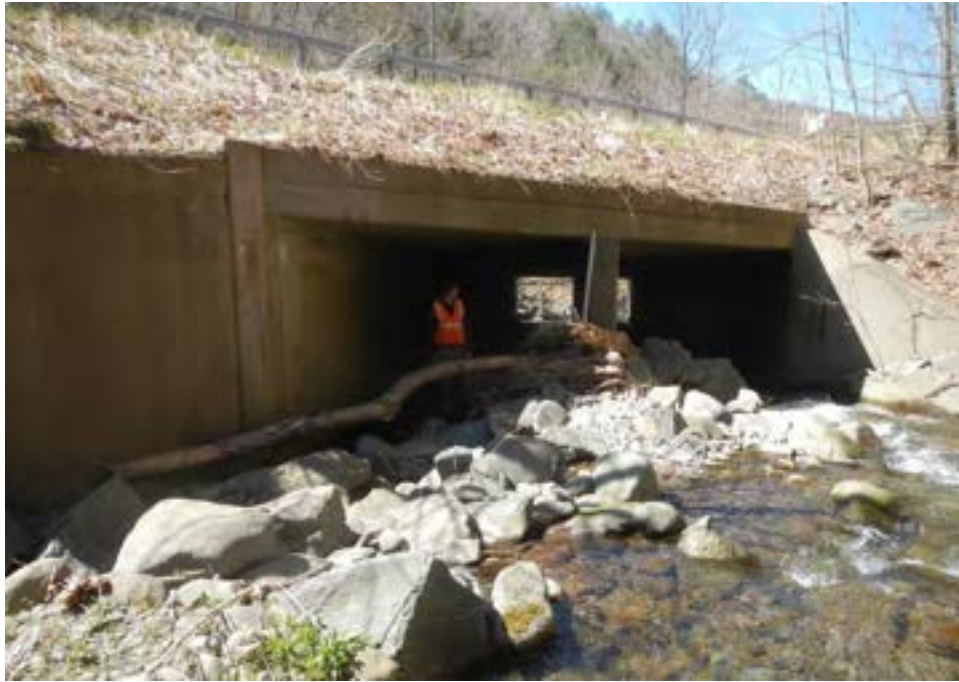
Photo 3-13 NY-214 culvert over Myrtle Brook – inlet, looking downstream. Note partial obstruction by wood and sediment.

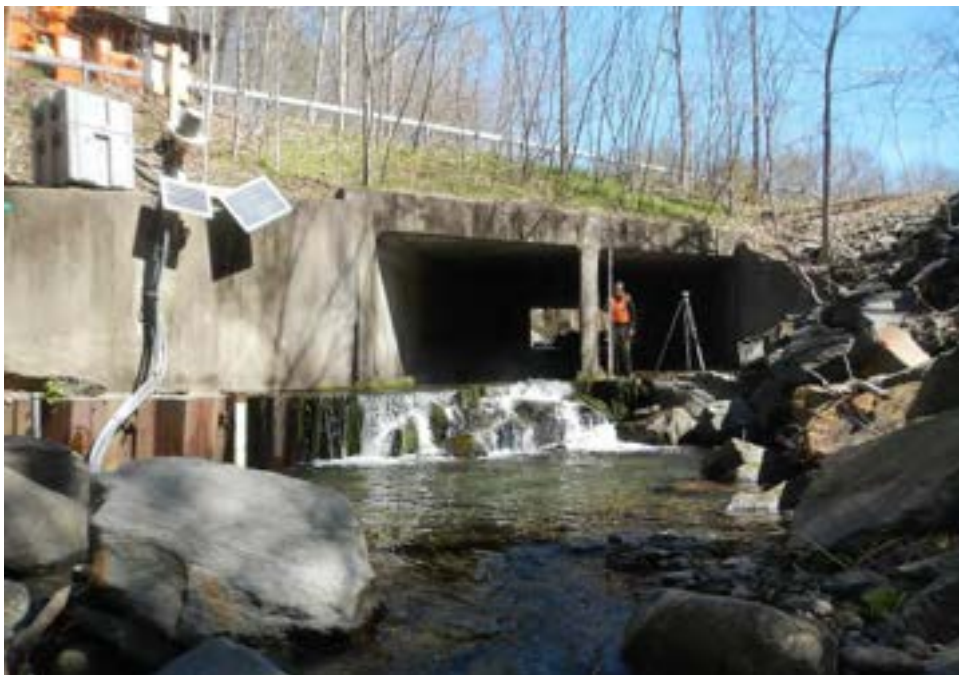
Photo 3-14 NY-214 culvert over Myrtle Brook – outlet, looking upstream. USGS gauging station at left. Note sheet piling and aquatic organism barrier.

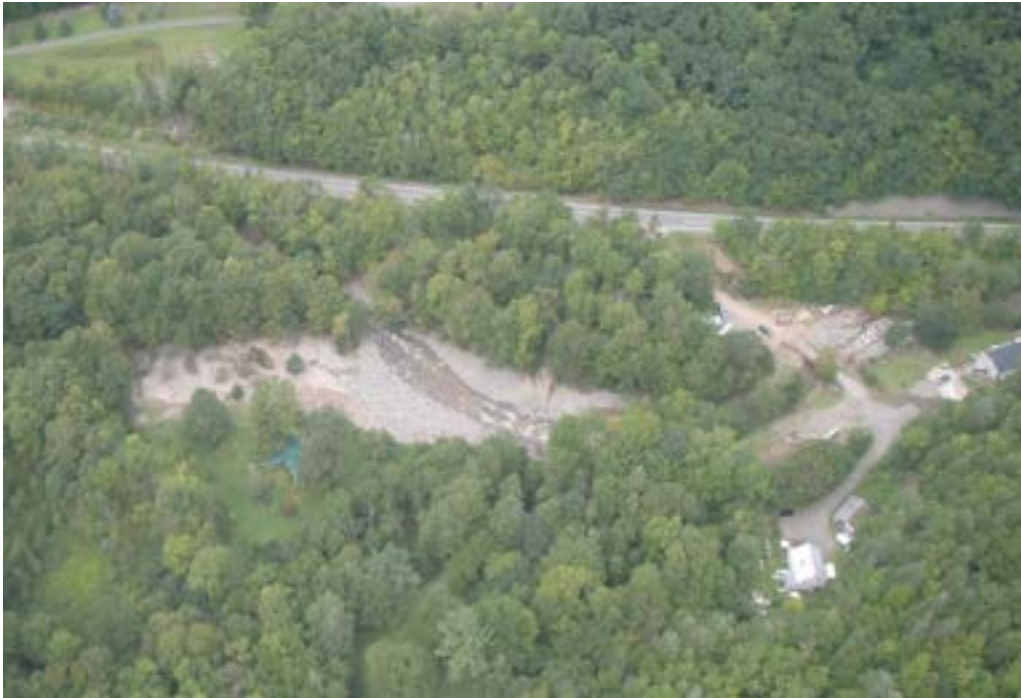
Photo 3-15 Private bridge washout (center of image) on Stony Clove Creek during Tropical Storm Irene in 2011. Benjamin Road bridge at right. Photo provided by NYCDEP SMP.

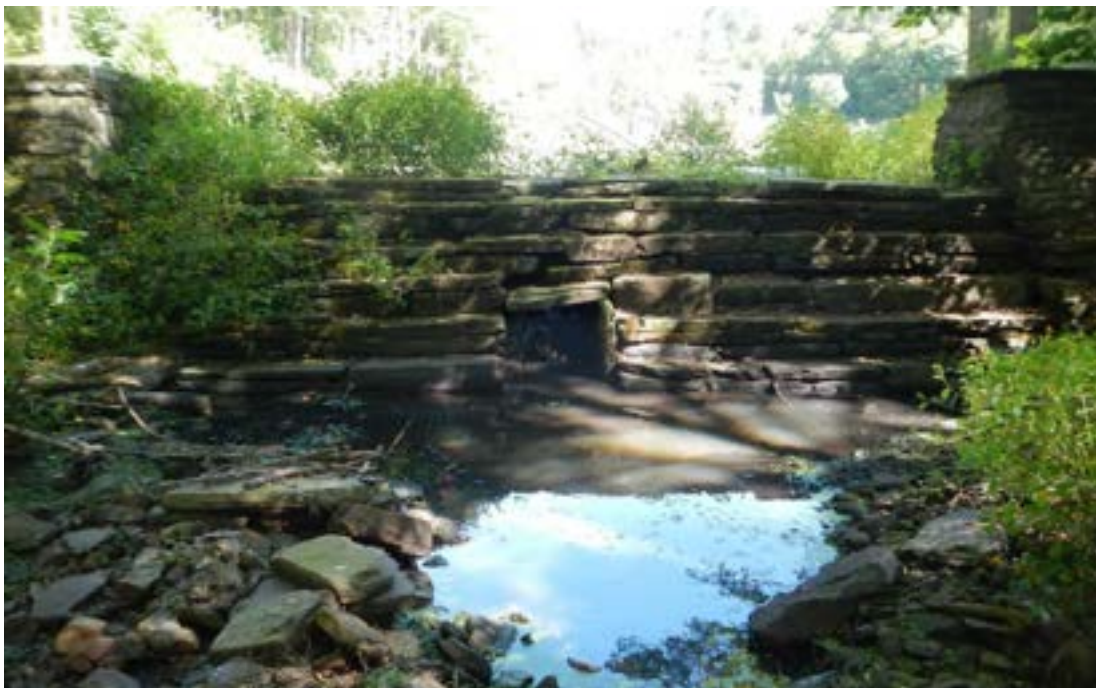
Photo 3-16 Notch Lake Dam spillway

It is recommended that NYSDEC inventory and inspect this dam, assign a hazard classification, and evaluate conformance with modern dam safety standards. A feasibility study is recommended to assess options to modify, repair, replace, or remove the dam. As the apparent owner, it is recommended that NYSDEC maintain this dam in safe condition per 6 NYCRR Part 673 and Environmental Conservation Law (ECL) Section 15-0507.

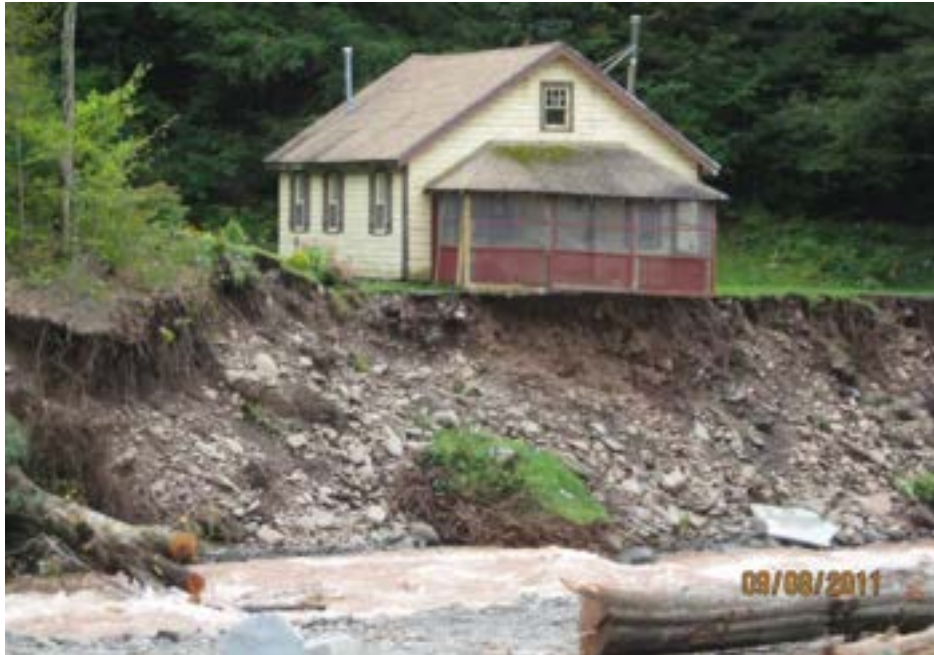
Photo 3-17 Damage to home along Stony Clove Creek from bank erosion in 2011 flooding. Photo provided by HLFRC.

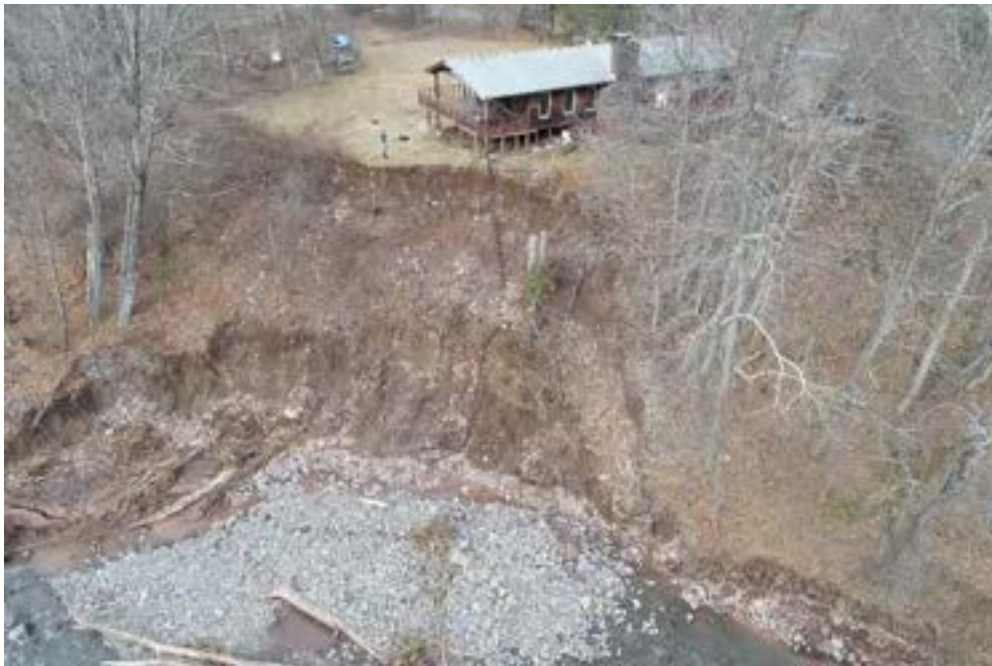
Photo 3-18 Stream bank-coupled hillslope failure along a dynamic reach of Stony Clove Creek (see Figure 3-35) threatening adjacent structure. January 1, 2021, photo. This property was purchased through the NYCFFBO due to erosion hazard risk.

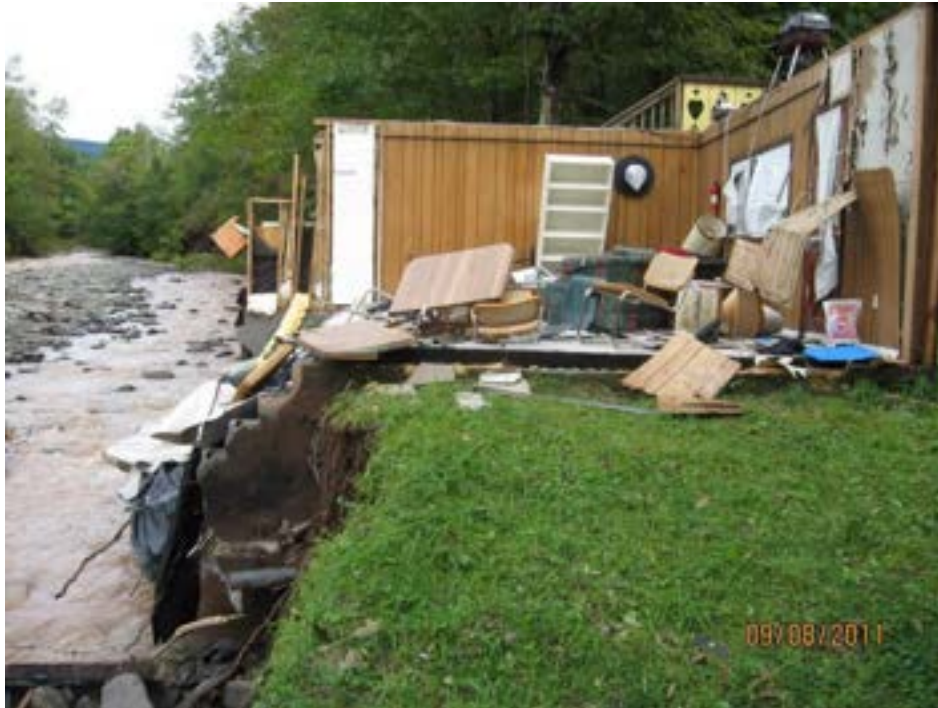
Photo 3-19 Home alongside Stony Clove Creek in Meadow Brook Drive neighborhood (Section 3.1.2) destroyed by stream bank erosion in 2011. This home went through the FEMA buyout process and the parcel is now owned by the NYCDEP. Photo provided by HLFRC.

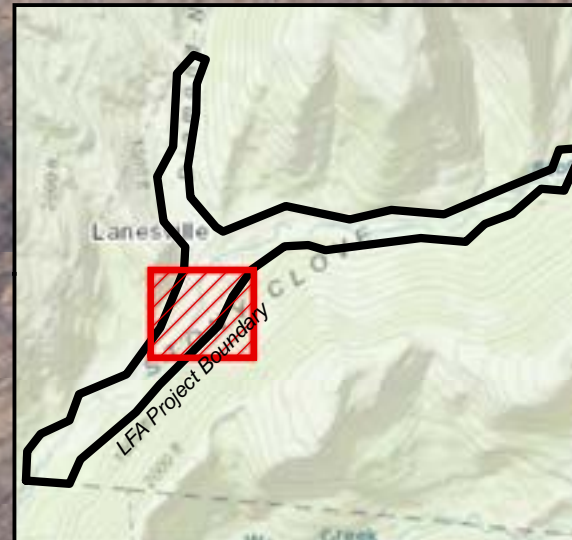
FIG. 3-36

Historical Alignments - Stony Clove Creek Downstream of Jansen Rd

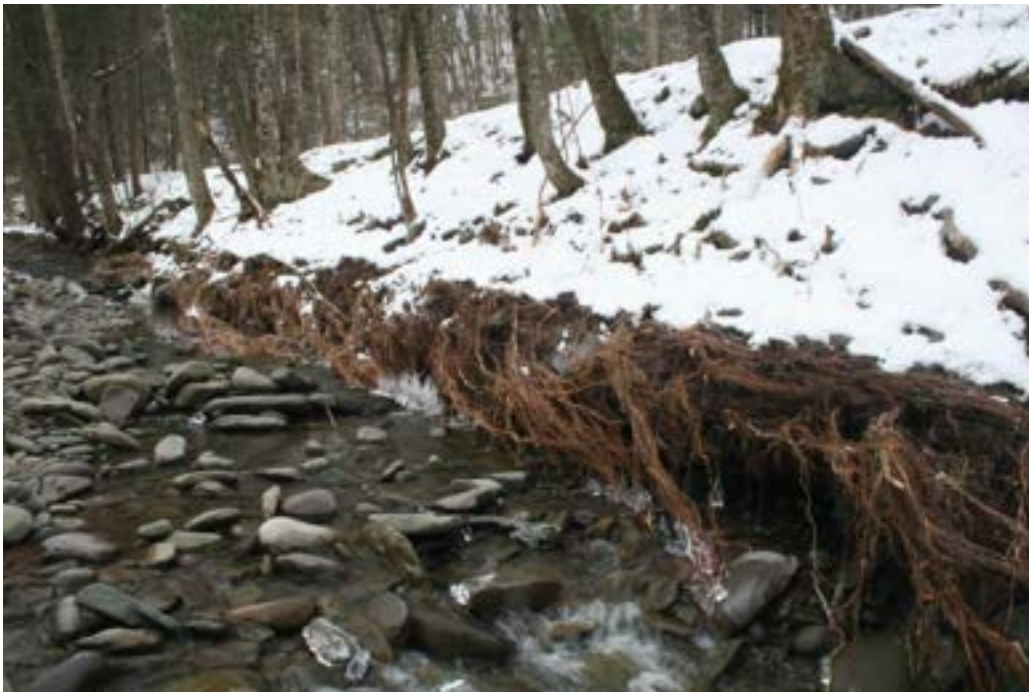
Photo 3-20 Roots from mature riparian vegetation mitigating bank erosion along Stony Clove Creek during December 25, 2020, flooding. January 11, 2021, photo.

The physical benefit of a riparian buffer to a stream has been shown to include **increased stability, reduced stream bank erosion, and reduced channel migration**. An example along Stony Clove Creek is shown in Photo 3-20. Scientific studies have found that intertwining roots within a stream bank can increase stream bank strength, increase resistance to erosion caused by high flows, and provide greater channel stability (Sweeney and Newbold, 2014). One study found that following major floods bank erosion was 30 times more prevalent along stream bends without forests than those with forests (Beeson and Doyle, 1996). Other studies have also shown that forested stream reaches exhibit slower channel migration and thus provide more stability than deforested channels (Hession et al., 2003; Allmendinger et al., 2005). The NRCS (2016) notes that stabilized stream banks also help maintain the geometry of the stream, including characteristics such as the meander length and profile.

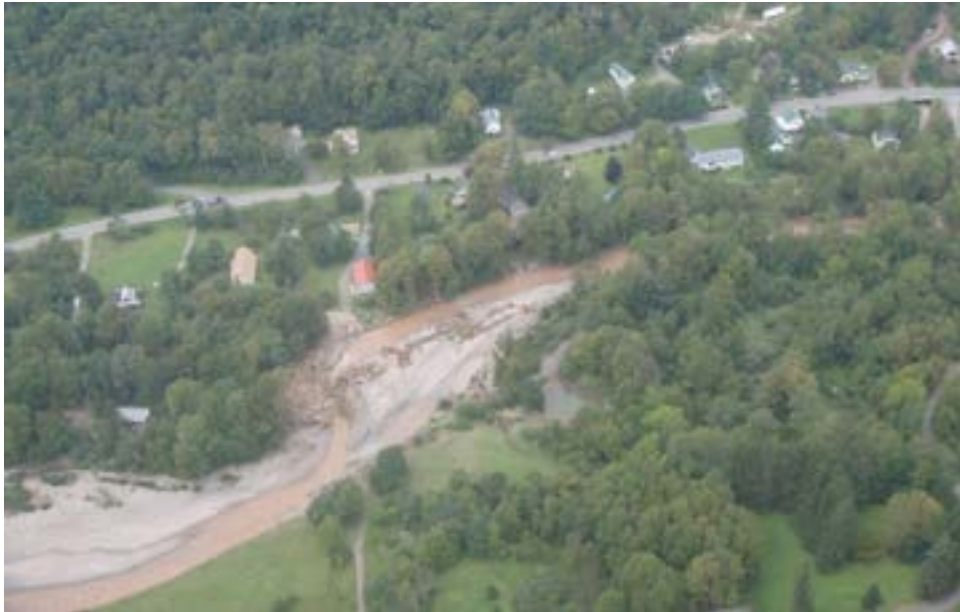
Photo 3-21 Large wood accumulation on Stony Clove Creek in Lanesville after Tropical Storm Irene in 2011. Photo provided by NYCDEP SMP.

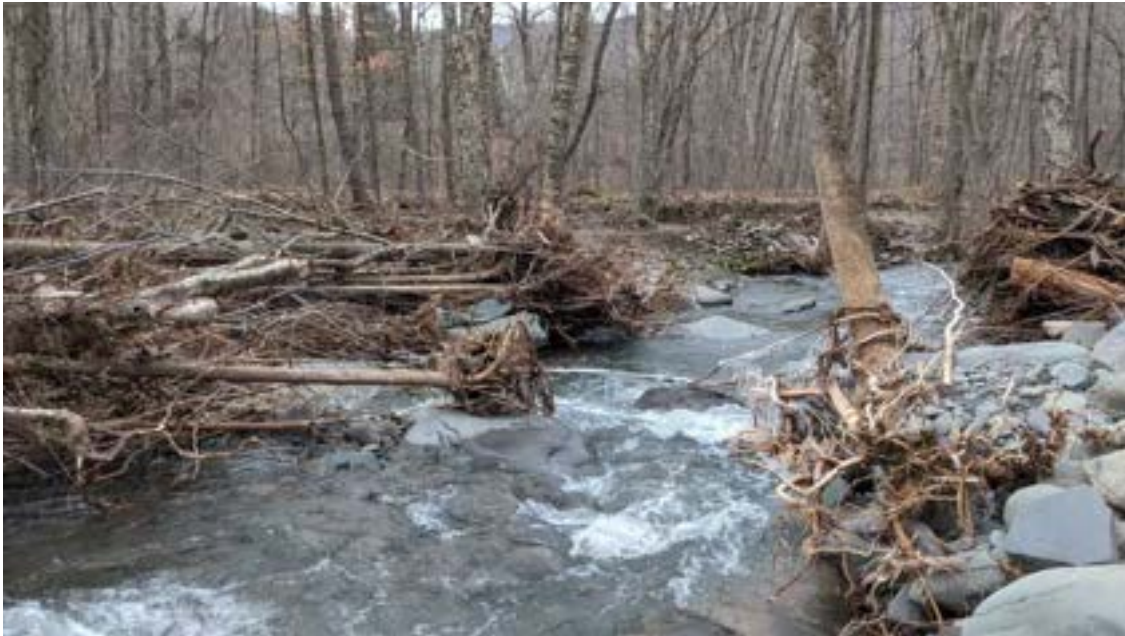
Photo 3-22 Wood accumulations along Hollow Tree Brook

removing wood from streams. No matter what the situation, removing wood can have unanticipated consequences, which may be negative. In many situations, wood in streams does not pose a risk to streamside property and may have benefits, including bed and bank stabilization (Photo 3-22).

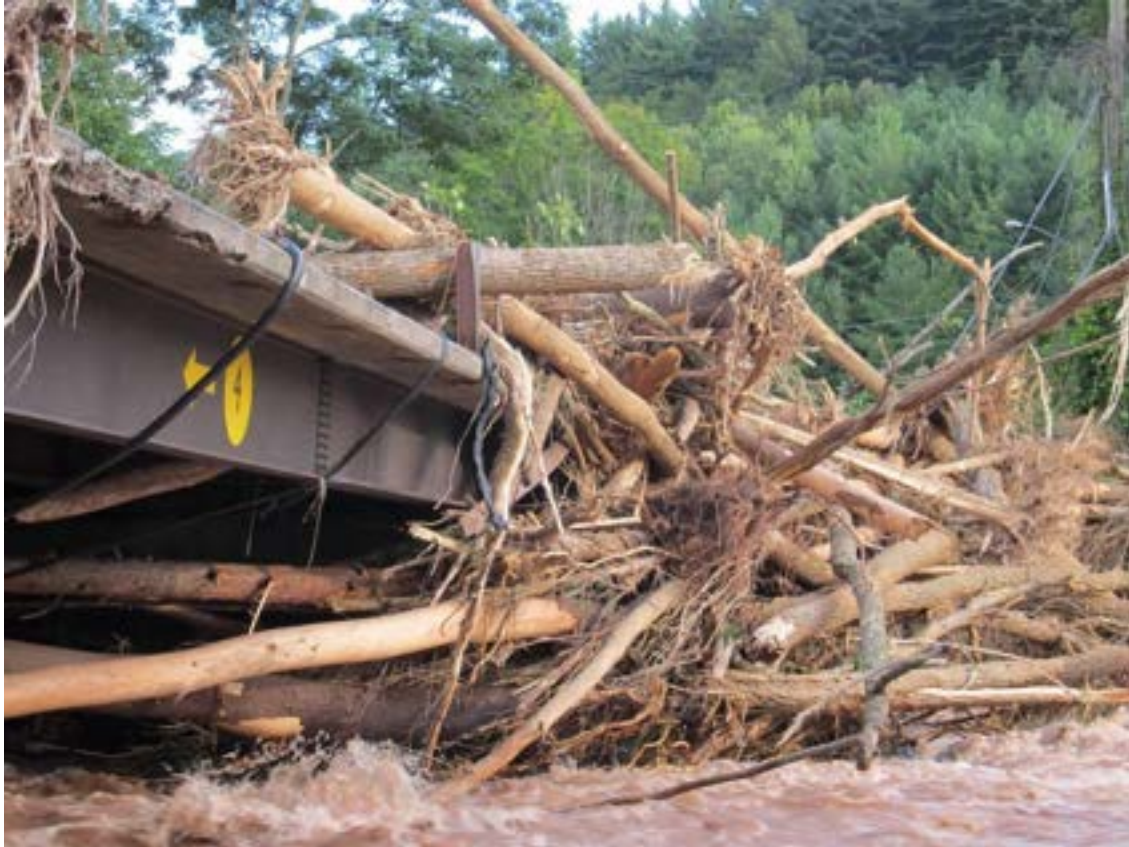
Photo 3-23 Large wood accumulation at Bridge Street bridge over Esopus Creek in Phoenicia during Tropical Storm Irene in 2011. Photo provided by Amy's Takeaway.

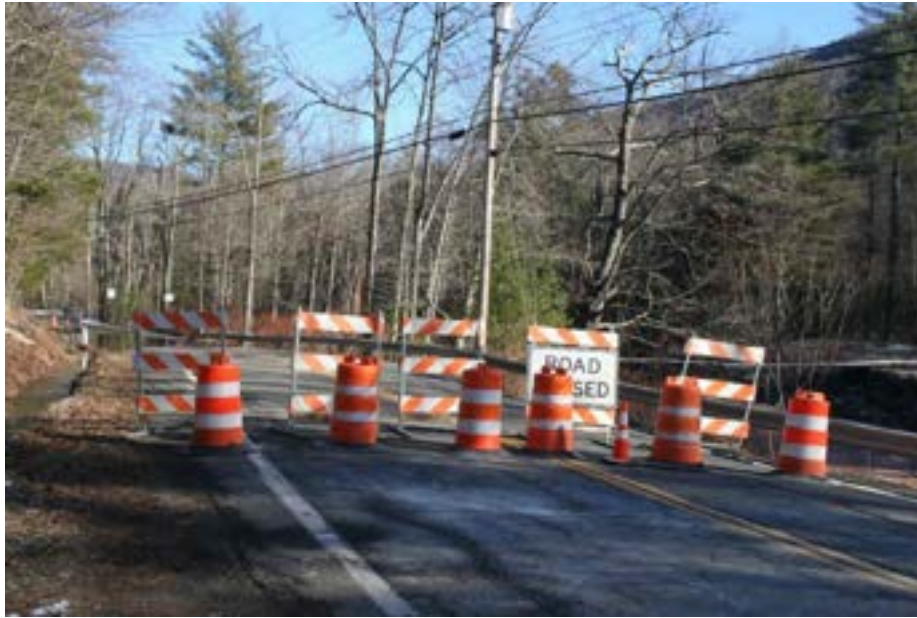
**Photo 4-1 Closure of NY-214 near the Greene-Ulster county line after flooding in 2020.
Photo provided by AWSMP.**

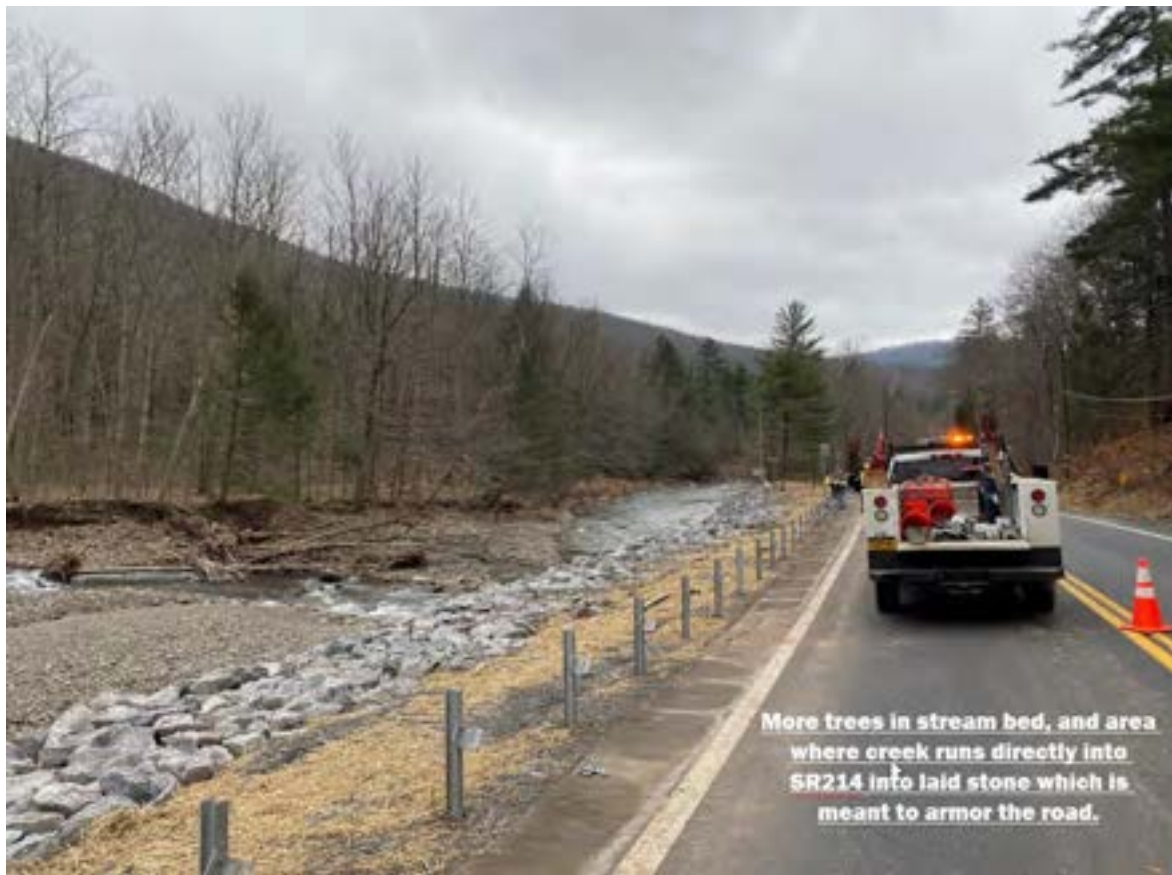
More trees in stream bed, and area where creek runs directly into SR214 into laid stone which is meant to armor the road.

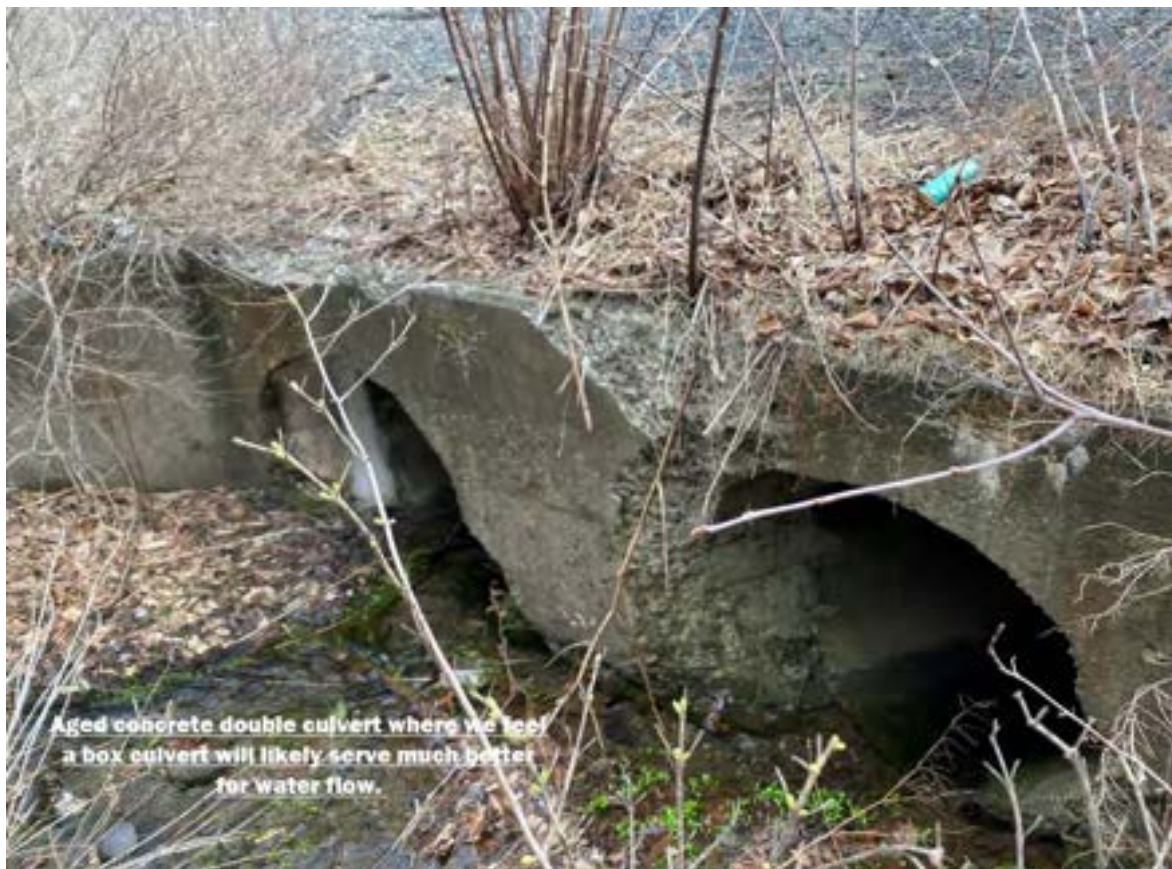
Aged concrete double culvert where we feel a box culvert will likely serve much better for water flow.
