FEBRUARY 2003

PROJECT REPORT

Broadstreet Hollow Stream Restoration Demonstration Project

Greene County Soil & Water Conservation District

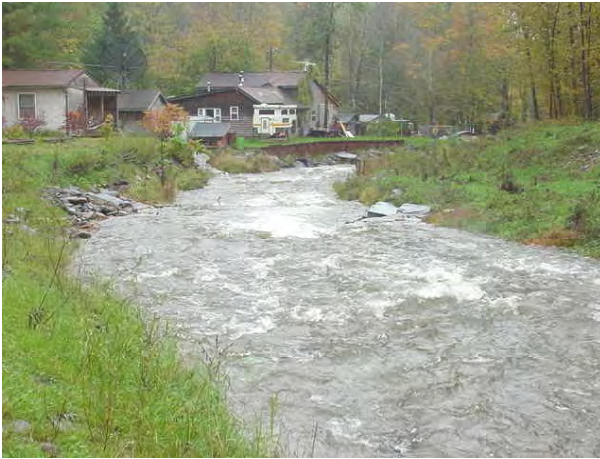
- Photograph 47: After the recession of the October 12, 2002 flow, the middle and lower portion of the project appears to be functioning properly during normal flow. (Reference image #45)

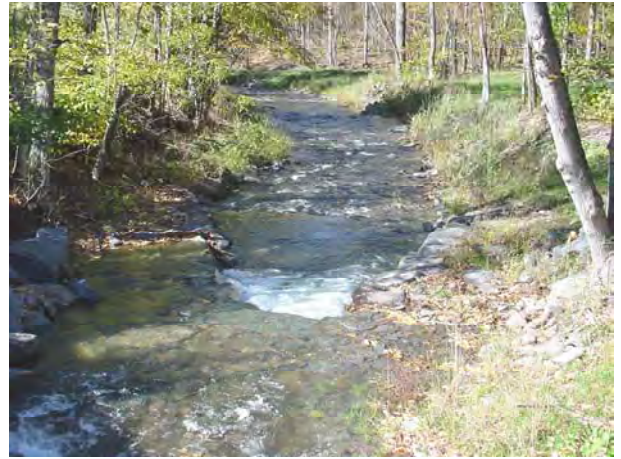
- Photograph 48: The lower portion of the project appears to be functioning properly under normal flow conditions.
