## **Chestnut Creek Stream Management Project Sites Detailed Descriptions**

In November 2002, SCSWCD put together a list and description of potential project sites noted during the 2001 Stream Assessment Survey. The Chestnut Creek Project Advisory Committee (PAC) was asked to vote on these sites to determine a Demonstration Restoration Site for the Stream Management Plan 2003. The following information was sent to the PAC and a meeting held to vote on the project site:

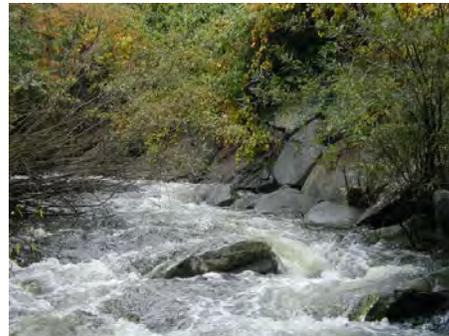
Split channel with riprap on right bank being undermined upstream of covered bridge, within 20' of Route 55

Complete historical aerial overlay to assess erosion rate and direction, as well as changes in plan form geometry at Covered Bridge, upstream to riprap near tennis courts.  
Begin assessment of the bridge and upstream area to determine changes in meander patterns  
Potential for “assisted” restoration  
Review of existing reports and designs as provided by Town  
A W-weir structure could redirect the stream and protect the bridge from future repairs as well as reduce gravel build-up

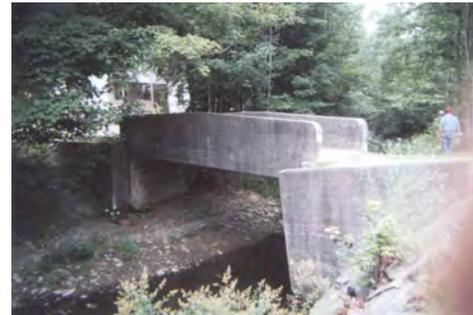
Concrete crib wall along Rte. 55 attached to failing abutment

The left bridge abutment is partially undercut and leaning toward the stream channel,  
The upstream wing wall is showing signs of erosion  
This abutment is directly attached to a concrete wall that lines the left bank near Rte 55  
Local NYS DOT is concerned that a bridge failure will affect the highway  
There is only one house accessed by this bridge

An inspection of the structure by the bridge engineer  
to determine its safety and anticipated design life.  
Possible replacement of structure designed and  
built to accommodate the stream flow and protect the road.

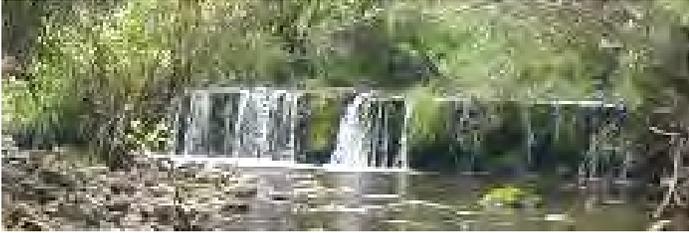
Looking upstream at eroded sewer line structure below Davis Lane Bridge

Any stream channel work through this area would be best applied during future efforts to repair the bridge structure
