A. Chestnut Creek Management Unit 1

1. Summary Description

Restoration and Management Recommendations Management Unit 1

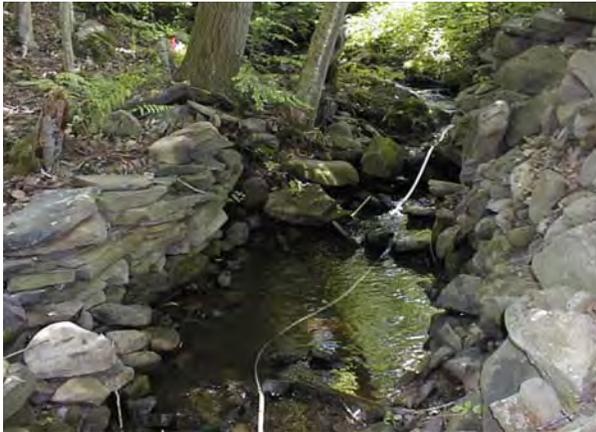
Because of ongoing channel modifications and maintenance, the *stream types* in the upstream section are not typical of what would be expected in this setting under natural conditions, though the current configuration appears to be functioning well. The stream is very small in this *headwaters* location, with *bankfull* channel cross sectional area between 2.5 and 4.5 square feet (Photo 12). As such, the adjacent *floodplain* and riparian areas are not as susceptible to flood inundation problems, though may be more susceptible to ongoing stability problems due to the

Photo 12. View looking upstream toward XS-10 from XS-11.

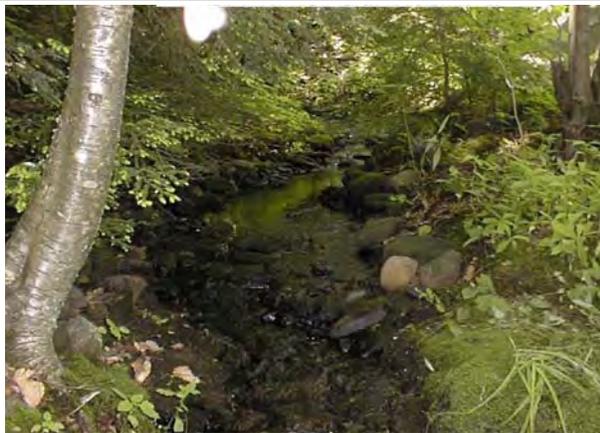
Photo 15. View looking upstream from XS-6 at narrow, well forested gravel and cobble bed stream.

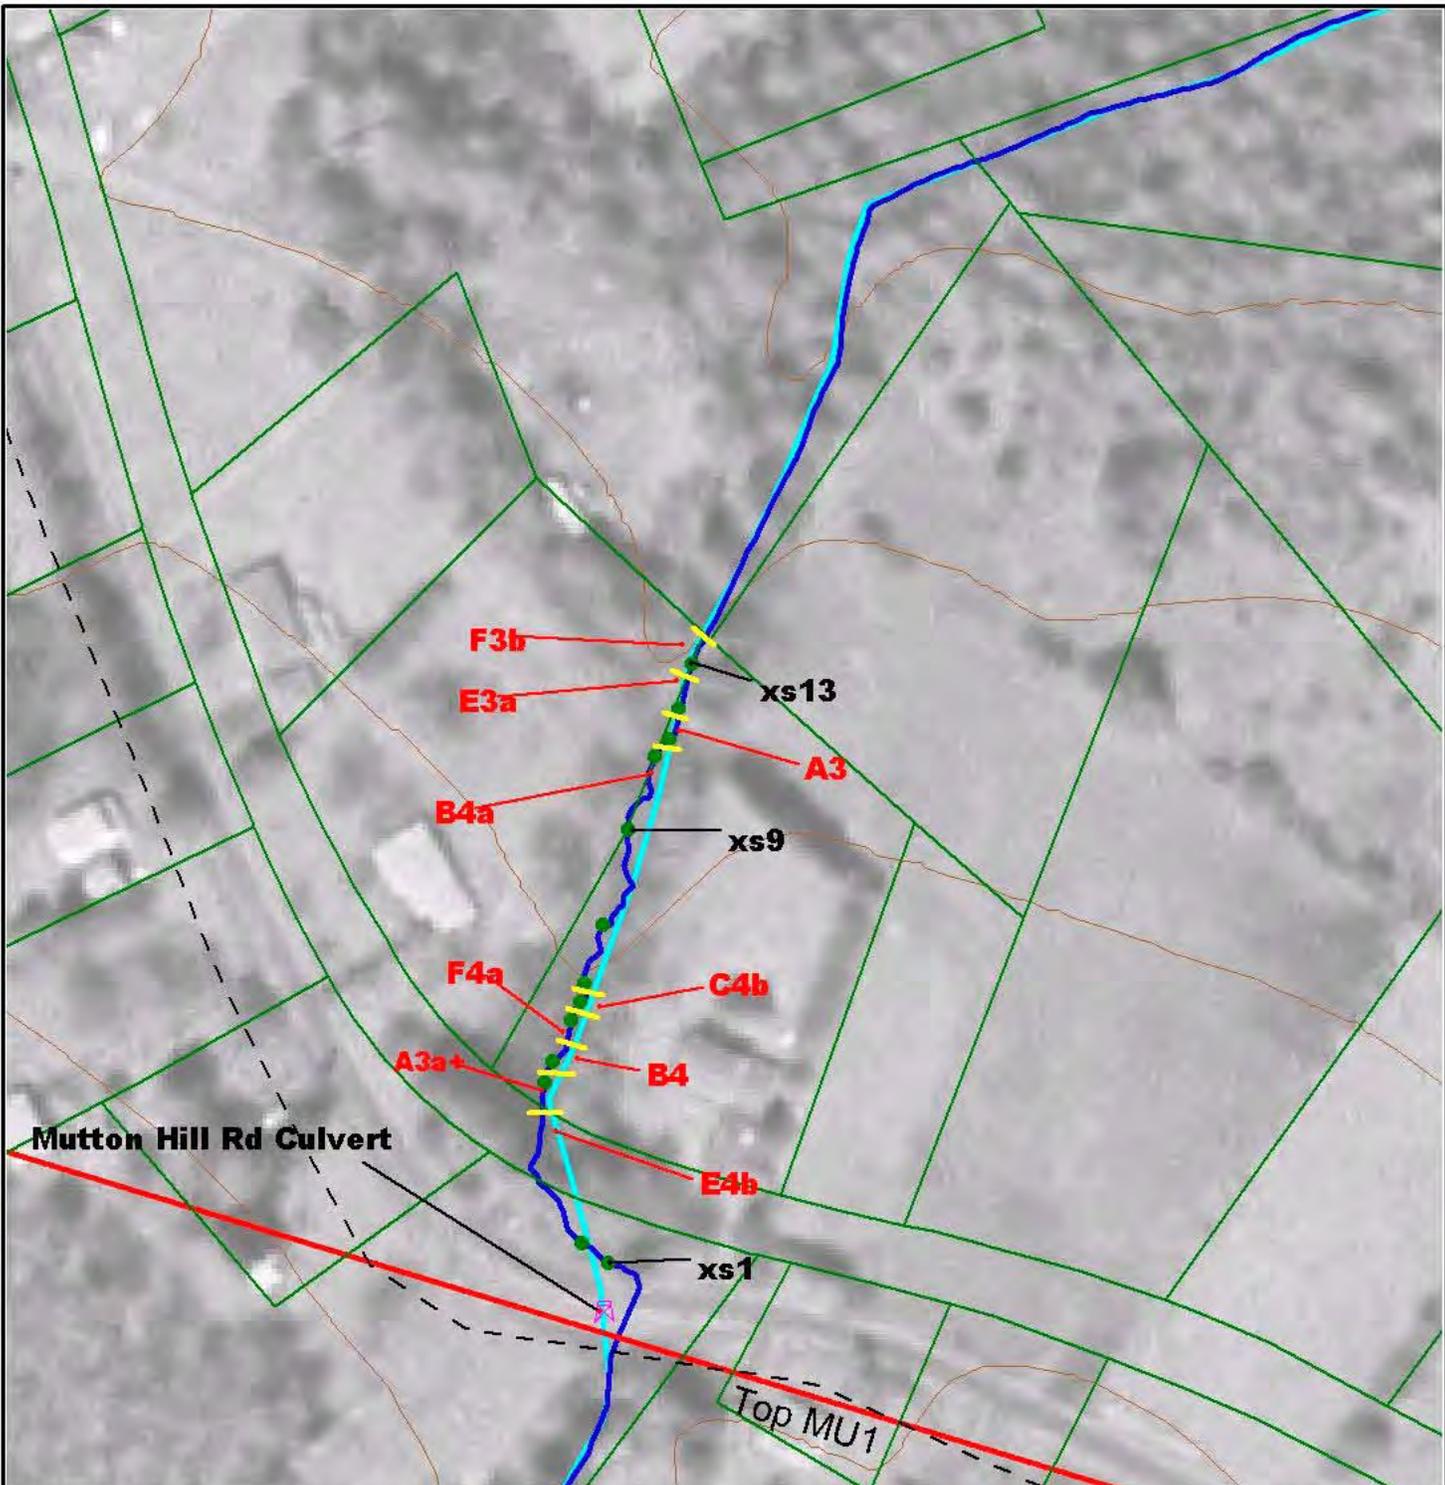
Figure 2. Chestnut Creek MU1 (upstream portion)

During the 2001 Stream Corridor Survey, MU1 was divided into 9 *reaches* on the basis of the Level II – Morphologic Description (Rosgen, 1996). The largest portion (47%) of this unit includes moderately entrenched channel types B and Ba (MU1 Stream Type & Cross Sections location map, Figure 2). With a low width to depth ratio (i.e., 11 – 16) and mature vegetation on the banks these types of channels tend to be very *stable* and are generally effective at moving *sediment* transported from upstream reaches. Although mature trees and shrubs provide lateral control along much of the management unit, channel maintenance activities in the upstream portion have left all of the reaches in this unit with moderate to low width to depth ratios making them more efficient at moving sediment (Photo 15), though not necessarily prone to severe *downcutting*, especially in reaches with coarser sediment in the lower reaches of the upstream section (Photo 16).

account for 9% of the total length. Because they lack a floodplain area (i.e., an area adjacent to the channel where floodwaters can spread out and reduce the energy against the streambed and banks), entrenched reaches experience considerable stress during storm flow and tend to be more susceptible to stability problems, particularly bank *erosion* and bed scour or *degradation*. In addition, these types of channels route storm flow quickly to downstream reaches where they can contribute to channel instability and flooding.

Morphological data collected along the reaches is summarized in Table 1 and illustrated in Figure 2. As can be discerned in the aerial photographs, the channel *planform*, or stream pattern, along this management unit is characterized by relatively low *sinuosity*, though shows a few truncated *meanders*. The greatest alteration in meander geometry appears to be associated with road locations, though does not appear to have changed appreciably since the 1970s. What
