C. Chestnut Creek Management Unit 3

1. Summary Description

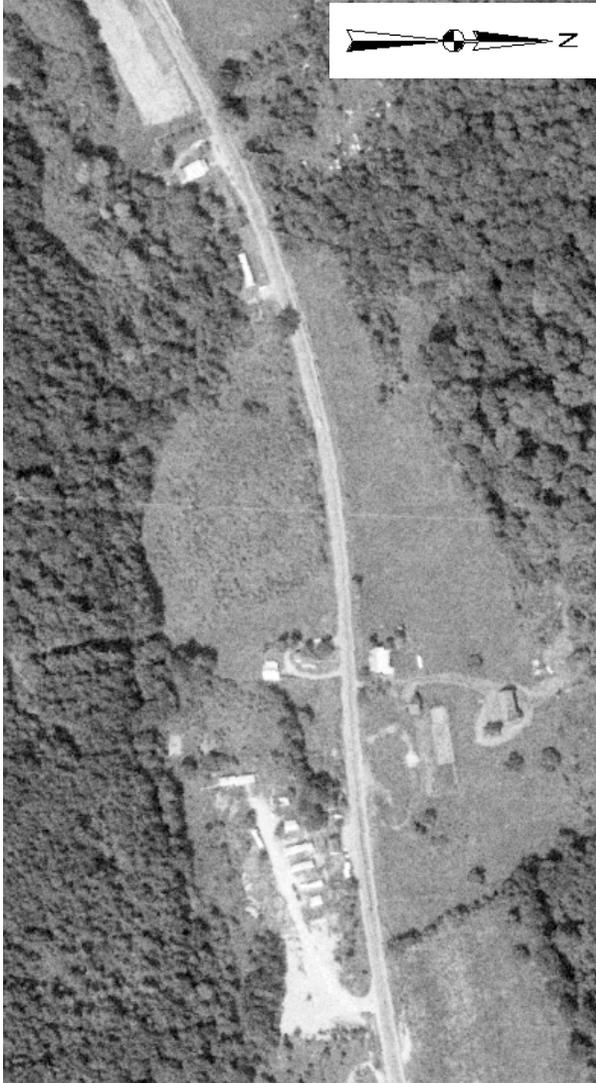
Photo 2. 1974 Aerial Photograph of MU3.

An analysis of a series of historic aerial photographs covering the period 1963-2001 documents the stability of the reach and consistent land use. The area remained forested with dense vegetation covering the stream channel and minimal change in land use or *riparian* structure in nearly 30 years. There was no evident change in channel *planform*, or stream pattern, through the aerial series. Aerial photos 2, 3, & 4 taken in 1974, 1985, and 2001 illustrate greatest contrast.

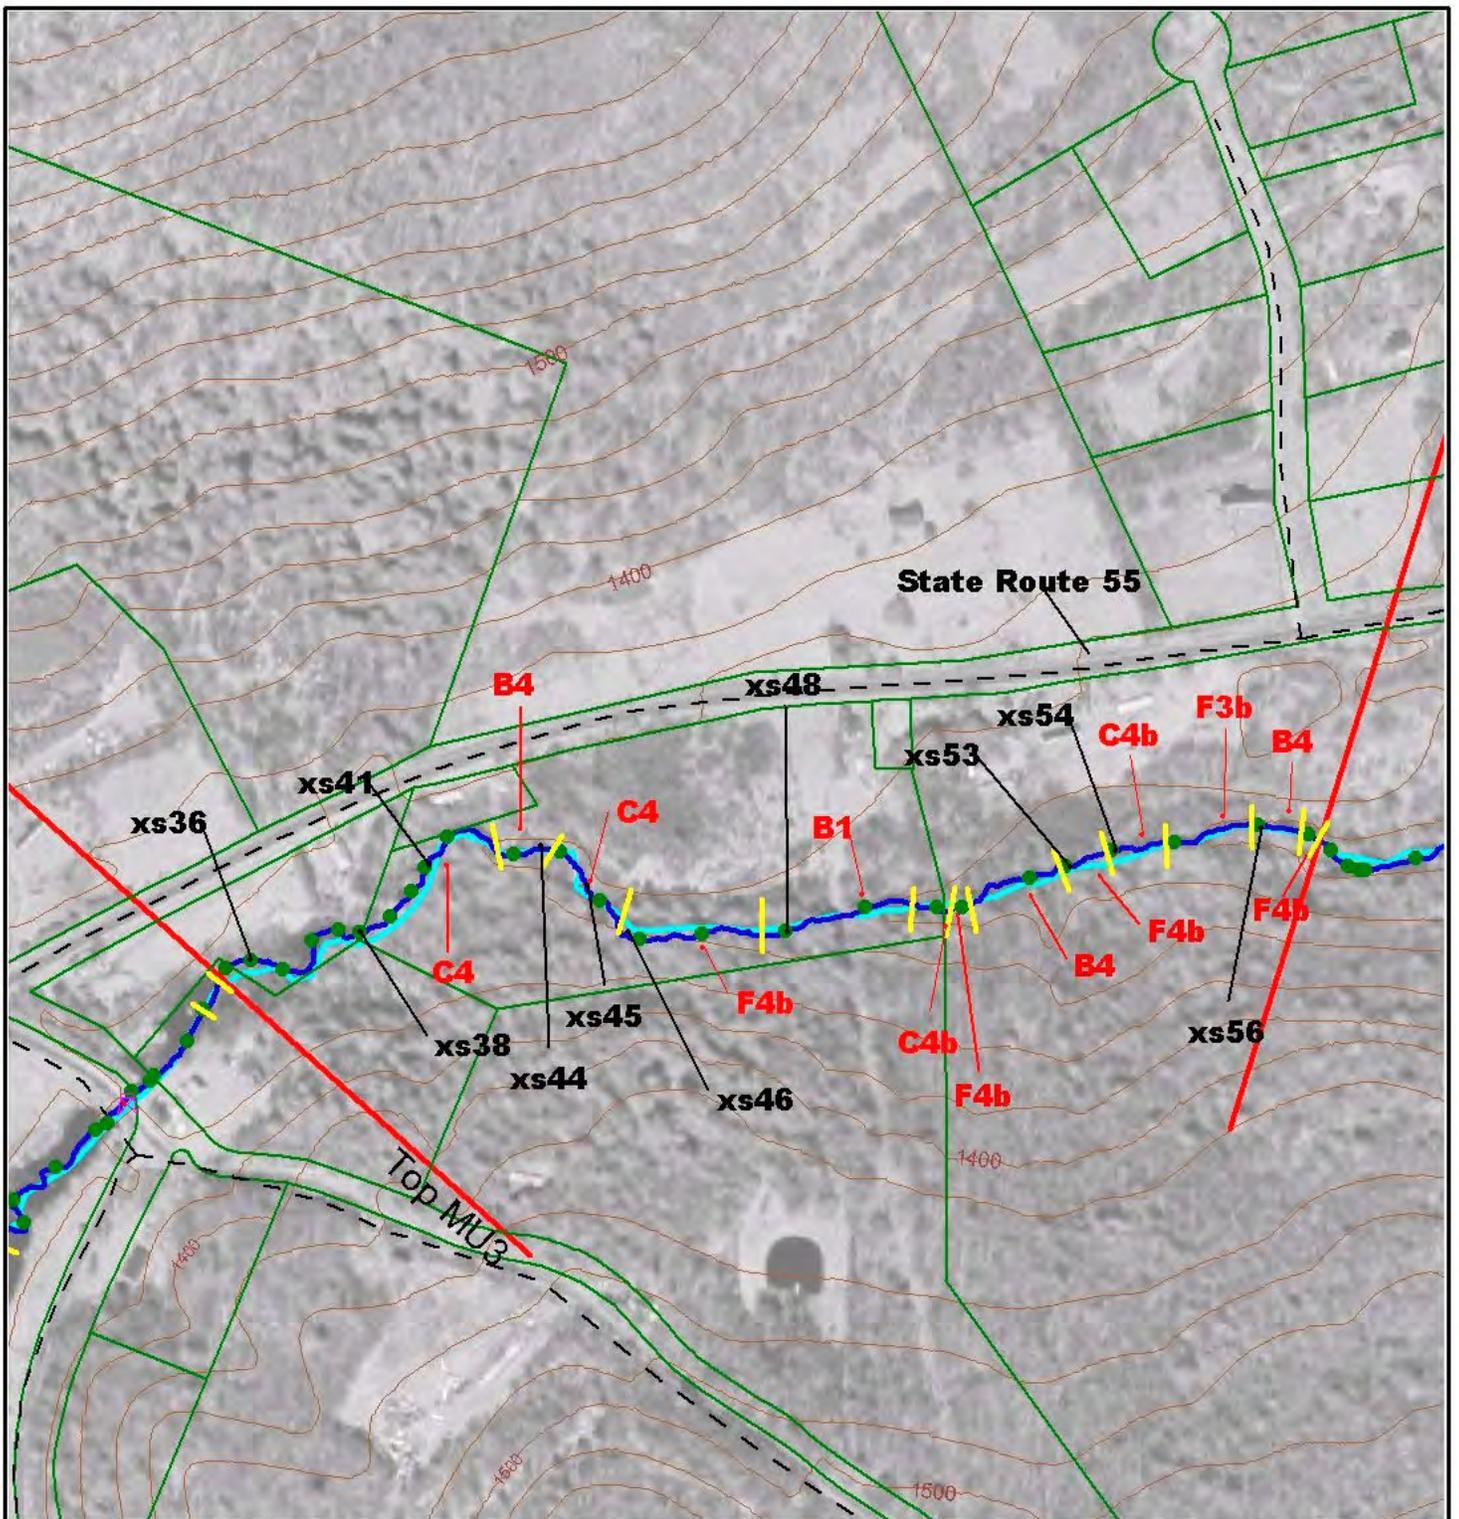
Figure 2. Chestnut Creek MU3 Stream Types & Cross Sections
Stream Assessment Survey 2001

Following the 2001 Stream Assessment Survey, MU3 was divided into thirteen *reaches* on the basis of the Level II – *Morphologic* Description (Rosgen, 1996). (MU3 Stream Types and Cross Sections map, Figure 2).

can contribute to channel instability and flooding. The stream types tend to shift multiple times throughout the unit, which could indicate an imbalance and should be monitored. The morphological data collected through the unit is summarized in Table 1 and illustrated in Figure 2.
