F. Chestnut Creek Management Unit 6

1. Summary Description

Chestnut Creek Stream Management Plan

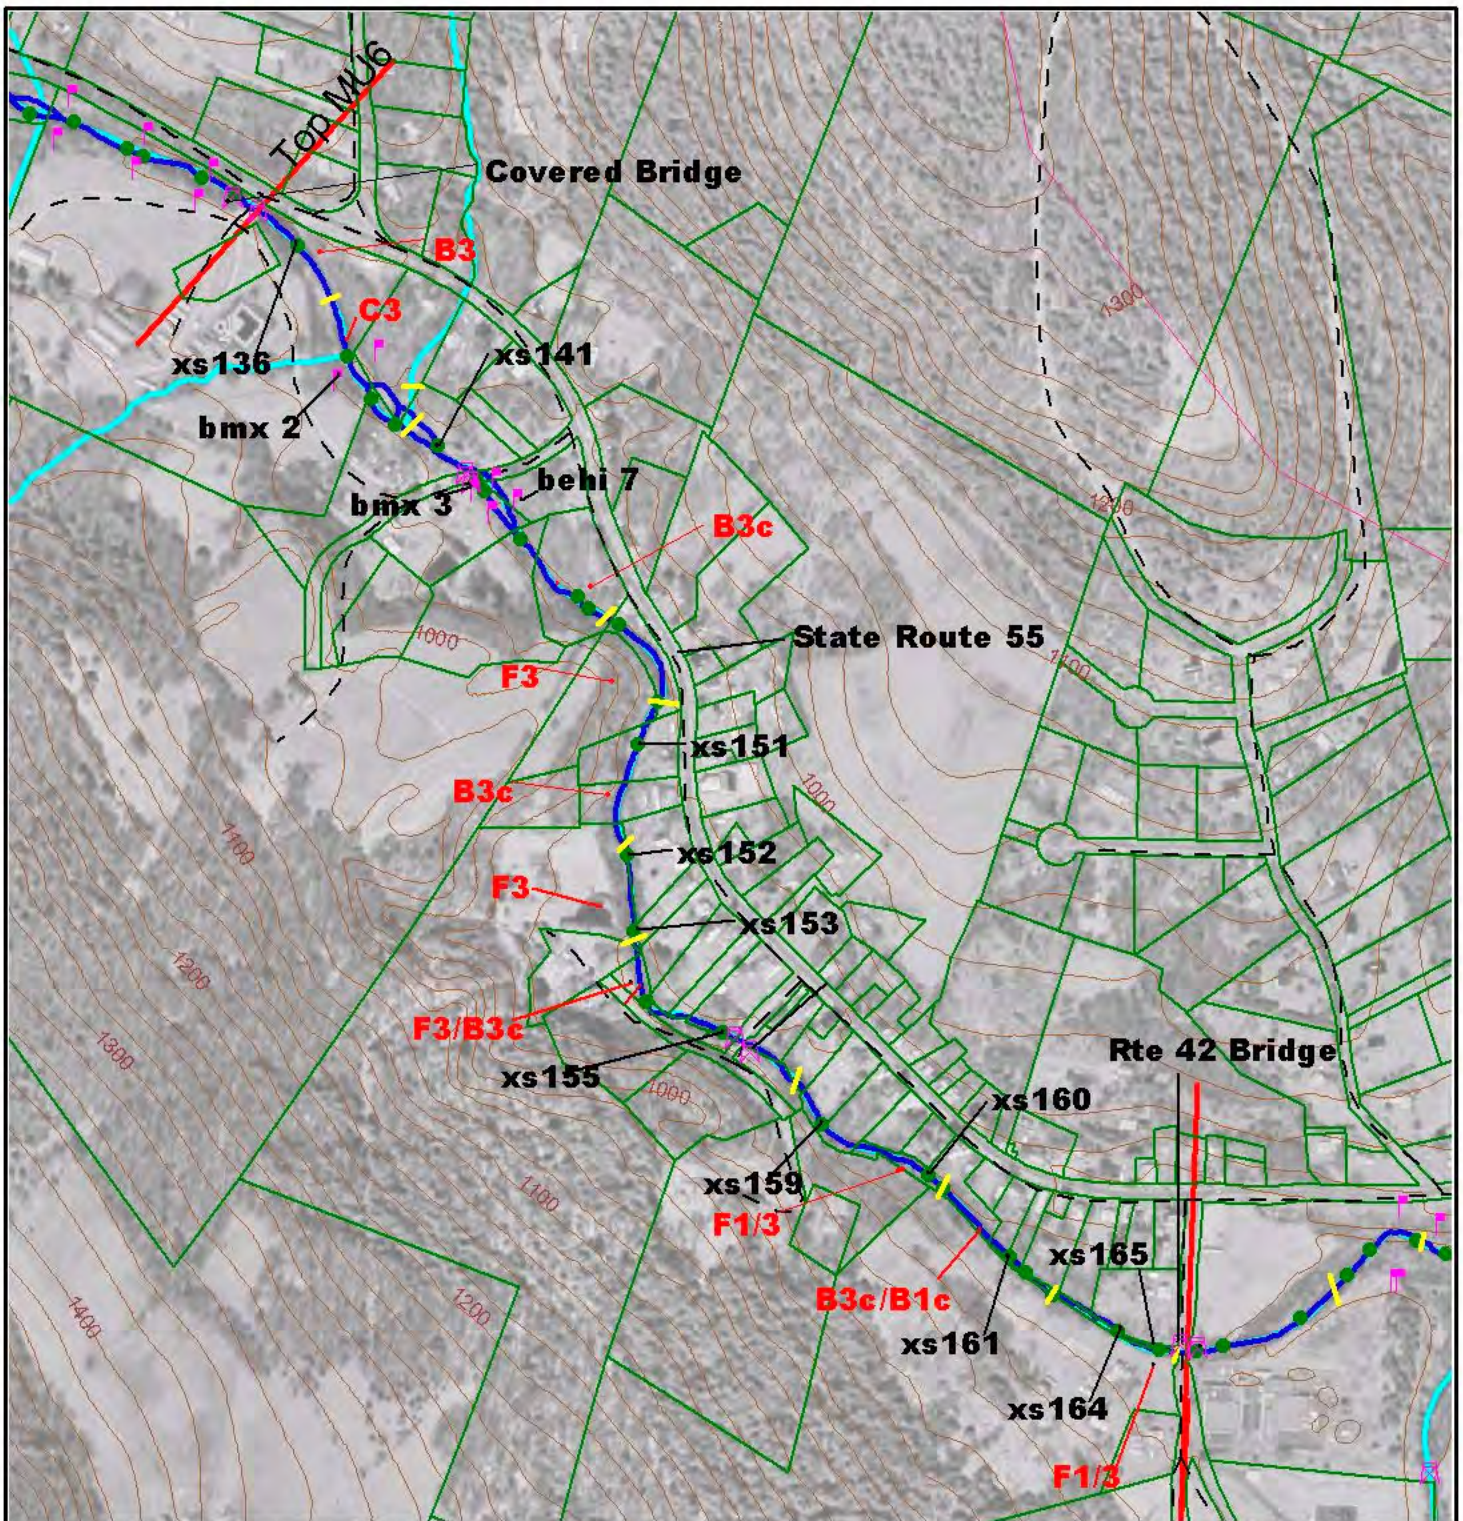
Figure 2. Chestnut Creek MU6 Stream Types and Cross Sections
Stream Assessment Survey 2001

be very stable and are generally effective at moving sediment transported from upstream reaches. Highly entrenched reaches (i.e., F-types) account for 30% of the total length. Approximately 28% of the unit includes reaches in transition from one stream type to another (i.e., B3/F3 and F3/B3c). Because they lack a floodprone area (i.e., an area adjacent to the channel where floodwaters can spread out and reduce the energy against the streambed and banks), highly entrenched reaches experience considerable stress during storm flow and tend to be more susceptible to stability problems, particularly bank erosion and bed scour or *degradation*. In addition, these types of channels route storm flow quickly to downstream reaches where they can contribute to channel instability and flooding. The remaining reaches are C-types, which make up 10% of the total length. Although these channel types are generally stable, woody vegetation is critical to maintaining bank stability. In addition, they are susceptible to stability problems where sediment loads are high. The *morphological* data collected along the reaches is summarized in Table 1 and illustrated in Figure 2.
