# East Kill Management Unit 1

Town of Jewett – Station 84120 to Colgate Lake Dam (Station 73769)

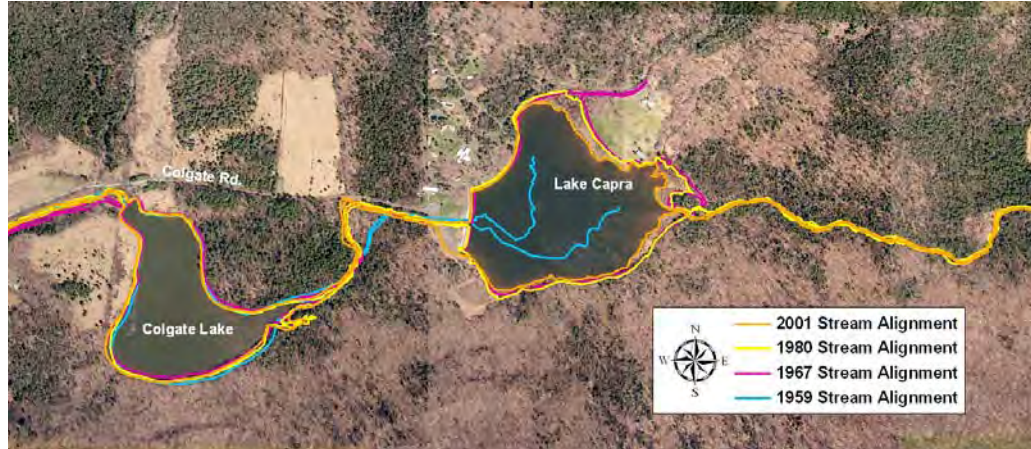
*Historic stream channel alignments overlaid with 2006 aerial photograph*

As seen from the historical stream alignments (above), the *planform* of the channel has experienced significant changes between 1959 and 1967. This is primarily due to the creation of Lake Capra. According to the National Inventory of Dams (NID), maintained by the U.S. Army Corps of Engineers (ACE), the Camp Harriman Dam was built in 1913 for recreational purposes. However, the formation of Lake Capra appears to have taken place between 1959 and 1967, as seen from the historical aerials below. Except for the historical changes due to the formation of Lake Capra and the subsequent changes in the size of the lake, the East Kill channel in management unit 1 has remained fairly stable. Due to its rural

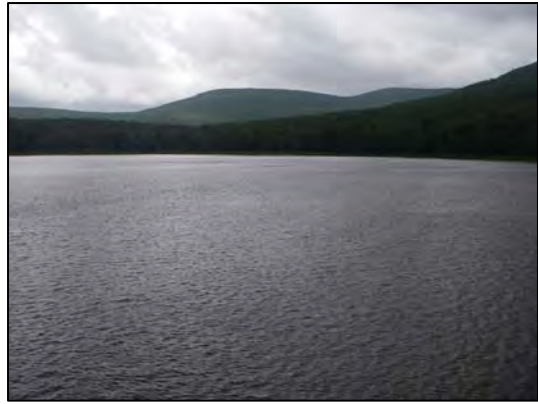
As mentioned previously, Lake Capra formed many years after the construction of Camp Harriman Dam (Inset B, Station 78431). The dam, a rockfill earth dam, was constructed of compacted excavated natural materials such as fine-grained materials, cobbles, and rock, and was built for recreational purposes. It measures 28

feet high and 640 feet in length. The drainage area of the dam is 4.6 mi<sup>2</sup>. The maximum storage space in the reservoir is 444 acre-feet, and the maximum discharge that the dam was designed for is 6,920 cu ft/sec. According to the National Inventory of Dams, the downstream hazard potential is considered high, which is defined by the U.S. Army Corps of Engineers (USACE) as a dam where failure or misoperation will probably cause loss of human life. However, the owner of the dam, the New York State Office of Mental Retardation and Developmental Disabilities, has developed an Emergency Action Plan that will help to reduce the potential for property damage and loss of life if the dam were to fail or there was a large flood. Lake Capra is on the grounds of a camp that provides recreational opportunities for people with developmental disabilities.
