East Kill Management Unit 5

Town of Jewett – Scribner Hollow Road Bridge (Station 51119) to Station 40130

This management unit began at Scribner Hollow Road Bridge, and continued approximately 10,989 ft. to a private bridge on the Farber Farm in the Town of Jewett.

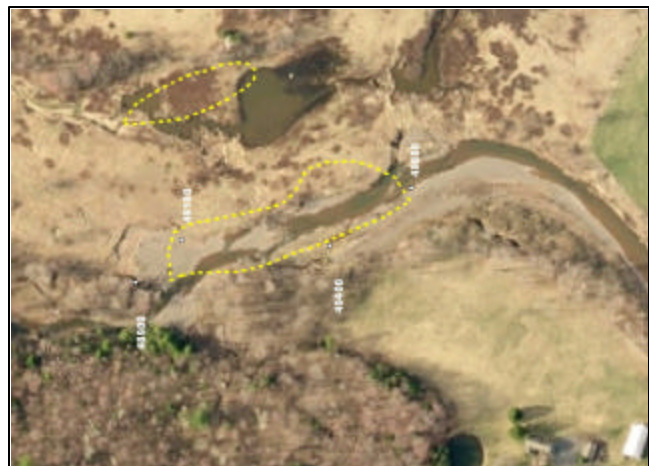
*Wetland boundaries approximately delineated by NWI
(Stations 49585 - 49060)*

Continuing downstream, there was a 1.2 acre riverine wetland (Stations 49585 - 49060). This wetland was classified as R3USA. Set back from the stream, along the right, there was a 0.4 acre palustrine wetland with emergent herbaceous vegetation (Stations 49357 – 49074). This wetland was classified as PEM1C (see Section 2.6 for detailed

wetland type descriptions). Wetlands are important features in the landscape that provide numerous beneficial functions including protecting and improving water quality, providing fish and wildlife habitats, storing floodwaters, and maintaining surface water flow during dry periods. Within the riverine wetland area, there was erosion (Stations 49600 – 49529) along 71 feet of the right stream bank. Again, this area only had herbaceous vegetation, which provides minimal bank stability protection. Riparian improvements along the toe and upland area may help to stabilize this bank.

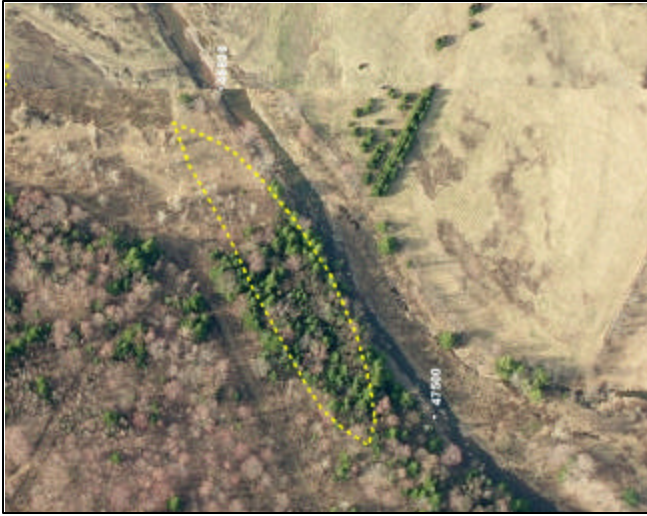
Wetland boundary approximately delineated by NWI
(Stations 47457 - 46800)

Continuing downstream, there was a 1.5 acre palustrine wetland (Stations 47457 - 46800) with scrub-shrub vegetation along the left stream bank. This wetland was classified as PSS1A (see Section 2.6 for detailed wetland type descriptions). Near the upstream portion of this wetland, there was a mass failure (Stations 47281 – 47126, Figure 5.5.1 Inset D) along the left bank. This mass failure had resulted in an erosion area of approximately 1,938 ft², exposing areas of mixed till and compromising mature trees along the bank. There were multiple exposures of lacustrine clay (Stations 47389 – 47189) along the stream bank and the channel bed throughout this erosion site, and just upstream of the erosion. Clay inputs into a stream are a serious water quality concern because they increase *turbidity*, degrade fish

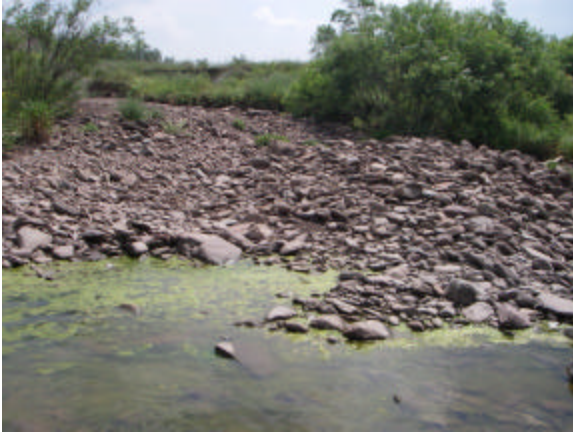
Tributary at Station 46535

As the stream meandered to the left, an unnamed tributary entered from the right stream bank (Station 46535). This tributary drained the lower slopes of the Blackhead Mountains before it reached the flatter topography of the valley floor where it entered the East Kill. As a result of this stream slope change, the tributary lost its ability to transport sediment gathered from the mountain slopes, and began to deposit

sediment at its mouth and into the more gently sloped East Kill. This is a common feature of confluence areas, which often contain extensive sediment bars, function as important sediment storage areas, and are typically among the most dynamic and changeable areas in the stream system. At the time of the assessment, the tributary was entrenched and flow was subsurface at the confluence. As evidenced by the significant algal growth around the confluence, this tributary also appeared to cause nutrient enrichment, a process in which the addition of nutrients (primarily nitrogen and phosphorus) to water bodies stimulates algal growth. Runoff associated with the nearby agricultural activity is the likely cause of the nutrient enrichment. Investigation of the possible sources of nutrient inputs and developing measures to prevent *eutrophication* of the tributary is recommended. The New York State Department of Environmental Conservation classifies streams and rivers based on their “best use” (NYSDEC, 1994). This tributary was classified C by the NYS DEC, indicating that the best uses for this stream are supporting fisheries and other non-contact activities.

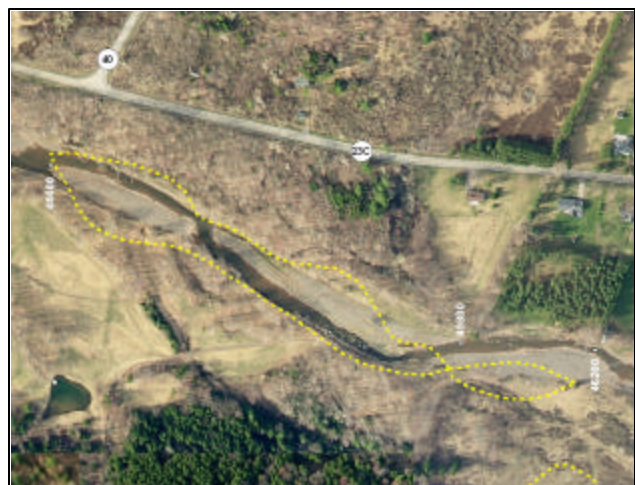
*Wetland boundary approximately delineated by NWI
(Stations 46142 - 44400)*

Continuing downstream, there were two wetlands. The first wetland was a 0.6 acre riverine wetland (Stations 46142 - 45756) along the left stream bank. This wetland was classified as R3USA. The second wetland was a 4.3 acre palustrine wetland (Stations 45756 - 44400) with forested vegetation. This wetland was classified as PFO1A (see Section 2.6 for detailed wetland type descriptions). Through this wetland, the left stream bank was reinforced with rip-

rap with some inter-planted vegetation including, willows and sedges. Although the rip-rap was in poor structural and functional condition at the time of the assessment, the vegetation that had established itself through the rip-rap appeared to provide some bank stability and there was a forested riparian buffer beyond the rip-rap. Just downstream of the revetment, there was erosion (Stations

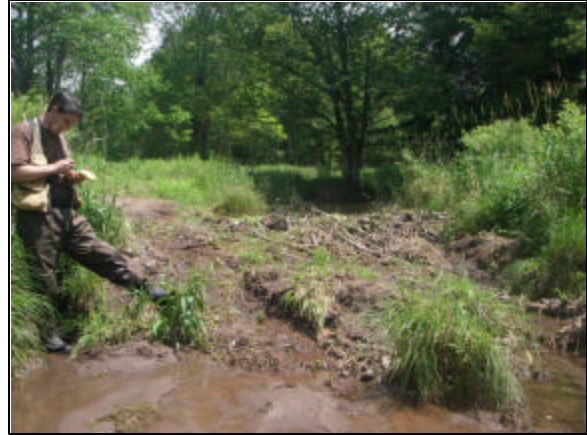
Tributary and beaver dam at Station 42829

Along the meander bend, an unnamed tributary entered along the left stream bank. There was a beaver dam constructed across the tributary just upstream of its confluence with the East Kill. While beaver impoundments can sometimes be a nuisance, beavers have historically played a beneficial and ecologically important role in the stream system. Beaver activity adds organic debris (trees, leaves, etc. which provide the base of the food chain), reduces water velocities and flood-related hazards, filter sediment and release water to the stream and groundwater slowly throughout the year.
