# East Kill Management Unit 7

Town of Jewett –Station 37758 to Route 296 Bridge (Station 26386)

This management unit began at Station 37758, and continued approximately 11,372 ft. to Route 296 Bridge (#1045150) in the Town of Jewett.

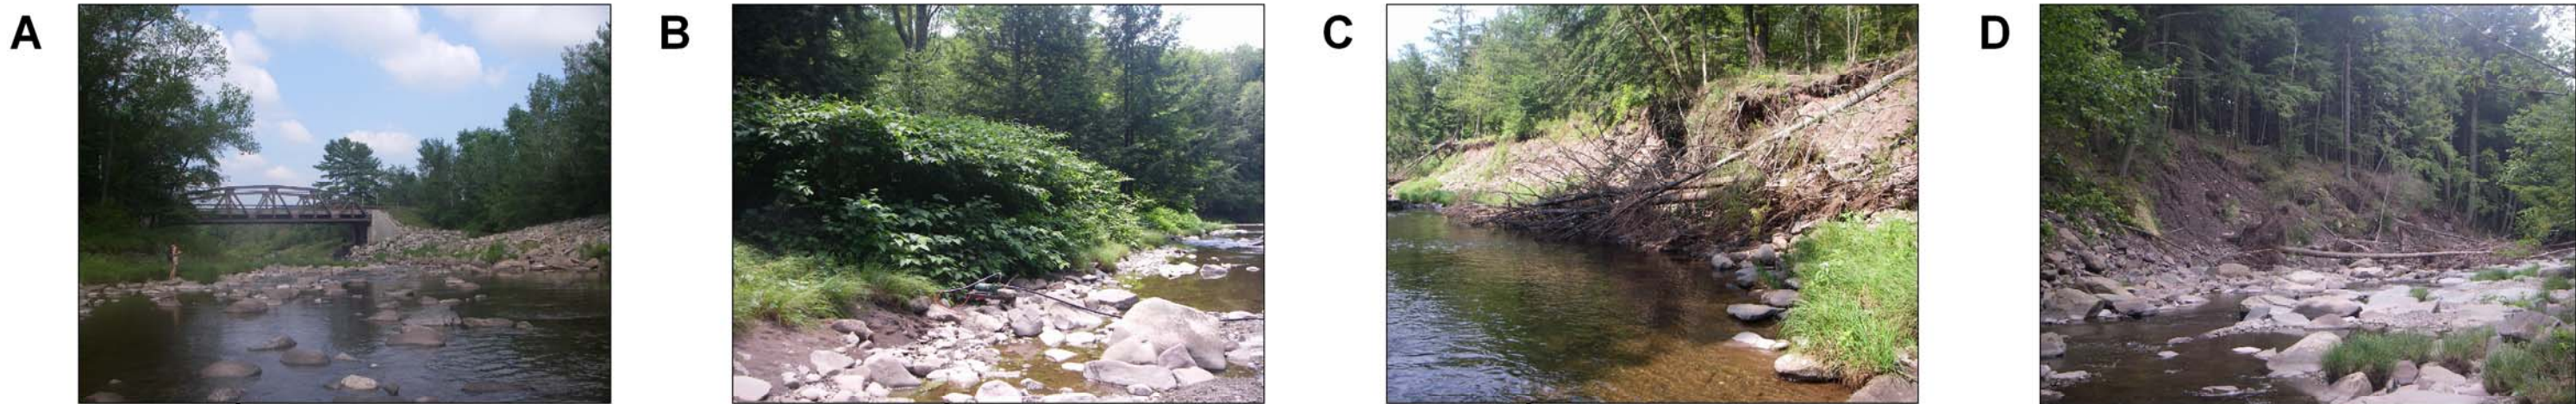
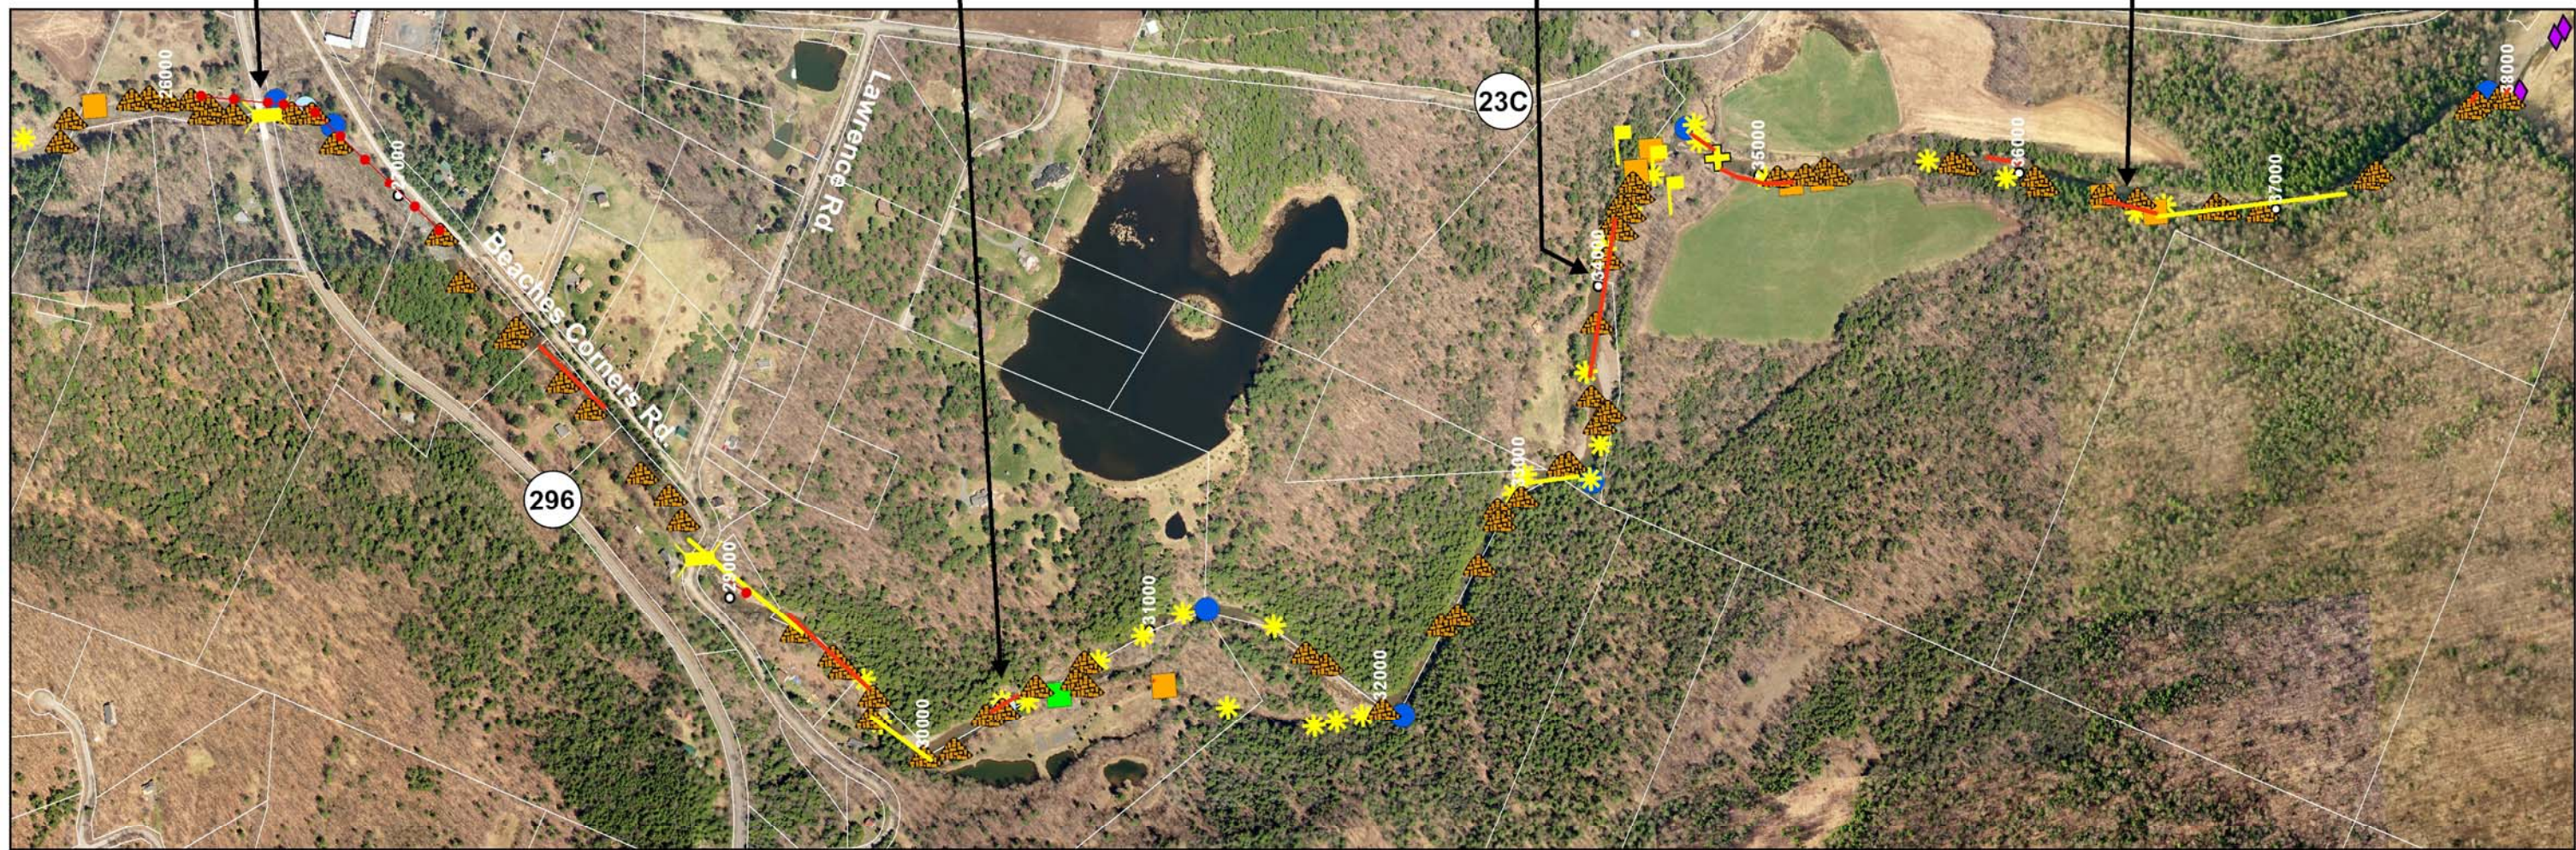
Figure 4.7.1 Management Unit 7 - 2006 aerial photography with stream feature inventory

The 2006 stream feature inventory revealed that 10.1% (2,298 ft) of the stream banks exhibited signs of active erosion along the 22,743 ft of total channel length in the unit (Figure 4.7.1). *Revetment* had been installed on 0.4% (85 ft) of the stream banks. No berms were identified in this management unit at the time of the stream feature inventory.

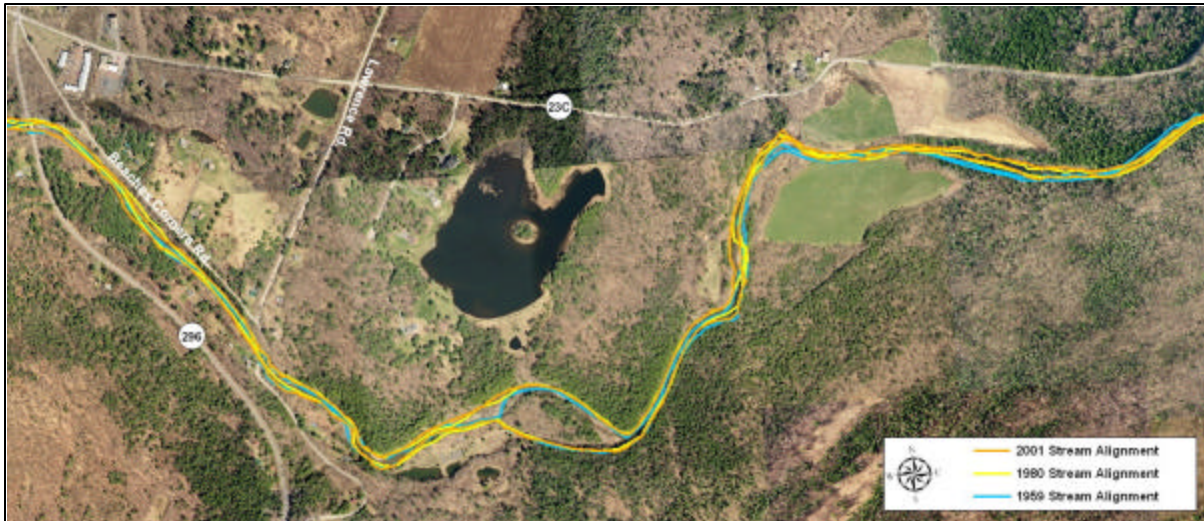
*Historic stream channel alignments overlaid with 2006 aerial photograph*

As seen from the historical stream channel alignments (above), the *planform* of the channel alignment has not changed significantly over the years along this management unit; the channel has remained fairly stable.

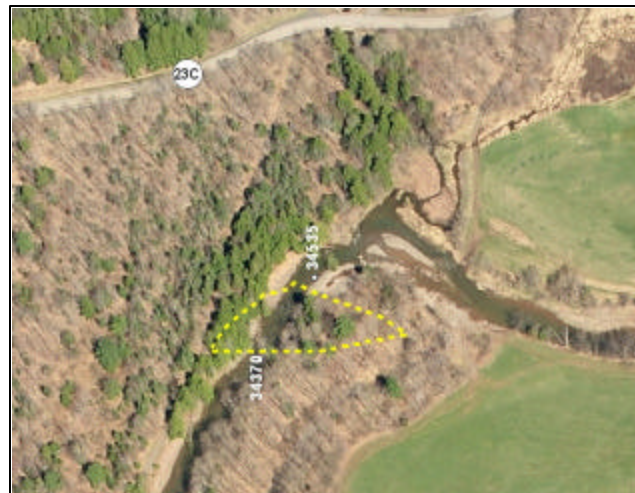
Along the meander bend, there was a 0.5 acre riverine wetland (Stations 34511 - 34348) that was classified as R3USA (see Section 2.6 for detailed wetland type descriptions). Wetlands are important features in the landscape that provide numerous beneficial functions including protecting and improving water quality, providing fish and wildlife habitats, storing floodwaters, and maintaining surface water flow during dry periods. There was abundant woody debris accumulation and aggradational conditions through this stretch of the stream.

*Wetland boundary approximately delineated by NWI (Stations 34511 - 34348)*

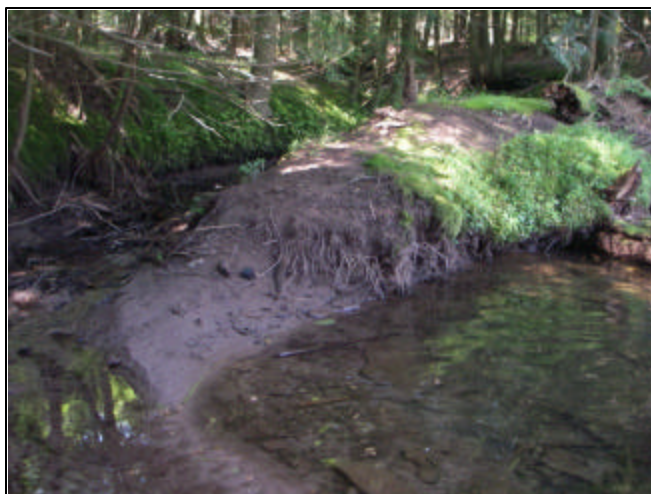
*Tributary at Station 33265*

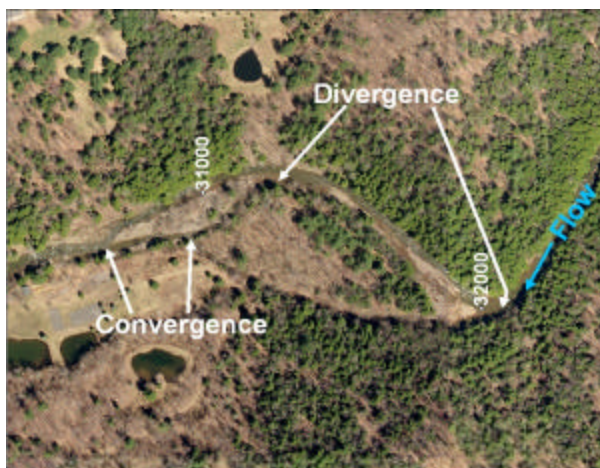
*Split channel between Stations 32020 – 30665  
Flood chute between Stations 31276 – 30900*

As the stream meandered to the right, there was a small intermittent unnamed tributary (Station 32061) entering along the steep forested bank on the left. Just downstream of the tributary there was a channel divergence (Station 32020) forming a split channel around a well established vegetated center bar. The main channel flowed along the right of the center bar; at the time of the assessment there was a

considerable amount of flow in the left channel. At the start of the center bar, there was newly deposited sediment and herbaceous vegetation, including grasses and sedges, followed by forest throughout much of the center bar with herbaceous areas interspersed and at the downstream end of the bar where the two channels converge (Station 30665). There was abundant woody debris accumulated along the center bar. Along the downstream portion of the center bar, there was a second channel divergence (Station 31276) on the right, forming a *flood chute* that had carved a channel through the forested center bar and converged (Station

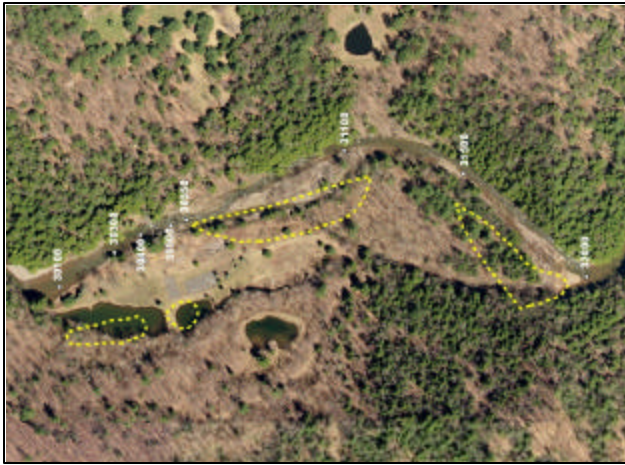
*Wetland boundaries approximately delineated by NWI (between Stations 31962 - 30100)*

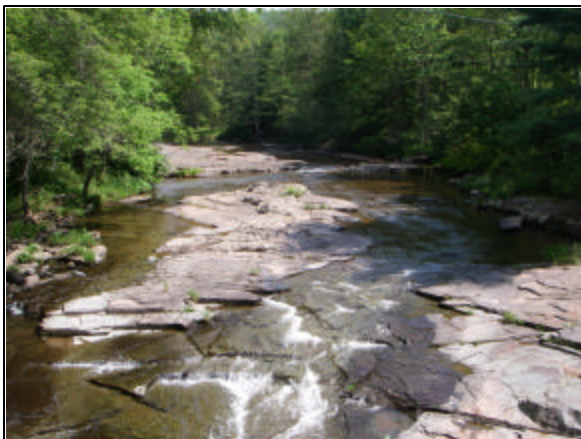
*Bedrock at Stations 29312 – 28756  
photo orientation – looking upstream*

Continuing downstream, there was bedrock (Stations 29312 – 28756) across the full channel for approximately 556 feet. The bedrock provided grade control for the stream by preventing degradation or downcutting of

the channel bed. Along the bedrock channel there was a stacked rock wall (Stations 29042 – 28957) reinforcing approximately 85 feet of the right stream bank. The rock wall was in poor functional condition and had begun to fail structurally. The stream bank was forested and there was herbaceous and shrubby vegetation interspersed through the rock wall. The stream bank appeared to be stable despite the conditions of the revetment.

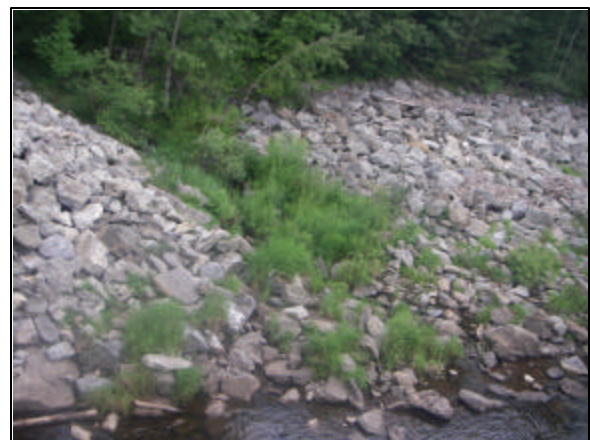
*Tributary at Station 26428*

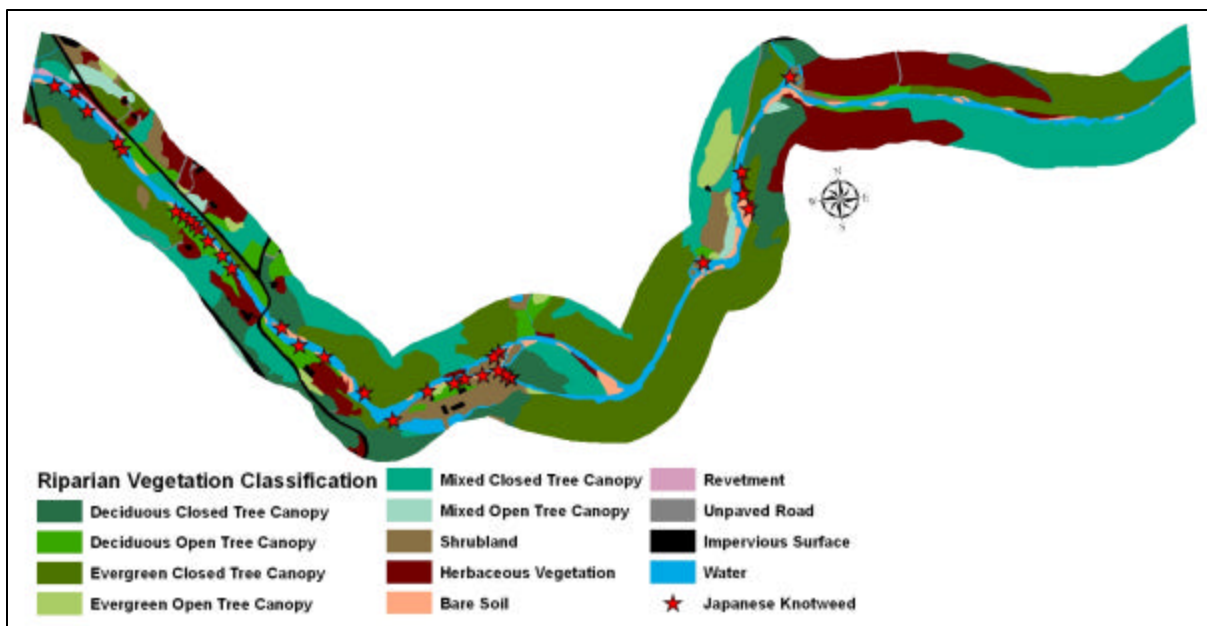
*Riparian vegetation classification map based on aerial photography from 2001*

An analysis of vegetation was conducted using aerial photography from 2001 and field inventories (see above map and Riparian Vegetation Mapping, Appendix B). In this management unit, the predominant vegetation type within the 300 ft. riparian buffer was forested (75%) followed by herbaceous (14%). *Impervious* area (2.5 %) within this unit's buffer was primarily the local and private roadways, and residential structures. Areas of herbaceous (non-woody) cover may present opportunities to improve the riparian buffer with tree plantings in order to promote a more mature vegetative community along the stream bank and in the floodplain.

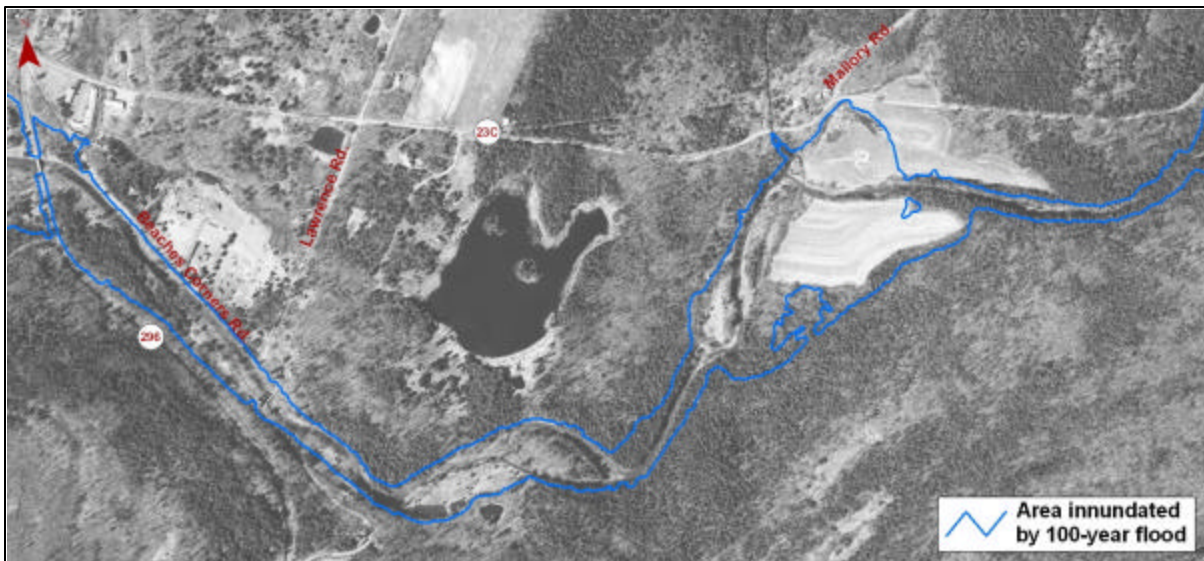
*100-year floodplain boundary map*

According to the current floodplain maps (above), three existing structures in this unit appeared to be situated within the estimated 100-year floodplain. The 100-year floodplain is that area predicted to be inundated by floods of a magnitude that is expected to occur once in any 100-year period, on the basis of a statistical analysis of local flood record. Most communities regulate the type of development that can occur in areas subject to these flood risks.
