East Kill Management Unit 8

Town of Jewett – Route 296 Bridge (Station 26386) to Station 15760

This management unit began at the Route 296 Bridge (#1045150), and continued approximately 10,626 ft. to Station 15760.

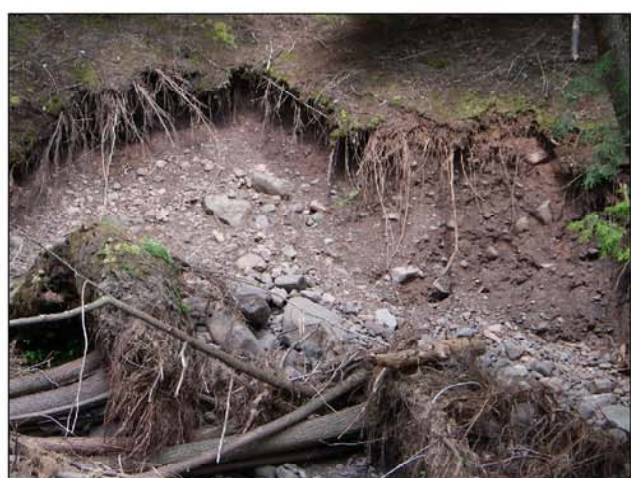
**B**

As the stream meandered to the left, there was a mass failure (Stations 18856 – 18642) along the right stream bank. This mass failure had resulted in an erosion area of approximately 3,215 ft², exposing areas of mixed till and compromising mature trees along the bank. The fallen trees that have accumulated along the toe of the bank appeared to be exacerbating the erosion upstream and downstream of the debris. Along the upstream portion of this eroding bank, there was a lacustrine clay exposure (Stations 18854 – 18789, Figure 4.8.1 Inset B)

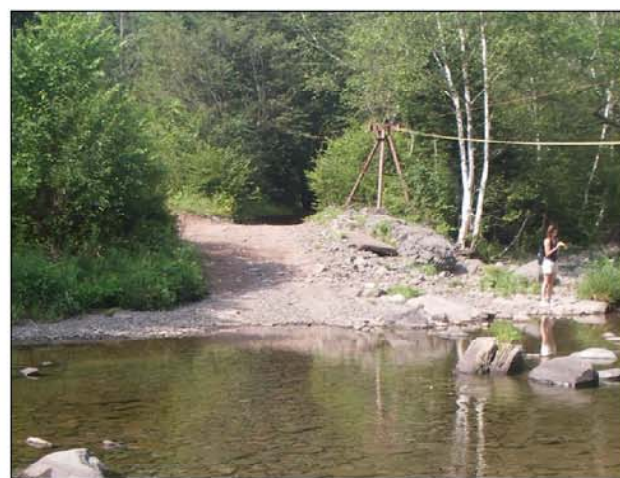
**C**

classifies streams and rivers based on their “best use” (NYSDEC, 1994). The headwaters of this tributary were classified C by the NYS DEC, indicating that the best uses for this stream were the support of fisheries and other non-contact activities. There was also a channel crossing (Station 20959, Figure 4.8.1 Inset C) with a dirt road on both sides of the stream, and a zip line

that crossed above the stream. To reinforce the base of the zip line and the right side of the dirt road, a *gabion basket* had been installed perpendicular to the left bank. Maintenance of the dirt road may contribute to the aggradational conditions downstream where excessive sediment deposition had caused full channel aggradation and the formation of side, point, transverse and center bars along the meander bend.

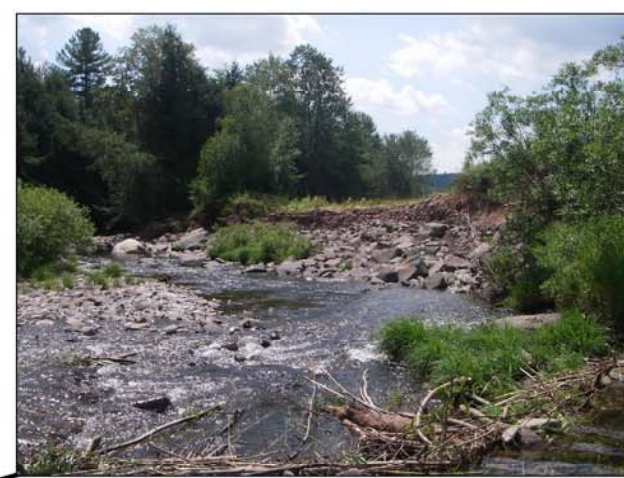
**D**

Along the downstream portion of the proposed riparian planting site, the right stream bank had eroded (Stations 24278 – 24045, Figure 4.8.1 Inset D) along approximately 233 feet of the bank. The top of the bank had herbaceous vegetation and there were two clay exposures (Stations 24235 and 24115) along the toe of the bank and the right channel bed. During the field assessment, this bank was identified as a proposed Bank Erosion Monitoring

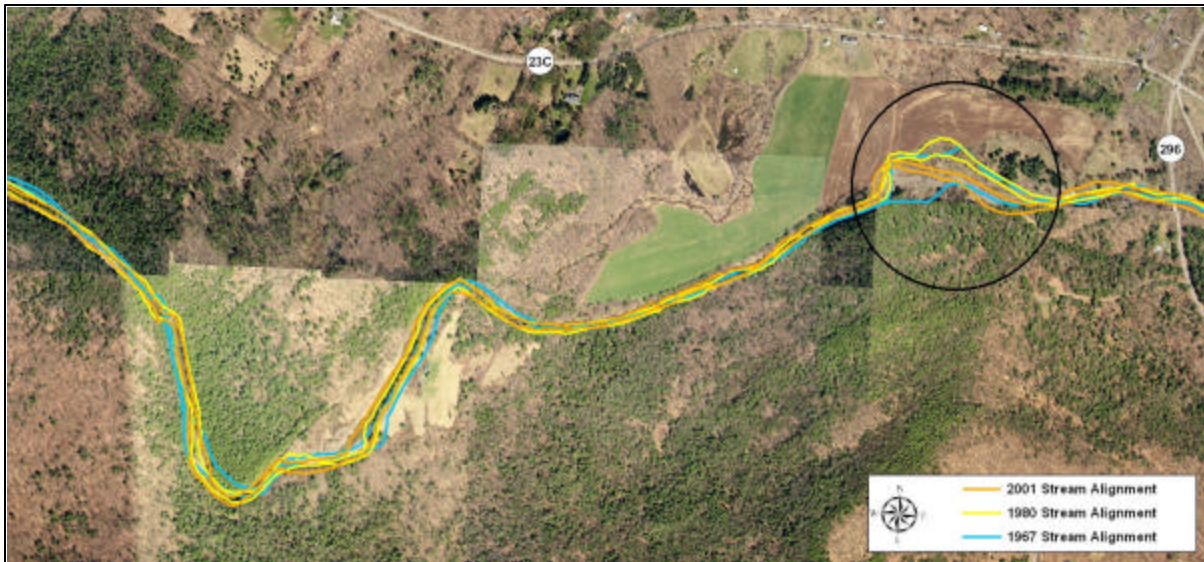
Historic stream channel alignments overlaid with 2006 aerial photograph

As seen from the historical stream channel alignments (above), the *planform* of the channel alignment has not changed significantly over the years along much of this management unit; the channel has remained fairly stable. However, there has been lateral migration of the channel along the upstream portion of this management unit as indicated on the alignment map above (between Stations 25500 and 24000).
