East Kill Management Unit 9

Town of Jewett –Station 15760 to Mill Hollow Road Bridge (Station 11254)

Stream Channel Conditions (2006)

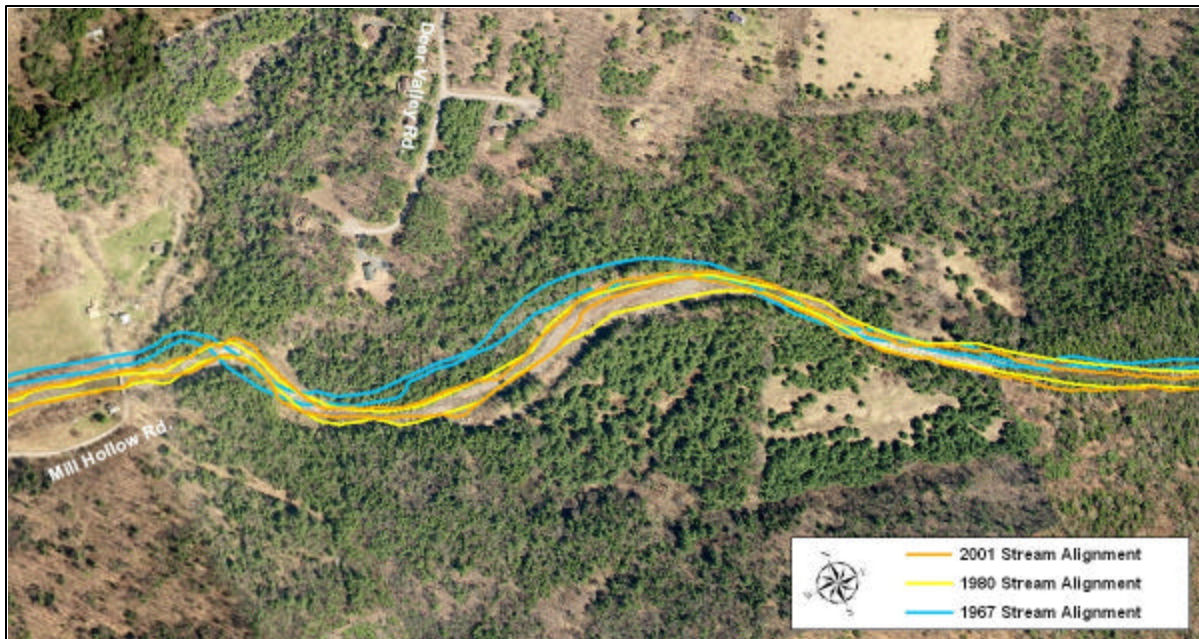
Historic stream channel alignments overlaid with 2006 aerial photograph

As seen from the historical stream channel alignments (above), the *planform* of the channel alignment has not changed significantly over the years along this management unit; the channel has remained fairly stable.

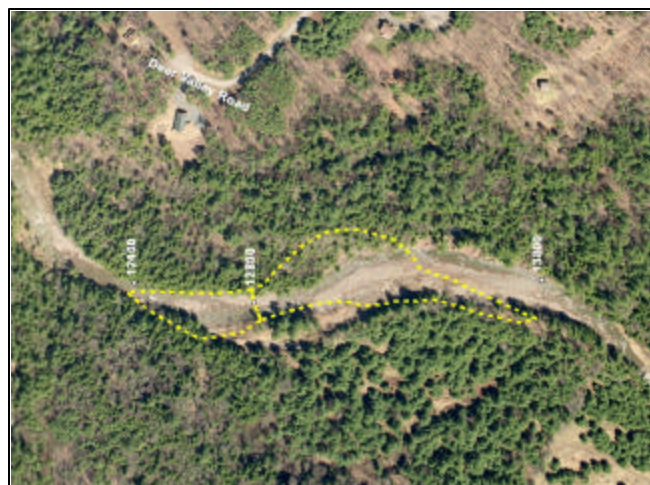
Mass failure at Stations 13961- 13005
100-year floodplain

Wetland boundary approximately delineated by NWI
(Stations 13800 - 12385)

deposition of fine sediment. If this site is to be considered for full restoration, an in-depth survey, a thorough morphological assessment and a project design would be required.

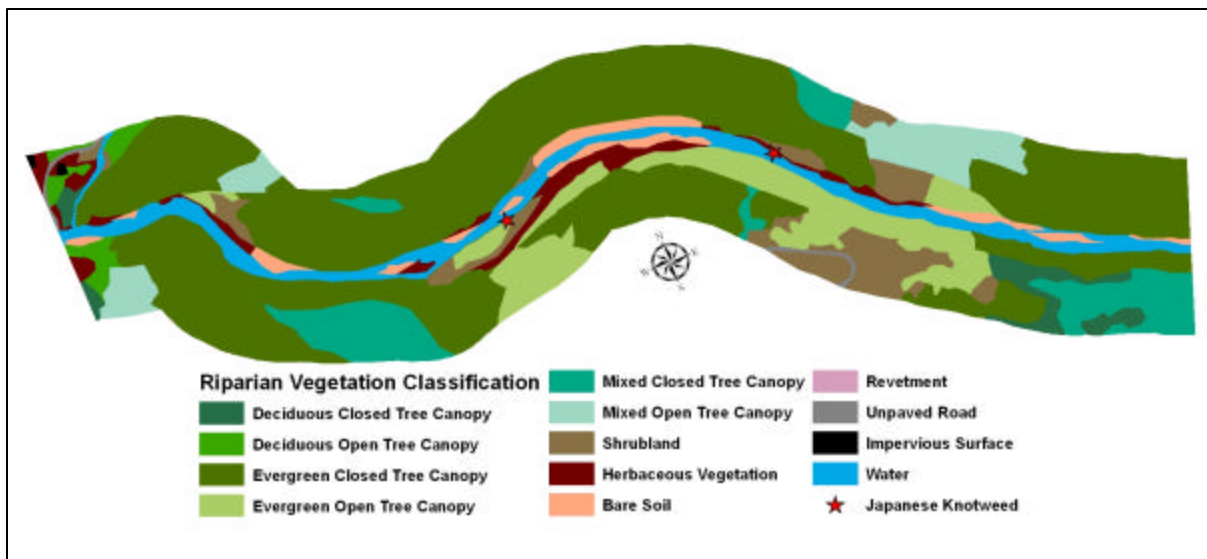
Riparian vegetation classification map based on aerial photography from 2001

An analysis of vegetation was conducted using aerial photography from 2001 and field inventories (see above map and Riparian Vegetation Mapping, Appendix B). In this management unit, the predominant vegetation type within the 300 ft. riparian buffer was forested (86 %) followed by shrubland (7%). *Impervious* area (0.10 %) within this unit’s buffer was primarily the local and private roadways, and residential structures. Areas of herbaceous (non-woody) cover may present opportunities to improve the riparian buffer with tree plantings in order to promote a more mature vegetative community along the stream bank and in the floodplain.

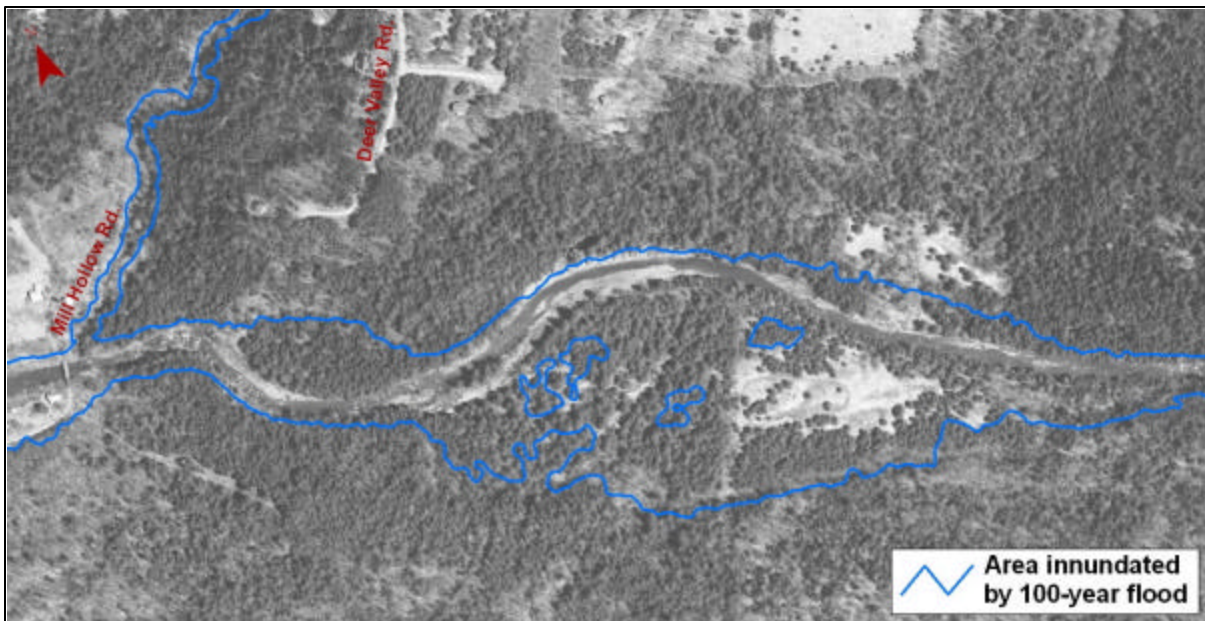
According to the current floodplain maps (below), no existing structures in this unit appeared to be situated within the estimated 100-year floodplain. The 100-year floodplain is that area predicted to be inundated by floods of a magnitude that are expected to occur once in any 100-year period, on the basis of a statistical analysis of local flood record. Most communities regulate the type of development that can occur in areas subject to these flood risks.

100-year floodplain boundary map
