East Kill Management Unit 10

Town of Jewett – Mill Hollow Road Bridge # 3201140 (Station 11254) to Mill Hollow Road Bridge # 3201130 at County Route 17 (Station 6699)

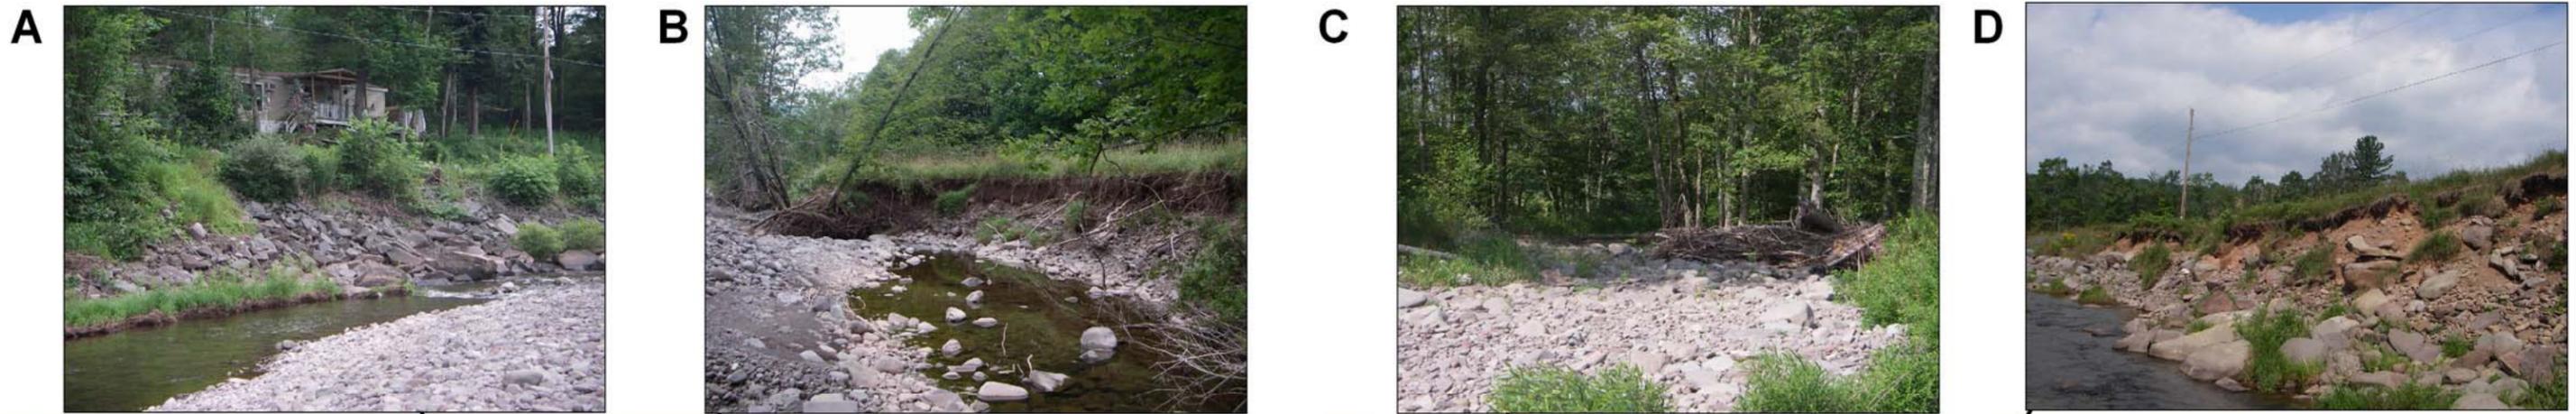
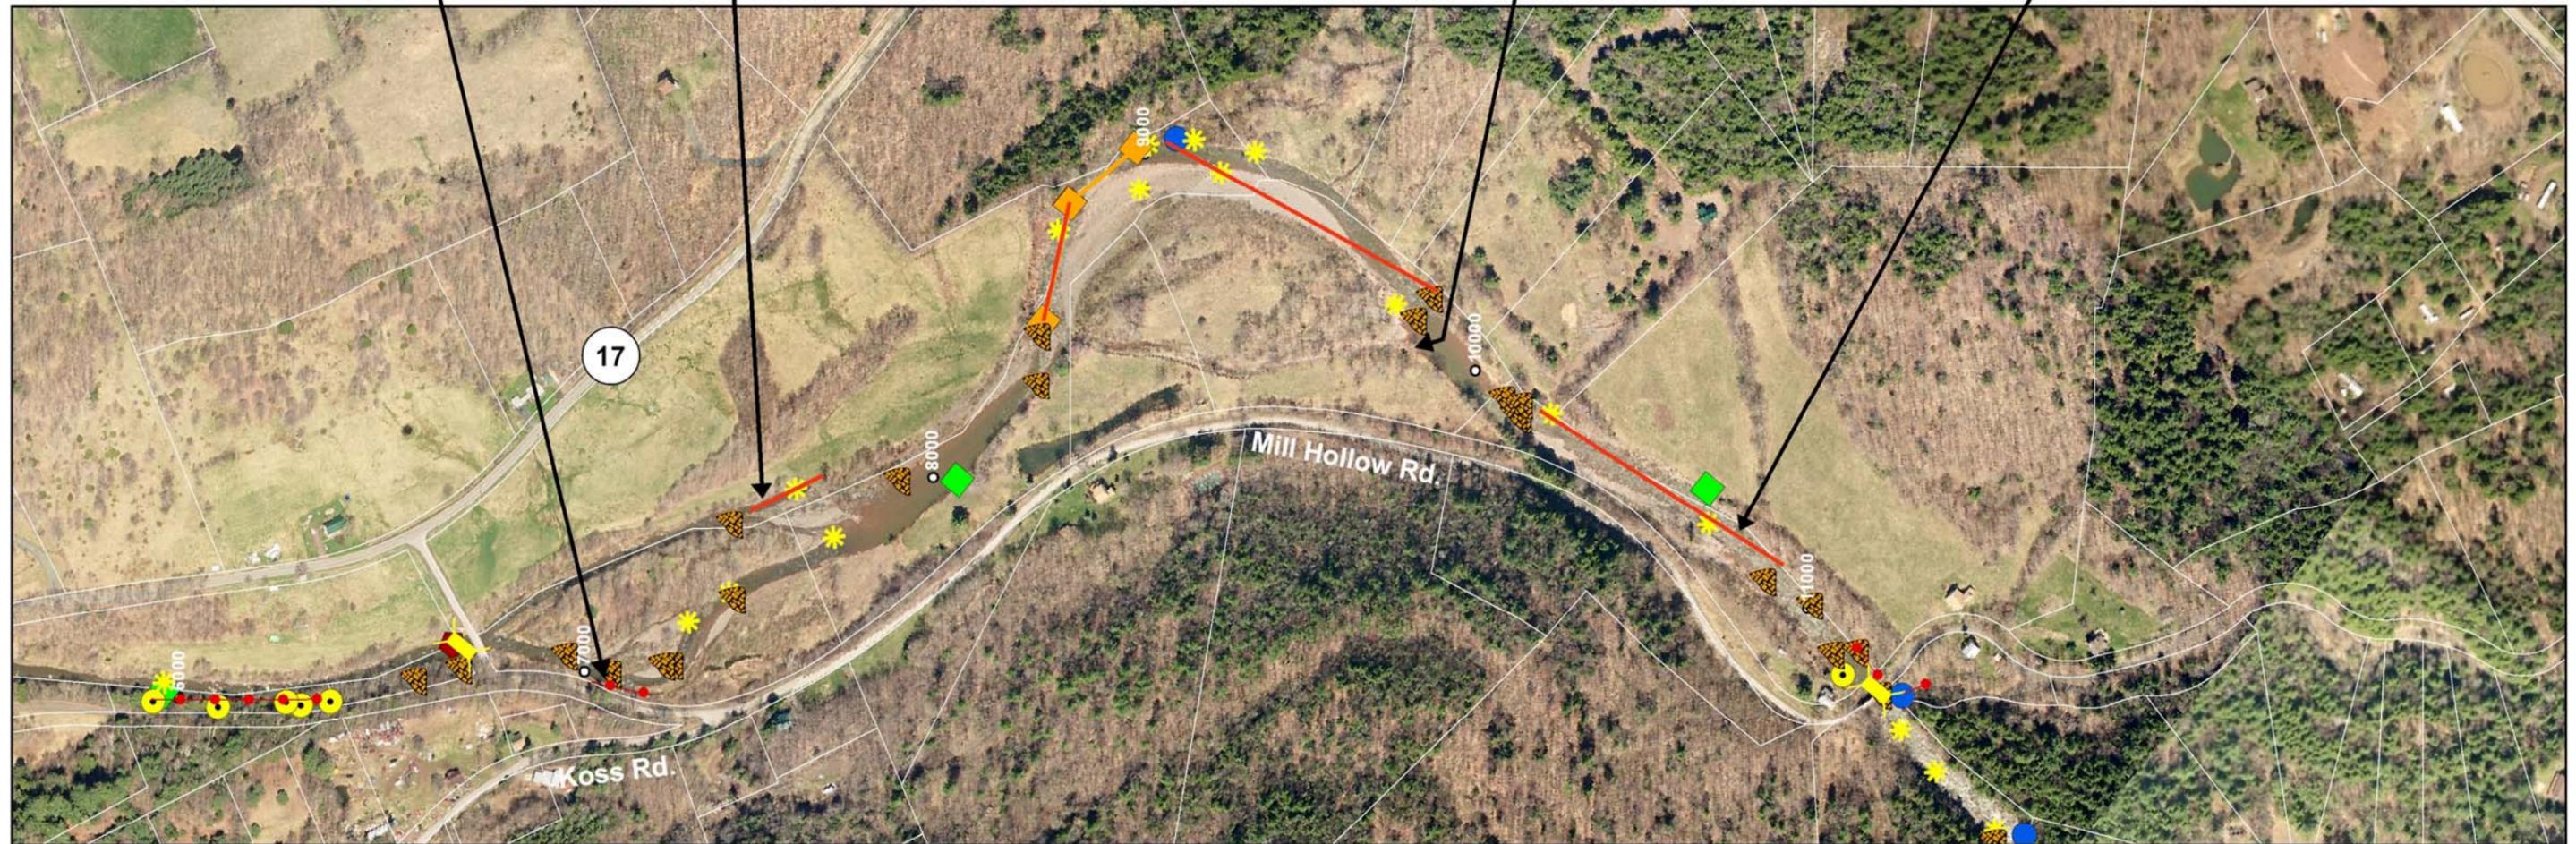
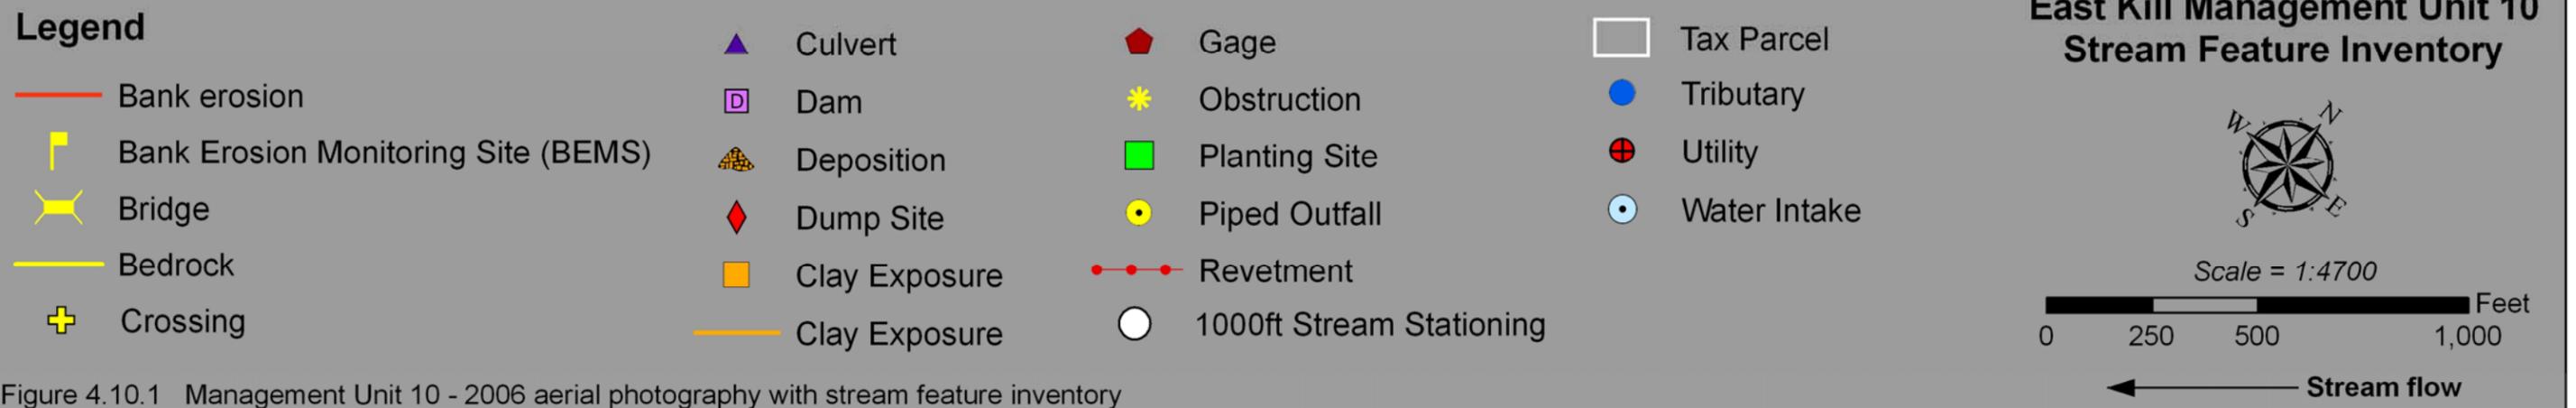
Figure 4.10.1 Management Unit 10 - 2006 aerial photography with stream feature inventory

The 2006 stream feature inventory revealed that 21% (1,909 ft.) of the stream banks exhibited signs of active erosion along the 9,110 ft. of total channel length in the unit (Figure 4.10.1). *Revetment* has been installed on 2.4% (218 ft.) of the stream banks. No berms were identified in this management unit at the time of the stream feature inventory.

Continuing downstream, there was an erosion site (Stations 10888 – 10200, Figure 4.10.1 Inset A) along approximately 688 feet of the right stream bank. Along the upstream and downstream portions of the erosion site, there was a narrow buffer of trees on the top of the bank. Along a significant portion of the erosion site there was an open field of herbaceous vegetation on the top of the bank, and the face of the bank had minimal

Summary of Recommendations Management Unit 10	
Intervention Level	Assisted Self-Recovery
Stream Morphology	No recommendations at this time
Riparian Vegetation	Treat, remove and prevent the spread of Japanese knotweed where feasible. Monitor Japanese knotweed and eradicate new introductions. Increase width of riparian buffer in appropriate locations.
Infrastructure	Interplant revetment
Aquatic Habitat	Watershed Aquatic Habitat Study
Flood Related Threats	No recommendations at this time
Water Quality	No recommendations at this time
Further Assessment	Establish a Bank Erosion Monitoring Site for erosion (Stations 8794 - 8505). Consider hydraulic analysis of private bridge openings.

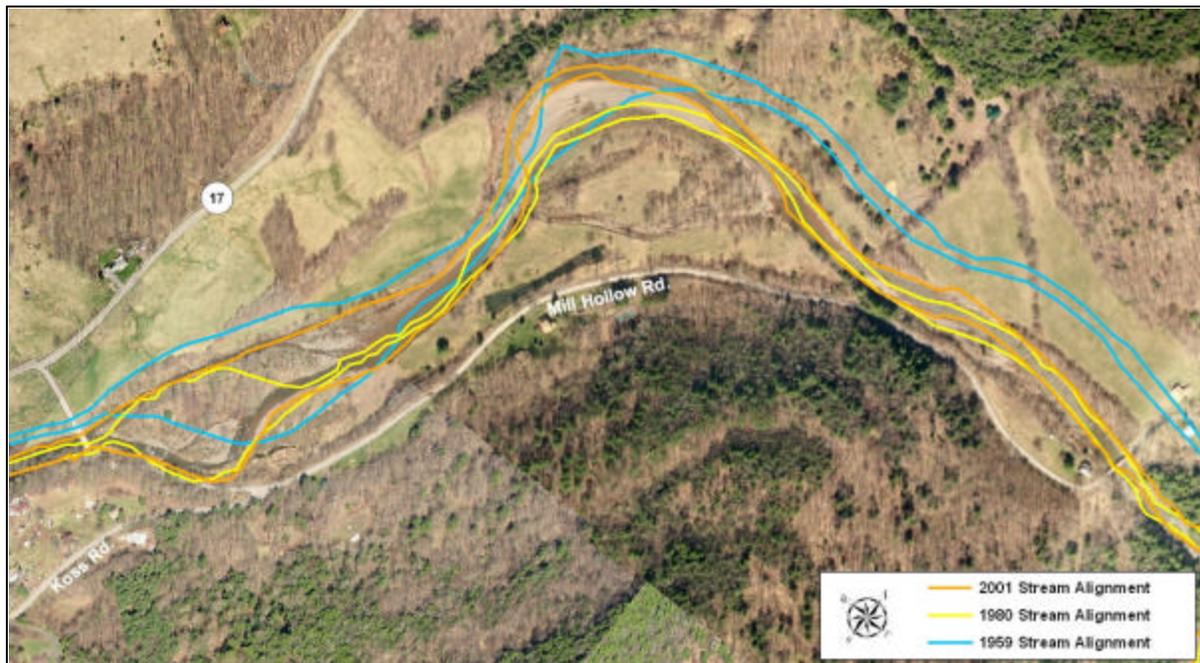
Historic stream channel alignments overlaid with 2006 aerial photograph

To digitally create the stream channel alignments (above), the aerial photos for 1959, 1980 and 2001 were georeferenced, or given a geographic location by matching control points on images with a known coordinate system. Although it appears as though the channel has moved significantly since 1959, this apparent movement can be primarily attributed to the georeferencing process. The stream channel has experienced some lateral migration over the years along this management unit. Lateral migration is the movement of a channel across its floodplain, which results in extensive bank erosion. The outside banks of meander bends tend to move laterally across the valley floor and down the valley. Generally, the *planform* of the channel alignment has not changed significantly over the years along this management unit; the channel has remained fairly stable.

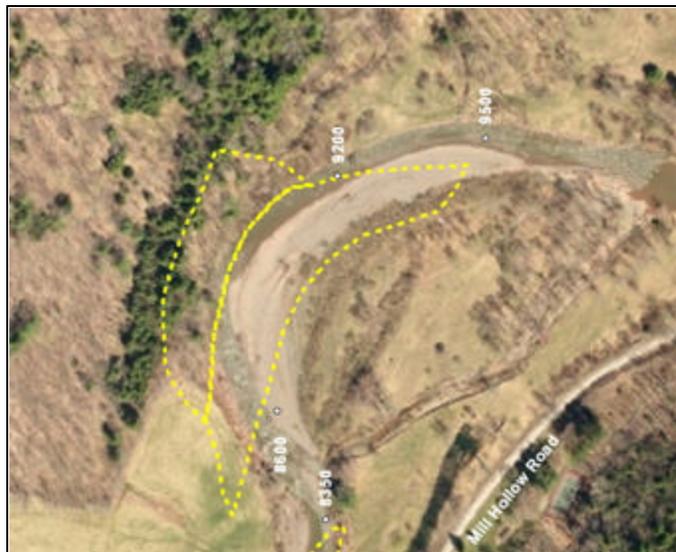
Along this meander bend, there was a wetland complex comprised of a 2.3 acre riverine wetland (Stations 9458 – 8376) and a 1.3 acre palustrine wetland (Stations 9140 – 8750).

Wetland boundary approximately delineated by NWI (Stations 9458 - 8376)

These wetlands were classified as R3USA and PEM1A, respectively (see Section 2.6 for detailed wetland type descriptions). Wetlands are important features in the landscape that provide numerous beneficial functions including protecting and improving water quality, providing fish and wildlife habitats, storing floodwaters, and maintaining surface water flow during dry periods.

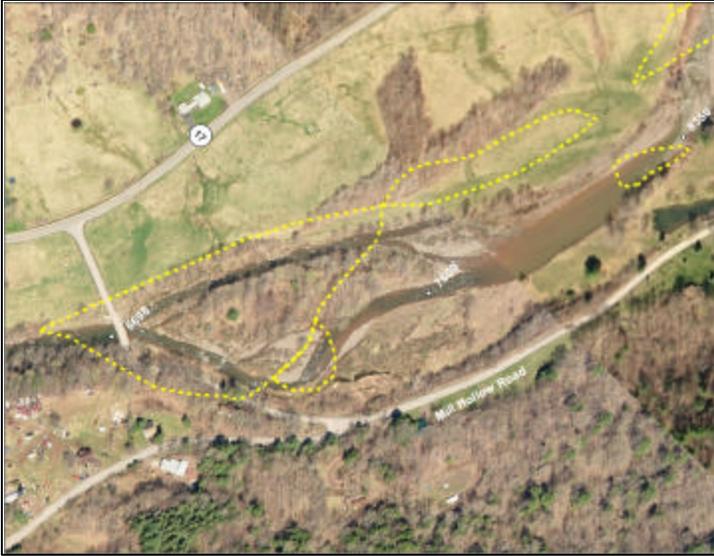
*Wetland boundaries approximately delineated by NWI
(Stations 8342 - 6528)*

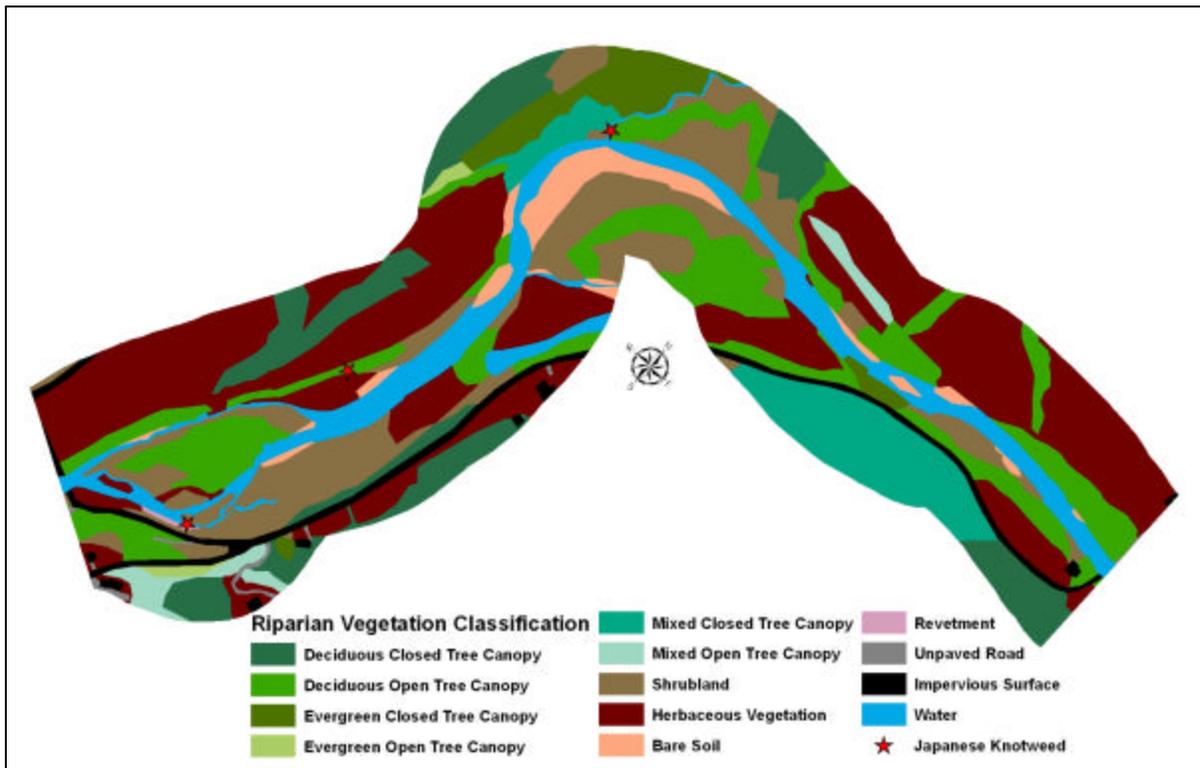
An analysis of vegetation was conducted using aerial photography from 2001 and field inventories (see map below and Riparian Vegetation Mapping, Appendix B). In this management unit, the predominant vegetation type within the 300 ft. riparian buffer was forested (42 %) followed by herbaceous (33%). *Impervious* area (3.6 %) within this unit’s buffer was primarily the local and private roadways, and residential structures. Areas of herbaceous (non-woody) cover may present opportunities to improve the riparian buffer with tree plantings in order to promote a more mature vegetative community along the stream bank and in the floodplain.

Riparian vegetation classification map based on aerial photography from 2001

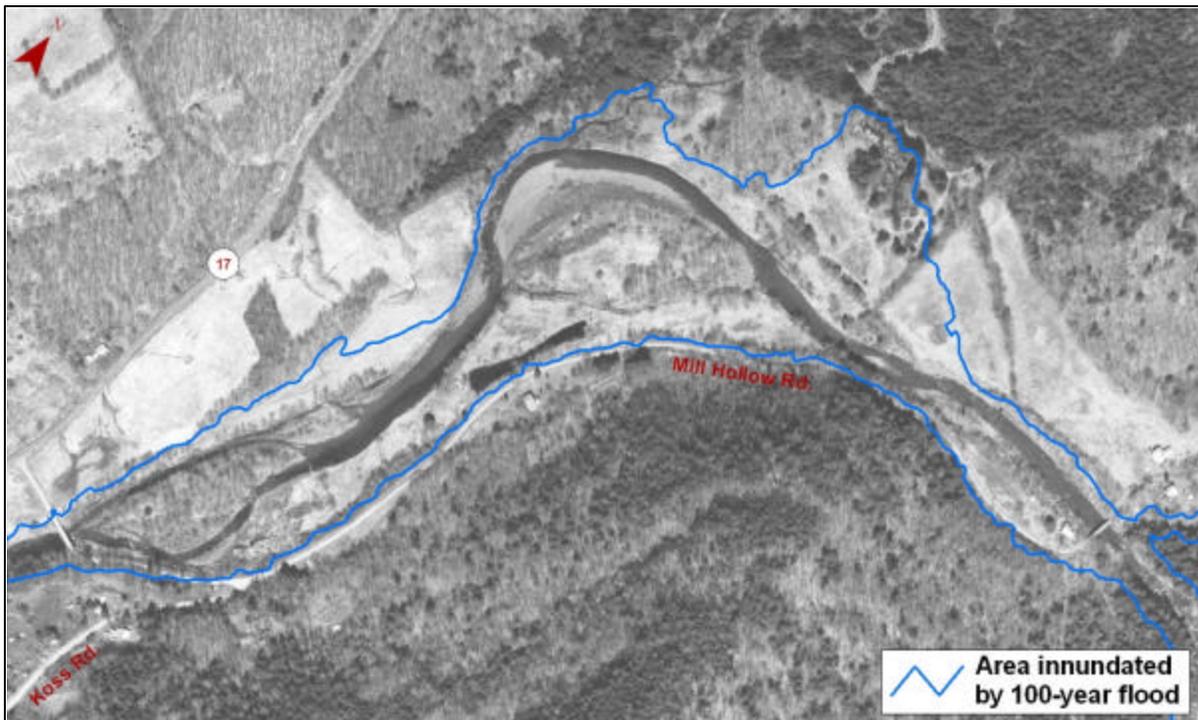
According to the current floodplain maps (below), one existing structure in this unit appeared to be situated within the estimated 100-year floodplain. The 100-year floodplain is that area predicted to be inundated by floods of a magnitude that is expected to occur once in any 100-year period, on the basis of a statistical analysis of local flood record. Most communities regulate the type of development that can occur in areas subject to these flood risks.

100-year floodplain boundary map
