# Manor Kill Management Unit 10

Town of Conesville –Station 1775 to Station 0

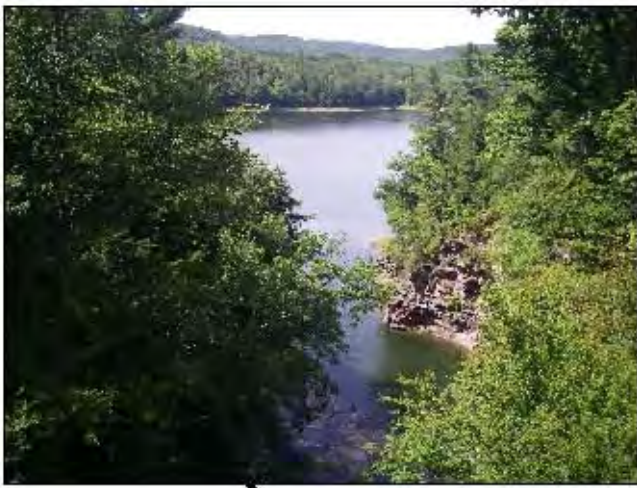
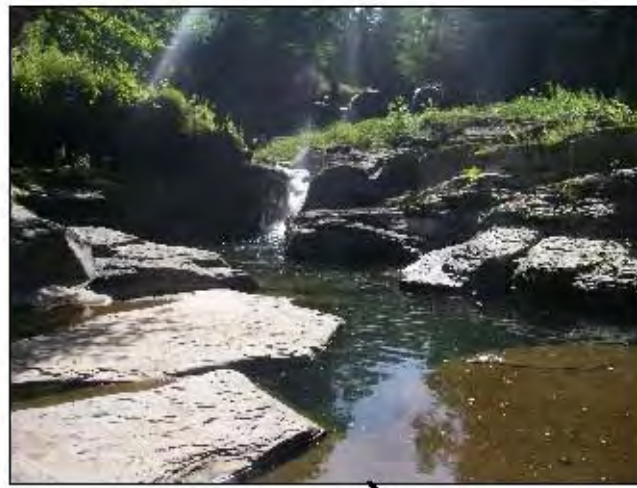
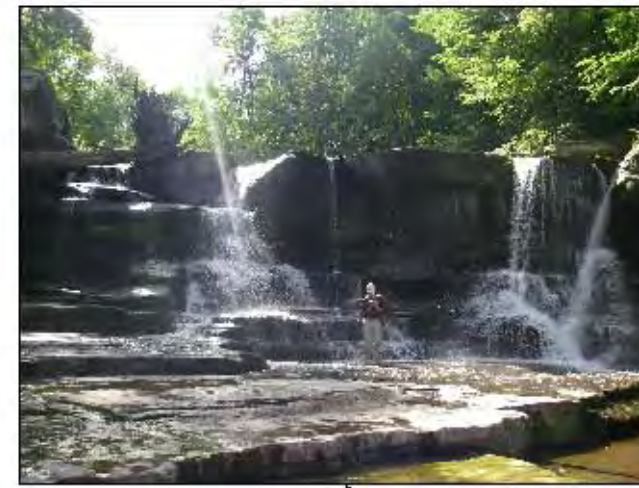
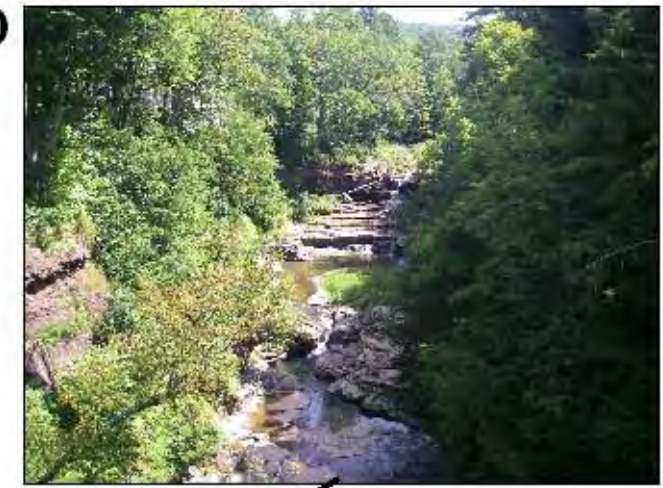
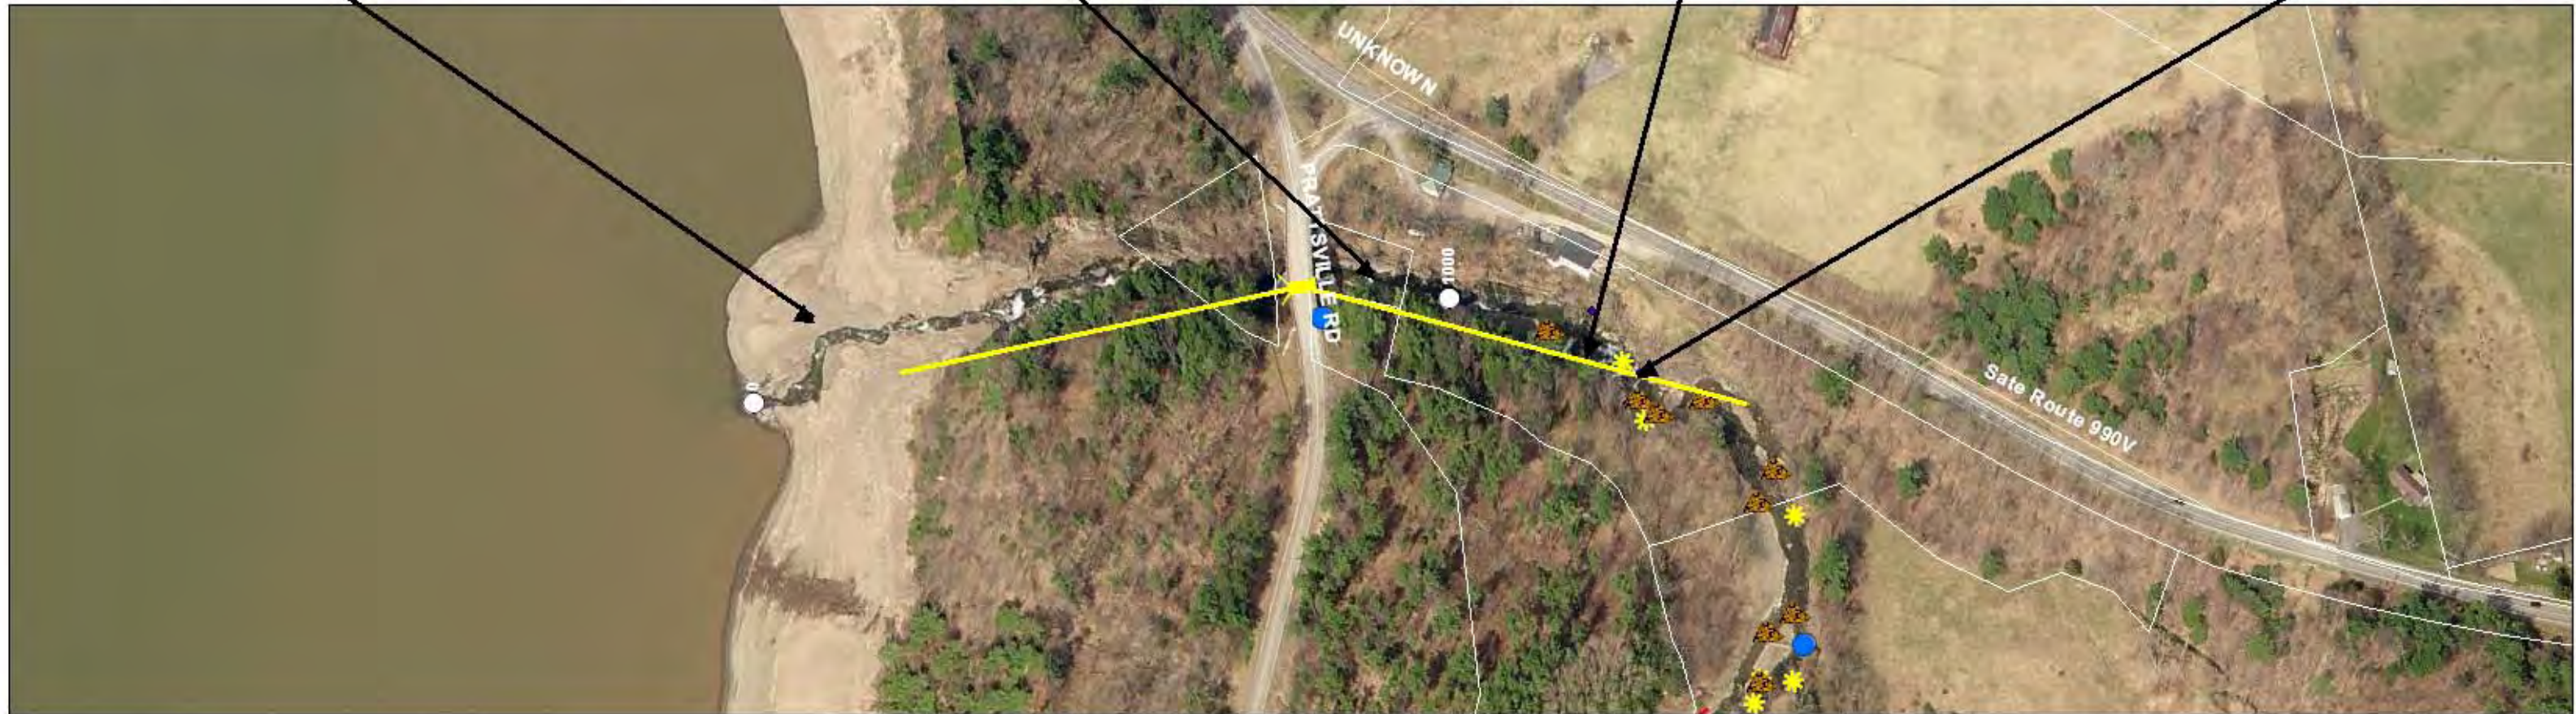
Figure 4.10.1 Management Unit 10 - 2006 aerial photography with 2008 stream feature inventory.

The 2008 stream feature inventory revealed that there were no streambanks with signs of active erosion along the 3,550 ft. of total streambank length in the unit (Fig. 4.10.1). There were also no *Revetments* or berms in Management Unit 10.

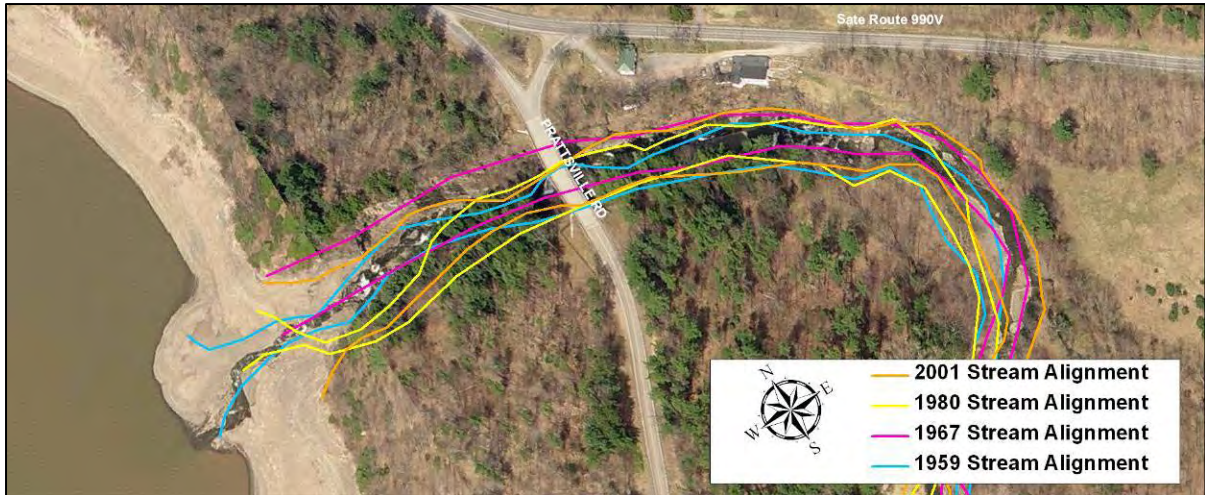
*Historic stream channel alignments overlaid with 2006 aerial photograph*

As seen from the historical stream channel alignments (above), the *planform* of the channel has not changed significantly over the years; the channel has remained fairly stable throughout this management unit.

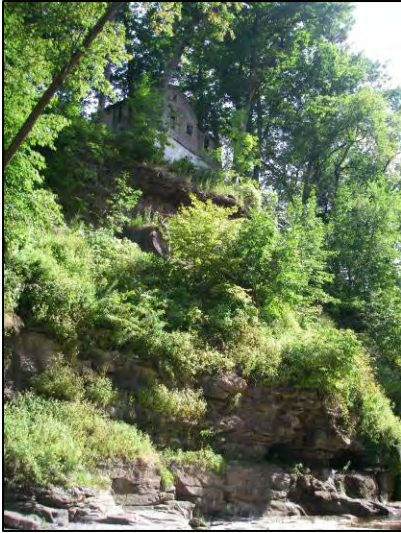
*Waterfall House at Station 1100*

Along the right bank there was old stacked rock along the bedrock which may have been part of a foundation or a staircase the led toward The Waterfall House at the top of the bank. The Waterfall House, which is currently a bar and restaruant, has been a landmark in West Conesville for over 50 years.

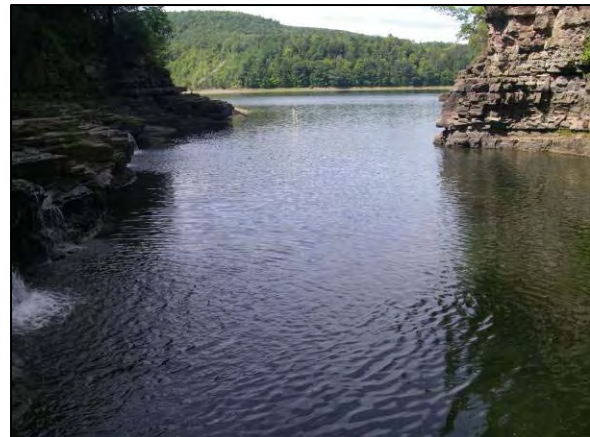
*Manor Kill Confluence with the Schoharie Reservoir*

showed no signs of scour and the bridge appeared to pass stream flows effectively. Under the bridge, a seep entered the stream over vegetated bedrock along the left bank. Management Unit 10 ended as the stream exited the pool downstream of the fourth tier and flowed into the Schoharie Reservoir. (Figure 4.10.1, Inset A, Station 0). The Schoharie Reservoir contributes approximately 15% of NYC water annually (Joint Venture, 2004).

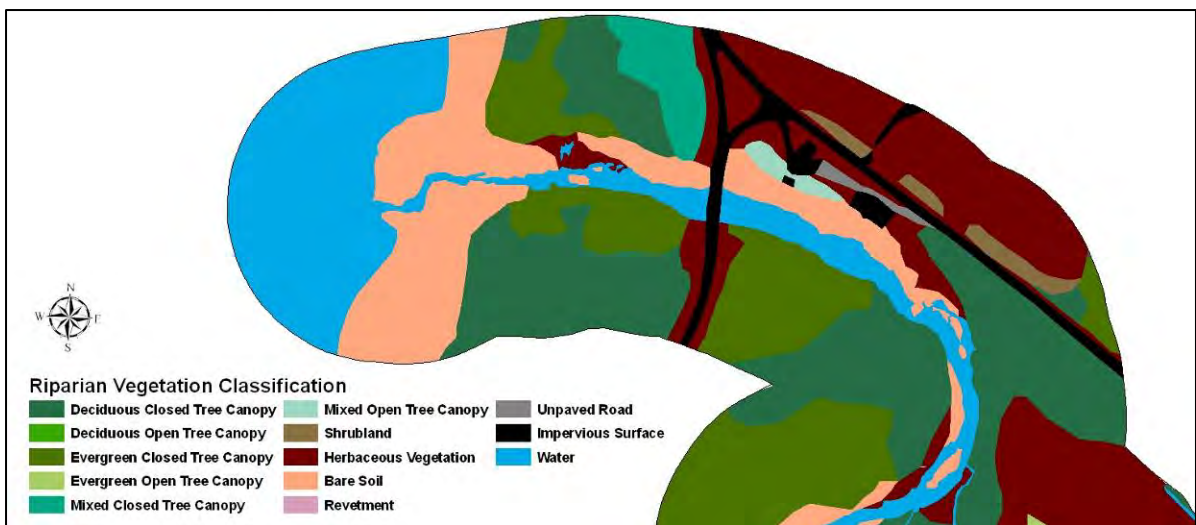
*Riparian vegetation classification map based on aerial photography from 2006*

An analysis of vegetation was conducted using aerial photography from 2006 and field inventories (see above map and Riparian Vegetation Mapping, Section 2.7). In this management unit, the predominant vegetation type within the 300 ft. riparian buffer was forested (45.66%) followed by herbaceous (17.12%). *Impervious* area (4.48 %) within this unit's buffer was primarily the local and private roadways. Areas of herbaceous (non-woody) cover may present opportunities to improve the riparian buffer with tree plantings in order to promote a more mature vegetative community along the streambank and in the floodplain.

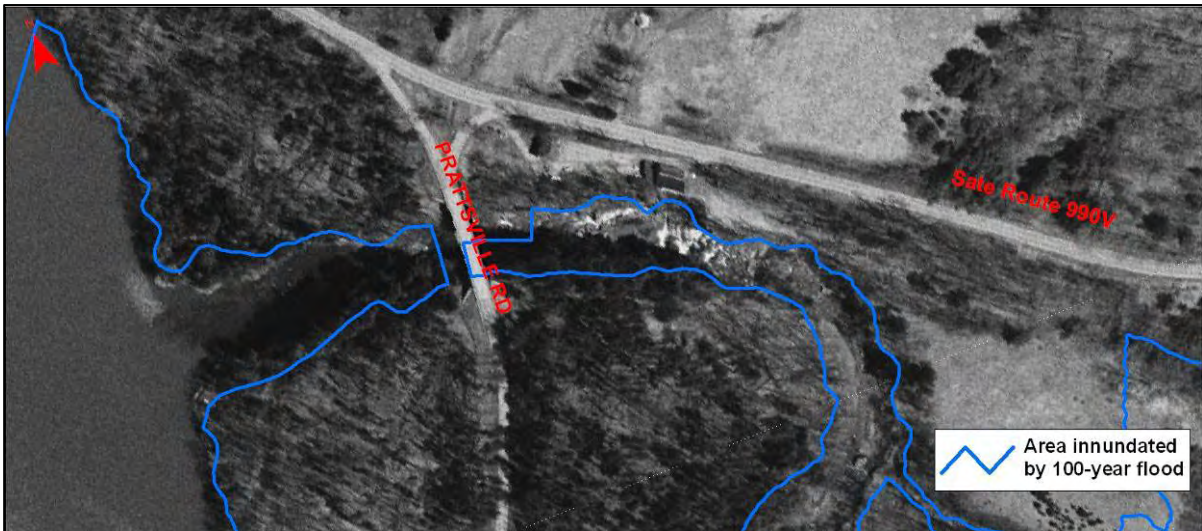
*100-year floodplain boundary map*

According to the current floodplain maps (below), no existing structures in this unit appeared to be situated within the estimated 100-year floodplain. The 100-year floodplain is that area predicted to be inundated by floods of a magnitude that is expected to occur once in any 100-year period, on the basis of a statistical analysis of local flood record. Most communities regulate the type of development that can occur in areas subject to these flood risks.
