Manor Kill Management Unit 2

Town of Conesville – Manor Creek Rd. (Station 45598) to Beaver Hill Rd. (Station 38909)

Figure 4.2.1 Management Unit 2 - 2006 aerial photography with 2008 stream feature inventory.

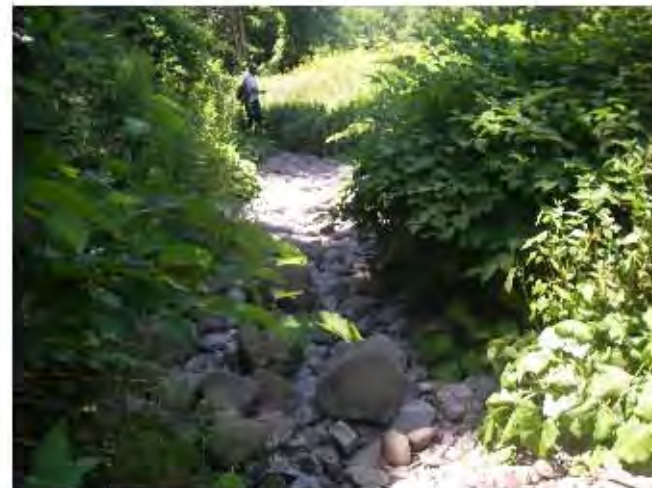
B

Downstream of the mass failure, there was a channel *divergence* (Station 40207) where a secondary channel (Figure 4.2.1, Inset B) split off from the main channel; it converges (Station 39662) with the main channel approximately 545 feet downstream. There was Japanese knotweed along both banks of the secondary channel. Along the left streambank of the secondary channel, there was erosion (near Station 39900) that had

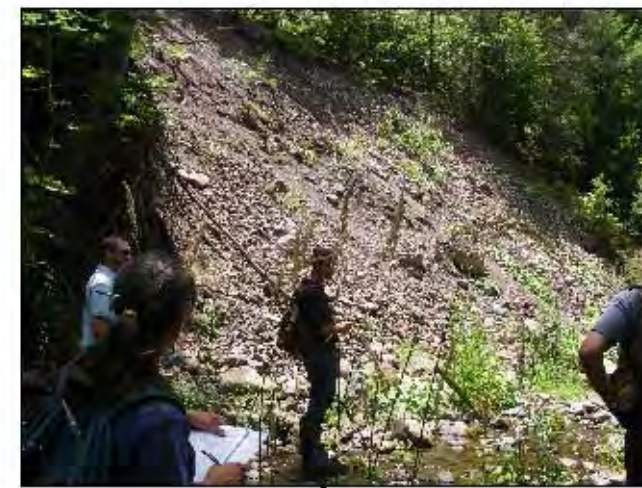
C

As the stream *meandered* to the right, there was a *mass failure* along the left streambank (Figure 4.1.1, Inset C, Stations 43193 - 42999). Streambank erosion often occurs on the outside of meander bends where the stream velocity is greatest during high flows.

Along this section of stream, the *thalweg* flows up against the toe of the bank undermining the steep slope, resulting in an erosion area of approximately 6,786 ft², exposing mixed till and compromising mature trees along the bank. Along the downstream portion of the mass failure, a young tree had fallen across the stream channel causing a minor obstruction (Station 43016) at low

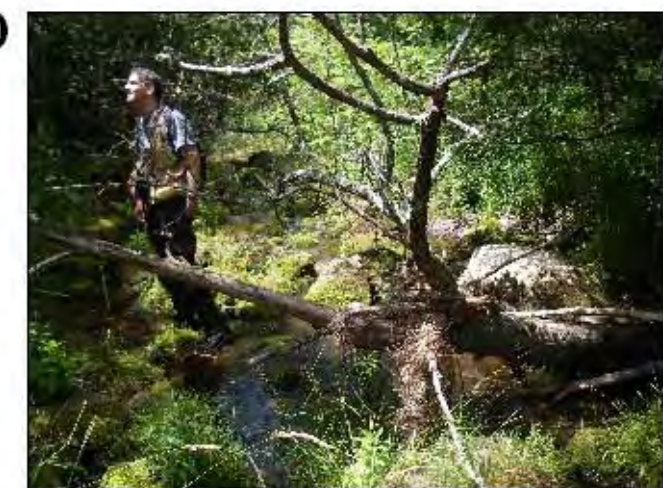
D

Continuing downstream, a tree had fallen (Figure 4.2.1, Inset D, Station 44383) from the right streambank across a portion of the stream channel. Some woody debris has accumulated along the fallen tree. At low flow, the tree and associated debris caused a minor obstruction to flow, but it may pose a more significant obstruction at higher flows. It appeared to be contributing to upstream scour along the right bank. However, woody debris is beneficial to a stream system, it provides critical habitat for fish and insects, and adds essential organic matter that will benefit organisms downstream.

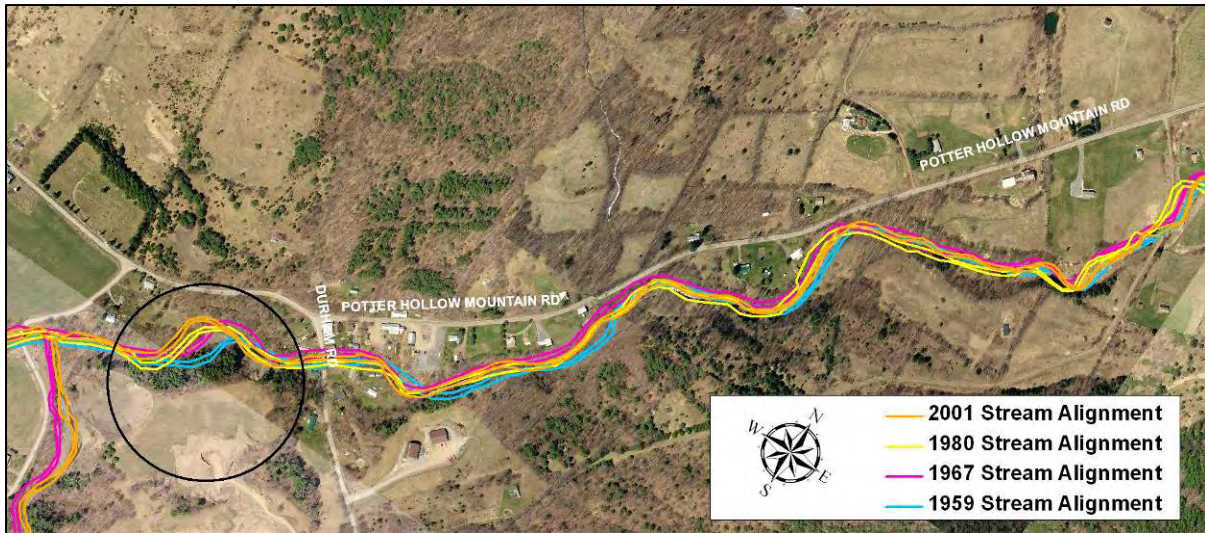
Historic stream channel alignments overlaid with 2006 aerial photograph

As seen from the historical stream channel alignments (above), the *planform* of the channel has not changed significantly from 1959 to 2001 along this management unit; the channel has remained fairly stable. However, there has been lateral migration (between Stations 40400 and 39500) and the formation of a secondary channel (between 2001 and 2006) along the downstream portion of this management unit as indicated on the alignment map above. Along this stretch of stream there is an active gravel mine that didn't appear to become active until sometime between 1967 and 1980. The activity associated with this gravel mine has contributed to streambank instability along this stretch of stream.

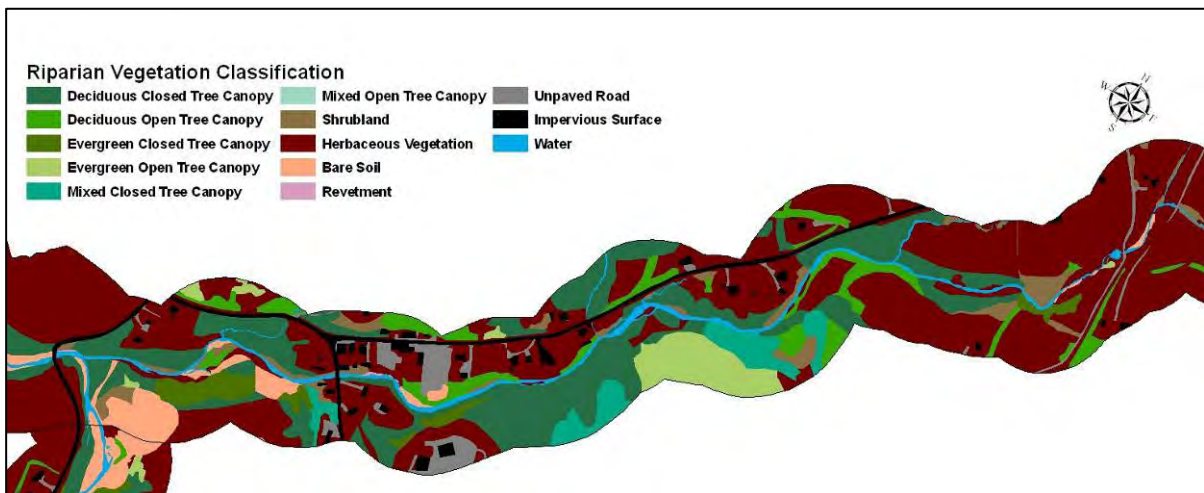
Riparian vegetation classification map based on aerial photography from 2006

field inventories (see above map and Riparian Vegetation Mapping, Section 2.7). In this management unit, the predominant vegetation type within the 300 ft. riparian buffer was herbaceous (44.57%) followed by forested (40.06). *Impervious* area (4.64 %) within this unit's buffer was primarily the local and private roadways. Areas of herbaceous (non-woody) cover may present opportunities to improve the riparian buffer with tree plantings in order to promote a more mature vegetative community along the streambank and in the floodplain.

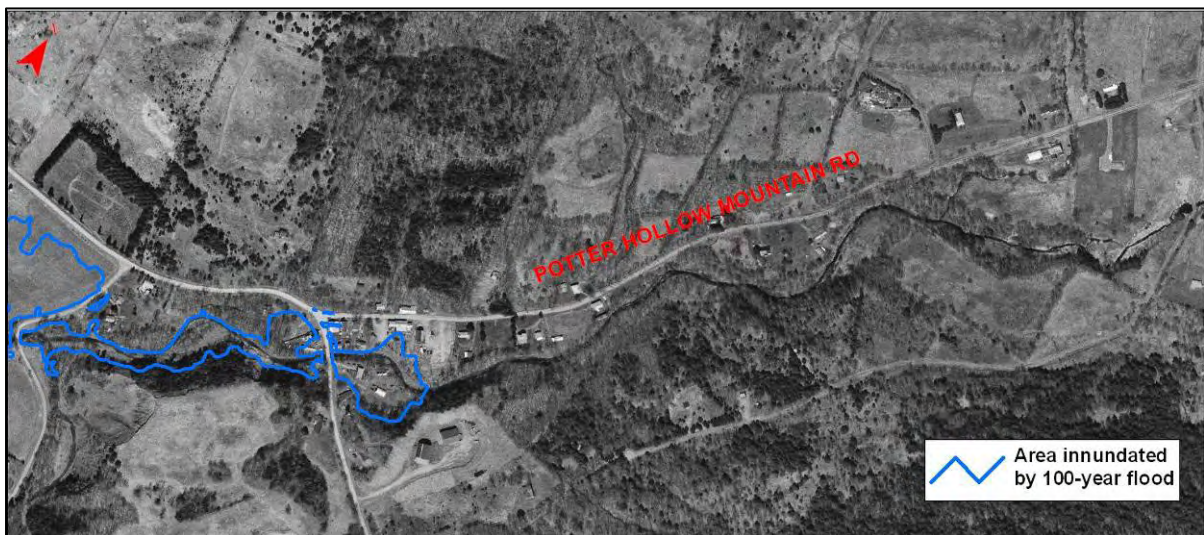
100-year floodplain boundary map

According to the current floodplain maps (above), eight existing structures in this unit appeared to be situated within the estimated 100-year floodplain. For this management unit, floodplain map coverage did not include the upstream portion of the Manor Kill. It is recommended that hydraulic analysis be completed to create floodway and floodplain maps from the end point of existing maps upstream to the headwaters wetland complex where the
