Manor Kill Management Unit 3

Town of Conesville – Beaver Hill Rd. (Station 38909) to Station 26995

This management unit begins at Beaver Hill Road, continuing approximately 11,914 ft to Station 26995 in the Town of Conesville.

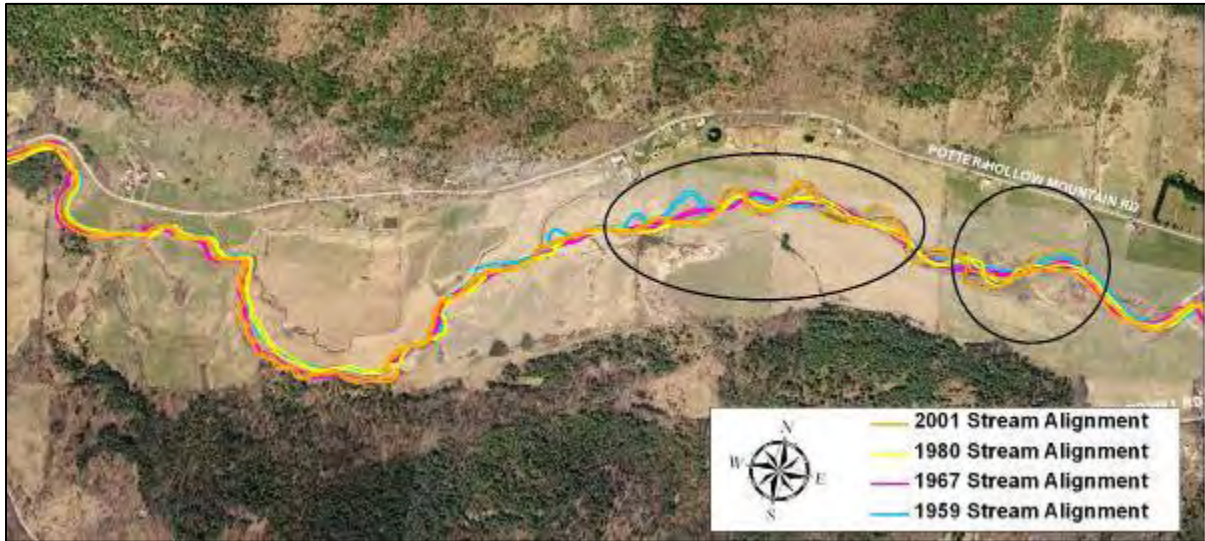
Historic stream channel alignments overlaid with 2006 aerial photograph

As seen from the historical stream channel alignments (above), the *planform* of the channel has changed significantly over the years along the upstream portion of this management unit; the channel has remained fairly stable through the downstream portion. The stream has experienced lateral migration in several locations over the years. Lateral migration is the movement of a channel across its floodplain, which usually results in extensive bank erosion. The outside banks of meander bends tend to move laterally across the valley floor and down the valley. Historically, the stream channel alignment appears to have been manipulated between 1959 and 1967, resulting in a straightened alignment (pink 1967); since then the stream has increased its sinuosity through lateral migration.

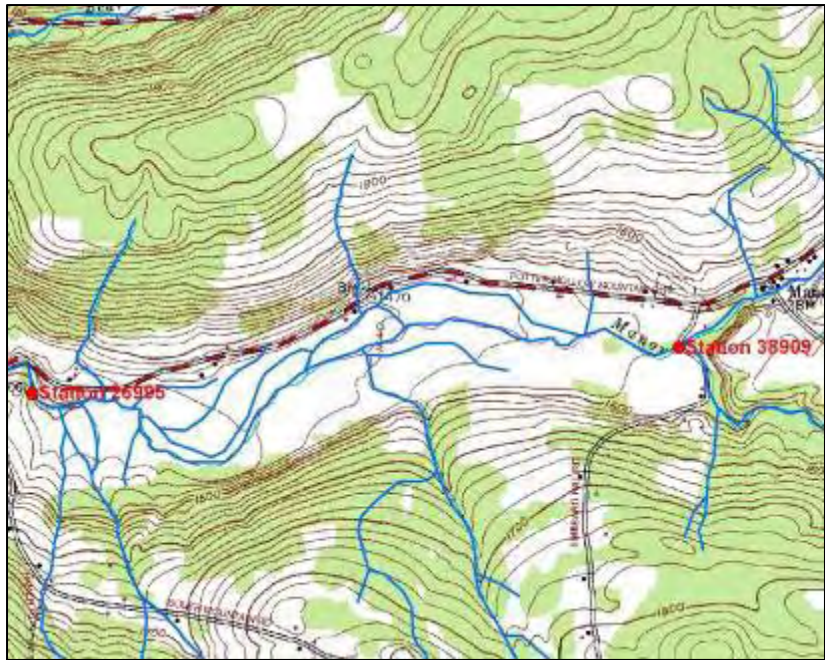
1980 USGS topographic map – Livingstonville Quadrangle
contour interval 20ft

Management unit #3 began at Beaver Hill Road. The drainage area ranged from 11.25 mi² at the top of the management unit to 16.26 mi² at the bottom of the unit. The valley slope was 0.78%.

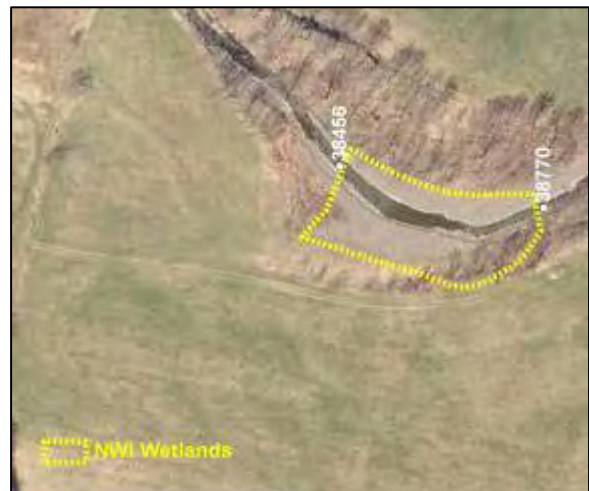
As the stream meandered to the right, there was a 0.8 acre riverine wetland (Stations 38770 – 38456). Wetlands are important features in the landscape that provide numerous beneficial functions including protecting and improving water quality, providing fish and wildlife habitats, storing floodwaters, and maintaining surface water flow during dry periods. This wetland is classified as R2USA, *riverine, lower perennial, unconsolidated shore, temporarily flooded* (see Section 2.6 for detailed wetland type descriptions).

Wetland boundary approximately delineated by NWI
(Stations 38770 - 38456)

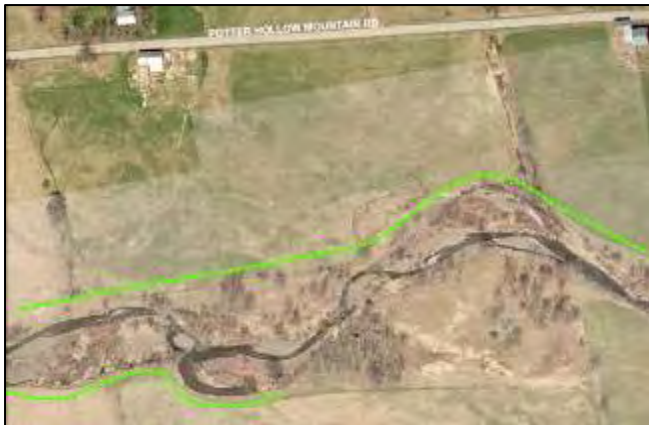
Riparian Planting Site at Stations 38170 - 36468

As the stream meandered to the left, and continuing downstream for approximately 1,702 feet, there was a proposed riparian planting site (Stations 38170 – 36468) along the right streambank. This is the first of many proposed planting sites within management unit three. A vigorous buffer with mature trees is important at this site because it may also filter

for approximately 1,277 feet. Vegetative and stream stability conditions are similar along this site. Recommendations for both sites include establishing a buffer where none exists, and augmentation of the existing buffered areas by planting native trees and shrubs along the streambank and the upland area. Buffer width should be increased by the greatest amount agreeable to the landowners. Increasing the buffer width to at least 100 feet

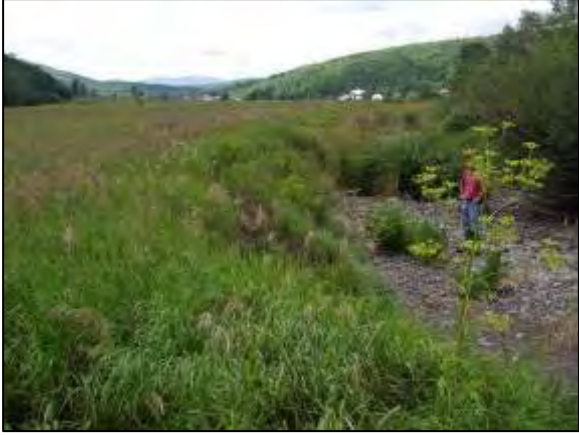
nutrients and pollutants, if any, from the adjacent agricultural fields. Along portions of this site, herbaceous vegetation is maintained to the edge of the stream, while there are also short sections with a thin wooded buffer. Opposite the downstream portion of this planting site, there is a second proposed planting site (Stations 37087 – 35810) along the left streambank

Riparian Planting Site at Stations 38170 - 36468

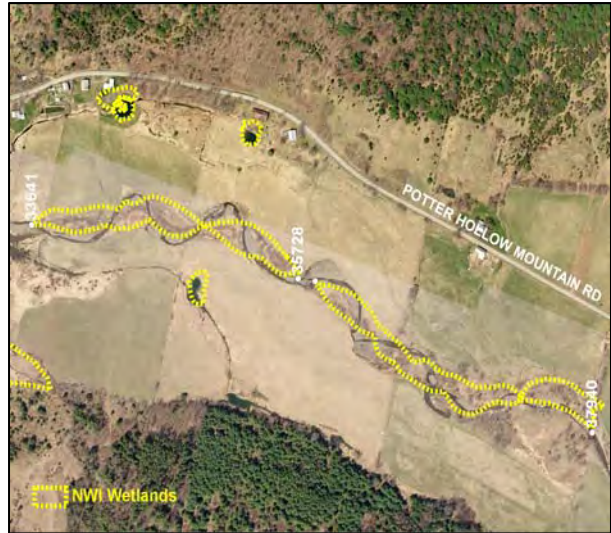
(Stations 37940 - 35800)

be given careful consideration when identifying the appropriate species and locations for plantings. A more detailed site assessment may be necessary to determine whether stream bank grading will be required. Along both planting sites, there was a 1.2 acre palustrine wetland (Stations 37940 – 37460) followed by a 3.3 acre riverine wetland (37460 – 35800). These wetlands were classified as PEM1A, *palustrine, emergent, persistent, temporarily flooded*, and R2USA, *riverine, lower perennial, unconsolidated shore, temporarily flooded*, respectively. Along these wetlands excess sediment deposition caused multiple point bars and full channel aggradation. Point bars commonly form on the inside of meander bends, where stream velocity is slower during high flows, allowing sediment to drop out of the water column and settle along the stream bed.

Wetland boundary approximately delineated by NW1

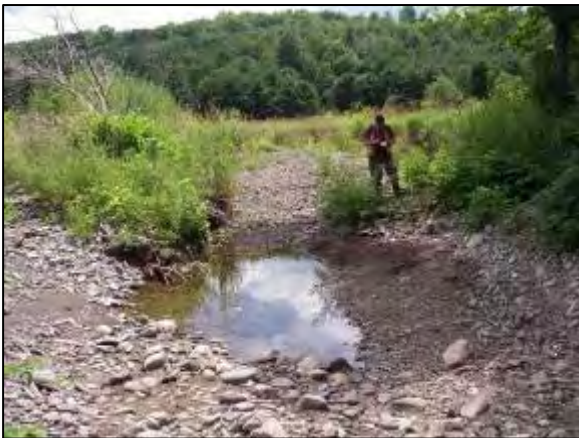
Convergence at Station 36855

divergence (Station 37112) along the left that converged (Station 36855) with the main channel approximately 257 feet downstream. Along this channel, there were approximately 359 feet of hydraulic erosion (Figure 4.3.1a Inset D, Stations 37120 – 36869), exposing 1,976 square feet of the left streambank. This eroding bank was along the second proposed riparian planting site that was previously discussed. Japanese knotweed persisted

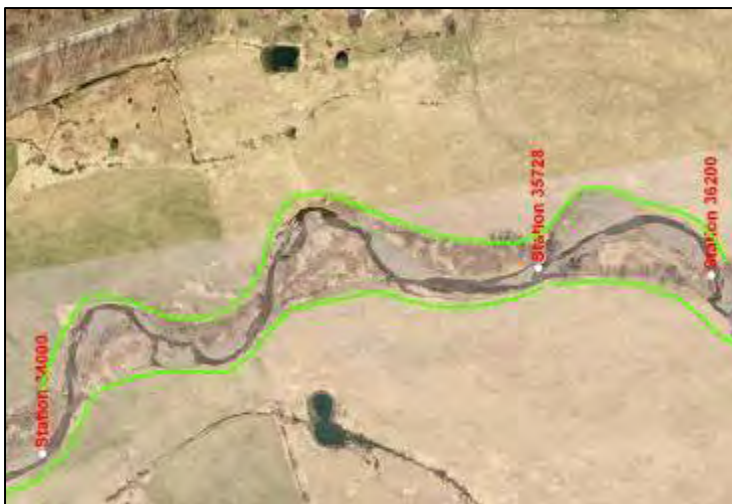
Riparian Planting Sites between Stations 36200 & 34000

As the stream meandered to the left, there was a third proposed riparian planting site (Stations 36190 – 34170) along

mentioned planting sites, recommendations for these sites include establishing a buffer where none exists and augmentation of the existing buffered areas by planting native trees and shrubs along the streambank and the upland area. Buffer width should be increased to 100 feet or by the greatest amount agreeable to the landowners. Portions of both proposed planting sites are experiencing erosion in multiple locations along the streambank. Therefore, prior to proceeding with any vegetative plantings, these conditions should be given careful consideration, and additional assessment may be necessary.

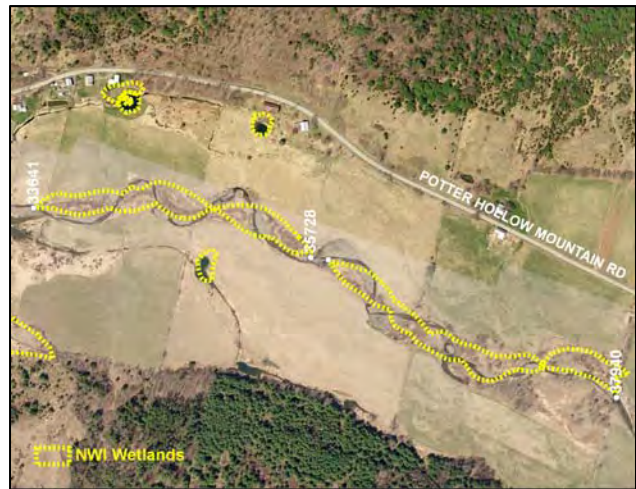
Wetland boundary approximately delineated by NWI (Stations 35728 – 33641)

33641). This wetland was classified as R2USA, *riverine, lower perennial, unconsolidated shore, temporarily flooded*. Set back from the stream's edge, there was a small, 0.3 acre, palustrine wetland classified as PUBHh, *palustrine, unconsolidated bottom, permanently flooded, diked/impounded*.

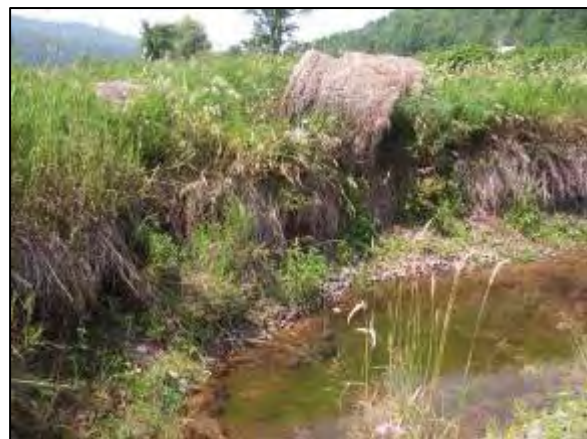
Erosion at Stations 34658 - 34547

converges (Station 34547) with the main channel approximately 111 feet downstream. There was erosion (Station 34658 – 34547) along approximately 139 feet of the left streambank of the secondary channel.

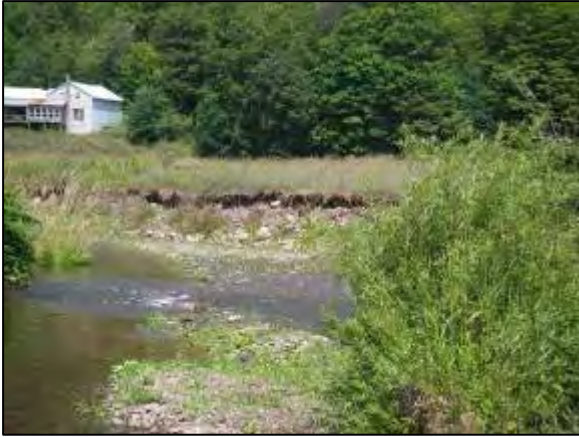
Erosion at Stations 34597 - 34159

34170) on the right streambank. Along this erosion site, there is a small clay exposure in the right stream bed. Excess sediment deposition persisted through this stretch of stream, including full channel aggradation, point and transverse bars.

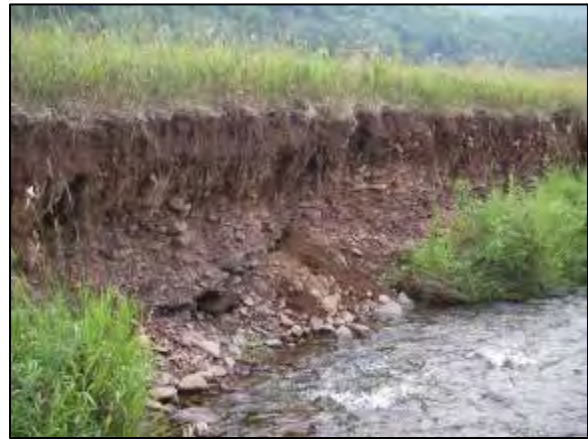
Just downstream of the eroding bank there was a stream crossing (Station 34166) to provide access to agricultural fields on both sides of the stream. Along the downstream end of the fourth proposed riparian planting site (Stations 35743 – 34149) there was erosion (Stations 34100 - 33881) for approximately 219 feet on the left streambank. Portions of the streambank were overhanging and slumping into the stream channel. At the downstream end of the erosion, lacustrine clay (Figure 4.3.1a, Inset A, Station 33915) was exposed for approximately 10 feet of the left bed and streambank. Aggradational conditions, which included a transverse bar (Stations 34043 – 33996), appeared to contribute to the instability at this site by directing flow towards the toe of the left streambank. The source of the aggregation condition should be determined prior to any work in this reach.

Erosion at Stations 34100 - 33881

Japanese knotweed persisted through this stretch of stream.

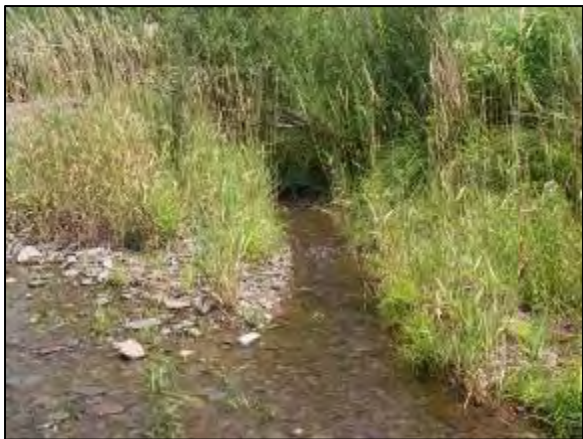
Tributary at Station 33464

Continuing downstream an unnamed *tributary* entered from the left streambank (Station 33464, photo orientation looking upstream). The New York State Department of Environmental Conservation (NYSDEC) classifies streams and rivers based on their “best use” (NYSDEC, 1994). This tributary was classified C by the NYS DEC, indicating that the best uses for this stream are supporting fisheries and other recreational activities. There was a relatively deep pond-

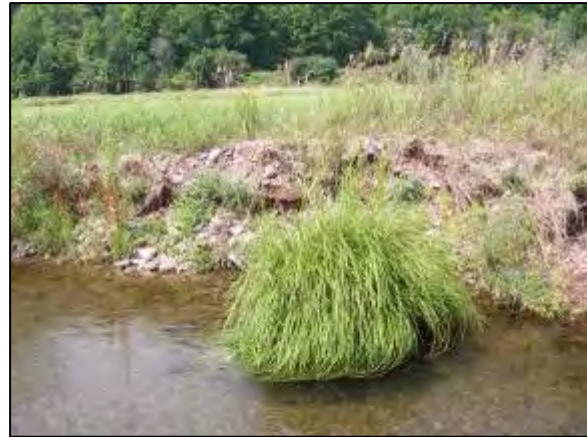
multiple beaver slides along this eroding bank. Just downstream, on the opposite streambank, there was an erosion site (Stations 33109 – 33010) along the right with lacustrine clay (Station 33059) exposed in the channel bed and streambank. At the downstream end of this erosion site, there was a *headcut* (Station 32995), or a marked change in stream bed slope, where the channel appears to have been modified by dredging activity.

Erosion at Stations 33109 -33010

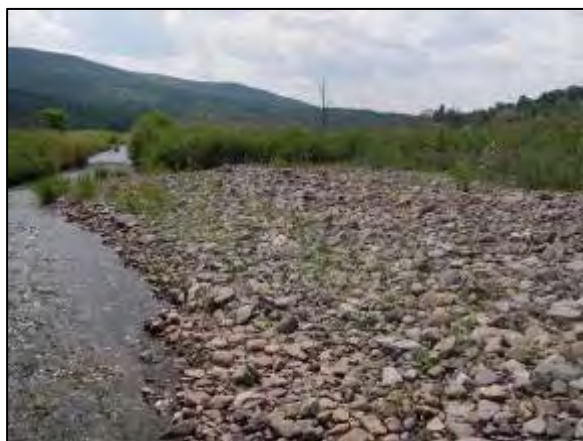
Continuing downstream, there were multiple areas with excess sediment deposition. The depositional features appeared to be caused by, or added to through channel modifications. Through this stretch of stream, it was evident that material was dredged from the stream bed and deposited along the toe of both streambanks, contributing to the formation of a point bar (Stations 33058 – 32925) along the left bank and a side bar (Stations 32967 – 32877) along the right bank. It appeared as though this material was being used to create a berm to provide streambank protection. However, due to the size of the material, it is likely

Side Bar at Stations 32967 - 32877

that much of it will be mobilized during future high flows. This type of channel modification is not recommended. The NYS DEC Protection of Waters Program requires a permit for stream bed or bank disturbance including excavating gravel material and placing fill along streambanks to provide stabilization.

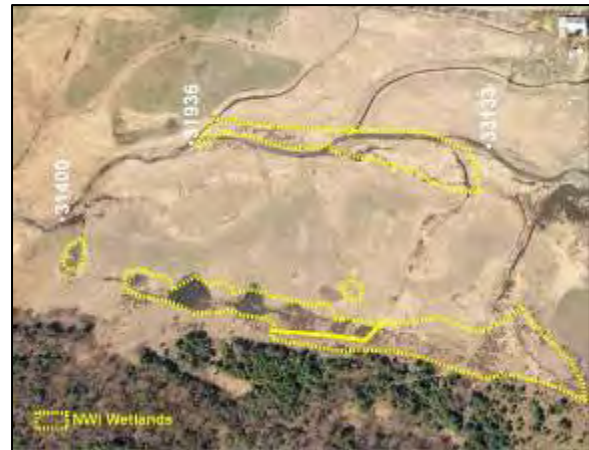
Beginning along this stretch of stream and continuing downstream, there was a 2.6 acre palustrine wetland (Stations 33133 - 31936) along the stream corridor. This wetland was classified as PEM1A, palustrine, *emergent, persistent, temporarily flooded*. Set back from the stream's edge, there was a wetland complex that drained to the Manor Kill through a downstream tributary (Station 31364).

Wetland boundary approximately delineated by NWI (Stations 33133 – 31400)

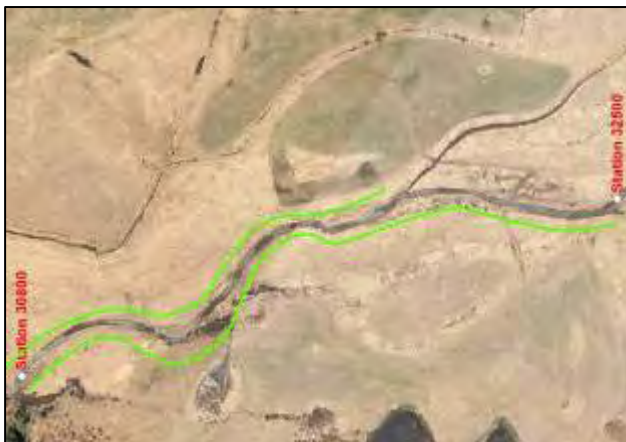
Riparian Planting Sites, Stations 32500 - 30800

Continuing downstream, there were additional proposed riparian planting sites along both streambanks. Along the left streambank, the planting site (Stations 32465 – 30800) stretched for approximately 1,561 feet. Along the right streambank, the planting site (Stations 31909 – 28916) stretched for approximately 2,654 feet. Along both of these sites, herbaceous vegetation was maintained to the edge of the stream. Aggradational conditions persisted along these planting sites, including multiple point, side, center and transverse bars.

As with the previously mentioned planting sites, recommendations for this site include planting native trees and shrubs along the streambank and the upland area. Buffer width should be increased to 100 feet or by the greatest amount agreeable to the landowners. Sections of both proposed planting sites are experiencing some erosion. Also, along this stretch of stream multiple beaver dams were

destroyed and deposited along the streambanks. Therefore, prior to proceeding with any vegetative plantings, these conditions should be given careful consideration, and additional assessment may be necessary. Any vegetation that is planted may require protection, such as tree tubes, to minimize the impact that beaver activity may have on survival of planted species.

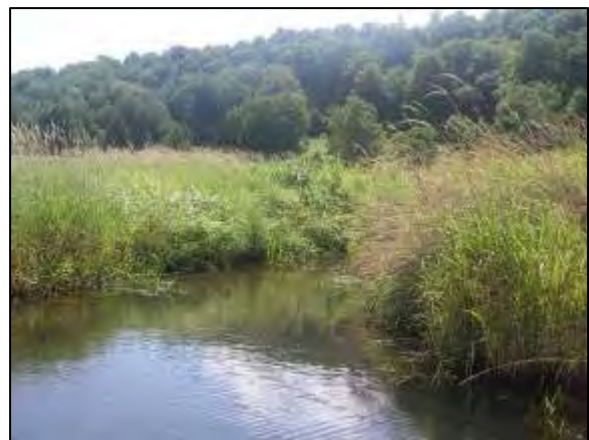
Tributary at Station 31364

As the stream gently meandered to the right, an unnamed tributary (Station 31364) entered along the left streambank. The tributary flows into a relatively deep pool along the Manor Kill; this pool is along the

left side of a center bar within the main channel. Upstream through the tributary channel, there were additional deep pool areas. There appeared to be abundant beaver activity along this tributary and wetland area.

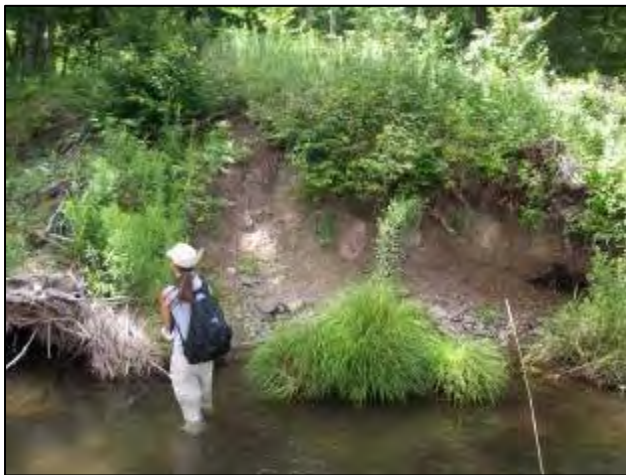
Erosion at Stations 30011 - 29959

Further downstream, aggradational conditions persisted, including multiple point and transverse bars. Along the left streambank, multiple trees had fallen from the left bank across the channel to the right bank causing an obstruction (Station 30011) at all flows. The obstruction appeared to contribute to upstream aggradation and to localized scour along the

channel bed and left streambank. Starting at the fallen trees and continuing for approximately 53 feet, there was significant erosion (Stations 30011 – 29959) along the left streambank. There was an open forest at the top of the streambank and some trees along this bank appeared to be compromised by beaver activity. Portions of the bank are overhanging and slumping into the stream channel. Continuing downstream, there

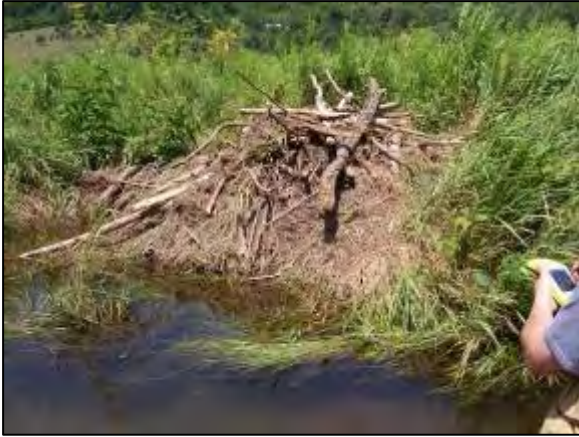
Beaver Lodge at Station 29715

Downstream of the obstructions, there were three beaver lodges along the main channel, including one on the right streambank (Station 29715) and two on the left streambank (Stations 29684 and 29572), and multiple locations of woody debris accumulation along both streambanks.

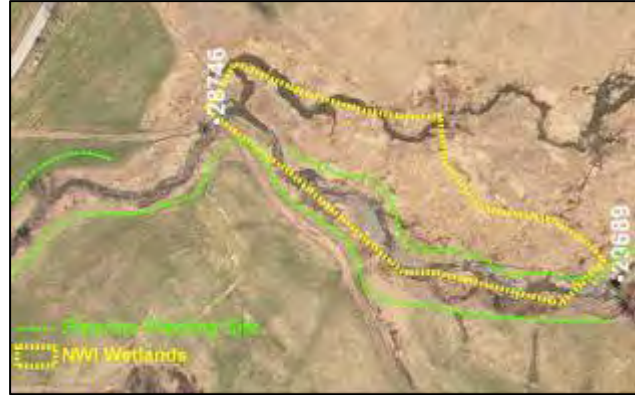
Wetland Boundary approximately delineated by NWI Riparian Planting Sites (Stations 25968 - 28200)

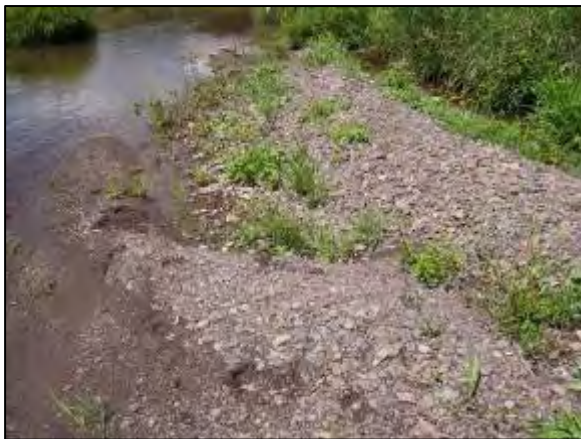
Point Bar at Stations 29549 - 29421

Continuing downstream, there was a large beaver dam (Figure 4.3.1b, Inset B, Station 29463). This dam has contributed to channel widening upstream of the dam, contributing to backwater conditions and creating a large, deep pool immediately upstream; there were also several smaller pools further upstream near the beaver lodges. Japanese knotweed was growing in the dam. The dam was contributing to downstream aggradational conditions,

including a point bar (Stations 29549 - 29421) on the right that directs flow towards the left streambank. Along the right side of the dam, there was a beaver slide, creating a small secondary channel where water gets around the dam and flows behind the point bar and a small area vegetated with willows; this channel converged (Station 29400) with the main stem approximately 63 feet downstream.

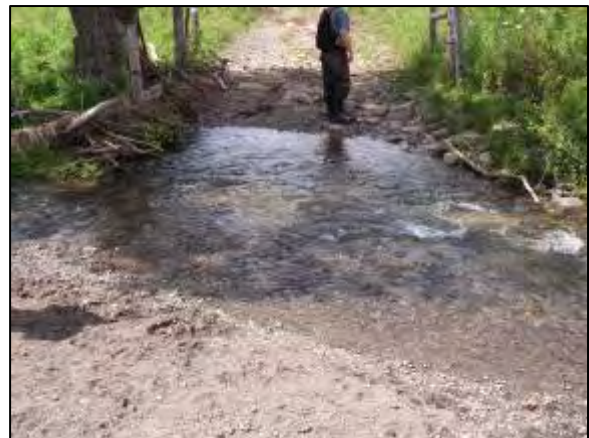
Channel Crossing at Station 28745

Continuing downstream, a small unnamed tributary (Station 28787) that drains the adjacent agricultural fields, entered along the right streambank. As the stream meandered to the left, there was a channel crossing to provide cows access to pasture fields along both sides of the stream. Along this crossing there was also full channel aggradation; maintenance of the crossing appeared to contribute to the localized aggradational conditions. Just downstream of the channel crossing, there was a short section of rip rap, comprised of small to medium cobbles, along

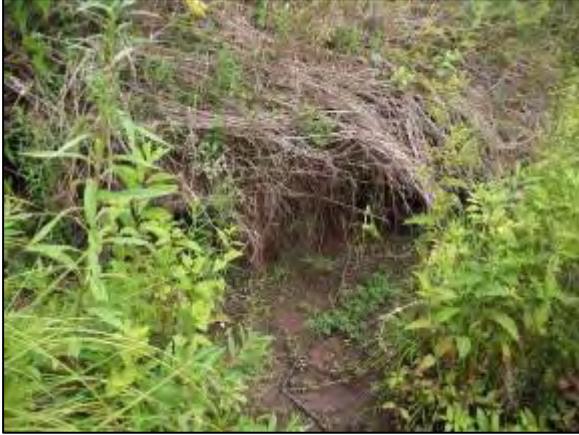
Erosion at Stations 28600 - 28585

the toe of the right streambank. Continuing downstream, there were multiple areas with minor hydraulic erosion along the left (Stations 28716 – 28702, Stations 28555 – 28487, and Stations 28377 - 28371) and right (Stations 28600 – 28585 and Stations 28509 - 28473) streambanks. Along this stretch of stream there continued to be excess sediment deposition within the stream channel, and there were multiple stands of Japanese

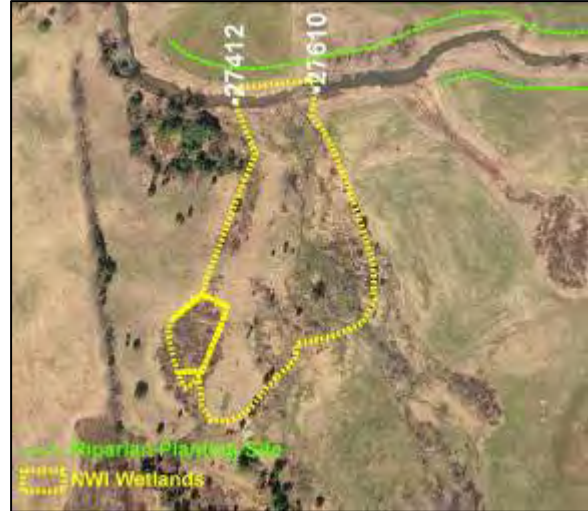
Wetland Boundary approximately delineated by NWI (Stations 27610 – 27412)

Continuing downstream, there was a wetland complex comprised of two palustrine wetlands. The complex began adjacent to the stream channel and stretched back into the fields along the left side of the stream. The first one was approximately 4.7 acres and is classified as PEM1B, *palustrine, emergent, persistent, saturated*. Two small tributaries (Stations 27552 and 27518) flowed through this wetland. The second wetland was approximately 0.4 acres and is classified PEM1/SS1A, *palustrine, emergent, persistent, scrub-shrub, broad-leaved deciduous, temporarily flooded*. A proposed riparian planting site continued along the opposite streambank.

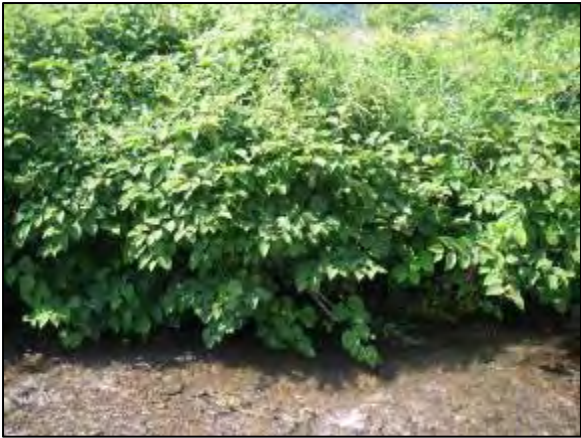
Japanese knotweed at Station 35300

Some plant species that are not native can create difficulties for stream management, particularly if they are invasive. Japanese knotweed (*Fallopia japonica*), for example, has become a widespread problem in recent years. Knotweed shades out other species with its dense canopy structure (many large, overlapping leaves), but stands are sparse at ground level, with much bare space between

narrow stems, and without adequate root structure to hold the soil of streambanks. The results can include rapid streambank erosion and increased surface runoff leading to a loss of valuable topsoil. Japanese knotweed locations were documented as part of the stream feature inventory conducted during the summer of 2008 (Riparian Vegetation Mapping, Section 2.7). In total, 63 Japanese knotweed occurrences along an estimated length of 5,682.6 feet were documented during the stream feature inventory. The best means for controlling knotweed is prevention of its spread, therefore, effort should be made to ensure that all fill brought into the area is clean and does not have fragments of knotweed or other invasive plants. If Japanese knotweed sprouts or small stands are observed, they should be eradicated immediately to avoid further spread within this unit and downstream management units.
