# Manor Kill Management Unit 4

Town of Conesville – Station 26995 to Station 24315

This management unit begins at Station 26995, continuing approximately 2,680 ft to Station 24315 in the Town of Conesville.

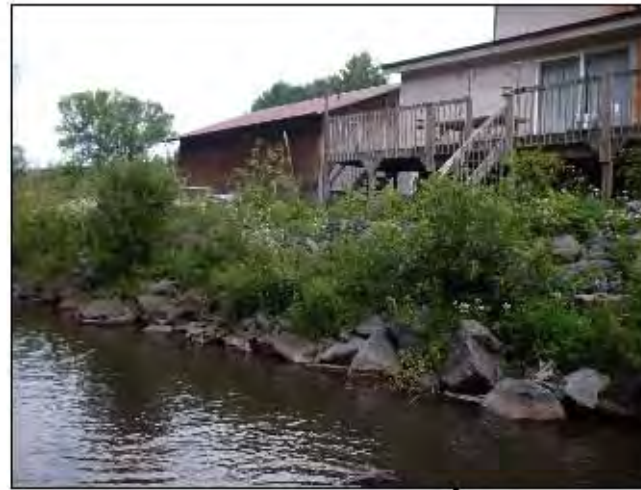
B

sediment deposition, including full channel aggradation (Station 25503) and a transverse bar (Stations 25337 – 25285). A small unnamed tributary (Station 25438) entered from the left streambank; there was a relatively large patch of Japanese knotweed just downstream of the tributary. Along this stretch of stream, the right streambank was reinforced with rip rap (Figure 4.4.1, Inset B, Stations 25485 – 25301) for approximately

184 feet. The rip rap was in good structural and functional condition and provided scour protection along the toe of the streambank. Along the upstream portion of the rip rap there was mowed lawn to the edge of the bank. Interplanting the rip-rap and reinforcing the toe of this streambank with native shrub and sedge species is recommended. Although this site was not identified as a proposed riparian planting site, planting native shrub and tree species along the upland area is recommended. As mentioned previously, a permit was issued for 100 feet of streambank rip rap repair, installation of new rip rap, and minor fill and grading in pre-disturbed lawn areas, in order to prevent the stream from undermining the adjacent home. This permit expires on September 30, 2009.

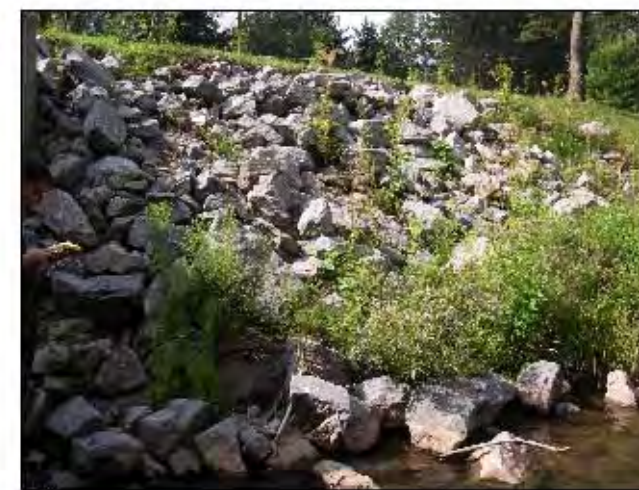
C

Along the left streambank, rip rap (Figure 4.4.1, Inset C, Stations 25833 – 25797) began at the bridge abutment and continued downstream for approximately 36 feet. The revetment was in good structural and functional condition and provided scour protection at the toe of the bank. Interplanting the rip-rap and reinforcing the toe of this streambank with native shrub and sedge species is

recommended. This planting will help to strengthen the revetment, while enhancing aquatic habitat. The riparian buffer beyond the rip-rap installation was sparse, with some mature trees and mown grass to the edge of the bank. The risk to bank stability can be minimized by maintaining mature trees along the critical 100 foot buffer zone. The buffer width should be increased by the greatest

amount agreeable to the landowners. In addition to interplanting the rip rap, recommendations for this proposed riparian planting site (Stations 25833 – 25673, photograph orientation looking upstream) include planting native trees and shrubs along the streambank and the upland area. Downstream of the revetment, and continuing along the proposed riparian planting site, the left streambank was eroding (Stations 25785 – 25632) for approximately 153 feet. At the downstream end of the erosion, there was a fallen tree (Stations 25632) with accumulated woody debris; it appeared to contribute to localized scour of the channel bed and the toe of the streambank. Prior to proceeding with any vegetative

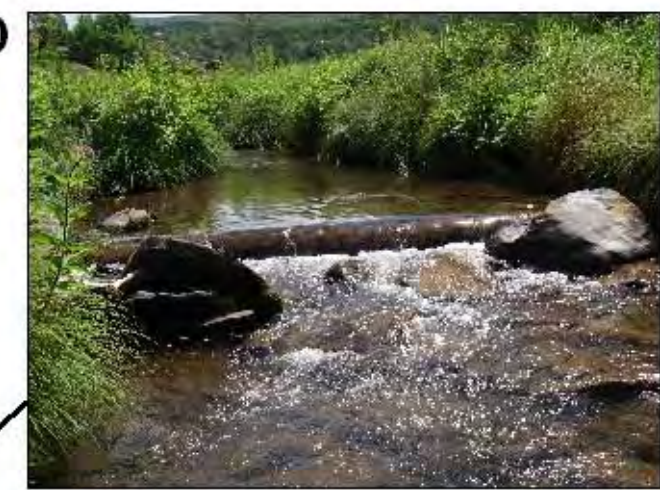
D

Continuing along this meander bend, there was log across the stream channel providing grade control (Figure 4.4.1, Inset D, photograph orientation looking upstream, Station 26687). The log appeared to have been placed to provide fish habitat, and may contribute to upstream aggradational conditions, including transverse and center bars. Water flows around the structure along the right side.

amount agreeable to the landowner. There were two significant stands of Japanese knotweed (Station 24586, Figure 4.4.1, Inset D, and Station 24500) along this planting site. Prior to beginning planting efforts, these stands should be removed if feasible, or effort should be made to avoid spreading this invasive plant.

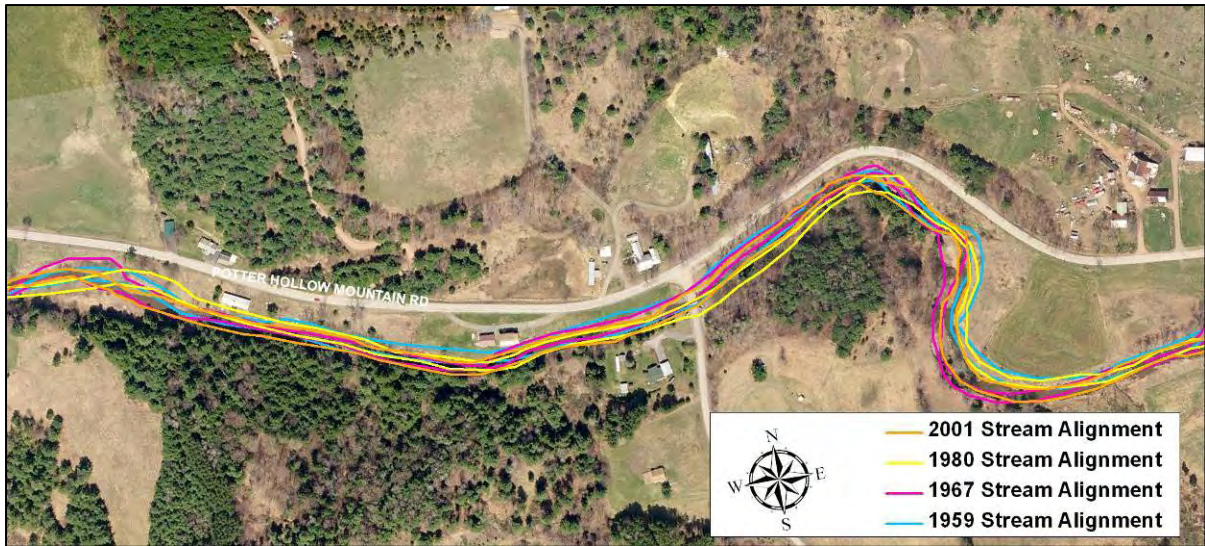
As seen from the historical stream channel alignments (above), the *planform* of the channel has not changed significantly over the years along this management unit; the channel has remained fairly stable.
