# Manor Kill Management Unit 5

Town of Conesville – Station 24315 to Station 19795

Figure 4.5.1 Management Unit 5 - 2006 aerial photography with 2008 stream feature inventory.

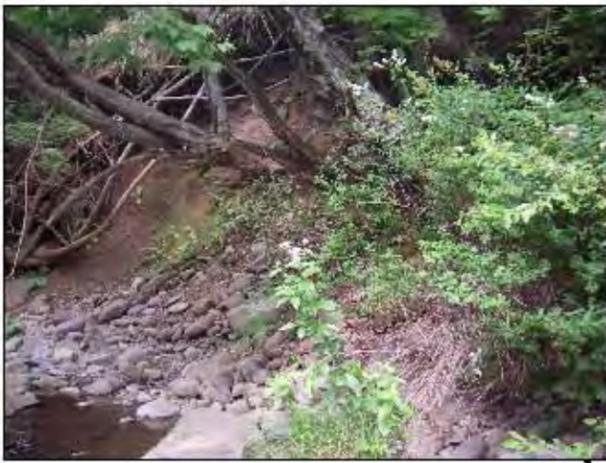
A

Along the middle portion of this planting site, there were two areas of erosion. The first erosion site (Figure 4.5.1, Inset A, Stations 20484 – 20374) stretched along approximately 110 feet of the right bank and resulted in an erosion area of 1,318 ft<sup>2</sup> with exposed roots, fallen trees and overhanging bank material. Some of the fallen trees and associated woody debris contributed to localized scour of the channel bed and toe of the streambank. The second erosion site (Stations 20335 – 20124), was less significant, although

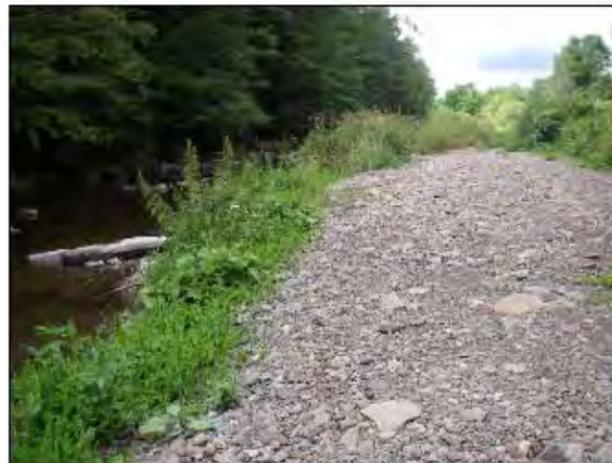
B

21024) at its confluence. There was also a significant side bar (Figure 4.5.1, Inset B, Stations 21022 – 20748) along approximately 274 feet of the right channel bed, just downstream of the tributary. Sediment deposition is a common feature of confluence areas, which often contain extensive sediment bars, function as important sediment storage areas, and are typically among the most dynamic and changeable areas in the stream system. This tributary was classified C(ts) by the NYS DEC, indicating that the best uses for this stream are supporting fisheries, including trout spawning, and other recreational activities.

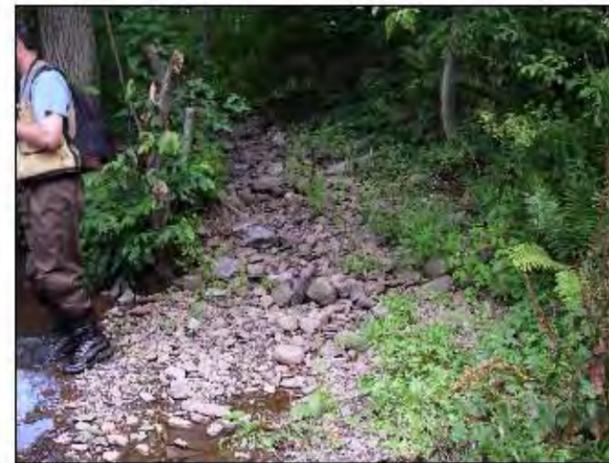
Downstream a sizable unnamed, intermittent tributary entered from the left streambank (Figure 4.5.1, Insert C, Station 21844, photograph orientation looking at). At the time of the assessment, flow was subsurface. The New York State Department of Environmental Conservation classifies streams and rivers based on their “best use” (NYSDEC, 1994). This tributary was classified C by the NYS DEC, indicating that the best uses for this stream are supporting fisheries and other recreational activities. Downstream of the tributary, there was a small patch of Japanese knotweed (Station 21833) along the right streambank and a side bar (Stations 21811 – 21743) along the left streambank.

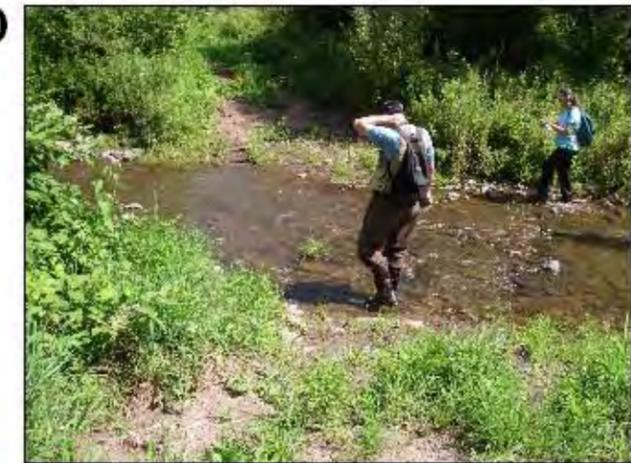
D

include planting native trees and shrubs along the streambank and the upland area. Buffer width should be increased by the greatest amount agreeable to the landowners. At this site, there was a narrow forested buffer beyond the successional old field, followed by maintained herbaceous agricultural fields. By planting this site from the stream's edge to the forested area, a 100 foot buffer would be created. Increasing the buffer width to at least 100 feet will increase the buffer functionality and protect the stream from nearby land uses. Along this planting site, there was a stream channel crossing (Figure 4.5.1, Inset D, photograph orientation looking at, Station 24253) that appeared to be used for recreational purposes.

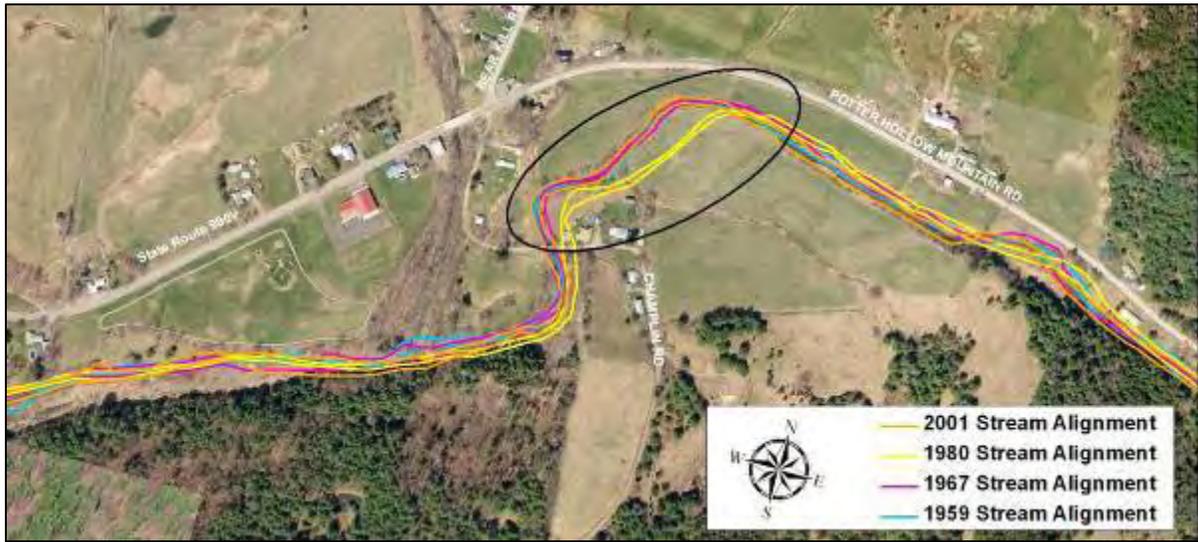
*Historic stream channel alignments overlaid with 2006 aerial photograph*

As seen from the historical stream channel alignments (above), the *planform* of the channel has not changed significantly over the years along this management unit; the channel has remained fairly stable. When *georeferencing* the 1980 aerial imagery, or establishing a relation between the images to map projections or coordinate systems within a *Geographic Information System (GIS)*, we encountered some problems with accuracy. The area indicated on the map above shows that the alignment and shape of the channel remained similar to previous years, although it is slightly off in location; this is primarily due to problems associated with the georeferencing process.

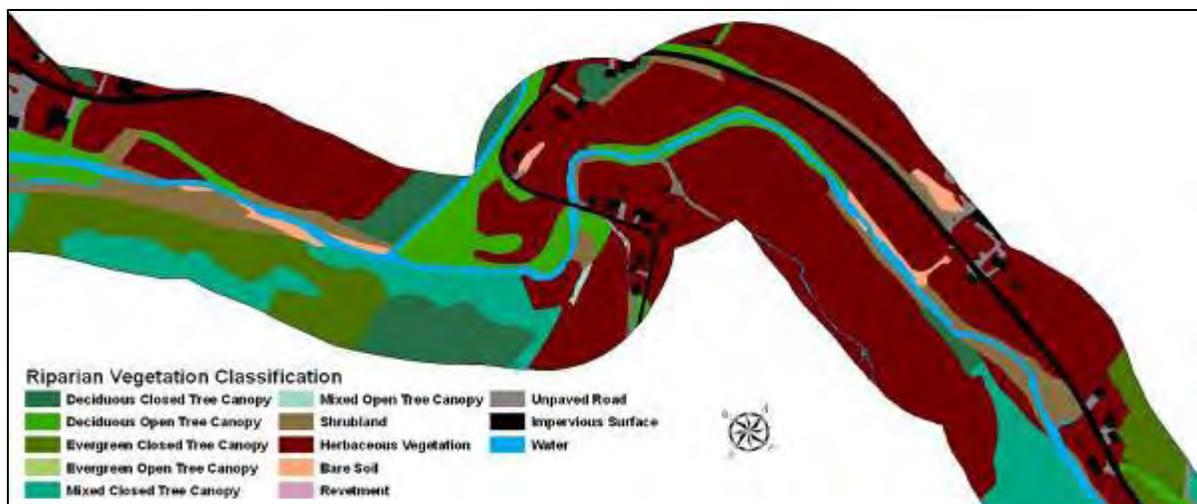
*Riparian vegetation classification map based on aerial photography from 2006*

An analysis of vegetation was conducted using aerial photography from 2006 and field inventories (see above map and Riparian Vegetation Mapping, Section 2.7). In this management unit, the predominant vegetation type within the 300 ft. riparian buffer was herbaceous (55.6%) followed by forested (27.58%). *Impervious* area (3.77 %) within this unit's buffer was primarily the local and private roadways. Areas of herbaceous (non-woody) cover may present opportunities to improve the riparian buffer with tree plantings in order to promote a more mature vegetative community along the streambank and in the floodplain.

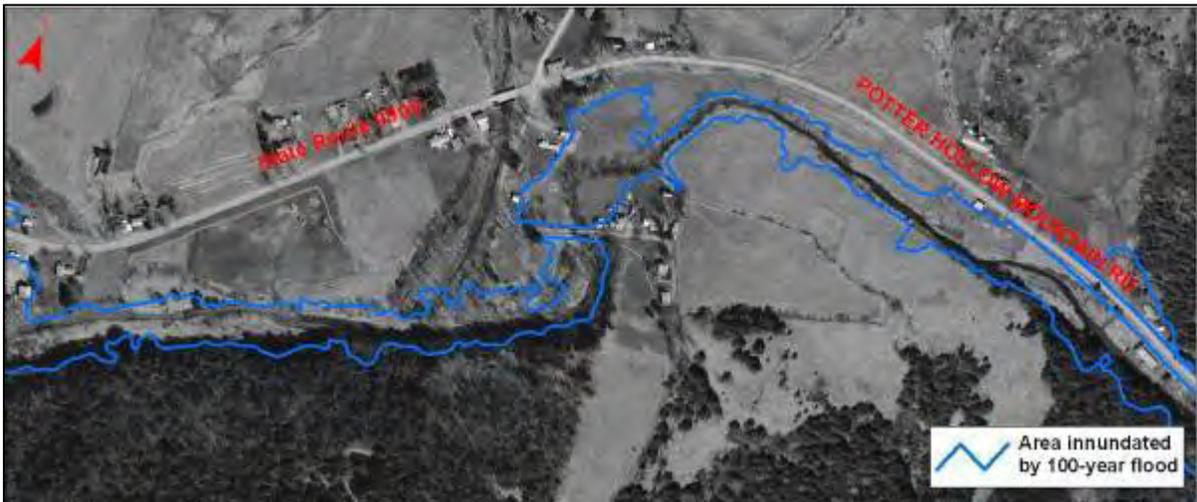
*100-year floodplain boundary map*

According to the current floodplain maps (above), two existing structures in this unit appeared to be situated within the estimated 100-year floodplain. The 100-year floodplain is that area predicted to be inundated by floods of a magnitude that is expected to occur once in any 100-year period, on the basis of a statistical analysis of local flood record. Most communities regulate the type of development that can occur in areas subject to these flood risks.
