Manor Kill Management Unit 6

Town of Conesville – Station 19795 to Station 15492

Figure 4.6.1 Management Unit 6 - 2006 aerial photography with 2008 stream feature inventory.

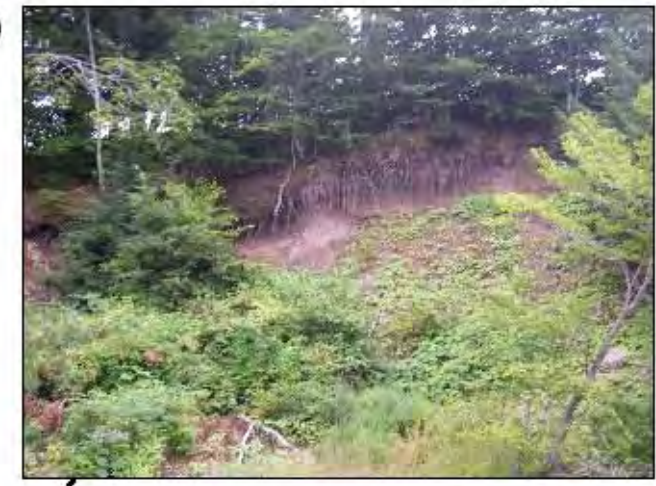
D

Continuing along this meander bend, the *thalweg*, or deepest part of the stream channel, flowed up against the left streambank causing the first mass failure (Figure 4.6.1, Inset D, Stations 19015 – 18872). This mass failure resulted in an erosion area of approximately 7,174 ft², exposing roots and compromising mature trees along the bank. During the field assessment, this bank was identified as a proposed Bank Erosion Monitoring Site (BEMS) to study erosion along this reach. To monitor BEMS, a cross-section and long profile may be conducted to collect baseline data. Once the baseline data has been collected, this cross-section can be resurveyed in the future to calculate the bank's erosion rate. Along this erosion site, multiple large trees (Stations 19000 and 18918) had fallen across the stream channel contributing to upstream aggradation and localized scour of the channel bed and toe of the streambank. The first woody debris obstruction contributed to scour that created large, deep pools. Woody debris such as this, is beneficial to a stream system, it provides critical habitat for fish and insects, and adds essential organic matter that will benefit organisms downstream.

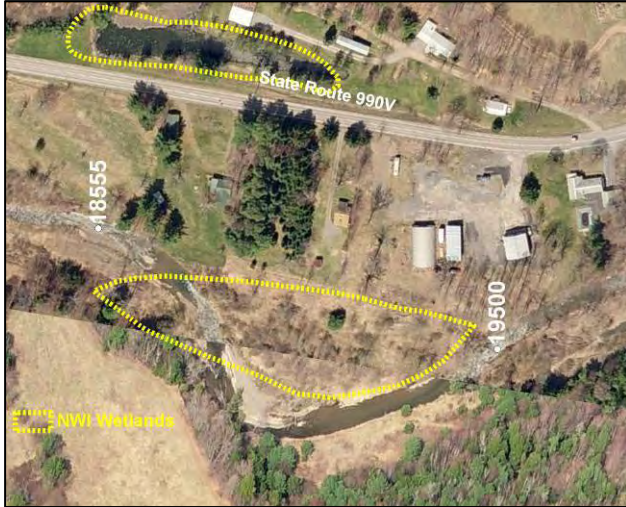
Wetland Boundary approximately delineated by NWI Stations 19500 - 18555

As the stream meandered to the right, there was a 2 acre palustrine wetland (Stations 19500 – 18555). Wetlands are important features in the landscape that provide numerous beneficial functions including protecting and improving water quality, providing fish and wildlife habitats, storing floodwaters, and under certain conditions

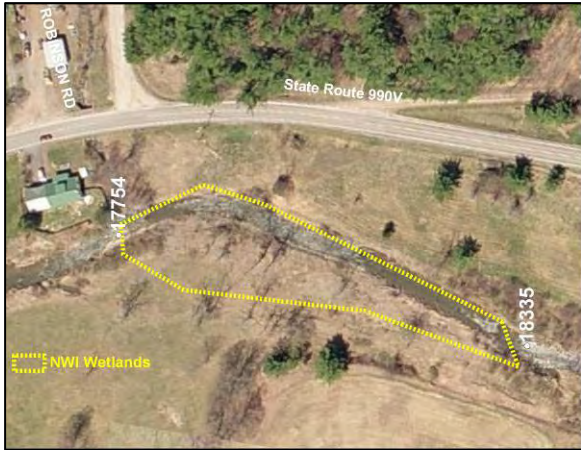
Wetland boundary approximately delineated by NWI Stations 18335 - 17754

appropriate species and locations for plantings. Aggradational conditions persisted along this stretch of stream. Downstream of the proposed planting site there was a one acre palustrine wetland (Stations 18335 – 17754) classified as PEM1A, *palustrine, emergent, persistent, temporarily flooded*.

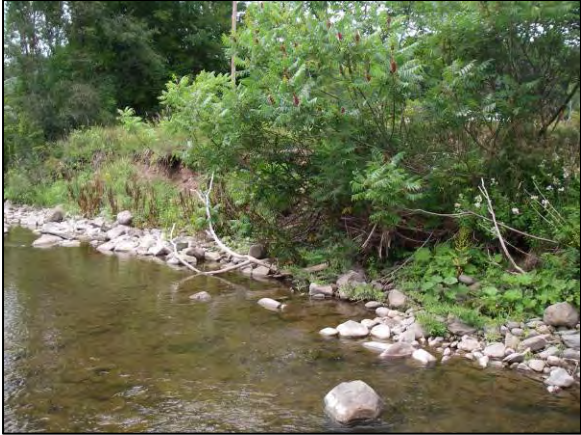
Erosion at Stations 17875 - 17793

persisted along this stretch of stream including multiple point bars and a transverse bar. Along the downstream portion of the planting site along the right streambank, there was erosion (Station 17875 – 17793) for approximately 82 feet. These conditions may need additional assessment and should be considered when identifying the appropriate species and locations for plantings along this portion of the planting site.

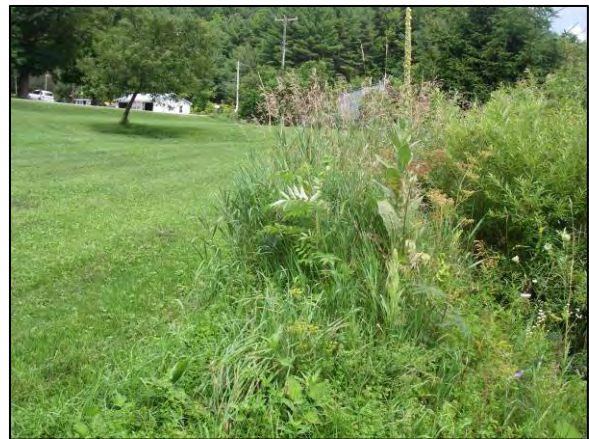
Riparian Planting Site at Stations 17618 - 17440

Further downstream, there were two additional proposed riparian planting sites. The first site stretched along the left streambank (Stations 17693 – 17418) for approximately 275 feet. There was herbaceous vegetation to the stream’s edge with a few willows and sedges along the bank. At the top of the bank, there was a fence surrounding a maintained field. Recommendations for this site include establishing a woody buffer by planting native tree and shrub species. The second riparian planting site (Stations 17618 – 17440) stretched along the right streambank for approximately 178 feet. This site had a mix of herbaceous vegetation and shrubs along the face of the streambank, with mown lawn to the top of the bank. In addition to augmenting the existing buffer with native plantings, recommendations for this site include discontinued mowing to the top of the

streambank, allowing succession to proceed with natural regeneration of shrub and early successional tree species. It is recommended that buffer width for both sites be increased to at least 100 feet or the greatest amount agreeable to the landowners. There were two small stands of Japanese knotweed along this stretch of stream which should be removed.

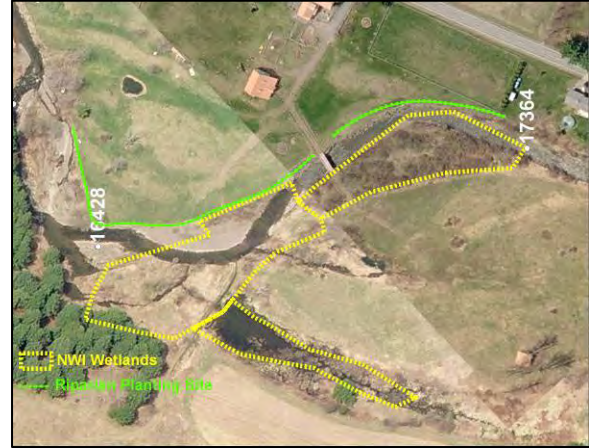
Wetland boundary approximately delineated by NWI Stations 17384 – 16428

As the stream meandered to the left, there was a significant wetland complex (Stations 17384 – 16428) comprised of three federal wetlands. Two of the wetlands were along the stream corridor, both of these were palustrine; the first was approximately a 0.8 acres, the second was approximately 1.4 acres in size. These wetlands are classified as PFO1A, *palustrine, forested, broad-leaved deciduous, temporarily flooded*, and PEM1A, *palustrine, emergent, persistent, temporarily flooded*, respectively (see Section 2.6 for detailed wetland type descriptions).

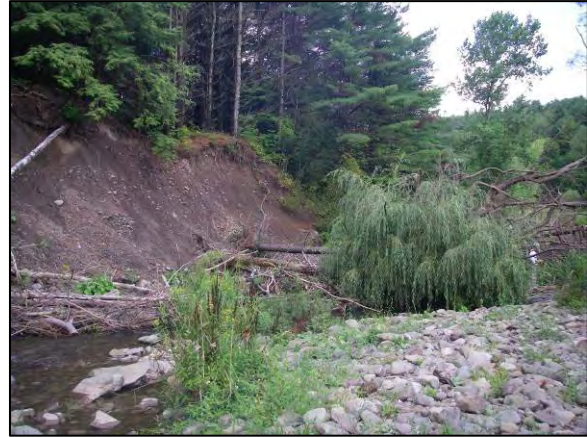
Woody Debris at Station 16052

the water column and settle along the stream bed. There was abundant woody debris on the upstream portion of the point bar that exacerbated the aggradational conditions through this stretch of stream.

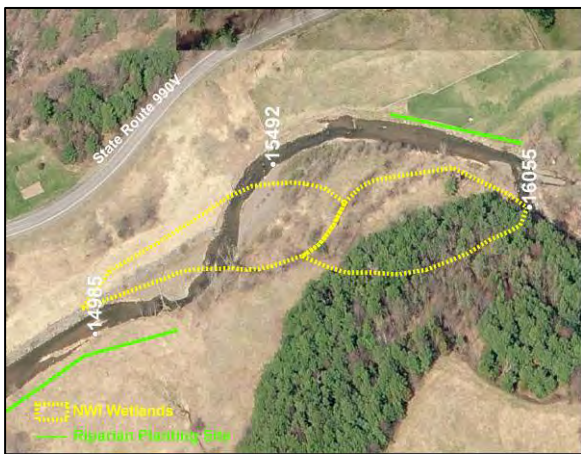
Wetland boundary approximately delineated by NWI Stations 16055 – 14985

Continuing downstream, there was a 1.3 acre palustrine wetland followed by a 1.1 acre palustrine wetland that started in management unit 6 and continued into management unit 7. These wetlands are classified PEM1E, *palustrine, emergent, persistent, seasonally flooded/saturated*, and PSS1E, *palustrine, scrub-shrub, broad-leaved deciduous, seasonally flooded/saturated*, respectively. At

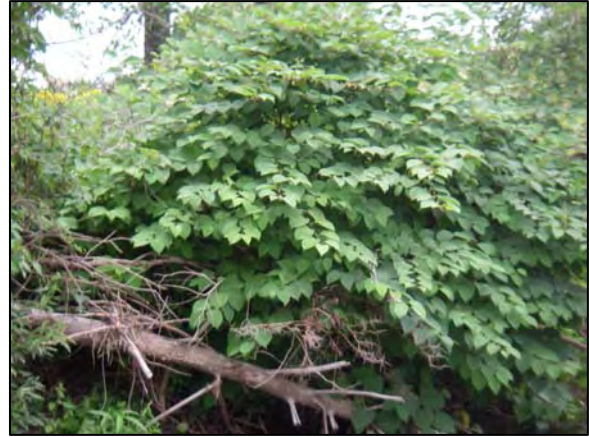
Japanese knotweed at Station 17973

Some plant species that are not native can create difficulties for stream management, particularly if they are invasive. Japanese knotweed (*Fallopia japonica*), for example, has become a widespread problem in recent years. Knotweed shades out other species with its dense canopy structure (many large, overlapping leaves), but stands are sparse at ground level, with much bare space between narrow stems, and without adequate root structure to hold the soil of streambanks.

The results can include rapid streambank erosion and increased surface runoff leading to a loss of valuable topsoil. Japanese knotweed locations were documented as part of the stream feature inventory conducted during the summer of 2008 (Riparian Vegetation Mapping, Section 2.7). In total, 10 Japanese knotweed occurrences covering an estimated length of 32 feet were documented during the stream feature inventory. The best means for controlling knotweed is prevention of its spread, therefore, effort should be made to ensure that all fill brought into the area is clean and does not have fragments of knotweed or other invasive plants. If Japanese knotweed sprouts or small stands are observed, they should be eradicated immediately to avoid further spread within this unit and to downstream management units.
