Manor Kill Management Unit 7

Town of Conesville – Station 15492 to Station 9805

This management unit begins at Station 15492, continuing approximately 5,687 ft to Station 9805 in the Town of Conesville.

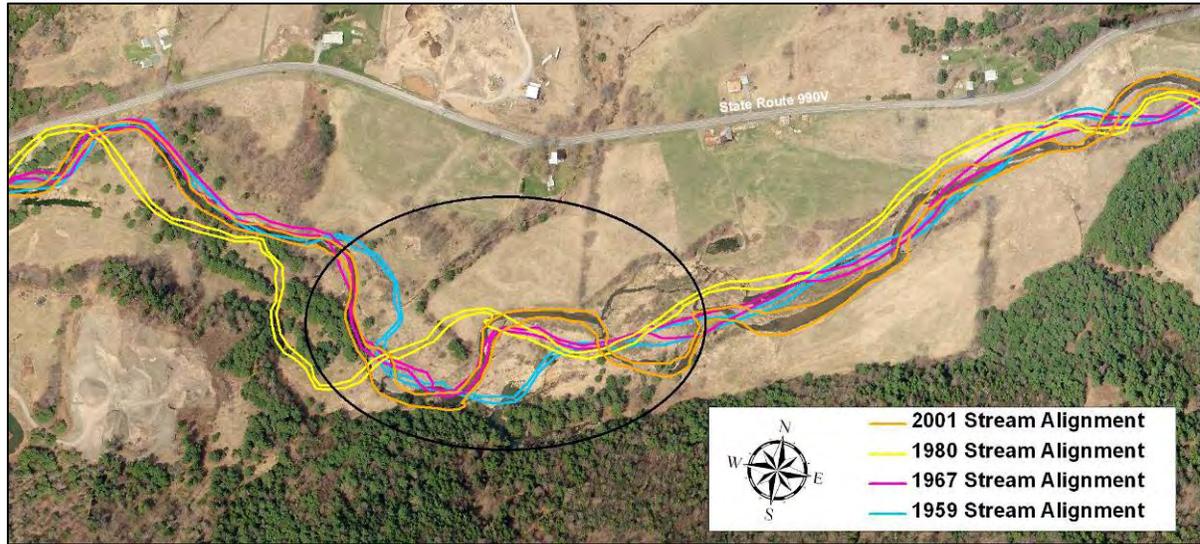
Historic stream channel alignments overlaid with 2006 aerial photograph

As seen from the historical stream channel alignments (above), the *planform* of the channel has changed significantly over time along this management unit. The stream has experienced lateral migration in several locations over the years. Lateral migration is the movement of a channel across its floodplain, which usually results in extensive bank erosion. The outside banks of meander bends tend to move laterally across the valley floor and down the valley.

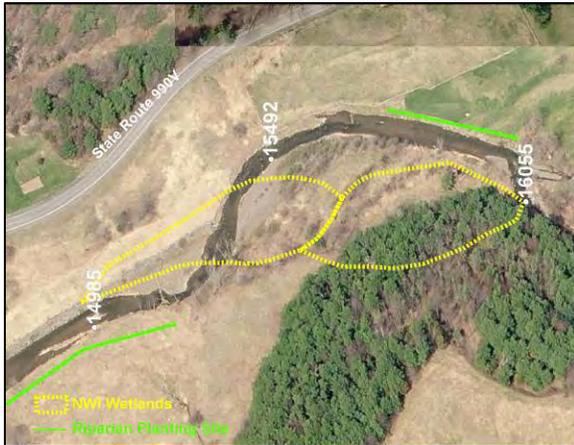
Riparian Planting Site at Stations 15127 - 14683

Wetland boundary approximately delineated by NWI Stations 16055 – 14985

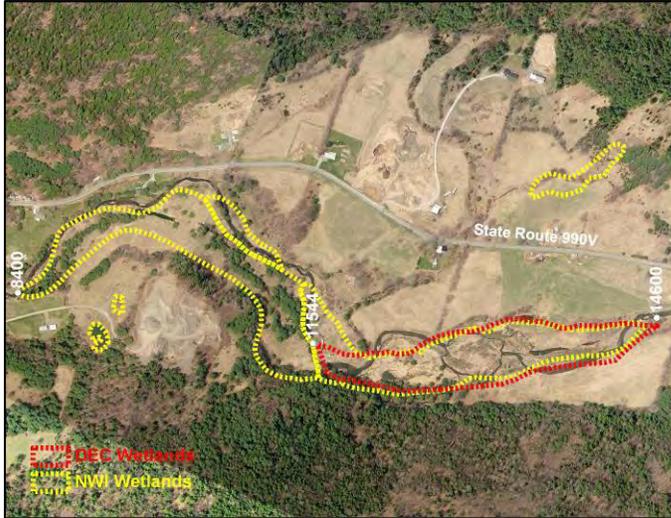
Wetland boundaries approximately delineated by NWI
 NYS DEC designated wetland
 Stations 14600 - 8400

Continuing downstream, there was a large Class II New York State designated wetland and a contiguous complex of federal (NWI) wetlands (Stations 14600 – 8400) that occupies the remaining length of this management unit and continues into management unit 8. The Class II NYS

wetland began at station 14600, covering approximately 17.5 acres surrounding the stream corridor, and ended at station 11544. The NYS Freshwater Wetlands Act (FWA) classifies wetlands from Class I, wetlands which provide the most benefits, to Class IV, wetlands which provide the fewest benefits. Around every regulated wetland is a regulated adjacent area of 100 feet, which serves as a buffer area for the wetland (NYS DEC, 2003). The first NWI wetland that overlaps the NYS wetland is approximately 15.3 acres and classified PEM1E, *palustrine, emergent, persistent, seasonally flooded/saturated*. This wetland complex continues with two additional palustrine wetlands; one approximately 15.3 acres in size, classified as PEM1/SS1E, *palustrine, emergent, persistent, scrub-shrub, broad-leaved deciduous, seasonally flooded/saturated*, and one approximately 1.7 acres, classified as PEM1C, *palustrine, emergent, persistent, seasonally flooded*.

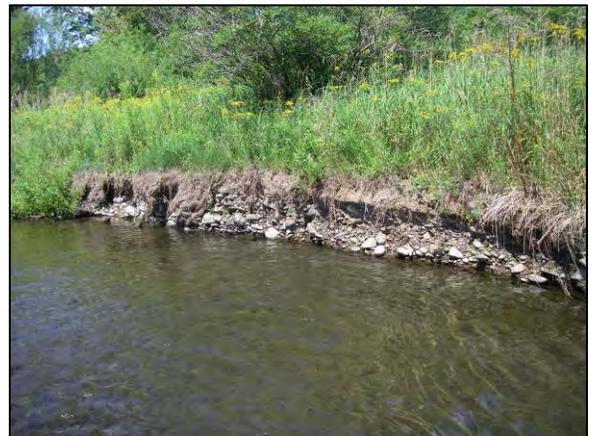
Erosion at approximate Stations 13050-12960

the secondary channel, it appeared as though much of this excess sediment deposition was caused by a large fallen tree and accumulated woody debris (Station 13050) that posed a significant obstruction to channel flow. Downstream of the fallen tree, there was surface flow, additional woody debris, and the aggradational conditions persisted.

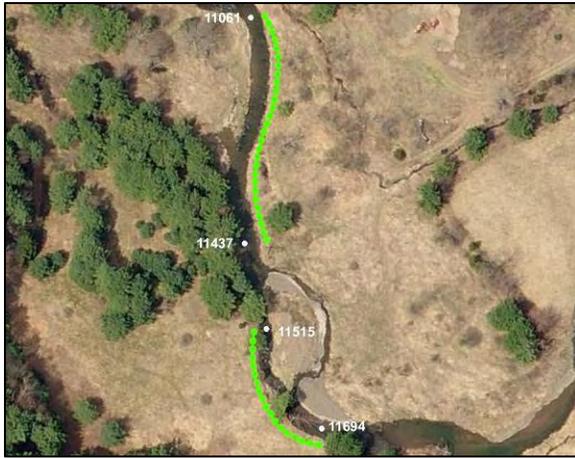
Proposed Planting Sites at Stations 11694-11515 and 11437-11061

This erosion was along a proposed riparian planting site (Stations 11694-11515). Recommendations for this site include discontinued mowing to the stream’s edge to allow succession to proceed with natural regeneration of shrub and early successional tree species. Buffer width should be increased by the greatest amount agreeable to the landowners; however erosion along this site may need to be addressed prior to proceeding with any riparian plantings of native sedge,

shrub and tree species. A more detailed site assessment may be necessary to determine whether stream bank grading will be required. Downstream along the right streambank an additional proposed riparian planting site was identified (Stations 11437-11061). This site included a successional old field with few shrubs and trees. Recommendations include continuing to allow succession to proceed by not mowing, and planting native trees and shrubs along the streambank and the upland area, increasing the buffer width to at least 100 feet.

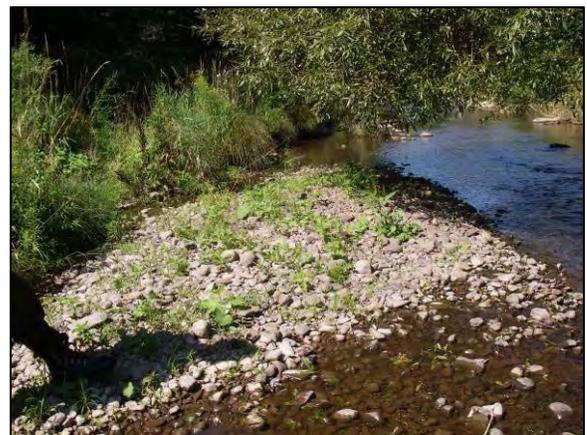
Transverse Bar at Stations 10914-10854

As the stream meandered to the left, a tributary (Station 11029) entered from the right streambank. This tributary drains the slopes of Bull Hill Mountain before it reaches the flatter topography of the valley floor where it enters the Manor Kill. The New York State Department of Environmental Conservation classifies streams and rivers based on their “best use” (NYSDEC, 1994). This tributary was classified C by the NYS DEC, indicating that the best uses for this stream are supporting fisheries and other recreational activities. Downstream of the tributary were multiple depositional features including transverse and point bars. Excess deposition is a common feature of confluence areas, which often contain

extensive sediment bars, function as important sediment storage areas, and are typically among the most dynamic and changeable areas in the stream system.

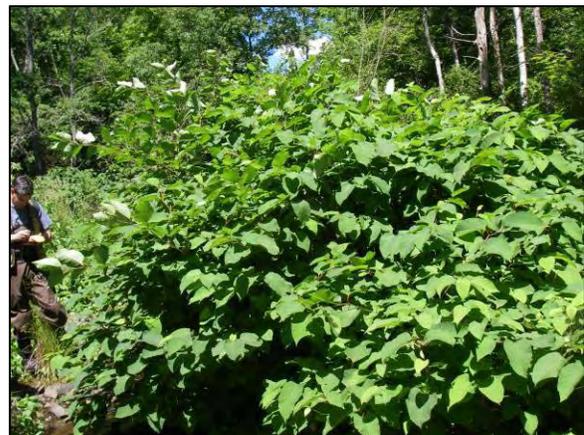
Japanese knotweed at Station 42469

Plant species that are not native can create difficulties for stream management, particularly if they are invasive. Japanese knotweed (*Fallopia japonica*), for example, has become a widespread problem in recent years. Knotweed shades out other species with its dense canopy structure (many large, overlapping leaves), but stands are sparse at ground level, with much bare space between narrow stems, and without adequate root structure to hold the soil of streambanks. The result can include rapid streambank erosion and increased surface runoff leading to a loss of valuable topsoil. Japanese knotweed locations were documented as part of the stream feature inventory conducted during the summer of

2008 (Riparian Vegetation Mapping, Section 2.7). In total, one 10-foot long patch of Japanese knotweed was documented during the stream feature inventory. The best means for controlling knotweed is prevention of its spread, therefore, effort should be made to ensure that all fill brought into the area is clean and does not have fragments of knotweed or other invasive plants. If Japanese knotweed sprouts, or small stands are observed, they should be eradicated immediately to avoid further spread within this unit and to downstream management units.

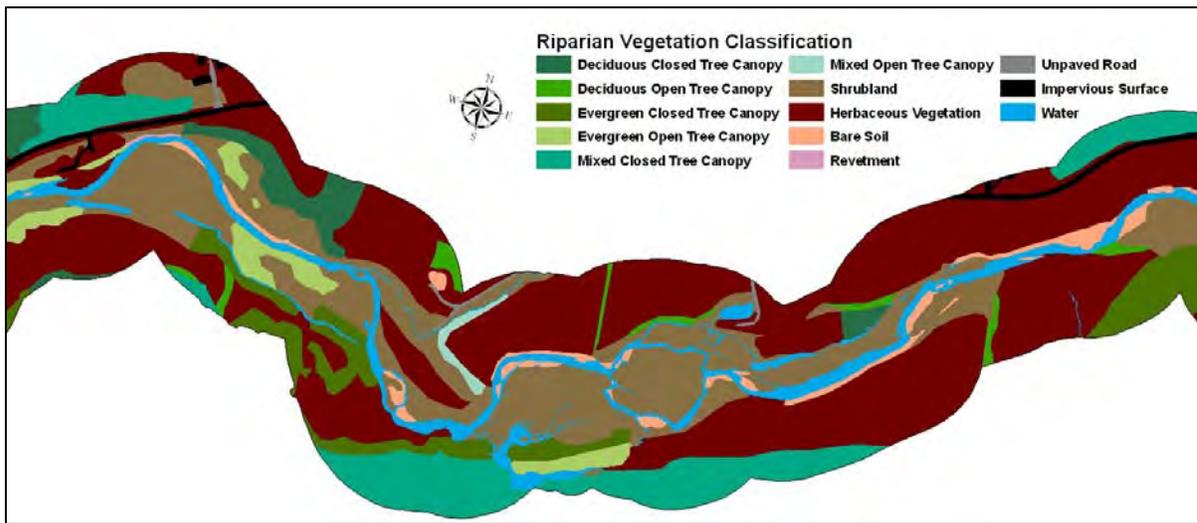
Riparian vegetation classification map based on aerial photography from 2006

An analysis of vegetation was conducted using aerial photography from 2006 and field inventories (see above map and Riparian Vegetation Mapping, Section 2.7). In this management unit, the predominant vegetation type within the 300 ft. riparian buffer was herbaceous (43.2%) followed by shrubland (23.06%). Impervious area (1.05 %) within this unit's buffer was primarily the local and private roadways. Areas of herbaceous (non-woody) cover may present opportunities to improve the riparian buffer with tree plantings in order to promote a more mature vegetative community along the streambank and in the floodplain.
