Manor Kill Management Unit 9

Town of Conesville – Station 4523 to Station 1775

Figure 4.9.1 Management Unit 9 - 2006 aerial photography with 2008 stream feature inventory.

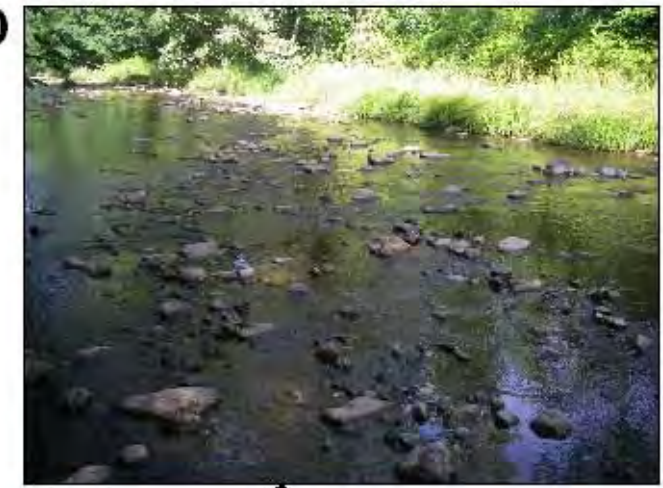
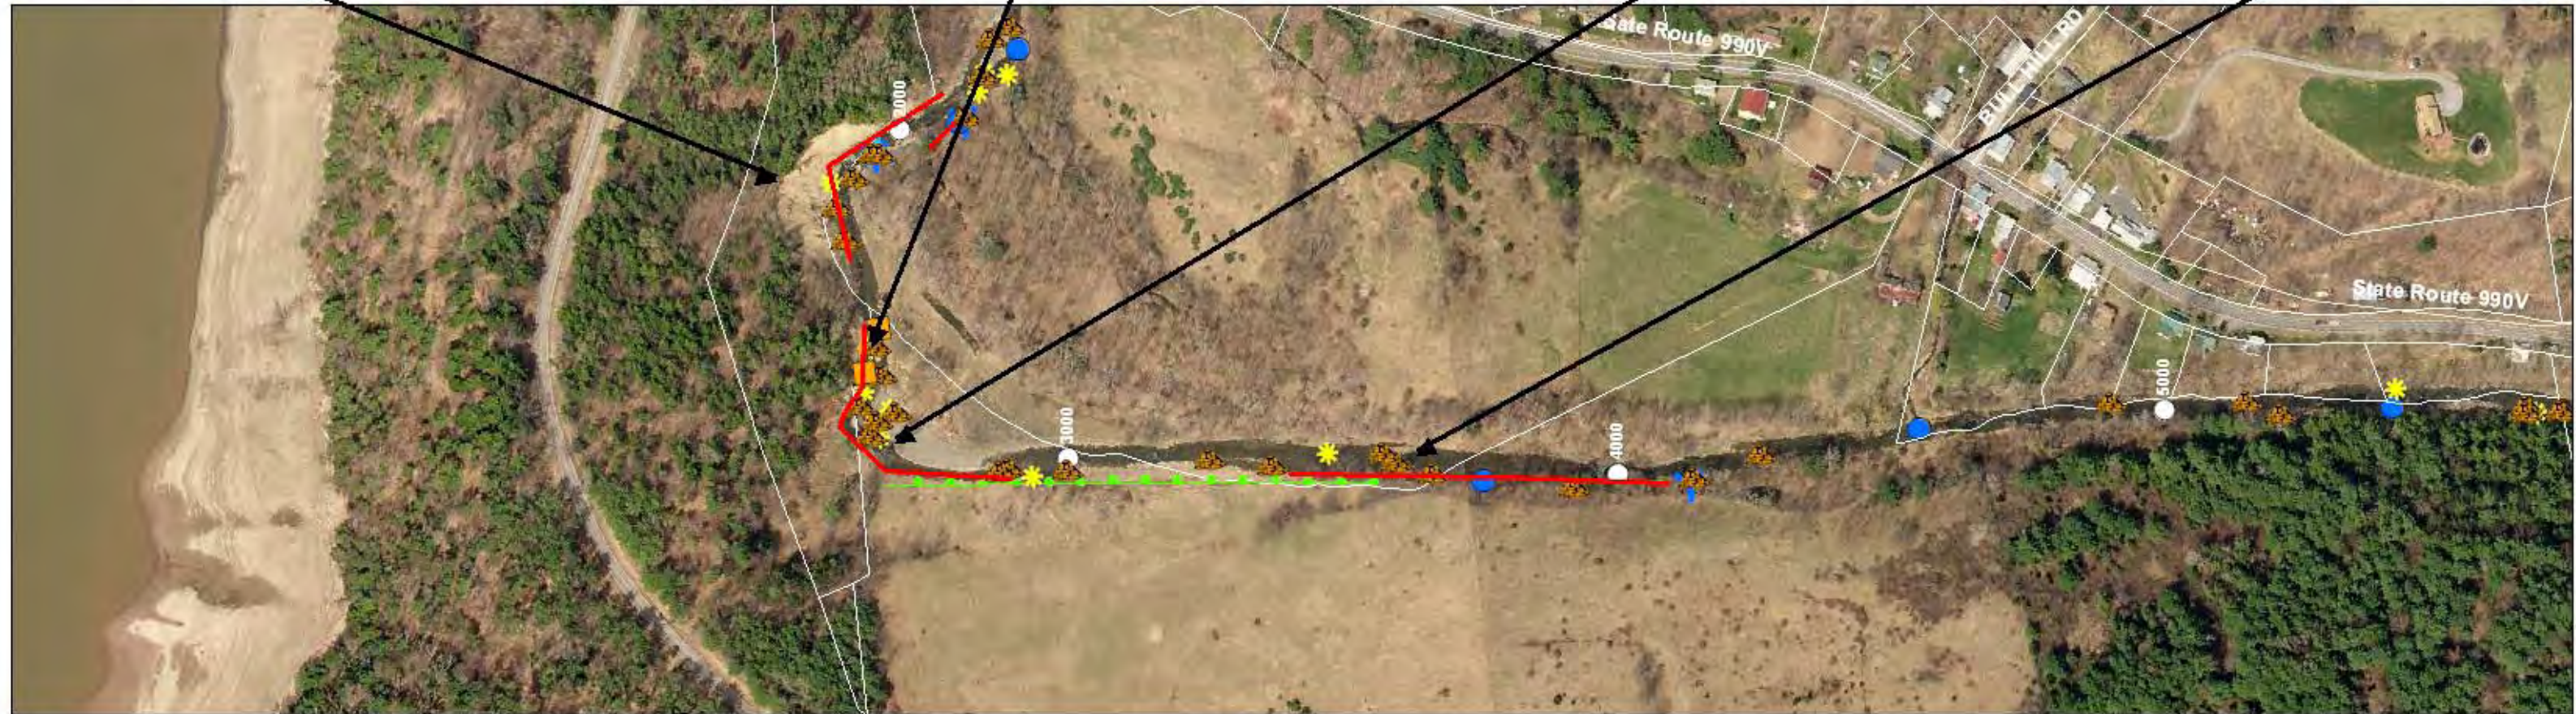
The 2008 stream feature inventory revealed that 31% (1,706 ft.) of the streambanks exhibited signs of active erosion along the 5,496 ft. of total streambank length in the unit (Fig. 4.9.1). There were no revetments or berms identified in this management unit during the 2008 assessment.

Valley morphology in this management unit was relatively unconfined with a broad glacial and alluvial valley flat. Generally, stream conditions in this management unit were unstable, with deficient sediment transport ability resulting in aggradational conditions throughout, and approximately 1,706 feet of erosion. There were six eroding banks documented in this management unit, including two mass failures. Management efforts in this unit should focus on preservation of existing wetlands and forested areas and improvements to the riparian buffer by planting herbaceous areas with native trees and shrubs.

Following the hydraulic erosion along the left bank, there was a mass failure (Stations 2552-2411) resulting in an erosion area of approximately 6,662 ft², exposing areas of lacustrine clay (Figure 4.9.1, Inset C, Stations 2497-2420) and compromising mature trees along the bank. Fallen trees were in multiple locations along the streambank. The mass failure was forested at the top of the bank with herbaceous vegetation on the face of the upstream portion of the bank.

As the stream meandered to the right, the thalweg, or deepest part of the stream channel, flowed up against the left streambank causing a second mass failure (Figure 4.9.1, Inset A, Stations 2289 – 1906). This mass failure resulted in an erosion area of approximately 12,547 ft², exposing roots and compromising mature trees. Land was forested from the top of the erosion to Prattsville Road – a distance of approximately 300 feet. Along the erosion, multiple trees had fallen into the stream contributing to localized scour and aggradation.

Summary of Recommendations Management Unit 9	
Intervention Level	Assisted Self-Recovery
Stream Morphology	No recommendations at this time.
Riparian Vegetation	Treat, remove and prevent the spread of Japanese knotweed, where feasible. Plant a buffer of trees and shrubs along proposed planting sites and increase width of riparian buffer in appropriate locations.
Infrastructure	No recommendations at this time.
Aquatic Habitat	Watershed Aquatic Habitat Study
Flood Related Threats	No structures in 100-year floodplain – protect floodplain from development.
Water Quality	Encourage homeowners to participate in the CWC septic program, if eligible.
Further Assessment	Establish bank erosion monitoring sites at the two mass failures - Stations 2552-2411 and Stations 2289 – 1906.

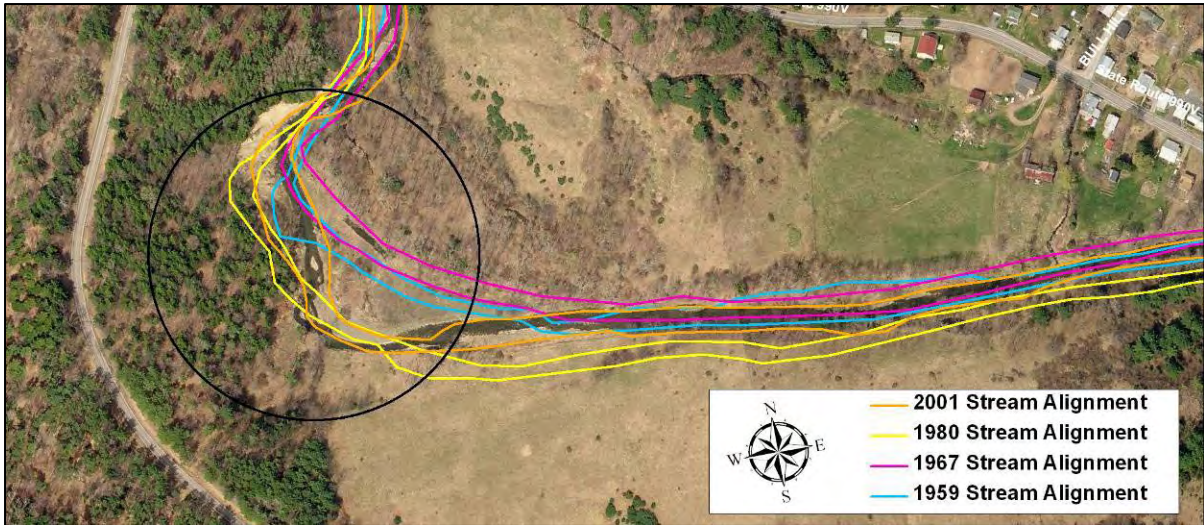
Historic stream channel alignments overlaid with 2006 aerial photograph

As seen from the historical stream channel alignments (above), the *planform* of the channel has remained fairly stable through the upstream portion of the management unit; the downstream portion appears to be experiencing *lateral migration*. Lateral migration is the movement of a channel across its floodplain, which usually results in extensive bank erosion. The outside banks of meander bends tend to move laterally across the valley floor and down the valley.

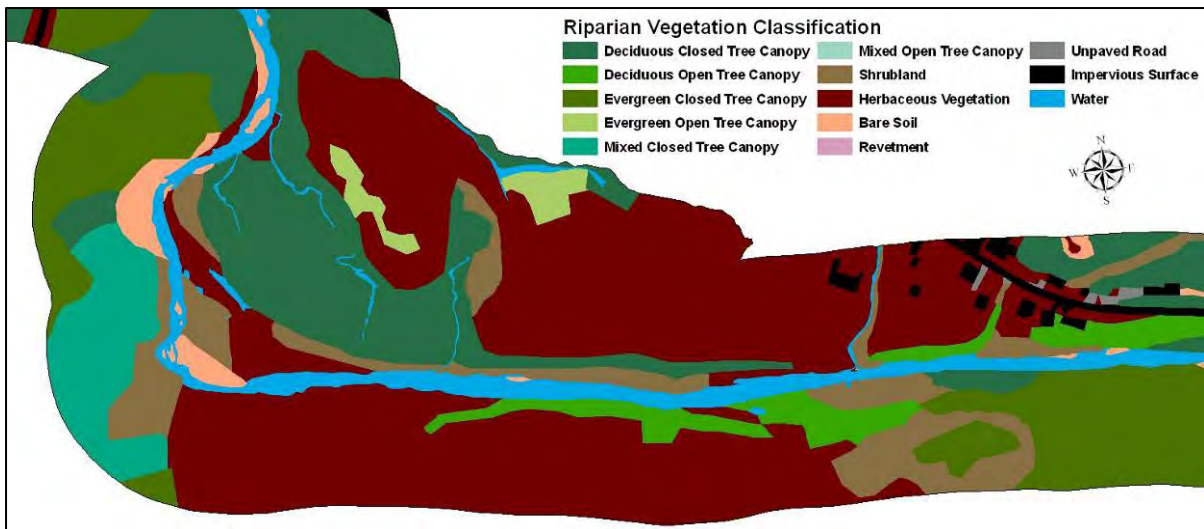
Riparian vegetation classification map based on aerial photography from 2006

An analysis of vegetation was conducted using aerial photography from 2006 and field inventories (see above map and Riparian Vegetation Mapping, Section 2.7). In this management unit, the predominant vegetation type within the 300 ft. riparian buffer was herbaceous (52.52%) followed by forested (32.22%). *Impervious* area (0.08 %) within this unit's buffer was primarily the local and private roadways. Areas of herbaceous (non-woody) cover may present opportunities to improve the riparian buffer with tree plantings in order to promote a more mature vegetative community along the streambank and in the floodplain.

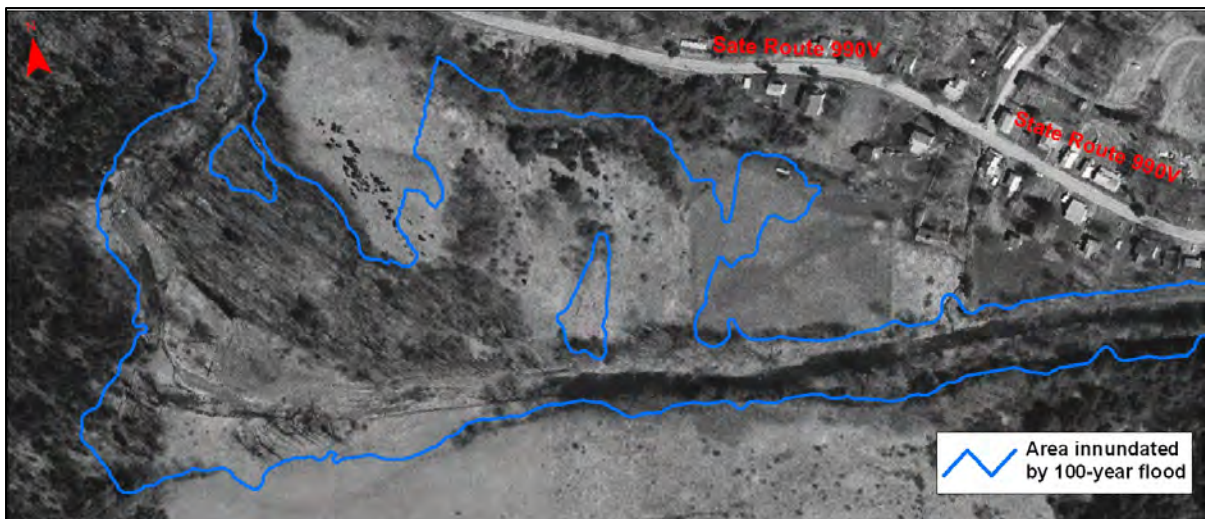
100-year floodplain boundary map

According to the current floodplain maps (above), no existing structures in this unit appeared to be situated within the estimated 100-year floodplain. The 100-year floodplain is that area predicted to be inundated by floods of a magnitude that is expected to occur once in any 100-year period, on the basis of a statistical analysis of local flood record. Most
