# Rondout Creek Management Unit 7

Management Unit 7  
Between Station 16,300 and Station 18,500

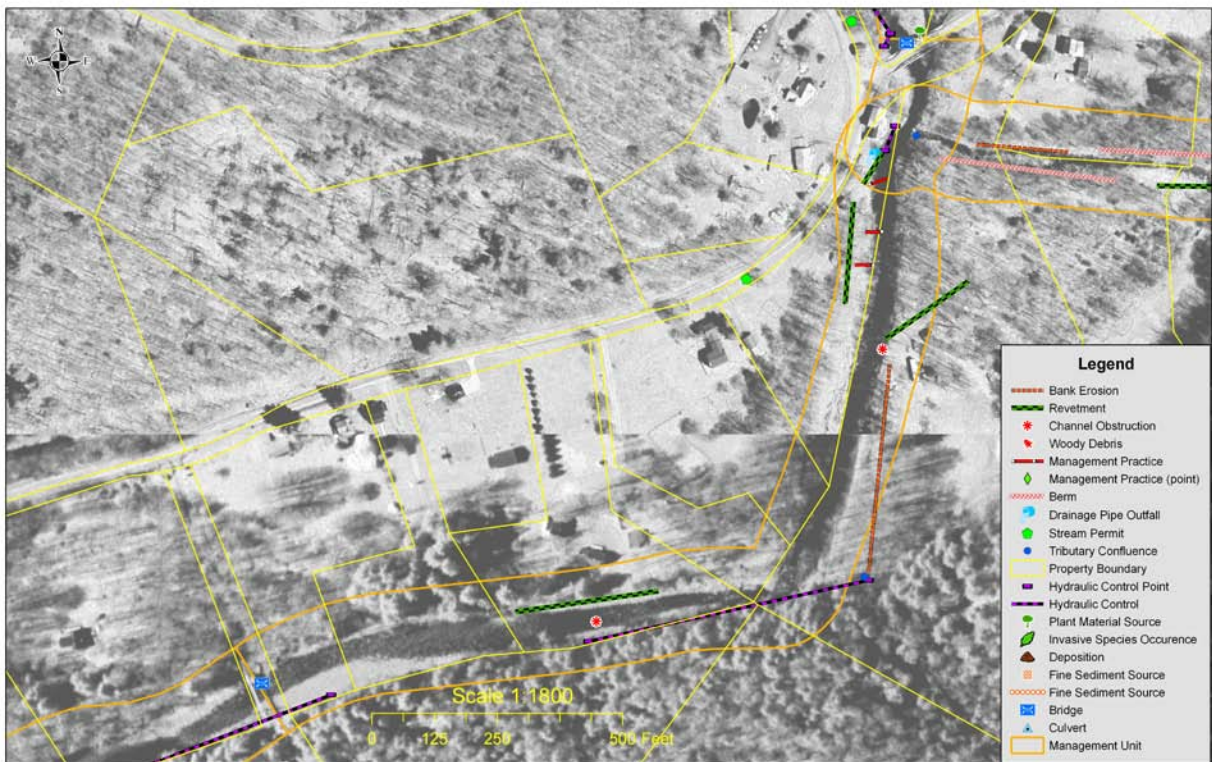
Figure 1 Stream Feature Inventory 2008

- 9% of stream length is experiencing erosion
- 18 % of stream length has been stabilized
- 2.34 acres of inadequate vegetation within the 100 ft. buffer
- 470 ft. of stream is within 50 ft. of the road
- 2 houses located within the 100-year floodplain boundary

The 2009 stream feature inventory revealed that 9 % (415 ft.) of the stream length exhibited signs of active erosion along 2,234 ft. of total channel length (Fig.1). Revetment has been installed on 17.12 % (766 ft.) of the stream length. No berms were identified in this management unit at the time of the stream feature inventory.

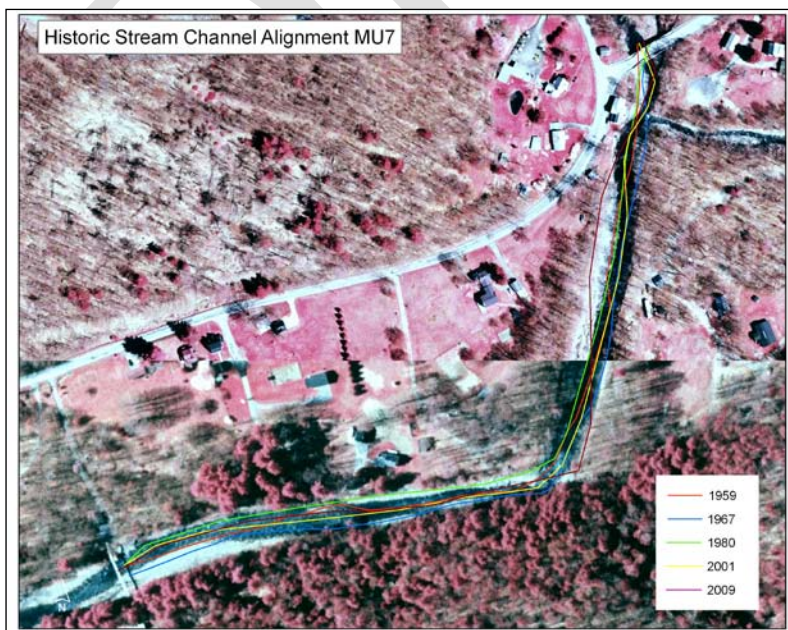
Figure 3 Historical channel alignments from five selected years

found at this confluence region tend to be highly changeable, with extensive channel shifting. The historical channel overlay shown in figure 4 below, however, indicates that while bank erosion and flooding may be endemic here, the channel position has remained relatively stable, with mature forest cover on both right and left banks for much of the reach.
