Rondout Creek Management Unit 10

Management Unit 10
Between Station 25,300 and Station 27,200

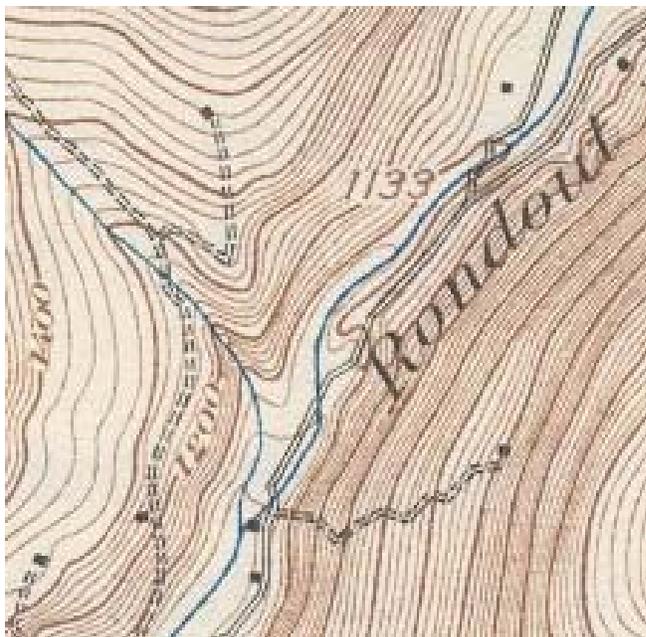
Figure 2 Excerpt of 1905 USGS topographic map MU10

As the Rondout Creek enters the upstream end of MU10, the channel runs along a high ledge on the left, with the bed elevation also controlled by bedrock. The valley floor is relatively pinched at this location, although the channel has a narrow but well-connected alluvial floodplain on the right (Figure 2), part of the historical deposition created by sediment supply and backwater from the confluence of High Falls Brook just downstream. Between Stations 26700 and 26400, the channel moves across this floodplain to the right valley wall. The 1905 USGS topo map (Figure 1)
