Schoharie Creek Management Unit 1

Town of Hunter - Prediger Rd. (Station 159225) to Dale Lane (Station 151439)

This management unit begins at Prediger Road, continuing approximately 7,786 ft. downstream to Dale Lane in the Town of Hunter.

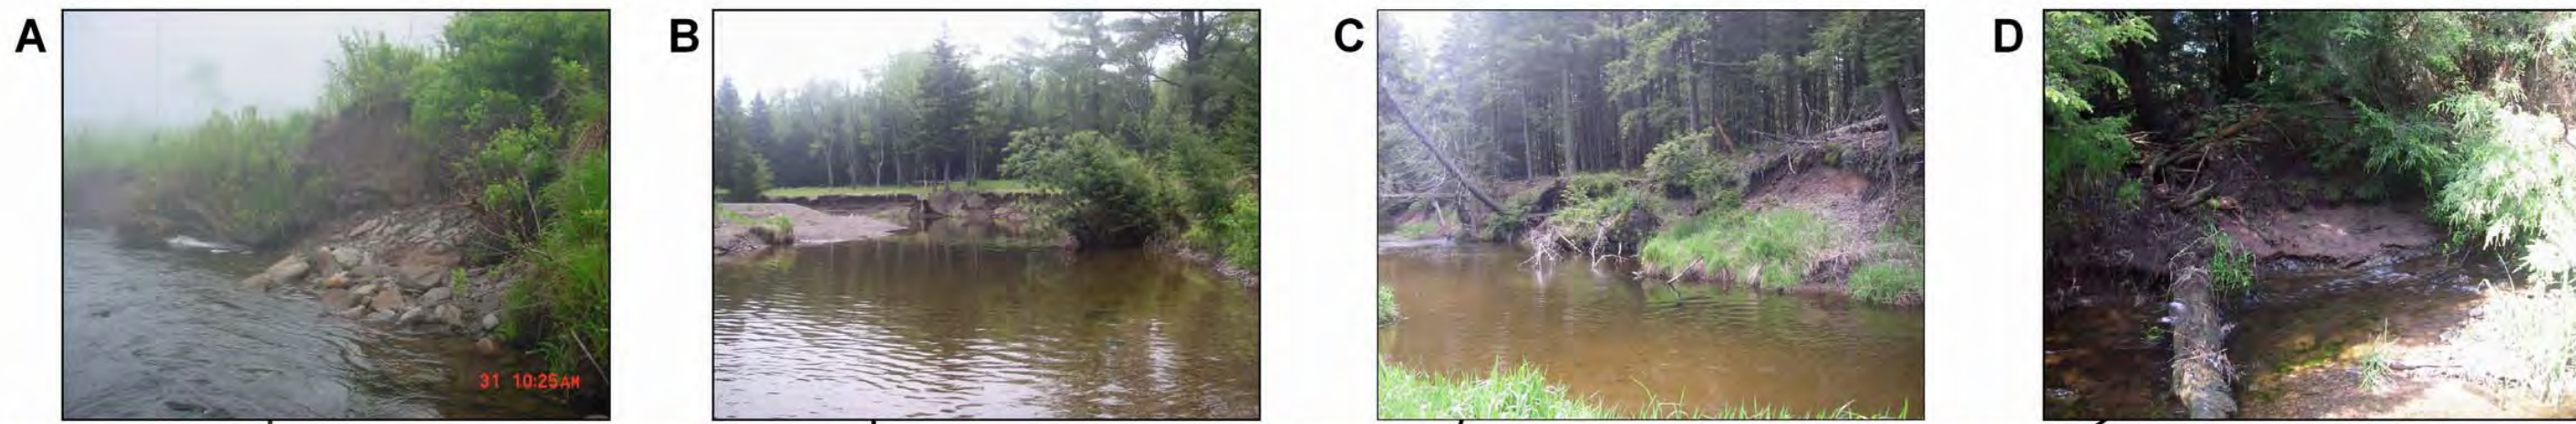
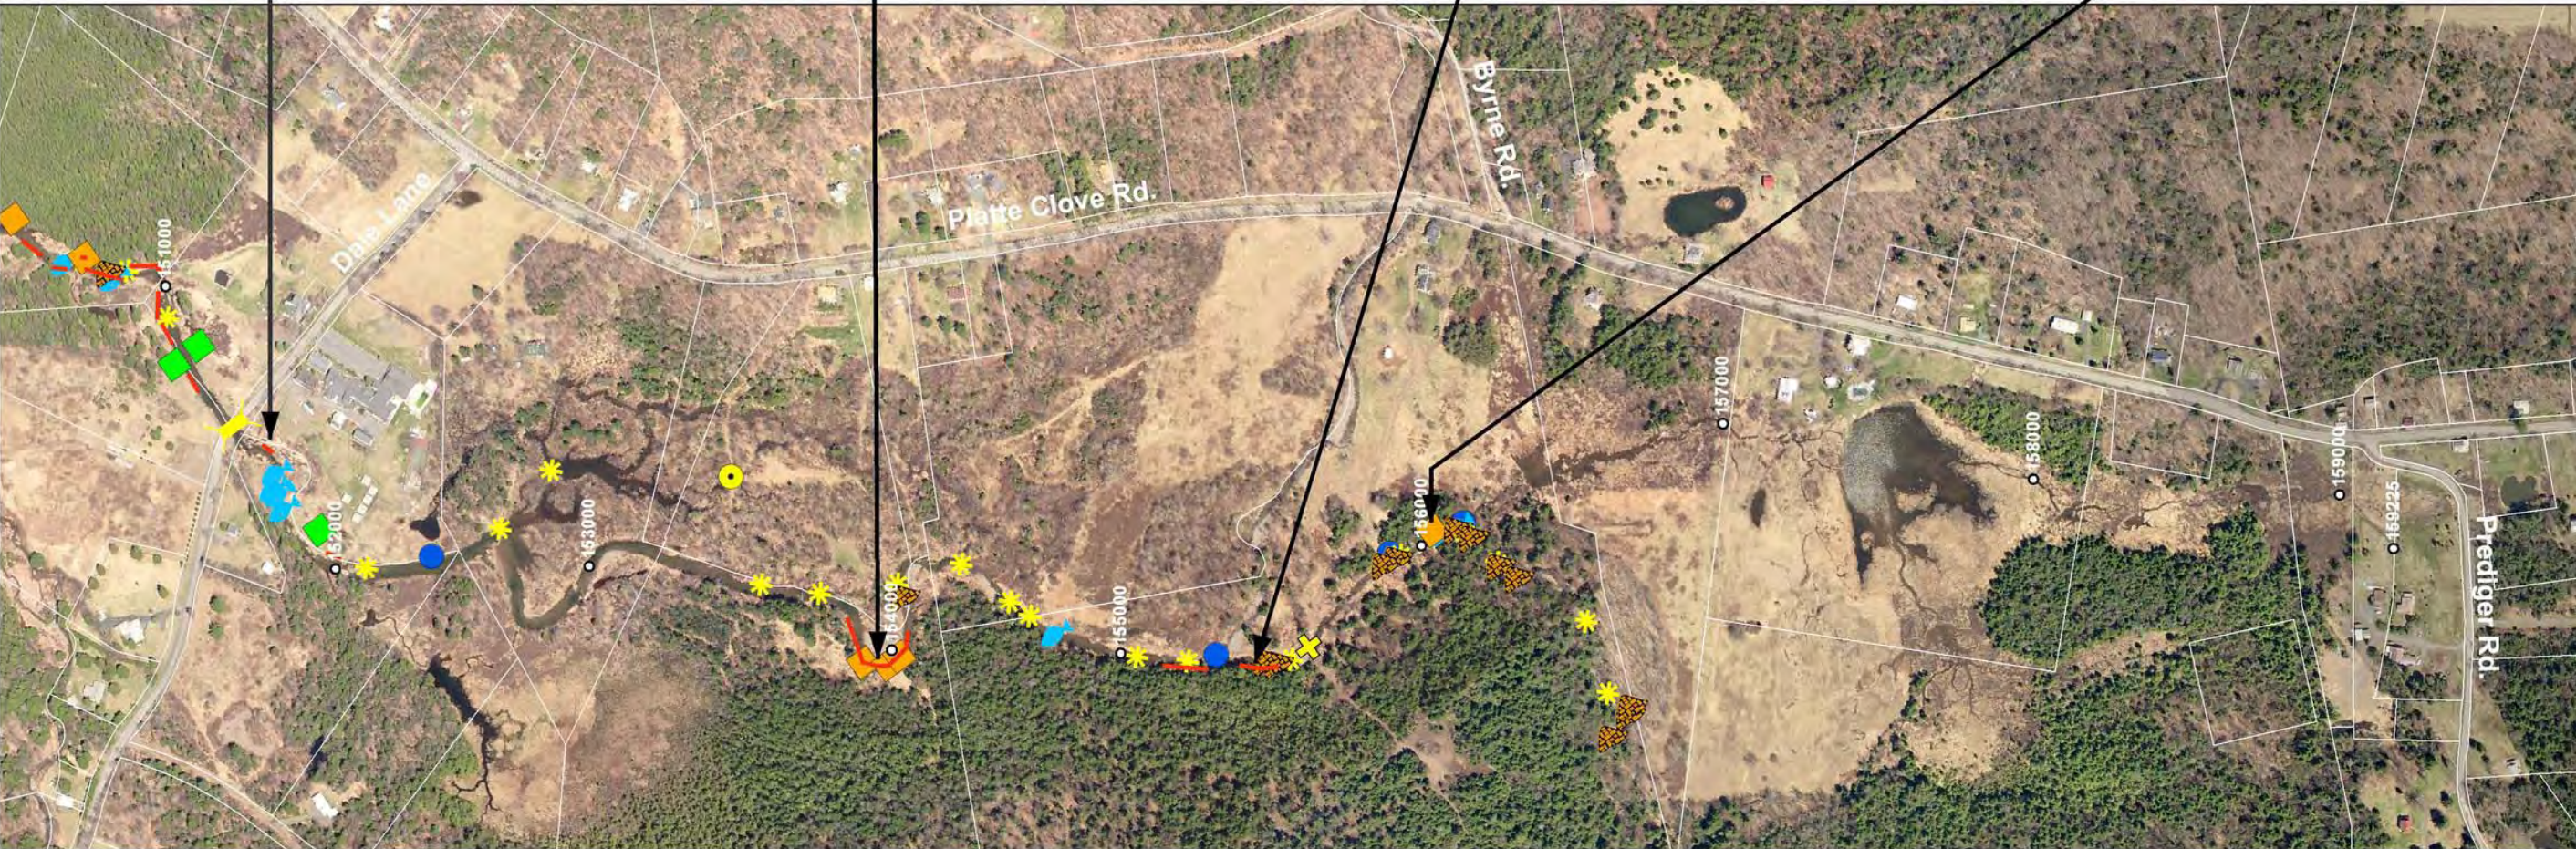
Figure 4.1.1 Management Unit 1 - 2006 aerial photography with stream feature inventory

The 2006 stream feature inventory revealed that 4.2% (653 ft.) of the streambanks exhibited signs of active erosion along 15,571 ft. of total channel length (Fig. 4.1.1). The total surface area of active erosion totaled approximately 5,555 ft². No *revetment* or *berms* were identified in this management unit during the 2006 stream feature inventory.

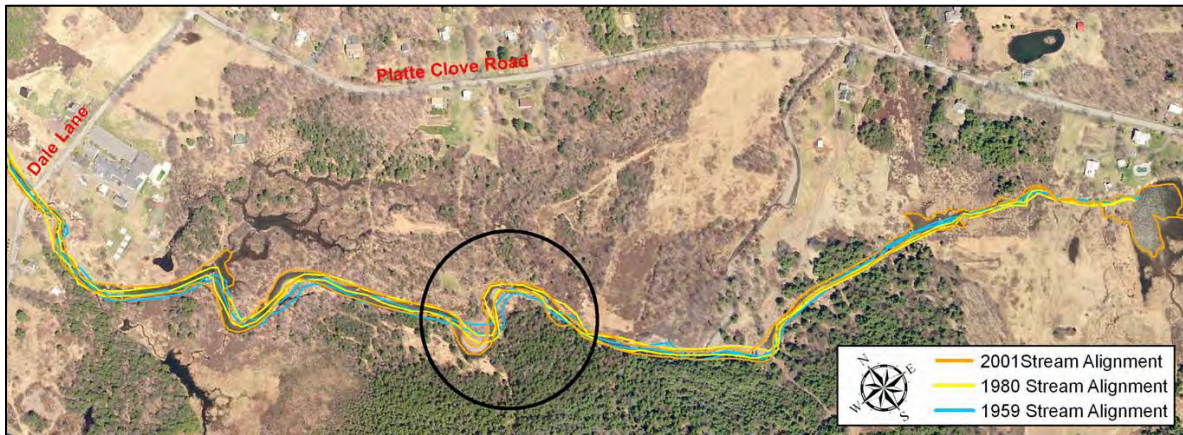
As seen from the historical stream channel alignments (below), with the exception of the *meander* bend in the middle of this management unit, the channel alignment has not changed significantly over the years.

Historic stream channel alignments beginning at Station 157400 overlaid with 2006 aerial photograph

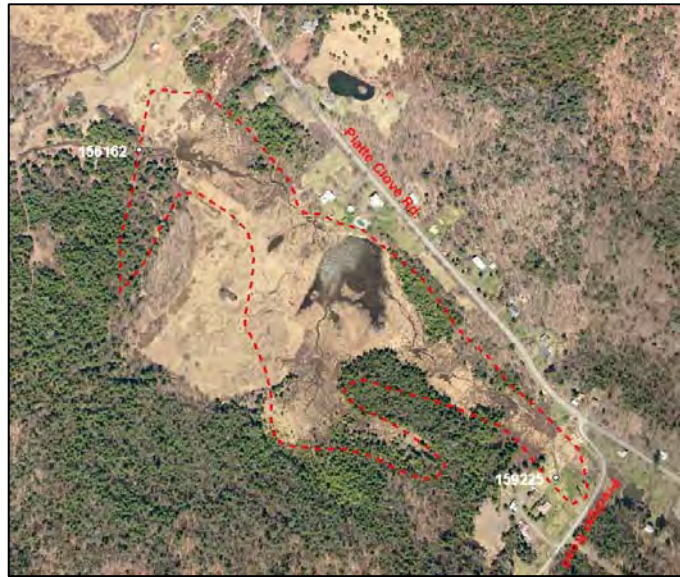
improving water quality, providing fish and wildlife habitats, storing floodwaters, and maintaining surface water flow during dry periods. This palustrine wetland was approximately 34 acres with forested, shrub-scrub, and emergent vegetation, as well as areas of open water (see Section 2.6 for detailed wetland type descriptions).

Palustrine wetland (Station 159225 – 156162)

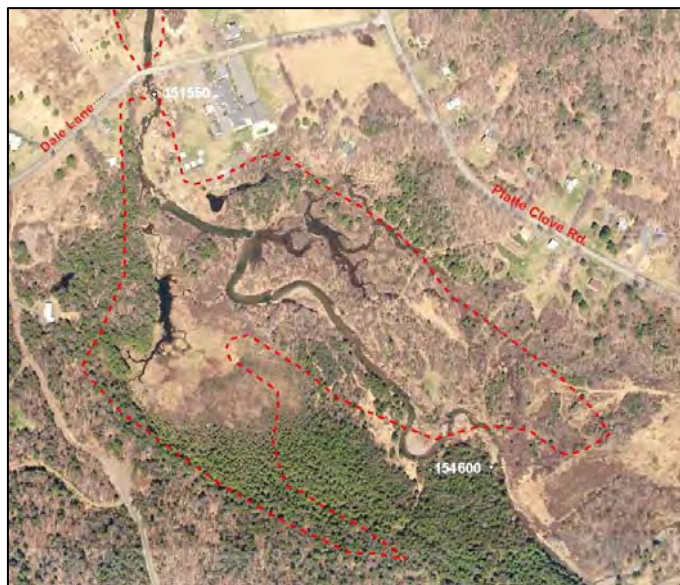
Palustrine wetland (Station 154600 – 151550)
