Schoharie Creek Management Unit 7

Towns of Hunter and Jewett – Bridge St.(Station 104521) to Station 91473

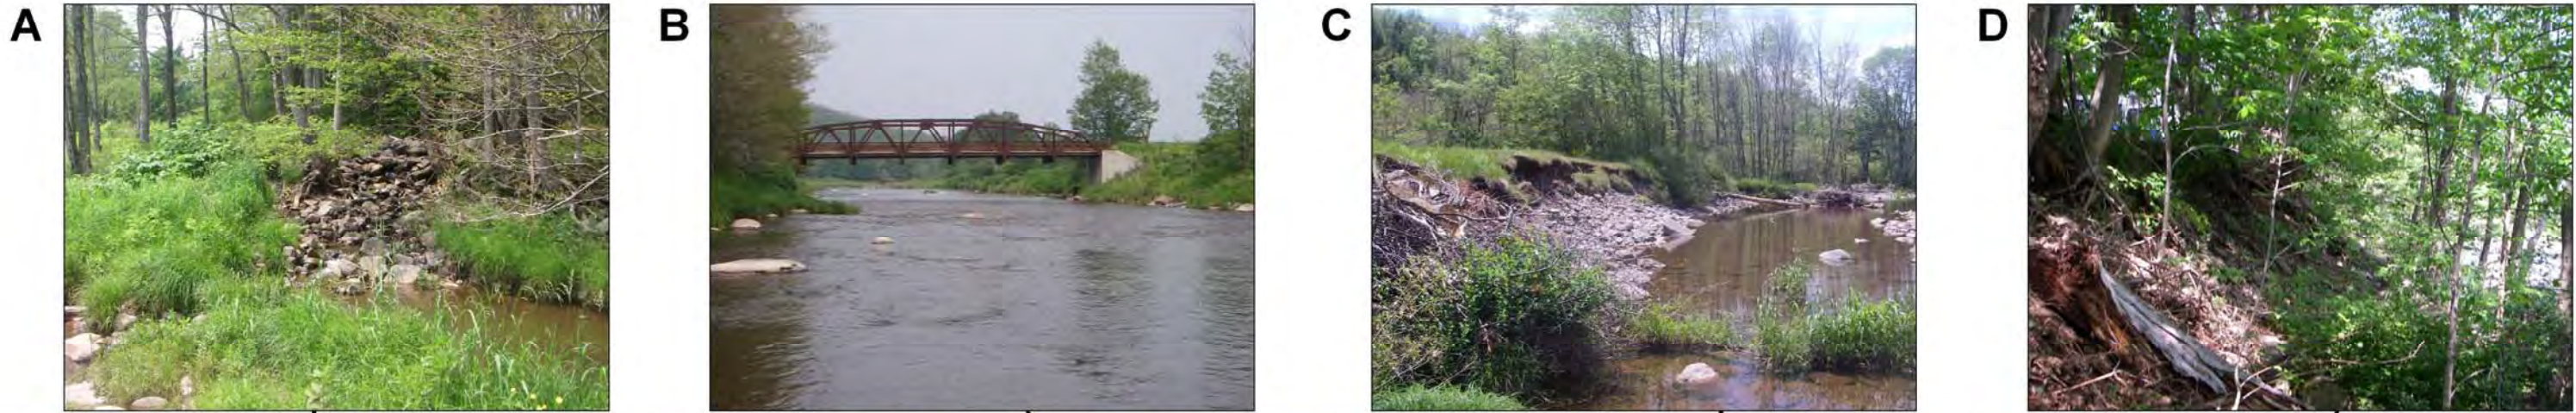
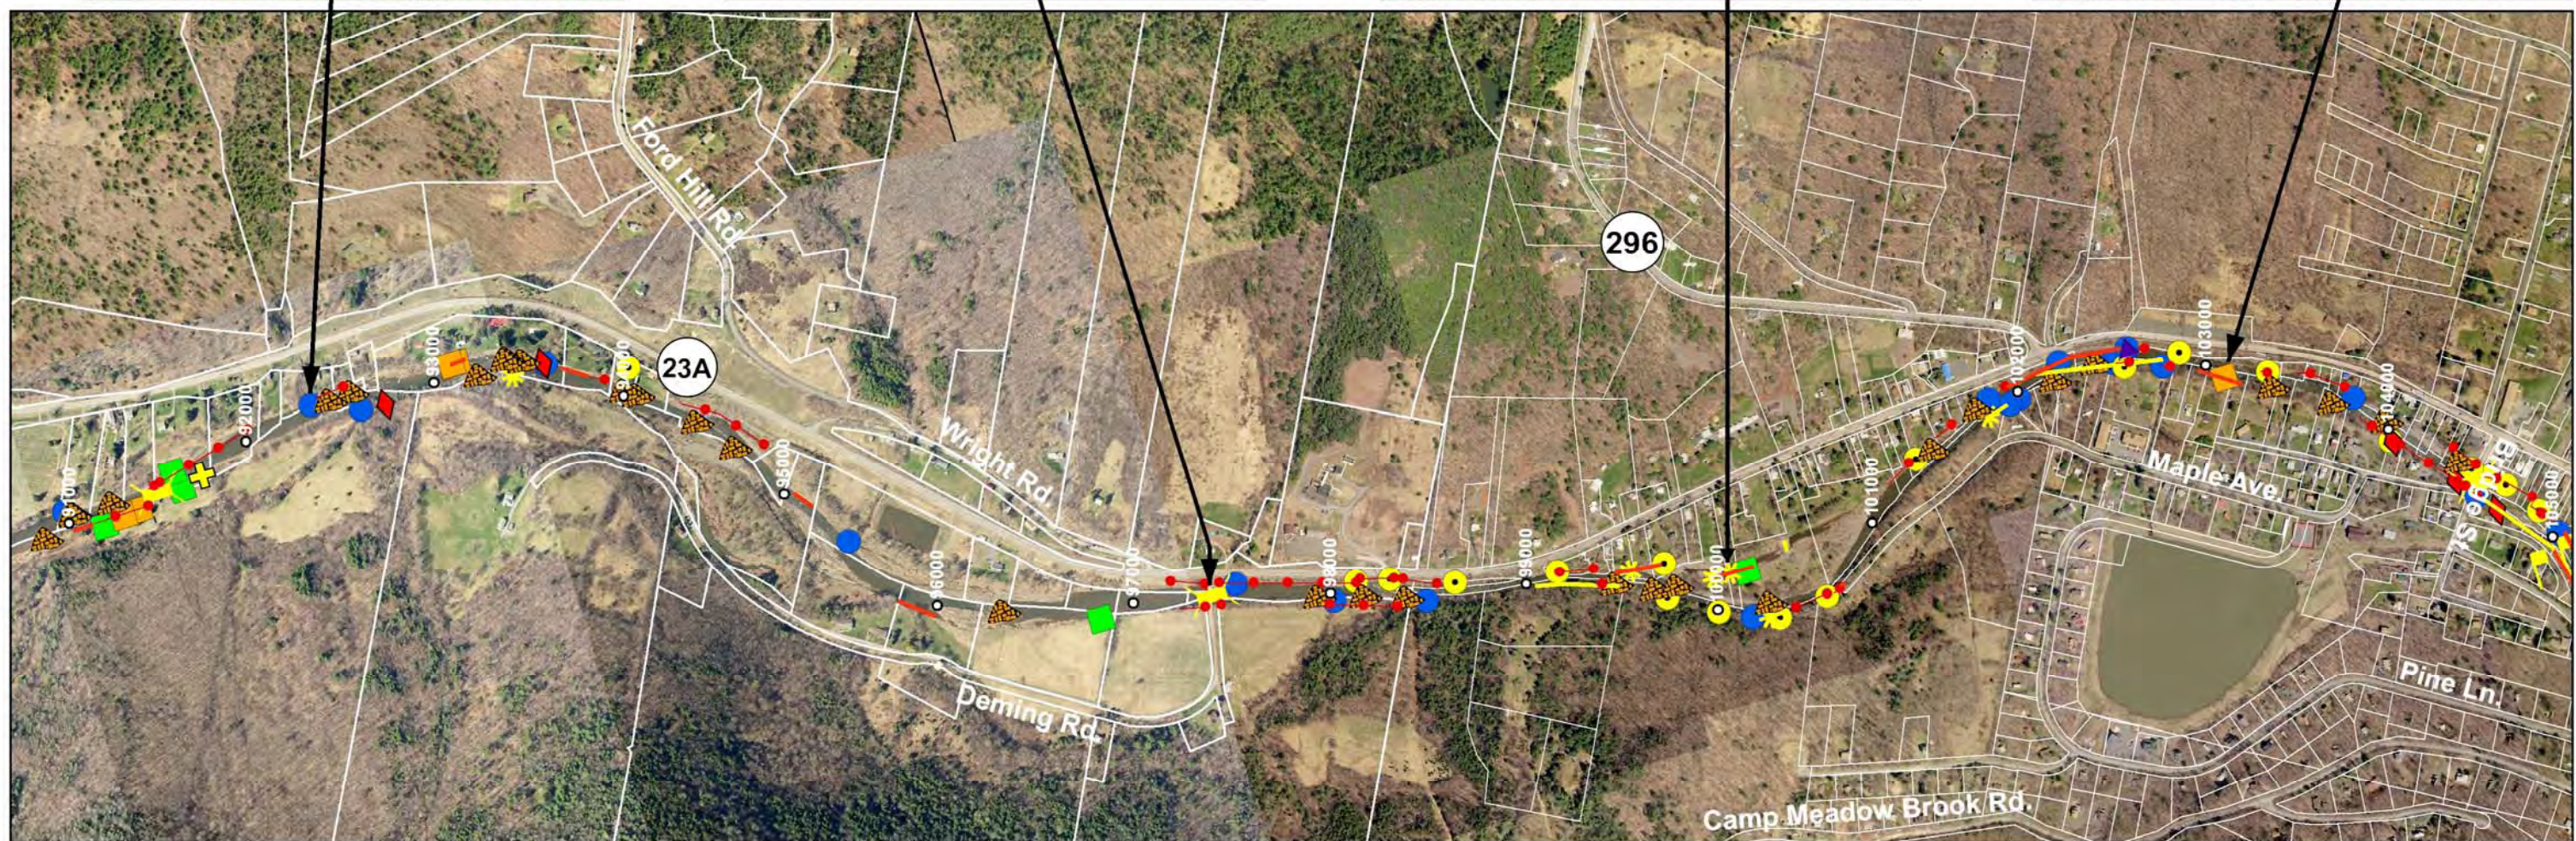
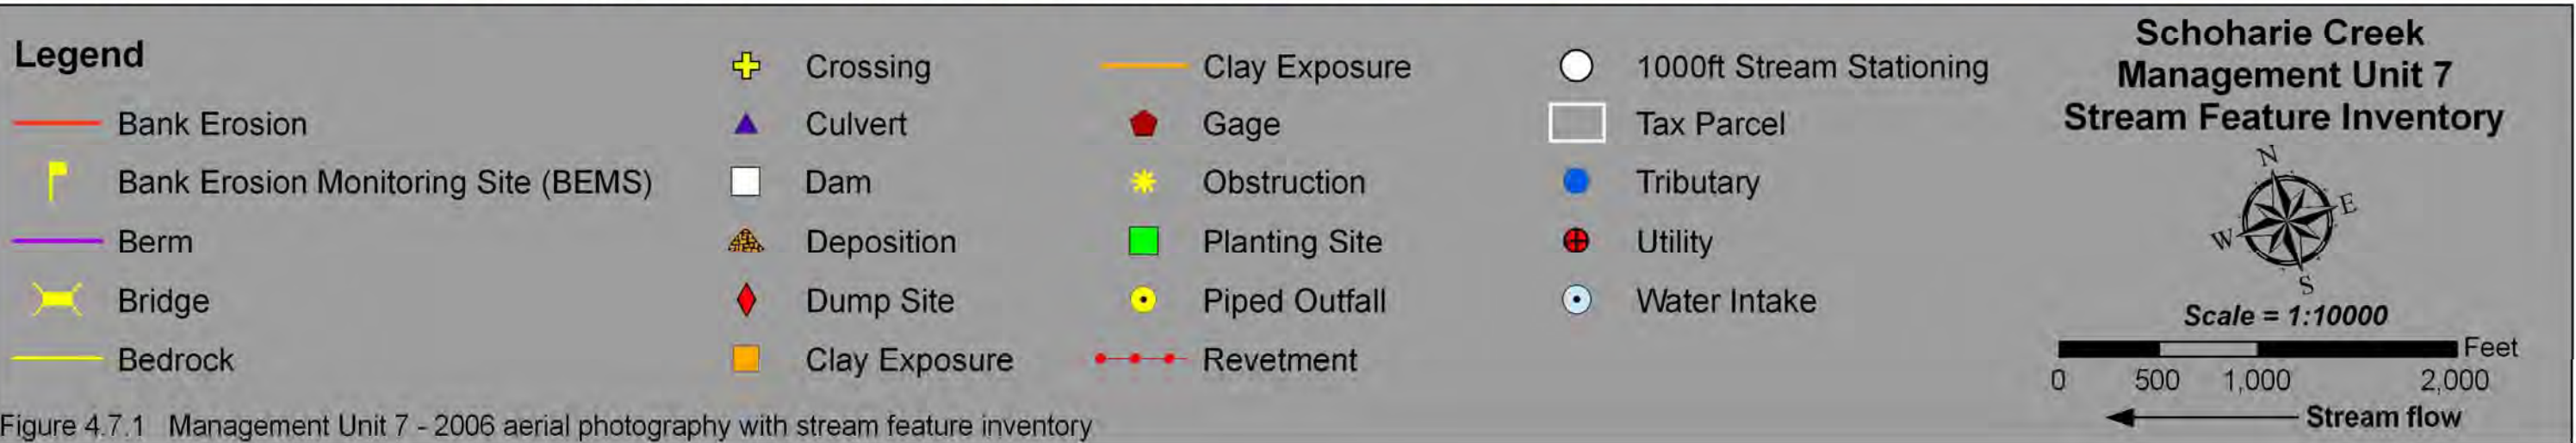
Figure 4.7.1 Management Unit 7 - 2006 aerial photography with stream feature inventory

The 2006 stream feature inventory revealed that 7.5% (1,958 ft) of the streambanks exhibited signs of active erosion along the 26,096 ft of total channel length in the unit (Figure 4.7.1). The total surface area of active erosion totaled approximately 29,691 ft². *Revetment* has been installed on 20.1% (5,247 ft) of the streambanks. No *berms* were identified in this management unit at the time of the stream feature inventory.

Summary of Recommendations Management Unit 7	
Intervention Level	Passive, Assisted Self-Recovery
Stream Morphology	No recommendations at this time
Riparian Vegetation	Plantings for assisted self-recovery of eroding banks at Stations 101130 & 99700, and enhancement of riparian buffer at Station 97370.
Infrastructure	No recommendations at this time
Aquatic Habitat	Watershed Aquatic Habitat Study
Flood Related Threats	Installation of flood plain drainage, and/or regrading of the right streambank floodplain area to floodplain elevation, and installation of riparian plantings to address flooding issues at private bridge (Station 91473).
Water Quality	Removal of dump sites at Stations 104440 & 104050.
Further Assessment	Community-Wide Stormwater Infrastructure Assessment & Planning

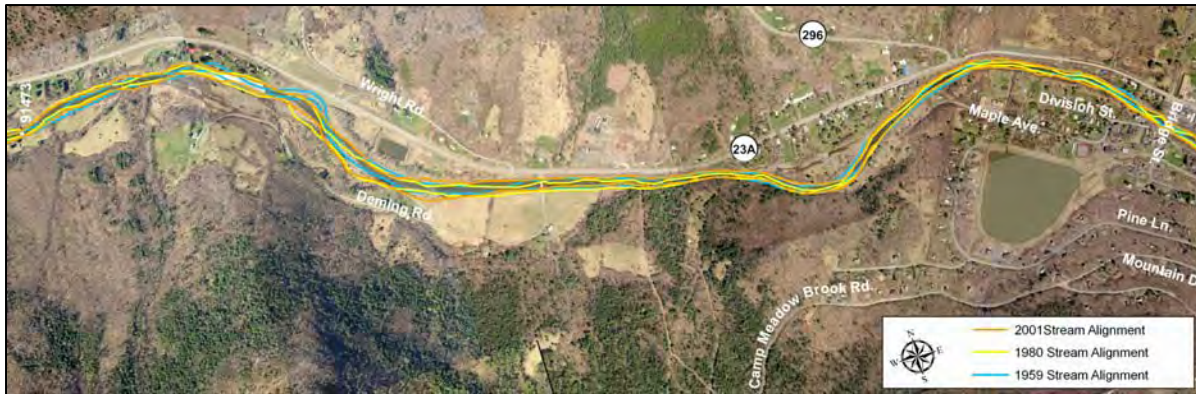
As seen from the historical stream alignments (below), the *planform* of the channel has remained fairly stable since 1959.

Historic stream channel alignments overlaid with 2006 aerial photograph

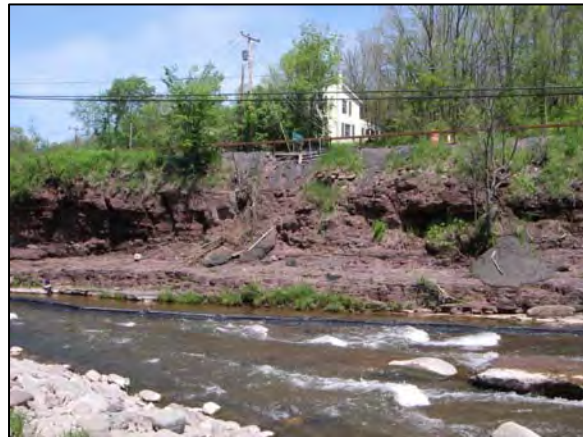
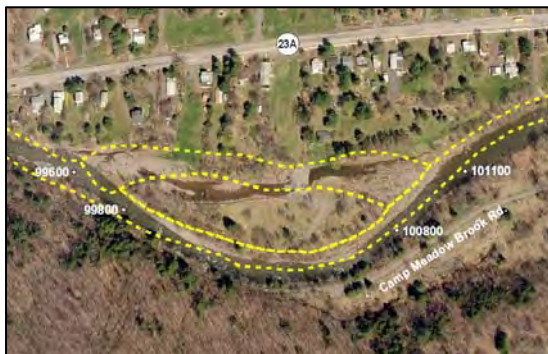
Wetland (Station 101100-99600 & 100800-99800)
Approximate wetland boundary delineated by NWI

At the next meander bend, stream confinement was reduced allowing some floodplain access. There were two wetlands mapped in this area. Along the right streambank there was a 2.5 acre palustrine wetland with emergent vegetation (PEM1E, Station 101100-99600) and a 3 acre upland wetland on the center bar (U, Station 100800-99800).

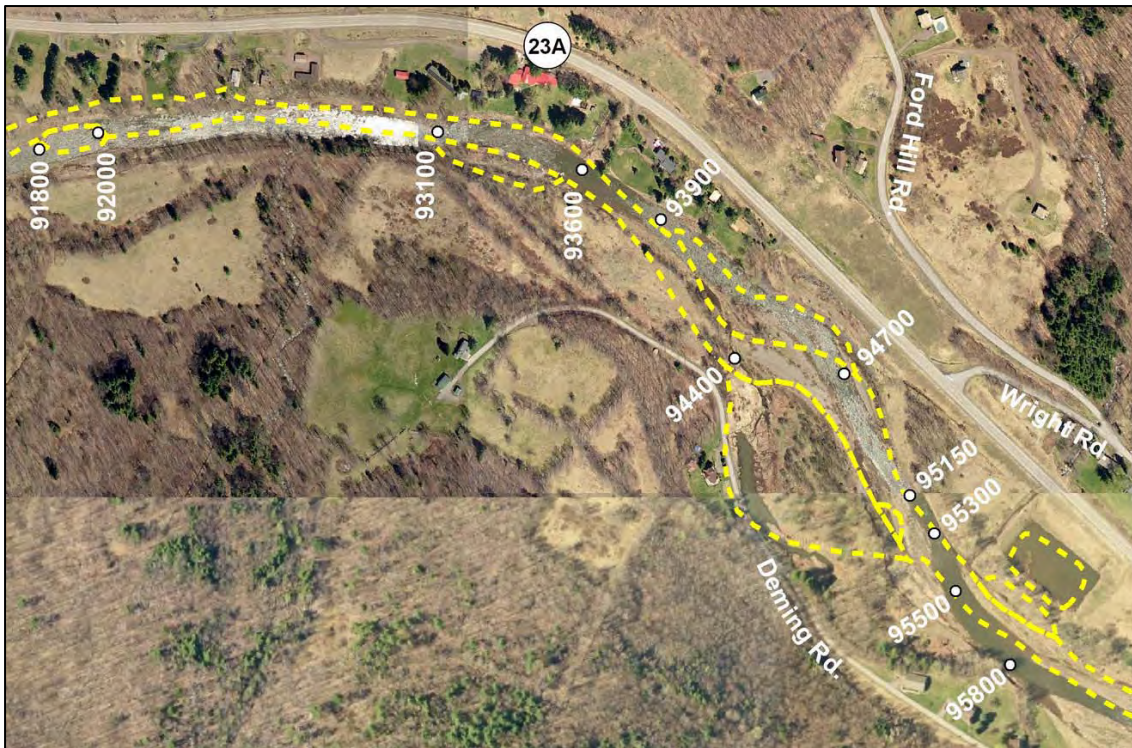
There were six wetlands located along the stream corridor from here to the end of the management unit. Four of these were classified as riverine lower perennial wetlands, located at Station 95800-95500 (R2USC, 0.4ac), Station 95300-95150 (R2USC, 0.09ac), Station 94700-93900 (R2USC, 1.7ac), Station 92000-91800 (R2USA 0.3ac). Two palustrine forested wetlands were located along the left streambank at Station 95300-94400 (PFO1A, 4.8ac) and Station 93600-93100 (PFO1A, 0.7ac).

Wetland boundaries approximately delineated by NWI from Station 95800 to 91800

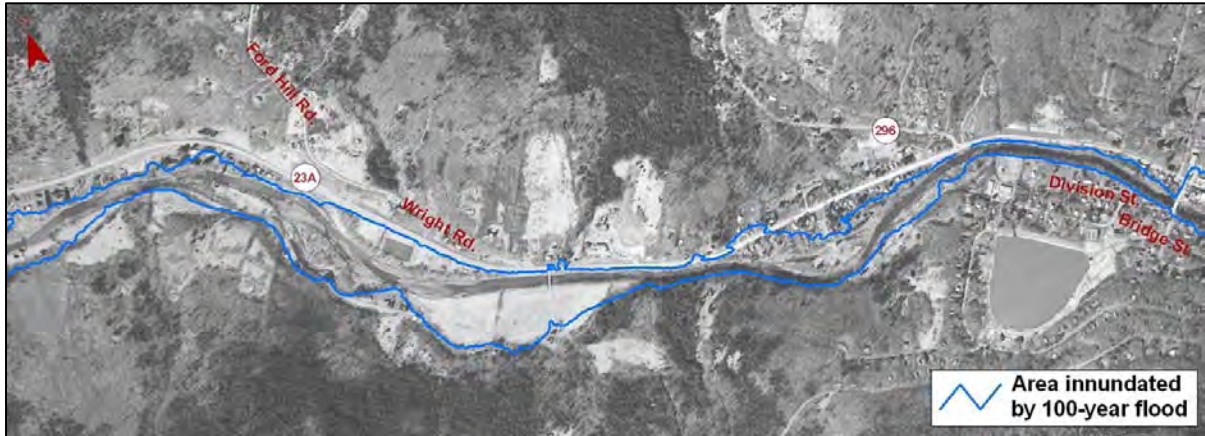
100-year floodplain boundary map

According to the current floodplain map (above), twenty-five existing structures in this unit appeared to be situated within the estimated 100-year floodplain. The 100-year floodplain is that area predicted to be inundated by floods of a magnitude that is expected to occur once in any 100-year period, on the basis of a statistical analysis of local flood record. Most communities regulate the type of development that can occur in areas subject to these flood risks.
