# West Kill Management Unit 1

## Management Unit 1

Between Station 56747 and Station 53971

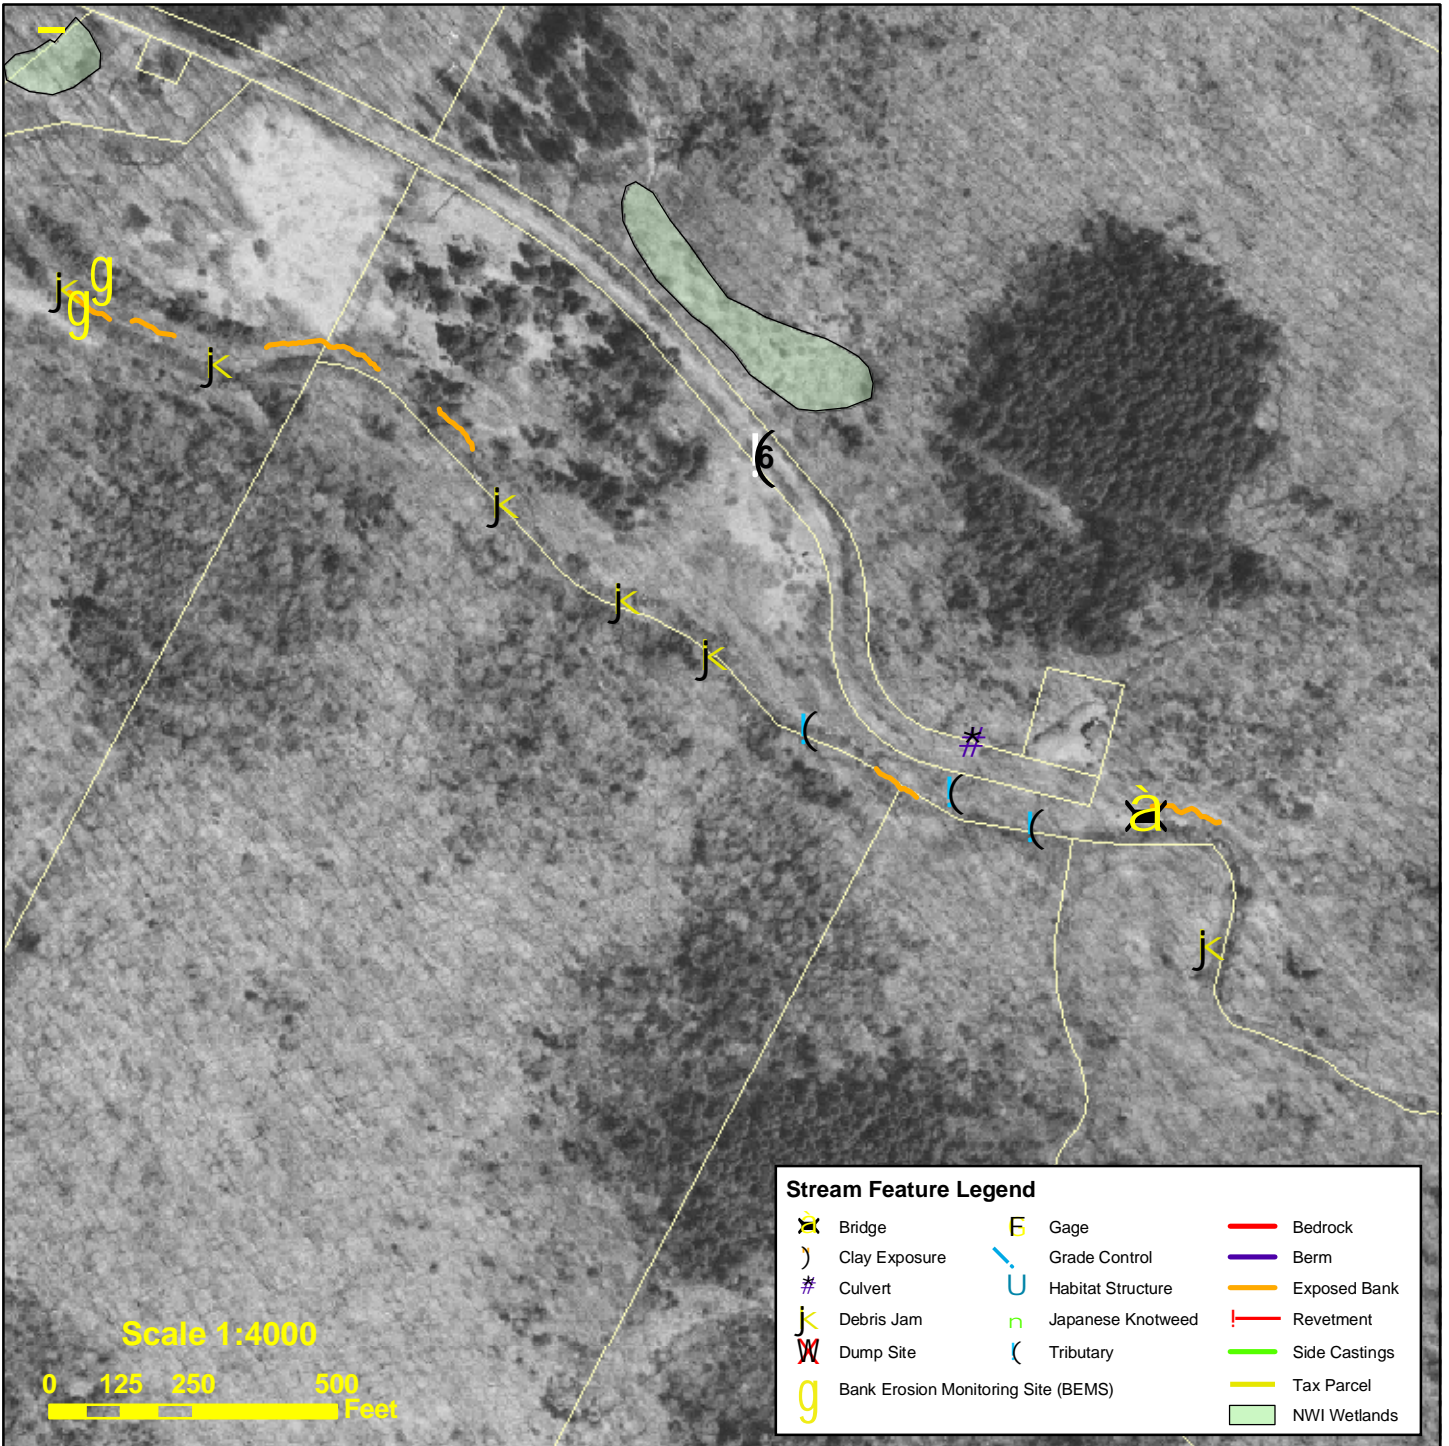
Figure 4.1.1 2004 aerial photography with stream feature inventory and tax parcels

- 23% of stream length is experiencing erosion
- 0% of stream length has been stabilized
- 2.0 acres of inadequate vegetation within the 300 ft. buffer
- 792 ft. of stream is within 50 ft. of the road
- 0 houses located within the 100-year floodplain boundary

The 2004 stream feature inventory revealed five eroding banks. Twenty-six percent (725 ft.) of the total channel length (2585 ft.) exhibited signs of active erosion on one or both banks (Fig. 4.1.1). None of these areas were significant enough to warrant documentation as a Bank Erosion Monitoring Site (BEMS), and there was no evidence of clay exposures in the unit. No revetment or berms were identified in this management unit at the time of the stream feature inventory.

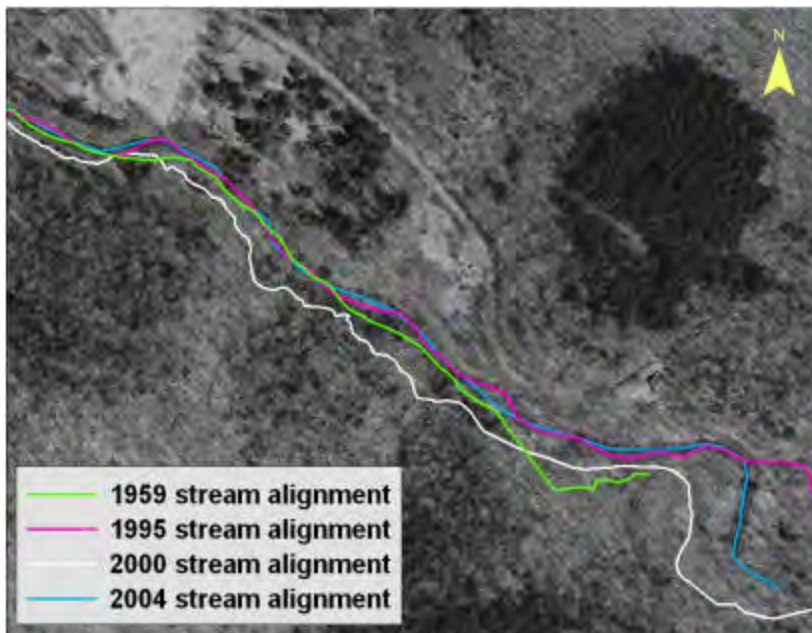
Historic Stream Channel Alignments in MU1

As seen from the historical stream alignments, the channel alignment has not changed significantly over the years.

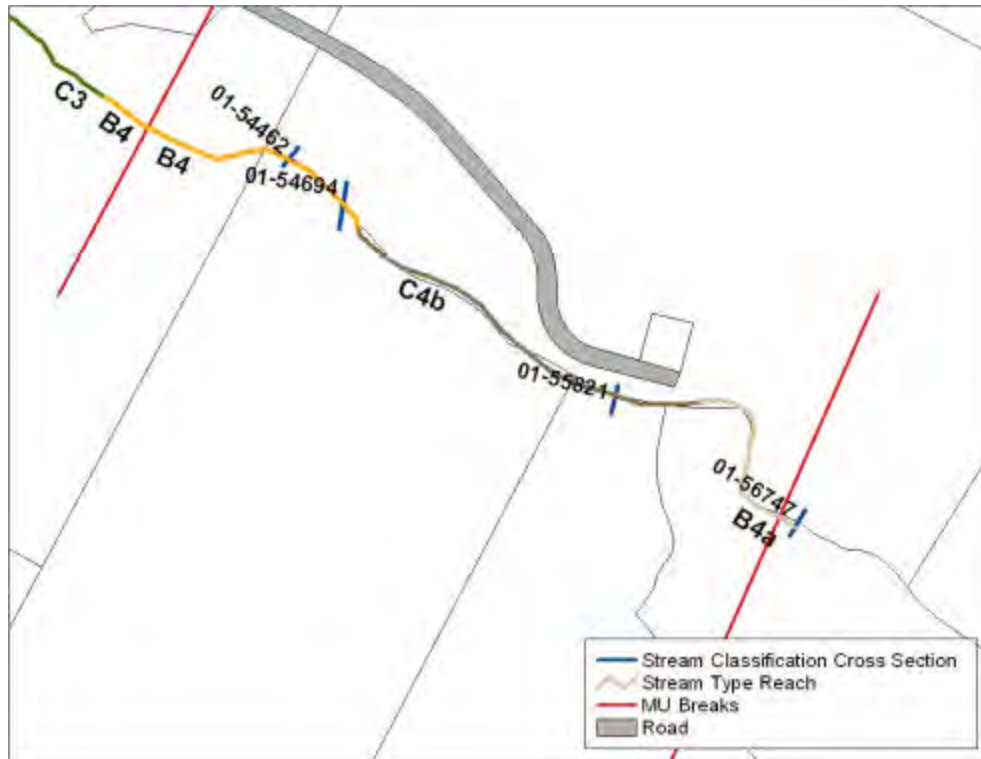
**Cross-section and Rosgen stream types in Management Unit 1**

Management Unit 1 begins with a 650 ft. section of B4a stream type, as determined from a monumented survey cross-section at the origin of our Stream Feature Inventory (Station 56747). The channel is moderately *entrenched*, or confined within the stream banks during high flood events. The channel slope is 4.02 %, and the bed material is dominated by gravel, but with abundant cobble and boulders. This reach appears exceptionally stable and should be monitored as a reference reach, for potential future use in design.

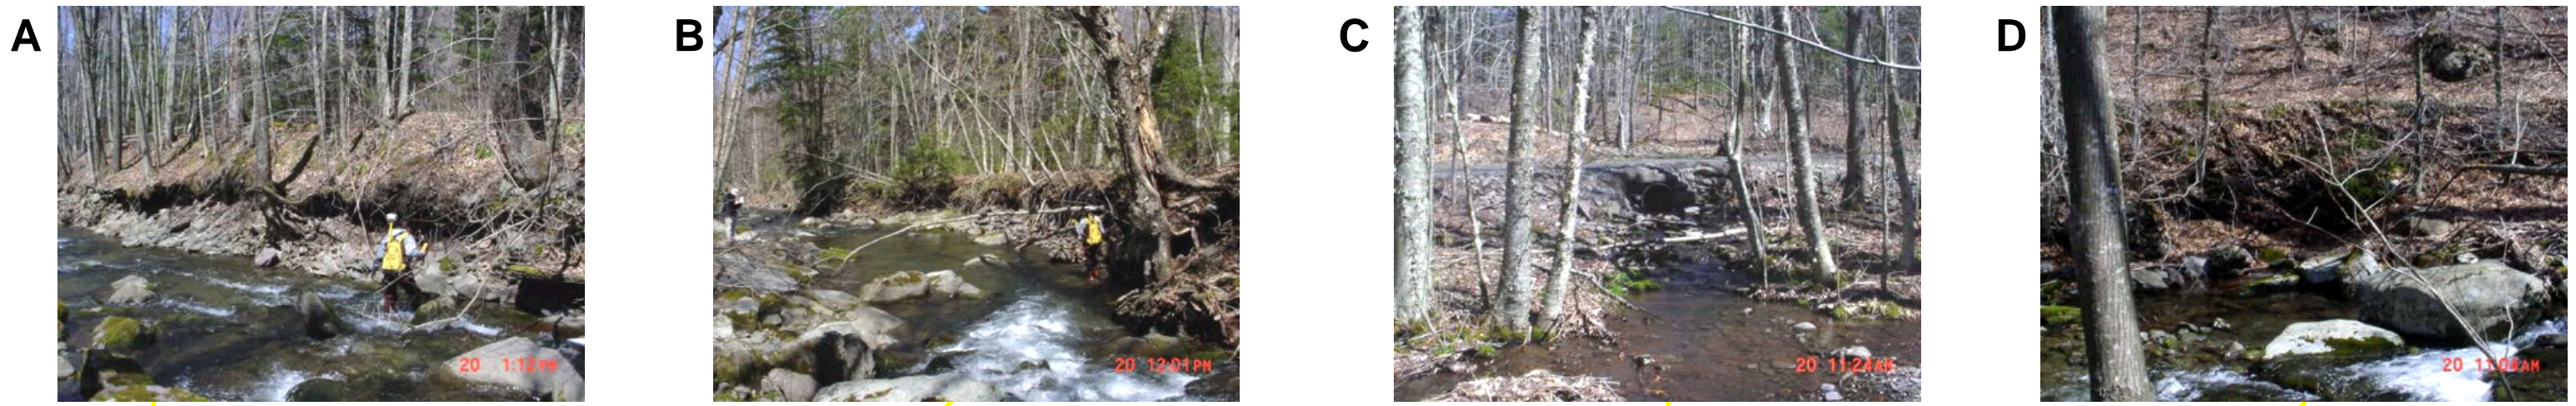
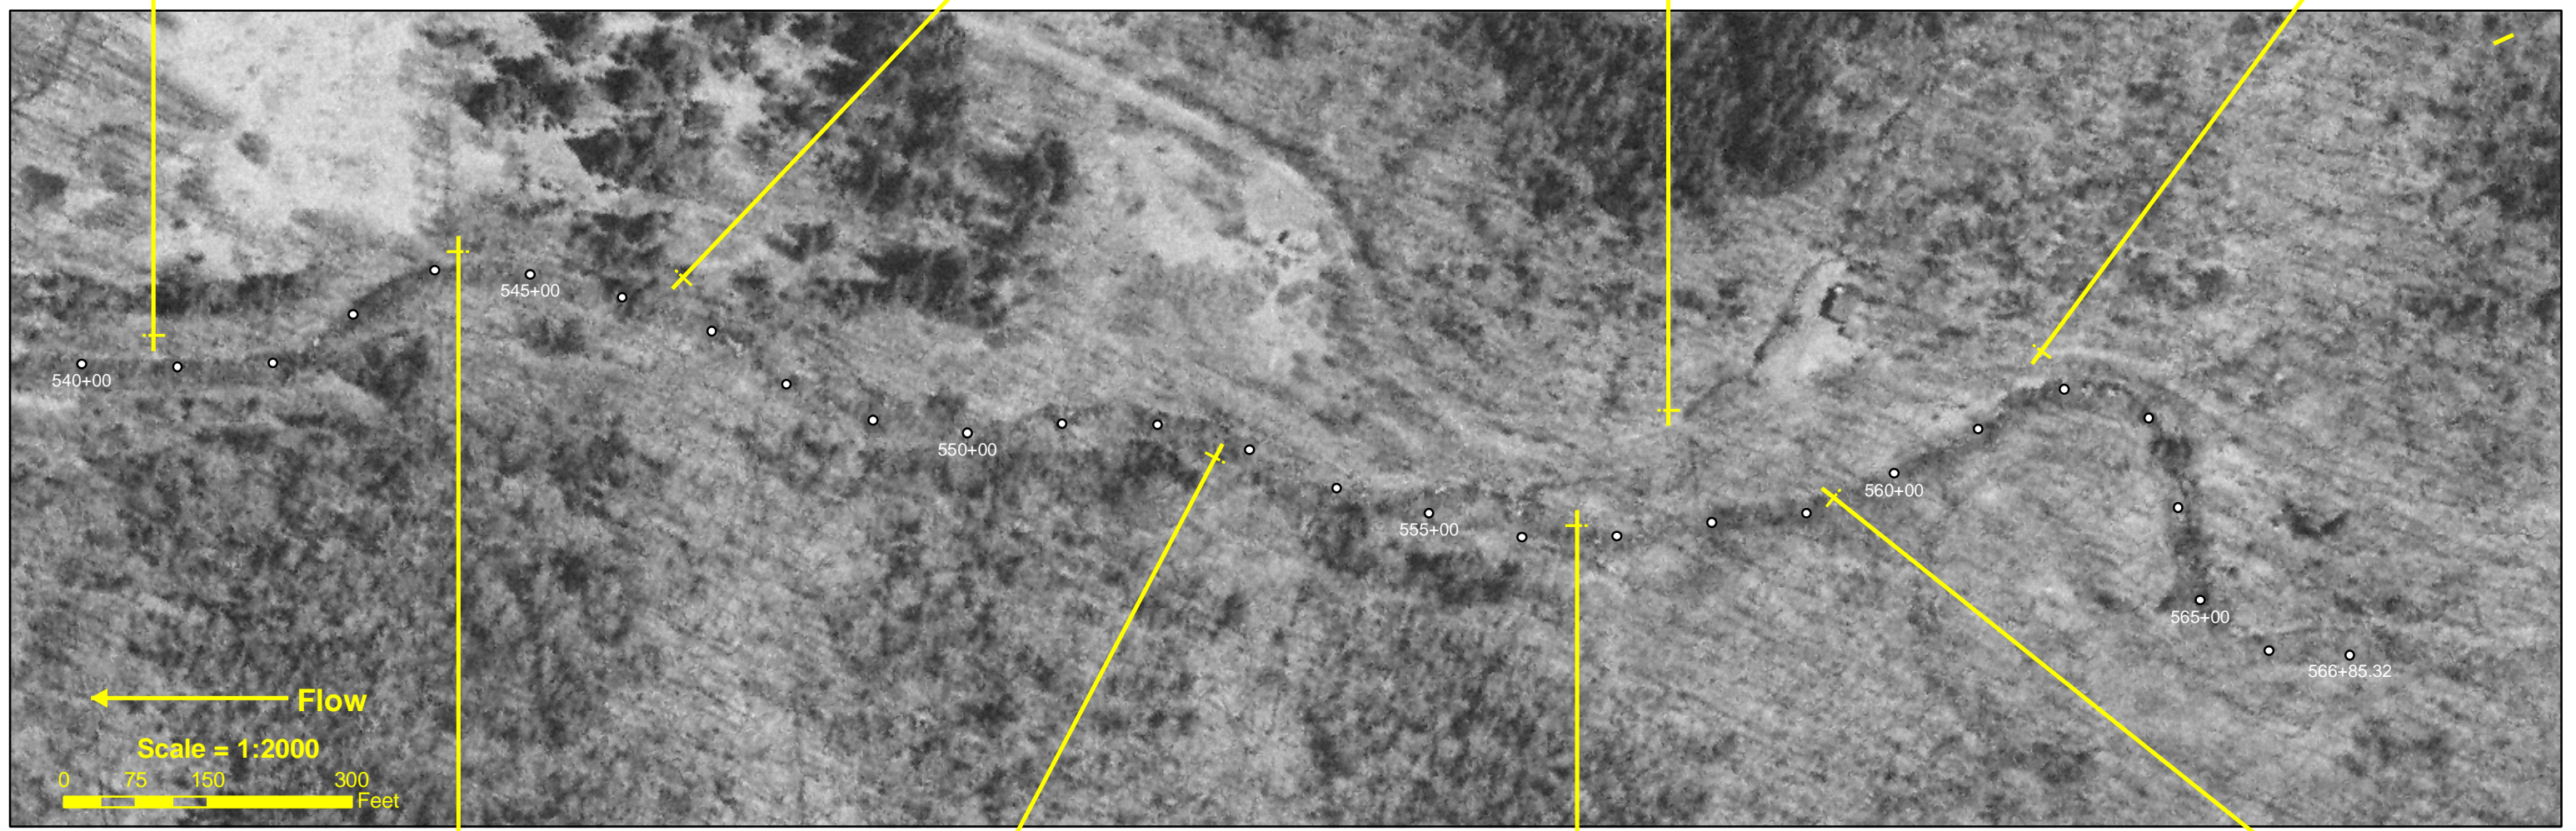
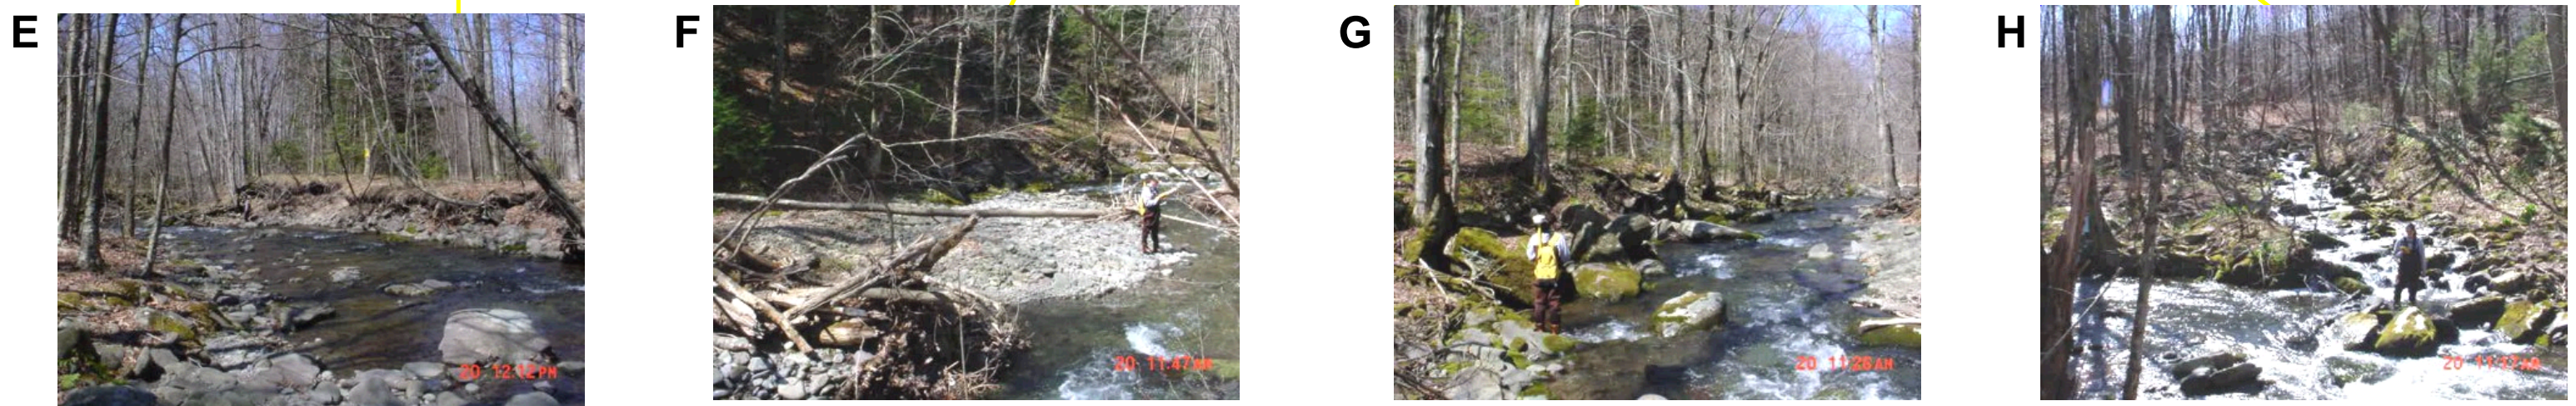
Figure 4.1.2 Management Unit 1 - 2004 aerial photography

Downstream of the abutments, an unnamed tributary enters from the left (Inset H, Fig. 4.1.2). Approximately 100 ft. downstream of the confluence, a monumented cross-section has been established (Station 55821). This 1300 ft. reach becomes a less entrenched C4b stream type, with slope diminishing to 2.49 %. Gravel still dominates the substrate.

Downstream, an unnamed tributary enters from the right (Inset C, Fig. 4.1.2). This tributary is conveyed under the adjacent dirt road on the right by a culvert (approximate diameter 30”), and becomes *braided*, with several distinct channels, at the confluence with the West Kill.

Continuing downstream, some minor erosion is evident on the left lower bank (Inset G, Fig. 4.1.2). The toe is protected by natural boulders, and has high potential for recovery without intervention. Downstream, an unnamed tributary enters from the left. The tributary appears stable and well
