West Kill Management Unit 3

Management Unit 3

Between 51153 and 48476

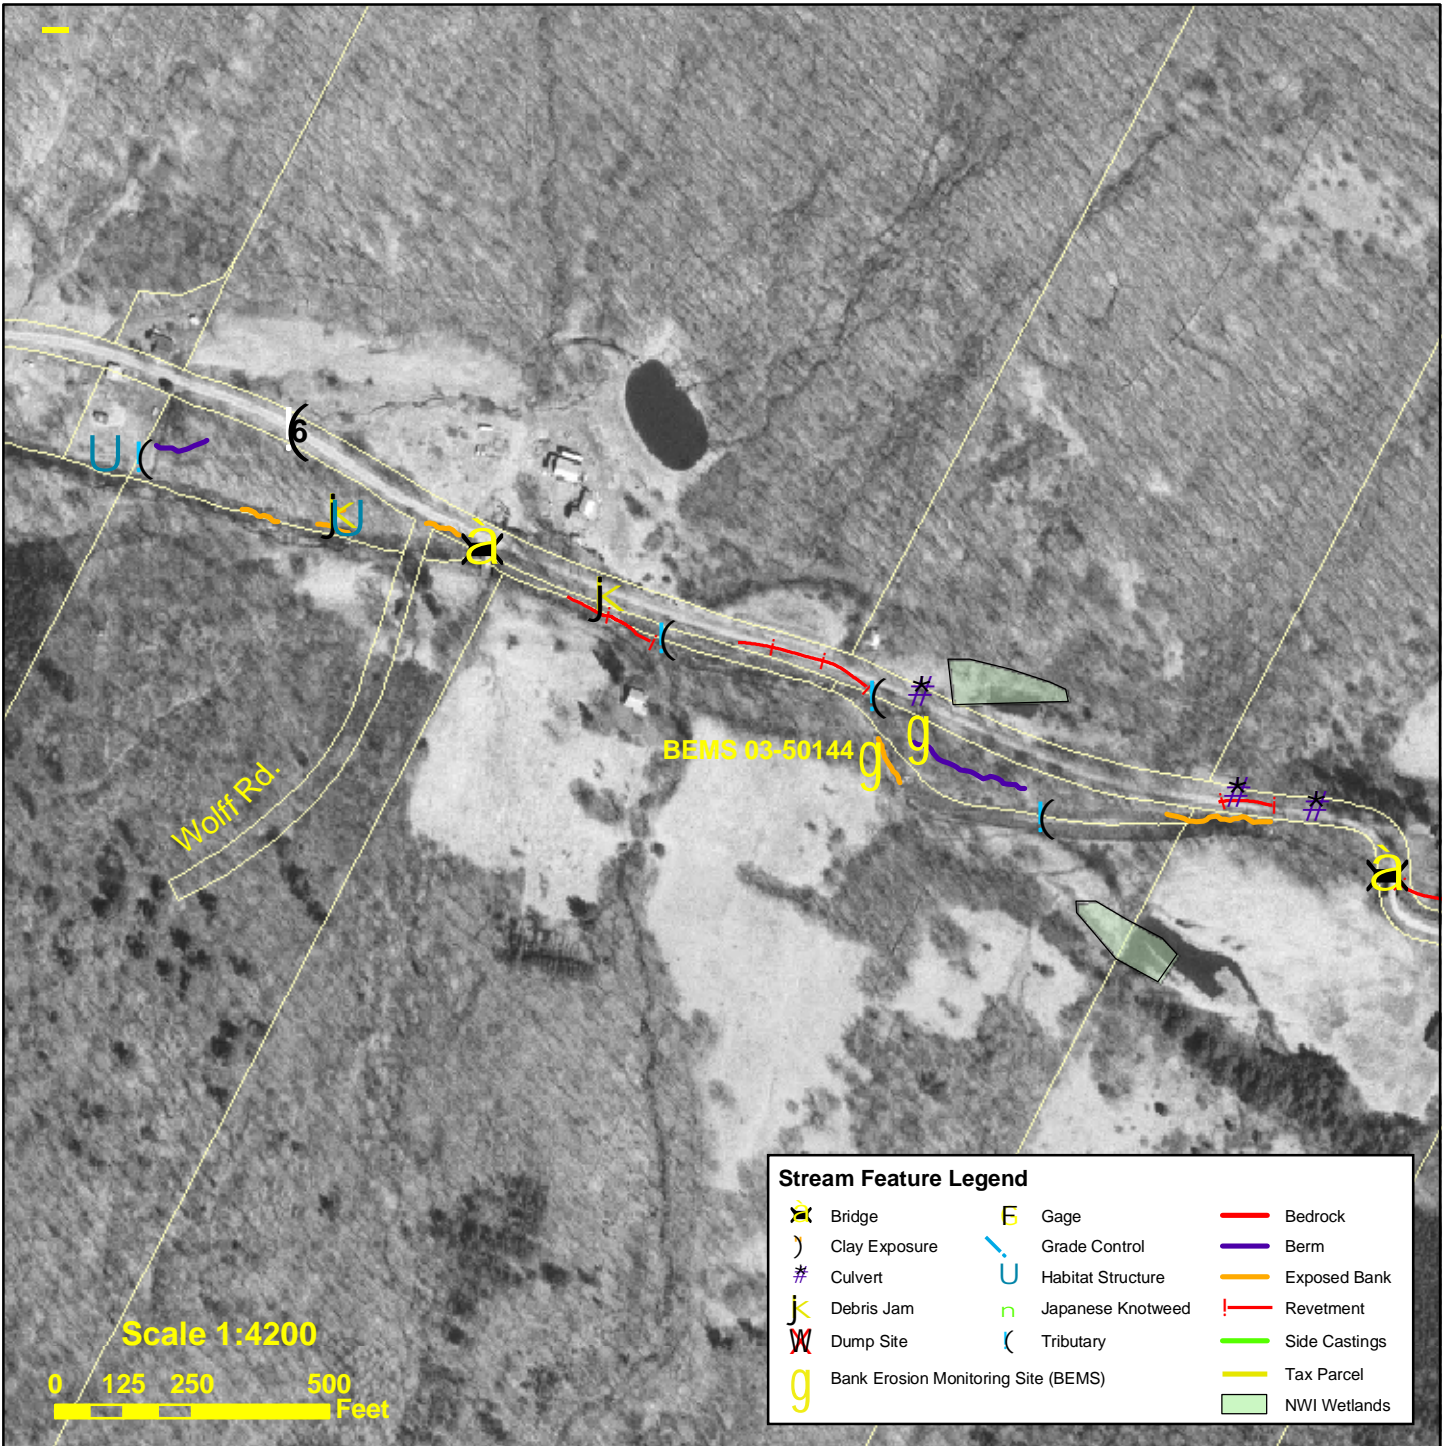
Figure 4.3.1 2004 aerial photography with stream feature inventory and tax parcels

The 2004 stream feature inventory revealed that 19% (512 ft.) of the stream exhibited signs of active erosion along 2677 ft. of total channel length (Fig. 4.3.1). Revetment has been installed on 20% (525 ft.) of total stream length. Two berms were identified in this management unit at the time of the stream feature inventory.

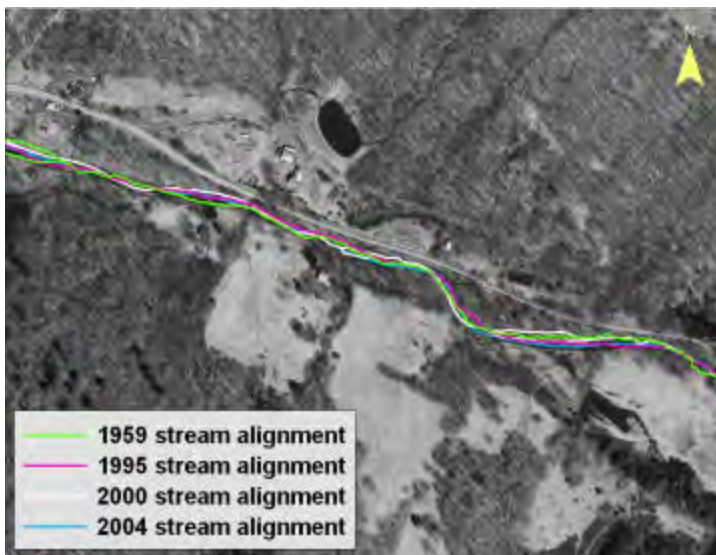
Historic Stream Channel Alignments in MU3

As seen from the historical stream alignments, the channel alignment has not changed significantly over the years.

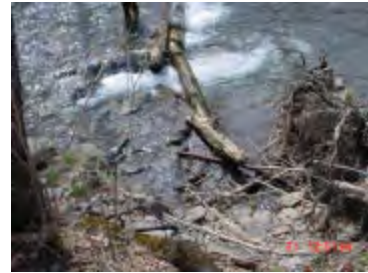
Bank Erosion, left (Inset F, Fig. 4.3.2)

Minor toe scour erosion associated with this structure is evident on both the left (60 ft.) and right (20 ft.) banks. On the right, the erosion is exacerbated by a collection of large woody debris. As the structure continues to deteriorate, these banks are likely to revegetate and stabilize over time. Downstream, previous erosion of the left bank has left a short lateral bar with abundant

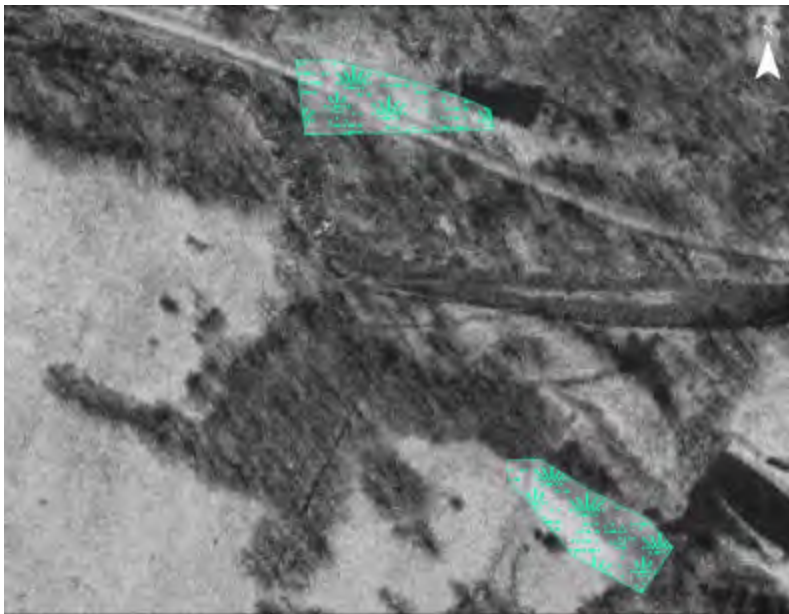
National Wetland Inventory wetlands in MU3

There are 2 wetlands within this management unit (Fig. 4.3.1) mapped in the National Wetland Inventory (see Section 2.5, Wetlands and Floodplains for more information on the National Wetland Inventory and wetlands in the West Kill watershed). Wetlands are important features in the landscape that provide numerous beneficial functions including protecting and improving water quality, providing fish and wildlife habitats, storing
