West Kill Management Unit 4

Stream Feature Statistics

Management Unit 4
Between Station 48476 and Station 46365

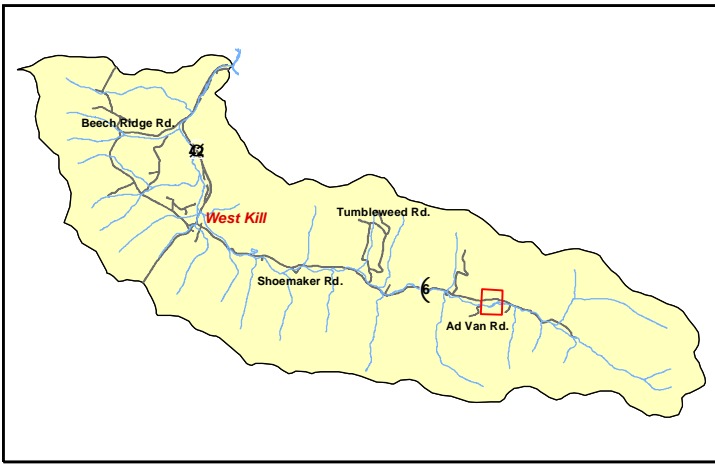
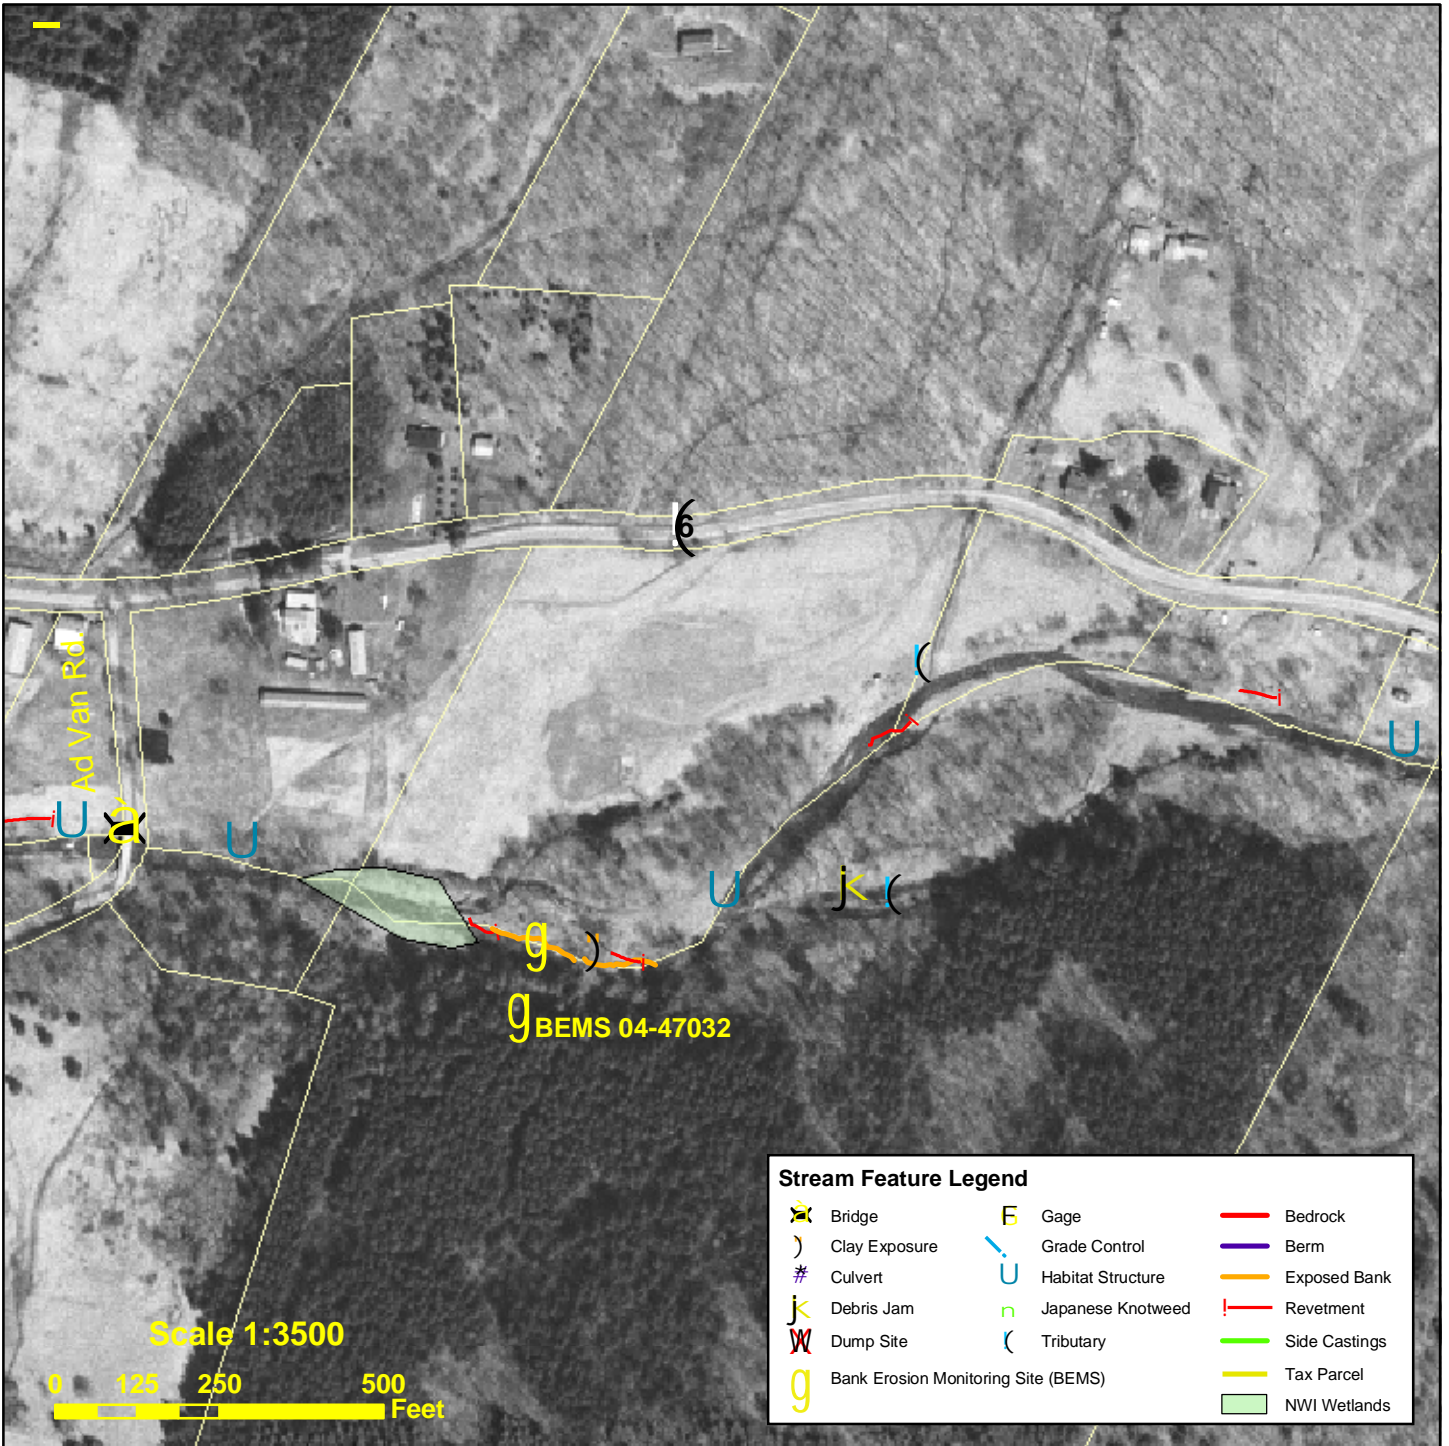
Figure 4.4.1 2004 aerial photography with stream feature inventory and tax parcels

The 2004 stream feature inventory revealed that 12% (258 ft.) of the stream length exhibited signs of active erosion along 2,111 ft. of total channel length (Fig. 4.4.1). Revetment has been installed on 11 % (237 ft.) of the stream length, including both rip-rap and log cribbing. No berms were identified in this management unit at the time of the stream feature inventory.

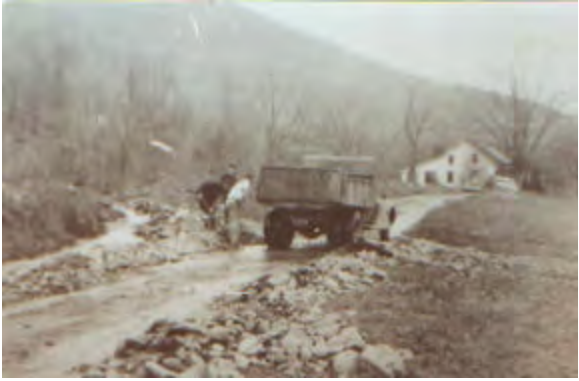
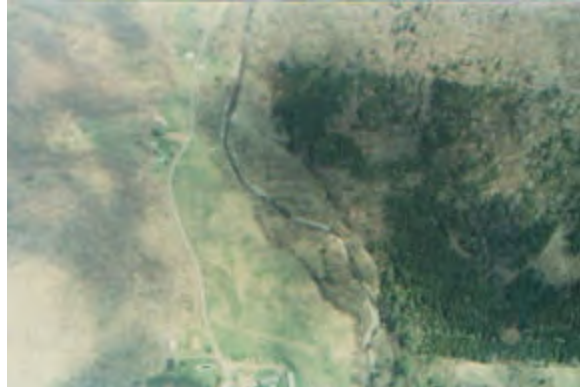
Managing a West Kill tributary, circa. 1950

Looking up the valley, the aerial photo shows a braided portion of channel in MU4, evident as far back as our earliest photography (1959). Braiding is not evident on the USGS 1903 topographic map.

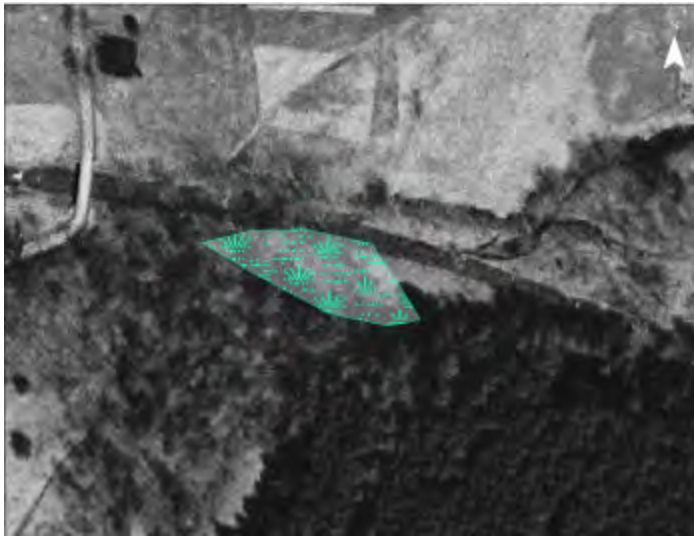
National Wetland Inventory wetlands in MU4

There is one wetland within this management unit (Fig. 4.4.1) mapped in the National Wetland Inventory (see Section 2.5, Wetlands and Floodplains for more information on the National Wetland Inventory and wetlands in the West Kill watershed). Wetlands are important features in the landscape that provide numerous beneficial functions including protecting and improving water quality, providing fish and wildlife habitats, storing floodwaters, and maintaining surface water flow during dry periods (See Section

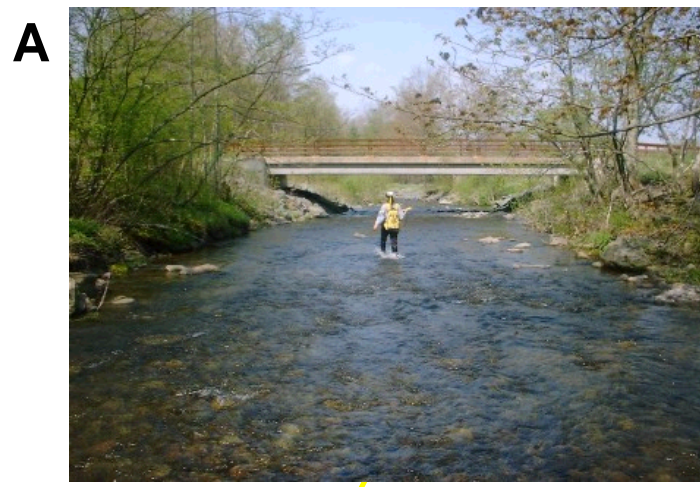
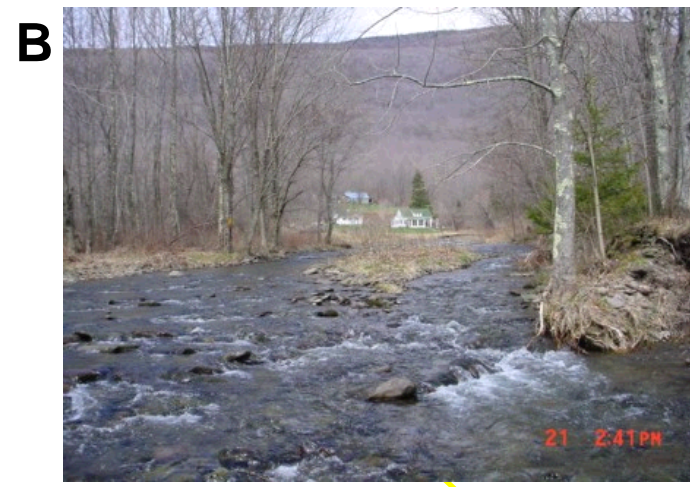
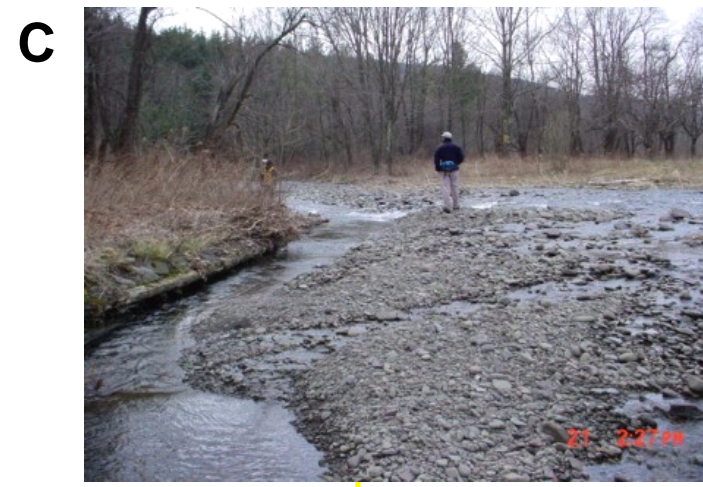
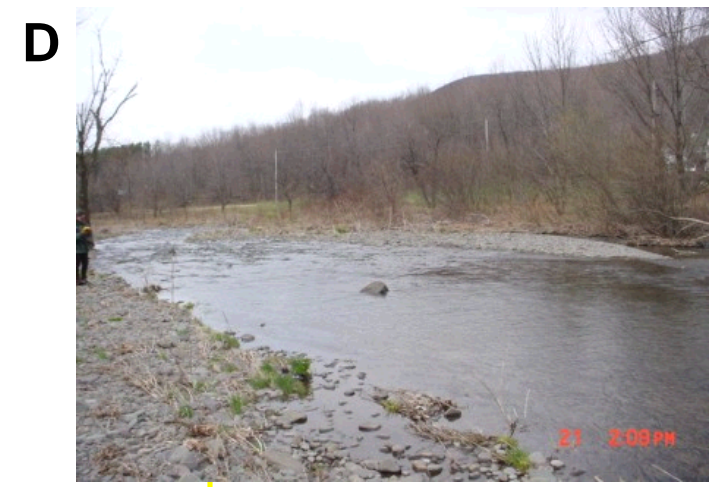
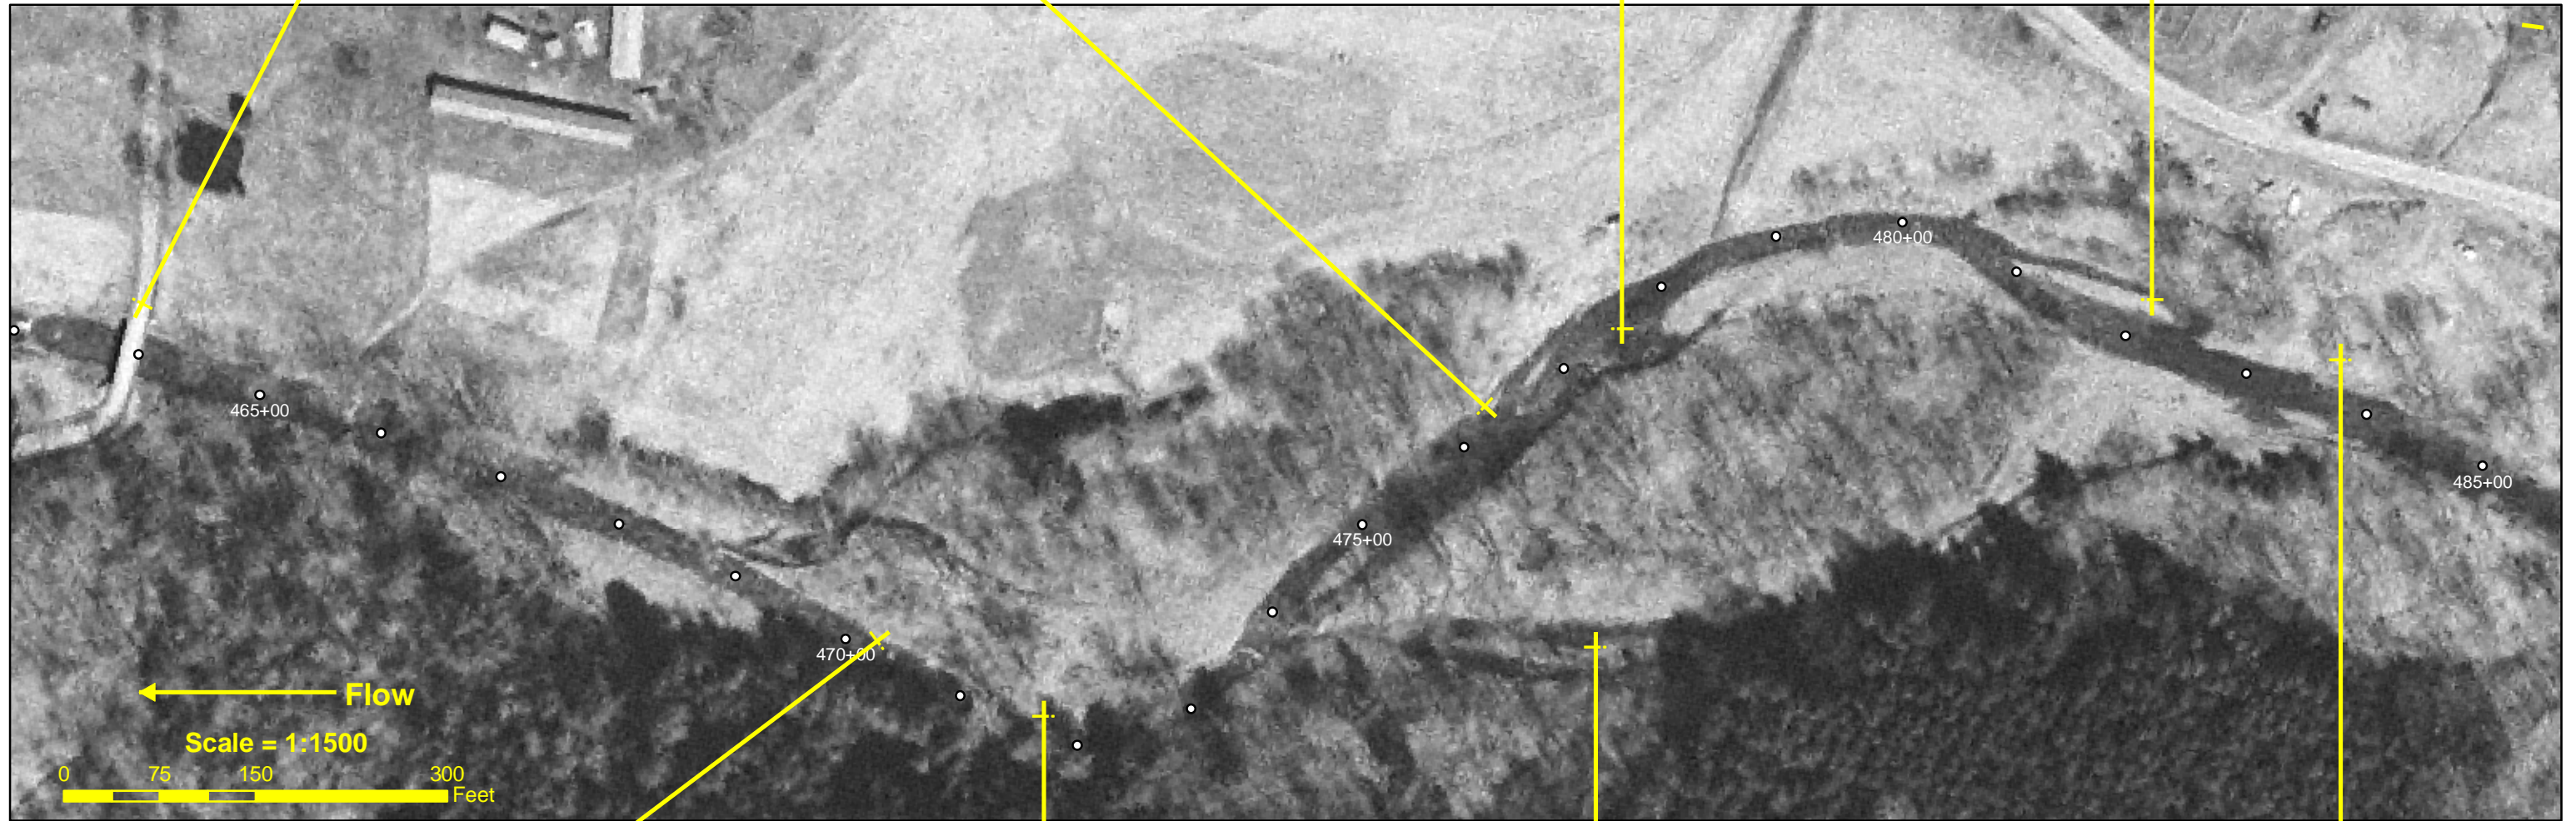
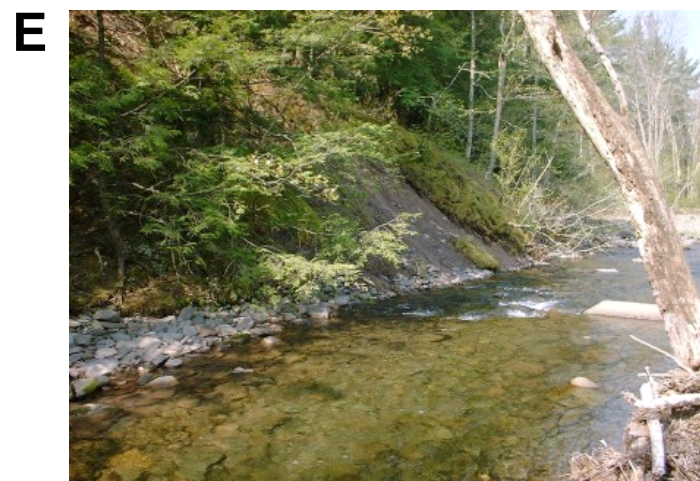
Figure 4.4.2 Management Unit 4 - 2004 aerial photography

As the channel slope drops, aggradation becomes evident, and a 59 ft. section of rip rap, dumped in place, has been installed on the right bank (Inset H, Fig. 4.4.2). The rip rap is in poor condition, but, protects against possible lateral channel migration in response to the aggradation.

Continuing downstream, aggradation becomes progressively more severe, eventually resulting in a distinct, two-thread channel divergence, near Station 48250 (Inset D, Fig. 4.4.2). Proceeding down the right channel thread, a monumented cross-section is established at Station 48060, which crosses over the vegetated island and the left thread as well, documenting this 1576 ft. reach of D4b streamtype. This type of channel morphology, typical of aggradational settings, is characterized by multiple, shifting channel threads, excessive

On the left bank of the right channel thread, the thalweg, or deepest part of the channel, flows against a section of log cribbing (Inset C, Fig. 4.4.2). The cribbing is failing at the downstream end, and is largely buried by gravel deposits, indicating the magnitude of aggradation here.

Downstream of the cribbing, a mid-channel bar has formed (Inset B, Fig. 4.4.2). The floodplain beyond both banks is forested, with evidence of frequent inundation and historical channel avulsions.

Approaching the end of the management unit, the approaches of the Ad Van Road bridge crossing constrict the floodplain at very high flows, but pass most flows effectively (Inset A, Fig. 4.4.2). Substantial abutment protection was documented, and no abutment scour was observed.
