West Kill Management Unit 5

Stream Feature Statistics

Management Unit 5

Between Station 46365 and Station 42743

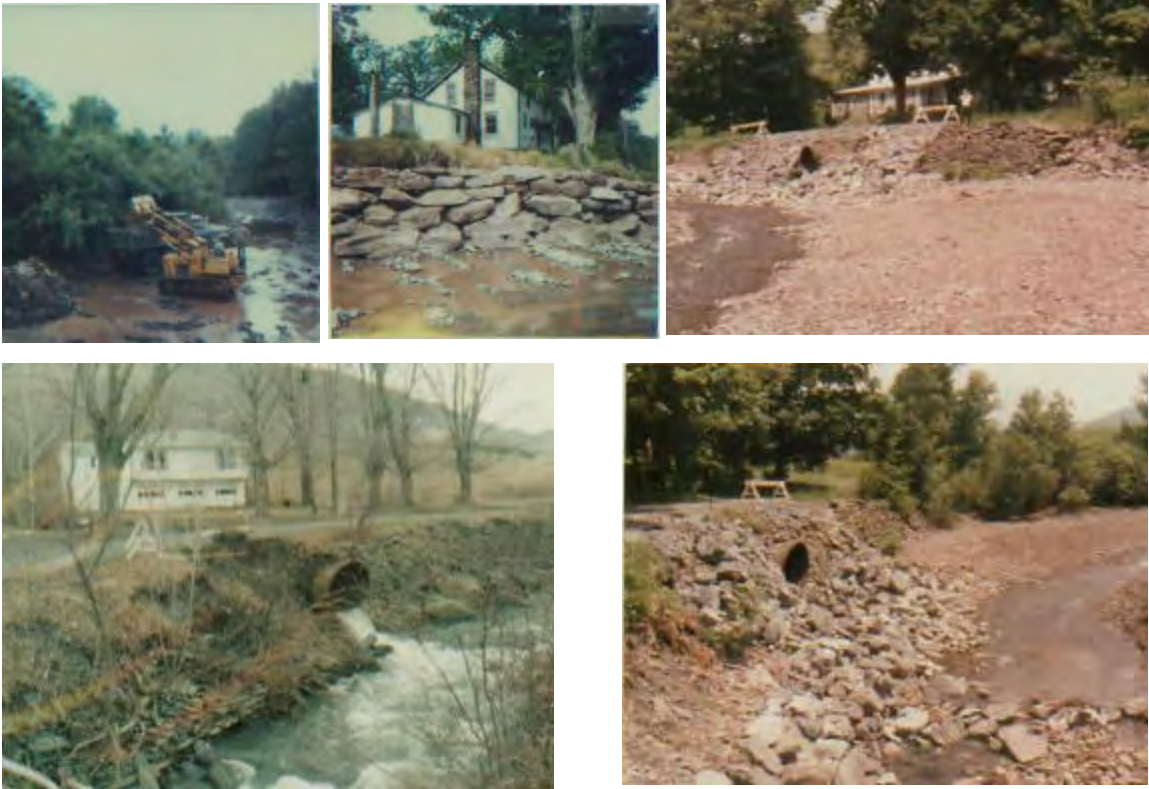
Photos courtesy of Lenard Conklin

The images above show historic flood damage and maintenance activity on Herdman Brook culvert near the Baker Road bridge, and neighboring stream reaches in MU5. According to available NYS DEC records there were no stream disturbance permits issued in this management unit following the 1996 floods.

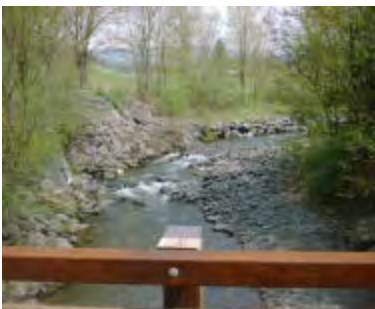
Looking upstream

At the downstream end of the rip-rap, a monumented cross-section (Station 43077) documents 1257 ft. of B3c stream type. The slope decreases to 1.6%, and the bed remains dominated by cobble. On the right, a low bench is protected by stacked rock rip-rap (Inset B, Fig. 4.5.2). At the head of the rip-rap, a small unnamed tributary enters from the right, draining a horse pasture along County Route 6 and a barnyard across the road. Nutrient loading from this tributary should be investigated.
