# West Kill Management Unit 6

**Management Unit 6**  
Between Station 42743 and Station 39851

**Management Unit Description**

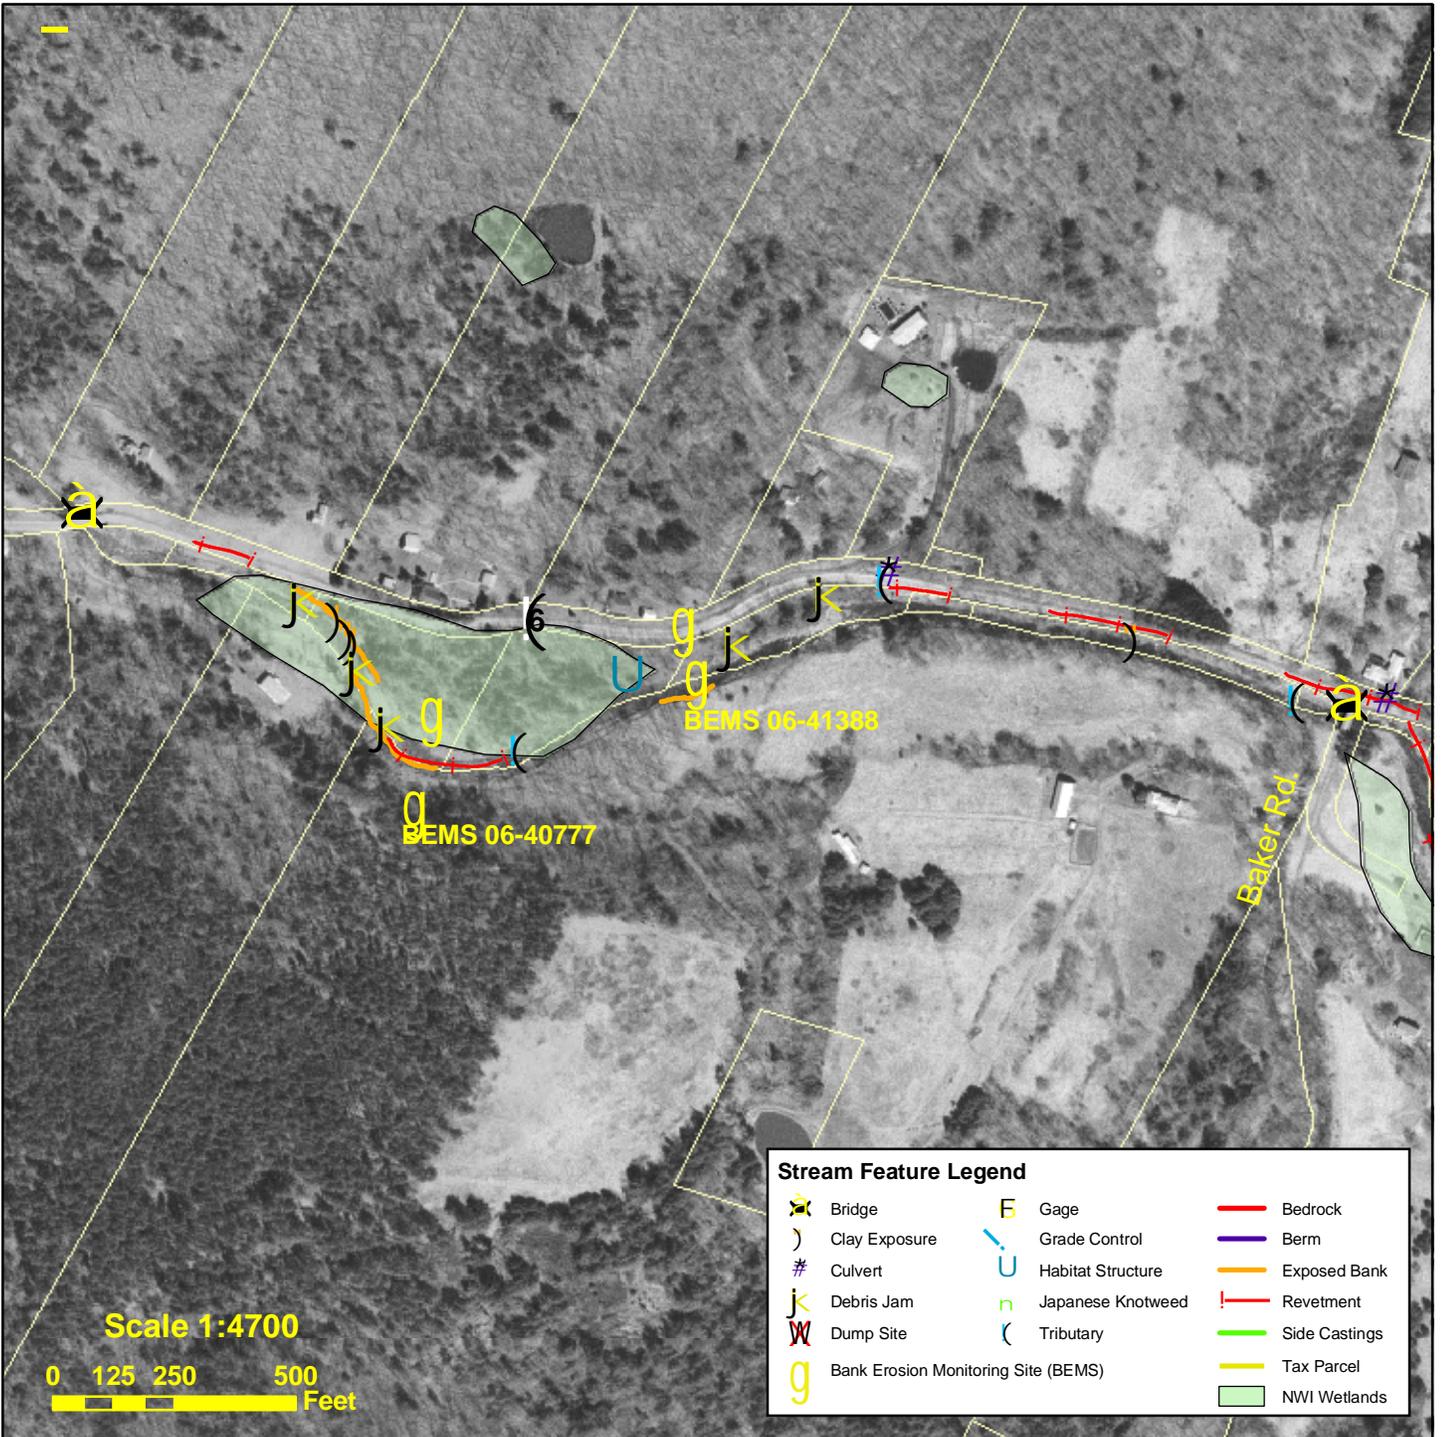
Figure 4.6.1 2004 aerial photography with stream feature inventory and tax parcels

The 2004 stream feature inventory revealed that 23% (659 ft.) of the stream banks exhibited signs of active erosion along 2,892 ft. of total channel length (Fig. 4.6.1). Revetment has been installed on 30 % (873 ft.) of the stream length. No berms were identified in this management unit at the time of the stream feature inventory.

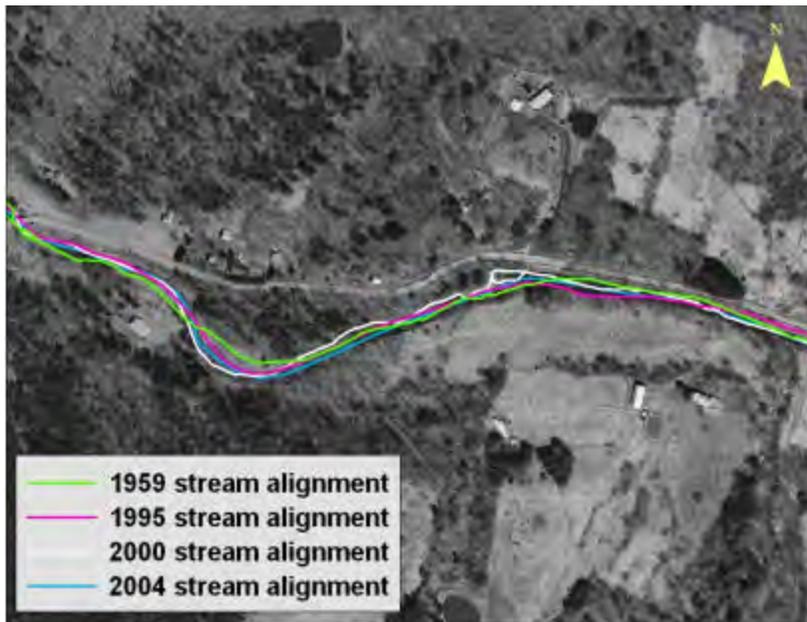
Historic Stream Channel Alignments in MU6

As seen from the historical stream alignments, the channel alignment has not changed significantly over the years, although a debris jam appears to have created a cutoff channel in response to the 1996 flood.

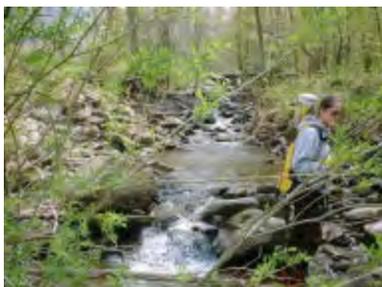
**Styles Brook confluence, left bank**

Styles Brook (1.5 mi.<sup>2</sup>), a significant tributary, enters on the left at a well-connected confluence. Continuing downstream, on the right, the stacked rock wall transitions to dumped rock. There is evidence of grading and associated aggradation throughout this reach.

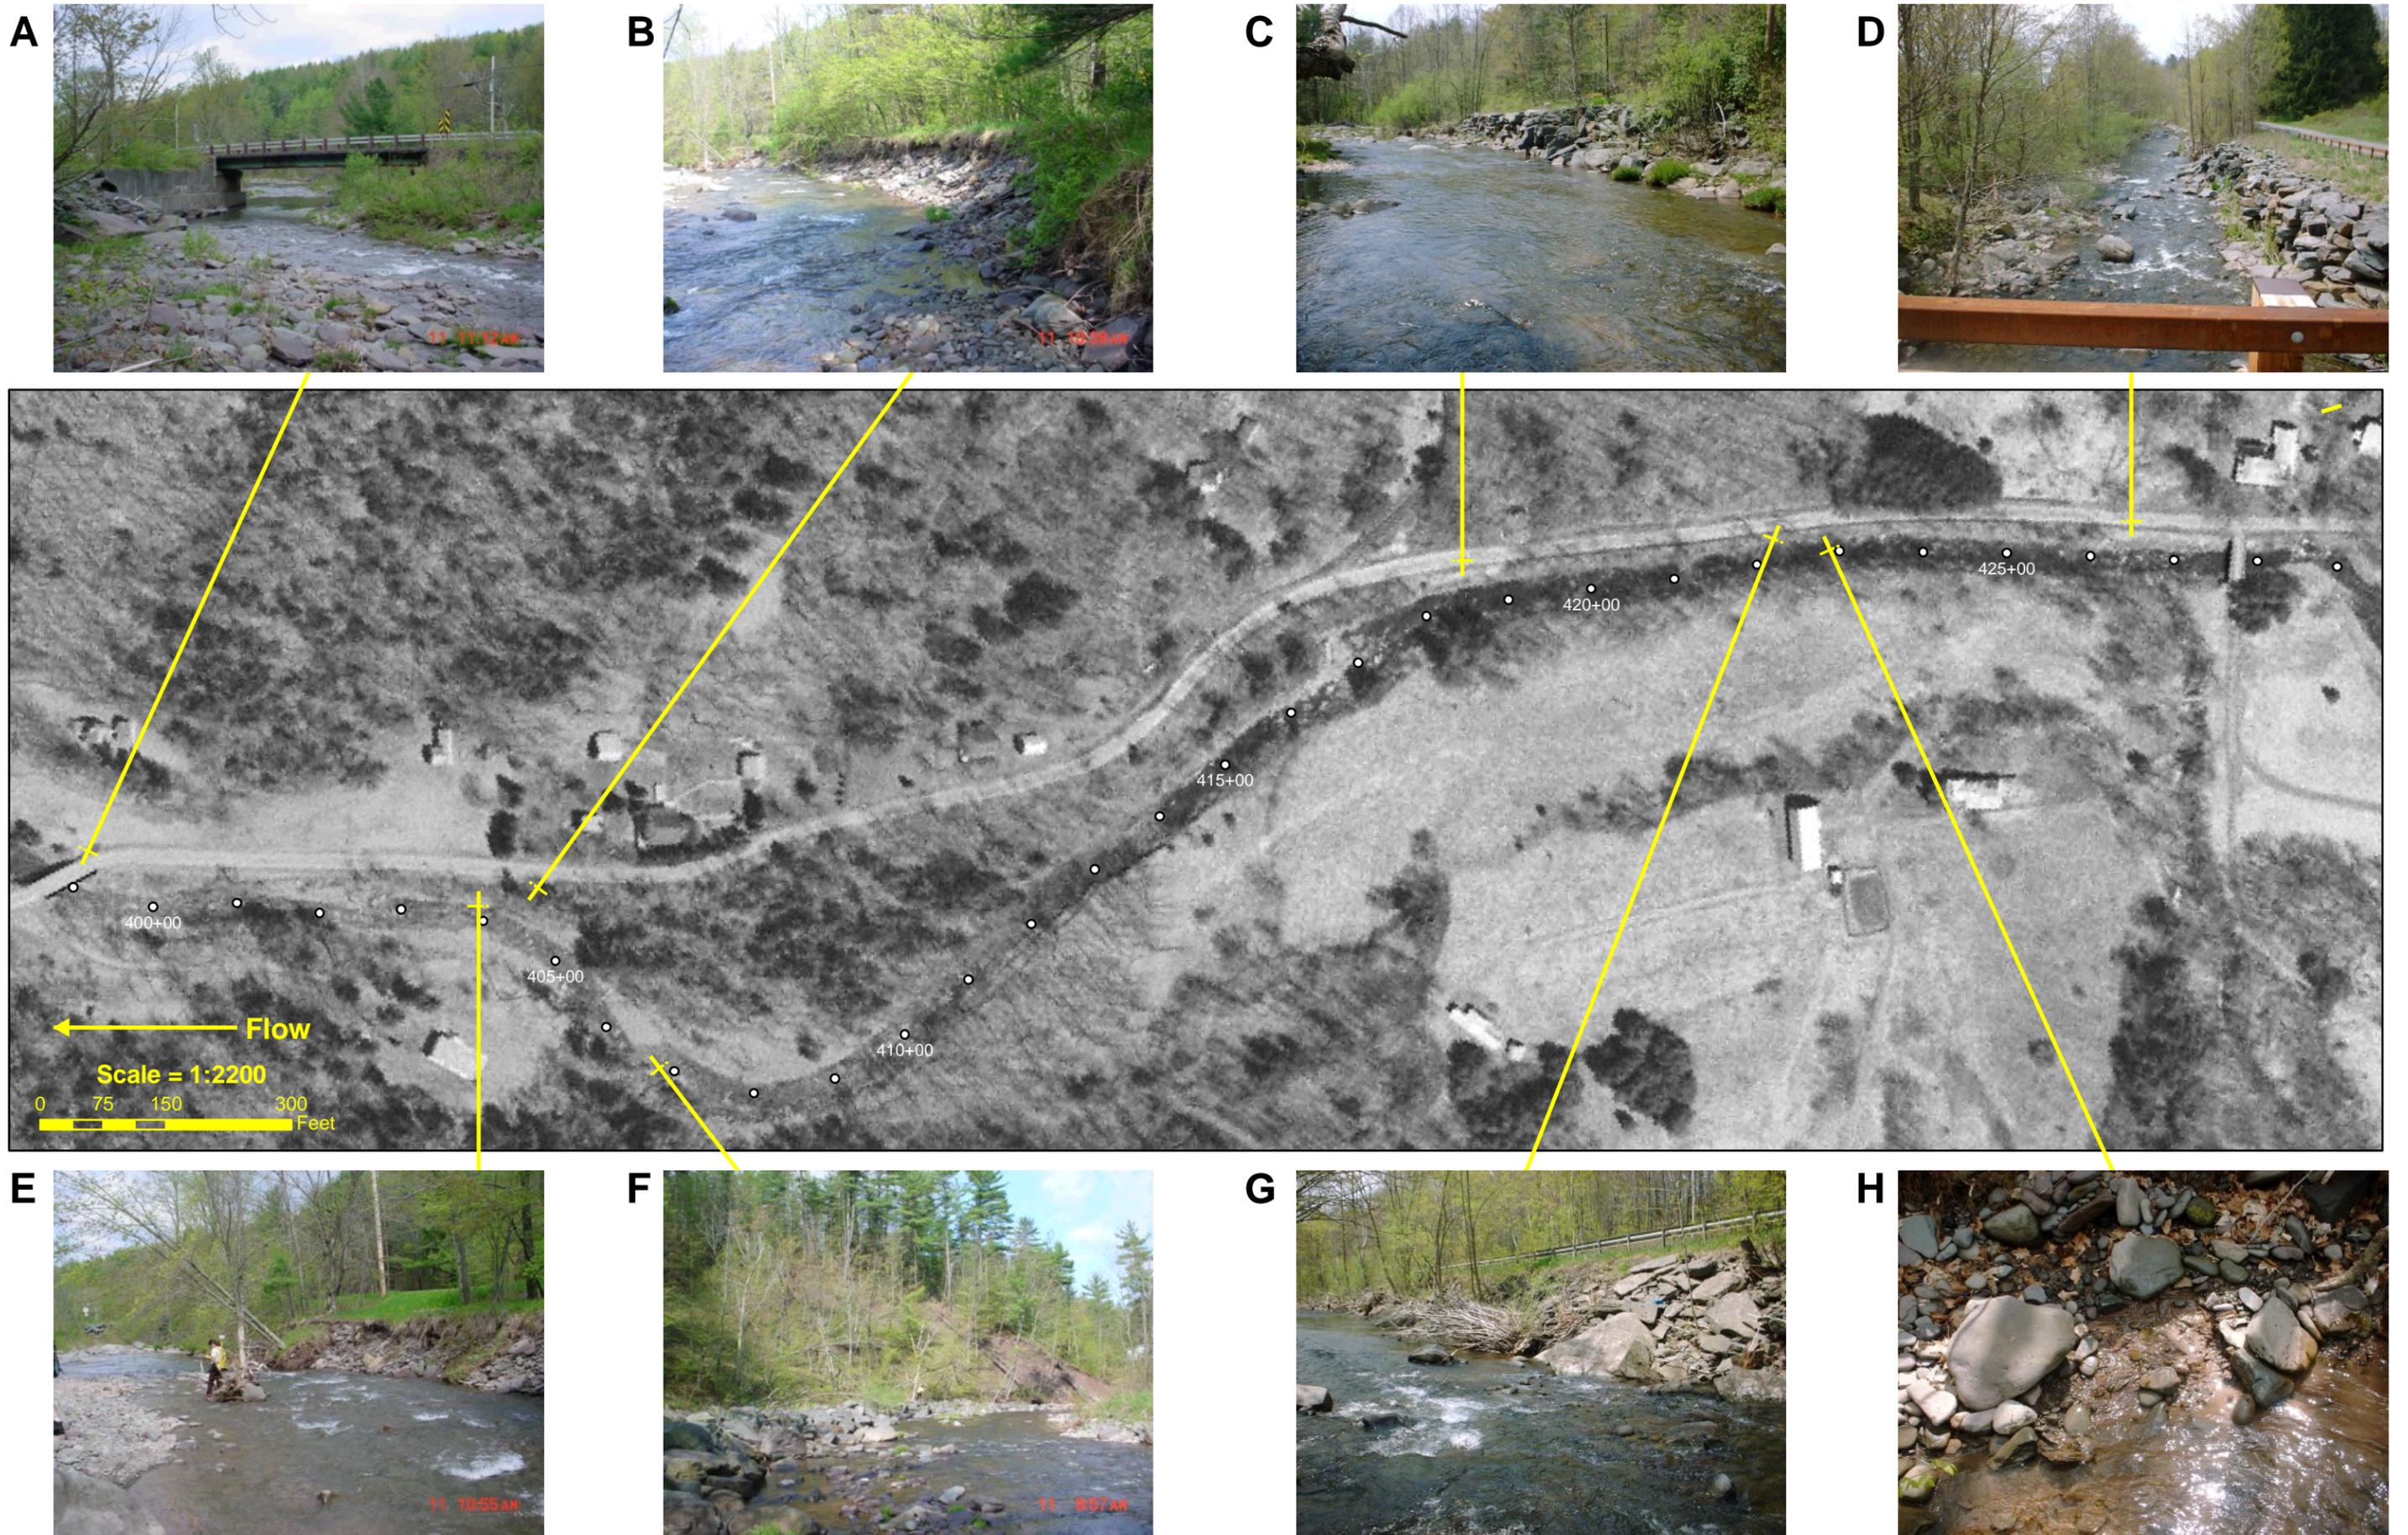
Figure 4.6.2 Management Unit 6 - 2004 aerial photography

Continuing downstream, a 251 ft. installation dumped riprap protects the County Rte. 6 road embankment on the right (see Inset G, Fig. 4.6.2). Lacustrine clay is exposed in the bed at the toe of the left bank, and groundwater seeps from the bank over these exposures.

Continuing downstream, the channel is aggrading, an artifact of backwater resulting from a debris jam further downstream that has since been moved to block an overflow channel (see Inset C, Fig. 4.6.2).. Near the downstream end of the straight reach, another 121 ft. section of stacked rock protects the road embankment. An 18" culvert enters on the right carrying road drainage and flow off the hillslope to the north under Spruceton Road (County Route 6). The culvert is without outfall protection, the headwall is in poor condition, and the confluence with the West Kill is perched, also without outfall protection, creating a high potential for headcutting. Vegetative stabilization is recommended here.

A small unnamed tributary enters from the left, with the confluence somewhat perched, just upstream of the head of a 258 ft., low installation of rip-rap on the left, intended to protect a large slope failure on the outside of a meander bed to the right. Some channel aggradation is evident here (see Inset F, Fig. 4.6.2).

Another fallen tree downstream presents a more significant problem for conveyance across the point bar on the right, and directs flow toward the eroding bank (see Inset B, Fig. 4.6.2).

the channel becomes confined by the County Route 6 embankment on the right, the dominant bed material changes to gravel, and the slope drops to 0.9%. A single line of trees buffers the stream from the road on the right, and erosion is undermining these as well. One tree is deposited here in the middle of the channel (see Inset E, Fig. 4.6.2).

Full Restoration is recommended for this site. This would likely involve establishment of a well-vegetated bench on the outside of each meander, with rock vanes to direct stream flows away from the banks and to establish grade control, and revegetation of the bank faces. In-depth survey and design would be required to plan a stream restoration project at this site.
