West Kill Management Unit 8

Management Unit 8

Between 36944 and 34845

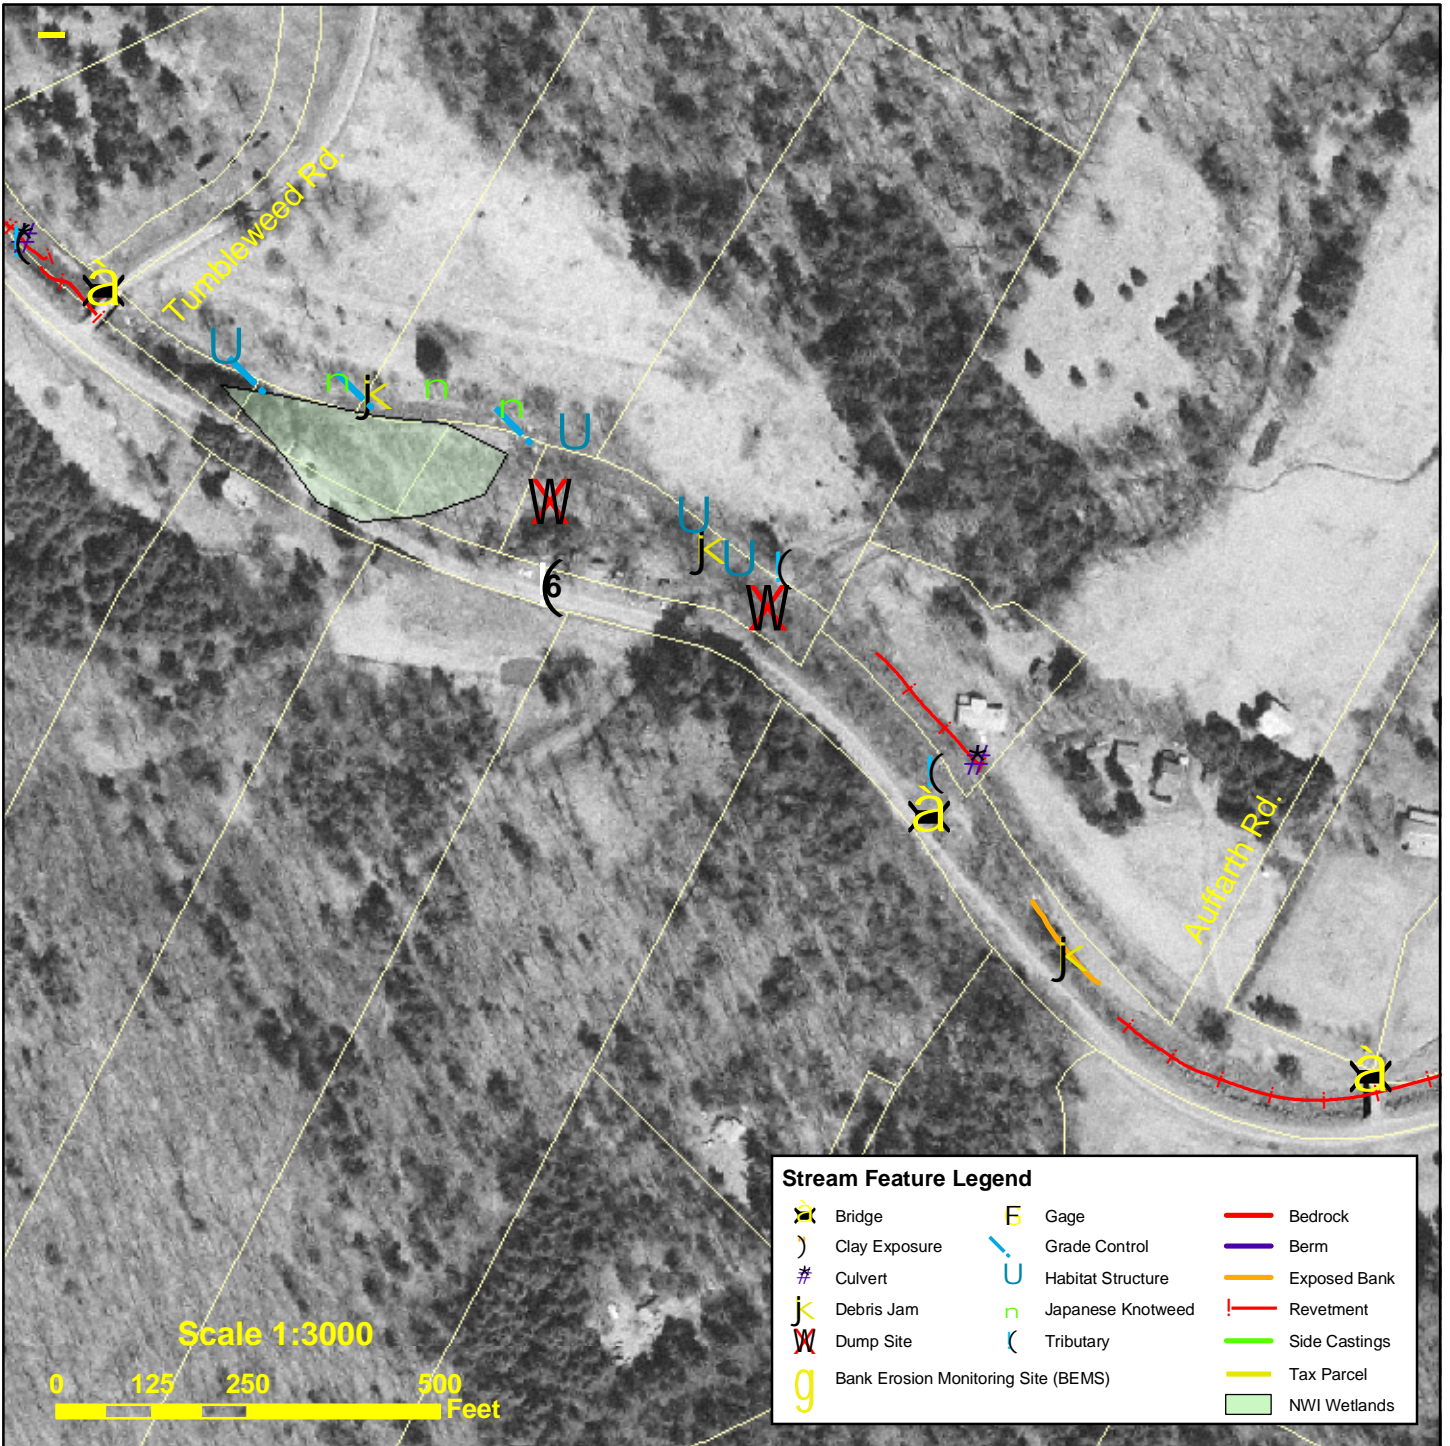
Figure 4.8.1 2004 aerial photography with stream feature inventory and tax parcels

7% of stream length is experiencing erosion
 28% of stream length has been stabilized
 11.4 acres of inadequate vegetation within the 300 ft. buffer
 181 ft. stream is within 50 ft. of the road
 3 houses located within the 100-year floodplain boundary

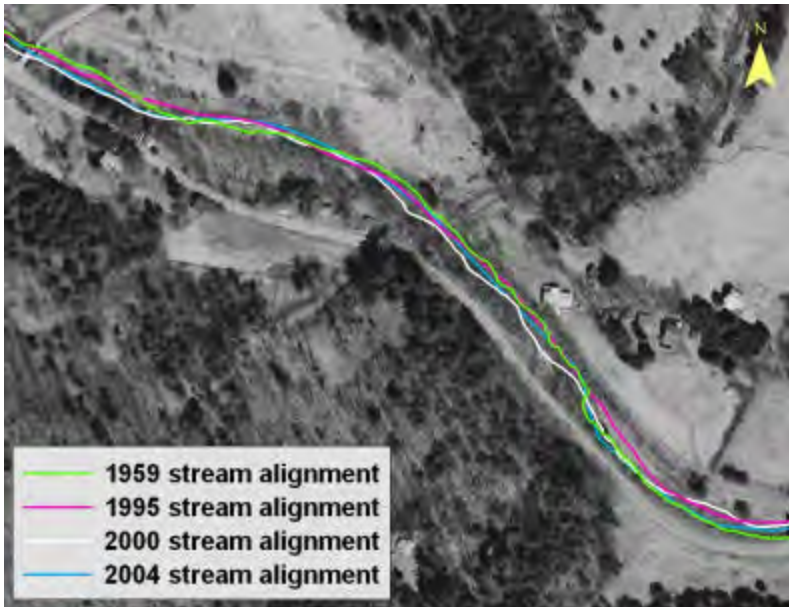
Historic Stream Channel Alignments in MU8

As seen from the historical stream alignments, the channel alignment has not changed significantly over the years. The lateral stability apparent from the aerial photography may be attributable, in part, to the sediment storage areas in Management Unit 7.

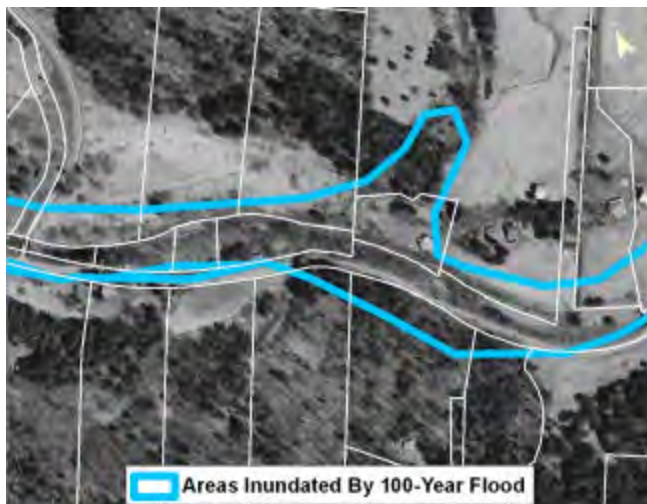
100 yr floodplain, MU8

As part of its National Flood Insurance Program (NFIP), the Federal Emergency Management Agency (FEMA) performs hydrologic and hydraulic studies to produce Flood Insurance Rate Maps (FIRM), which identify areas prone to flooding. There are three houses within the 100-year flood boundary. The NYS DEC Bureau of Flood Protection is currently developing new floodplain maps for the West Kill on the basis of recent surveys. These maps should be completed for the West Kill watershed in 2006.

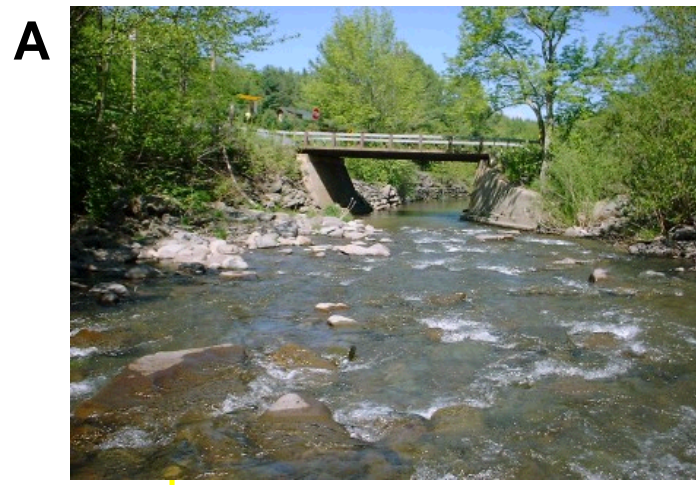
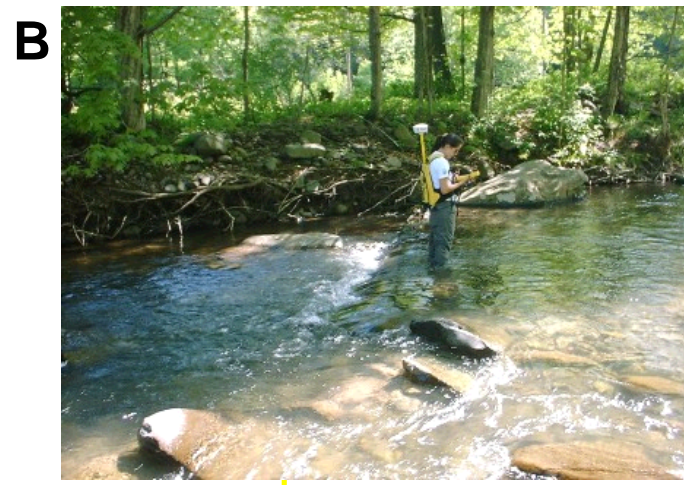
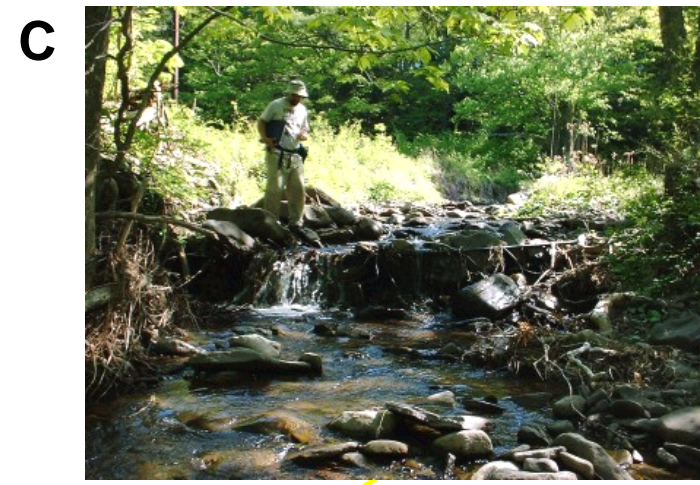
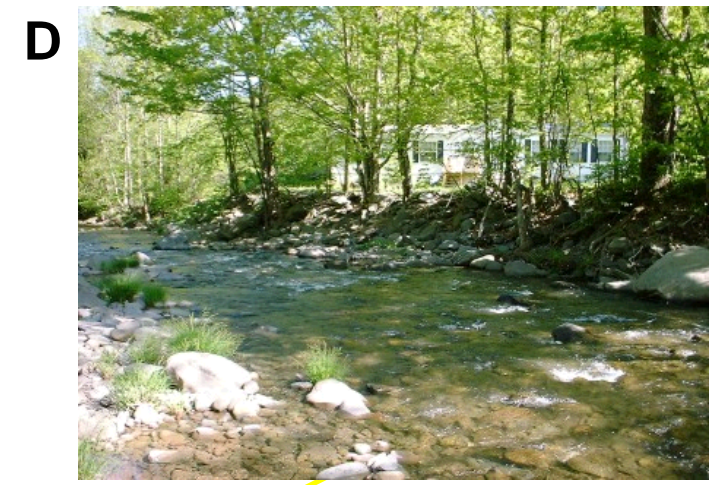
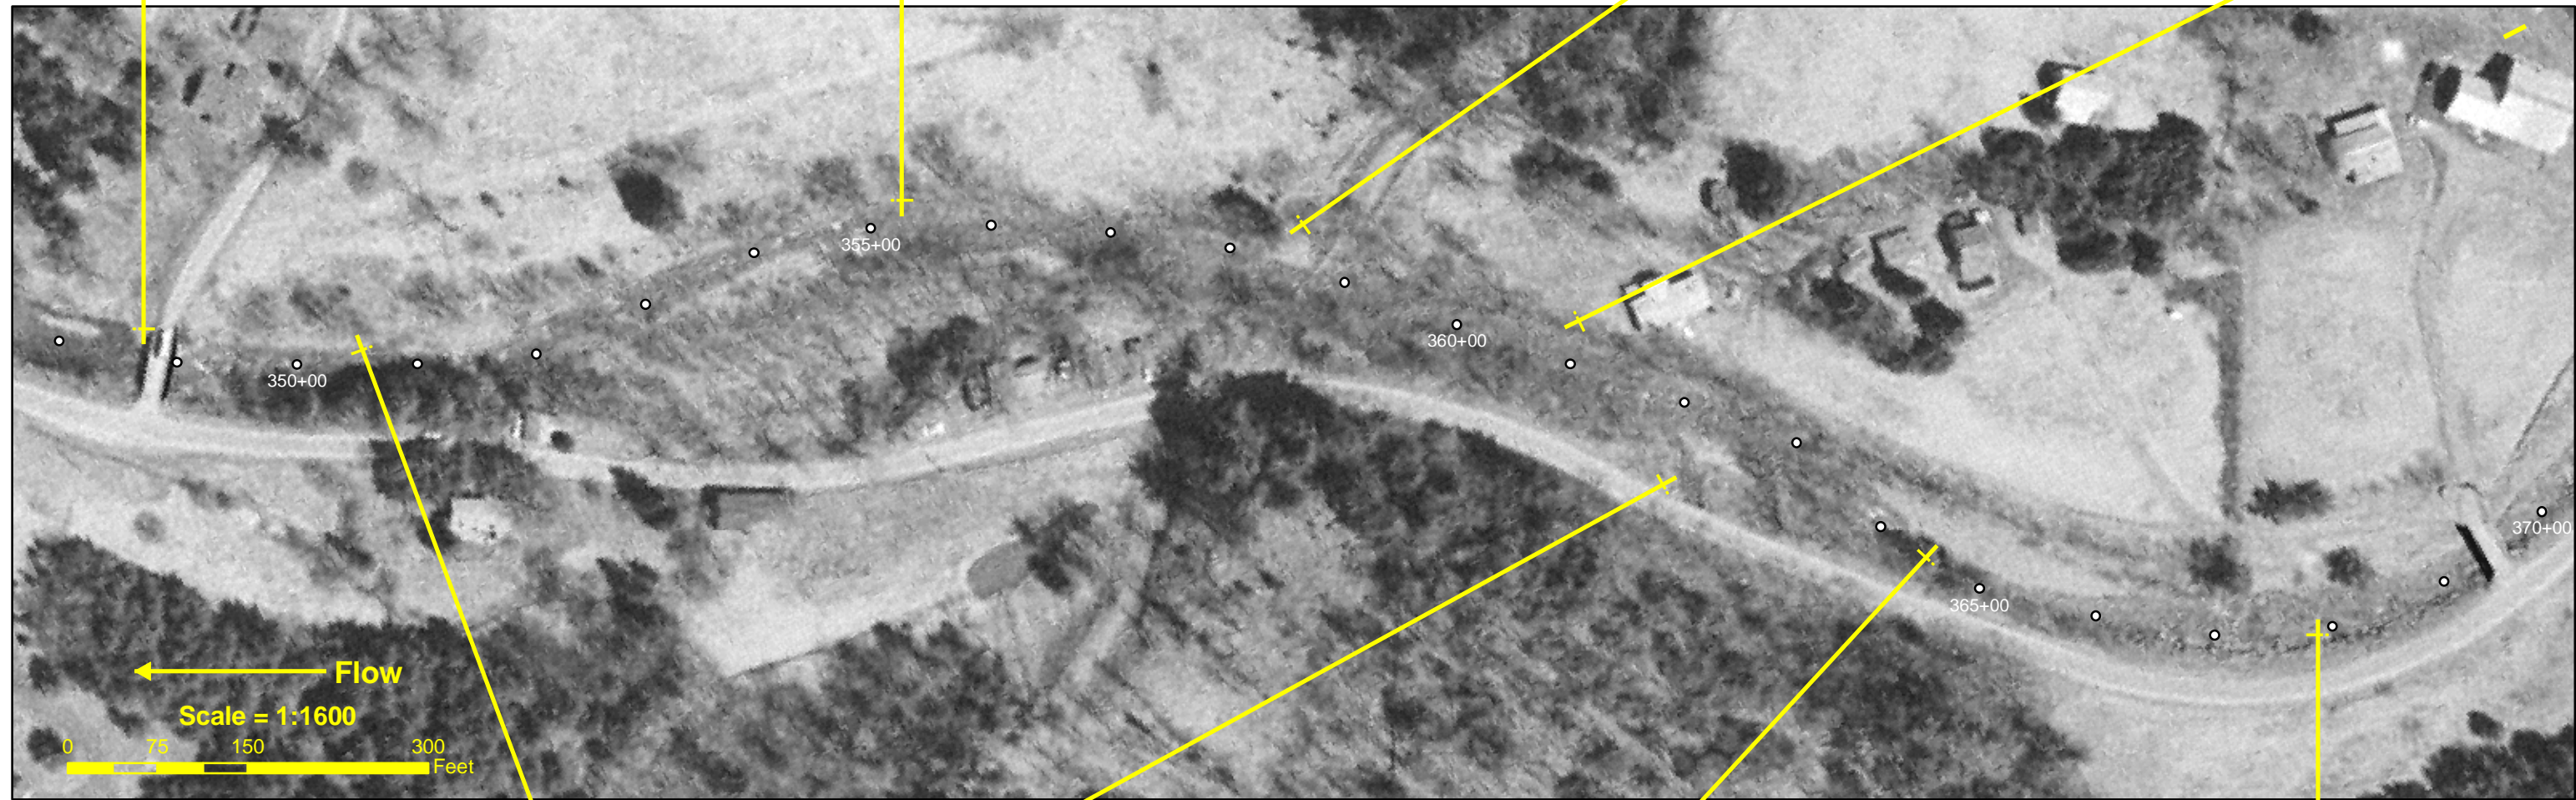
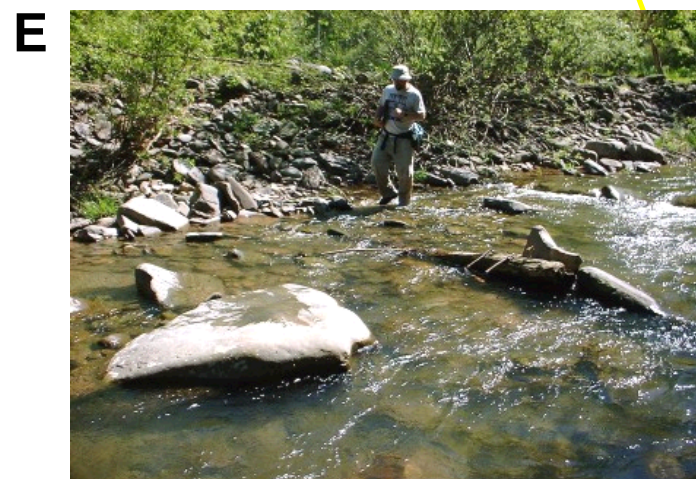
Figure 4.8.2 Management Unit 8 - 2004 aerial photography

The rip-rap at the left of the photo also continues from Management Unit 7 (Inset H, Fig. 4.8.2). The rip-rap protects the Aufarth Road Bridge abutments, and the County Route 6 embankment. It is made of large, angular quarry stone and is in good condition. This reach has virtually no riparian vegetation to buffer the stream from the potential thermal impacts and road runoff. The end of the rip-rap installation marks the transition from the F3 stream type to B3c. Recommendations here include interplanting of the rip-rap, and enhancement of the riparian buffer using ecologically appropriate tree and shrub species. The vegetative treatments will extend the longevity of the rip-rap installation, enhance the function of the riparian buffer, and improve fish habitat in this reach.

Just downstream of the rip-rap, bank erosion is evident on the left bank (Inset G, Fig. 4.8.2). The erosion is mild, and the buffer of trees, though quite narrow, offers a dense root mat which improves this bank's resistance to erosion. From a riparian buffer perspective, the vegetation here is inadequate to protect the stream from road runoff

Immediately downstream of the culvert, a 200 ft. long rip-rap installation is found on the right bank (Inset D, Fig. 4.8.2). The rip-rap protects a stream side residence, located on the terrace just beyond the rip-rap. The rip-rap is made of rounded river stone, and armors the bank against erosive flows delivered by both the West Kill and the Mink Hollow tributary.

Opposite the dumpsite, an unnamed tributary finds its confluence with the West Kill (Inset C, Fig. 4.8.2). The 0.9 mi² catchment appears to deliver moderate sediment loads, however, and a headcut is noted in the tributary near the confluence, which could result in accelerated sediment delivery as incision extends upstream. Recommendations for this tributary would include installation of a grade control structure at its mouth to prevent headward migration of the degradational processes noted here. The catchment for this tributary includes a recently developed residential subdivision; stormwater impacts upstream in this tributary should be investigated, both in terms of hydrology and water quality.

Summary of Recommendations Management Unit 8	
Intervention Level	Assisted Self-Recovery
Stream Morphology	None
Riparian Vegetation	Interplant rip-rap and enhance riparian vegetation upstream and downstream of Tumbleweed Road Bridge. Improve road side buffer at upstream end of unit.
Infrastructure	Interplant rip-rap near Aufarth Road, stabilize Greene County Route 6 embankment near station 36500. Below Tumbleweed Road Bridge, add rip-rap and interplant new and existing rip-rap.
Aquatic Habitat	Watershed wide study.
Flood Related Threats	None
Water Quality	Removal of refuse from identified dump sites.
Further Assessment	Investigate stormwater impacts from Tumbleweed Ranch subdivision.
