# West Kill Management Unit 9

## Stream Feature Statistics

**Management Unit 9**  
Between Station 34845 and Station 32092

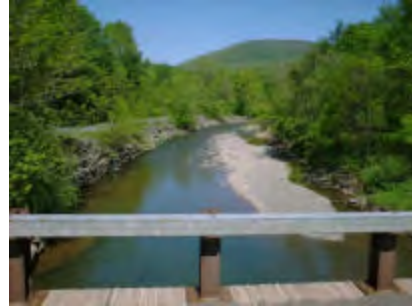
**Tumbleweed Road bridge**

Management Unit 9 (MU9) begins with a 145 ft. section of C1 stream type, but quickly transitions to a 150 ft. reach of B3c stream type as entrenchment increases somewhat, documented by a monumented cross-section at Station 36414. The channel invert under the bridge is a deep bedrock pool, providing grade control but shifting the erosive forces laterally onto the streambanks. While stream flows can access the floodplain at a mown lawn on the right, just downstream of the bridge, entrenchment increases somewhat downstream, and the floodplain is interrupted longitudinally. The channel bends gently to the right, with a point bar on the right, which has been scoured at the bridge outlet by backeddy scour.

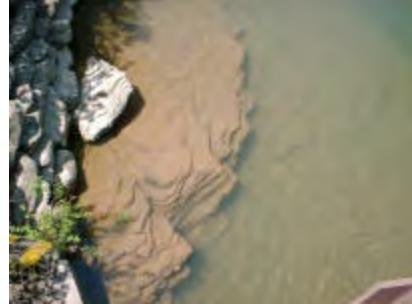
**Bedrock pool**

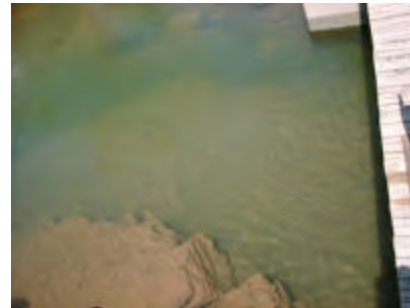
**Bedrock sill under bridge**

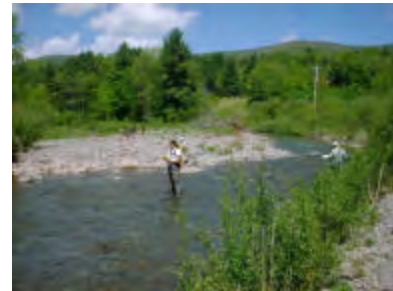
A small pile of woody debris on the left bank marks the head of a channel divergence at the back of a point bar on the left, as the channel crosses over and begins to meander back to the left.

**Point bar development**

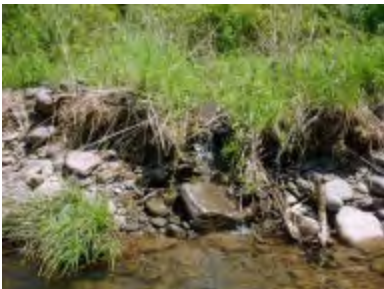
**Tributary confluence, right**

point bar, and a small, unnamed tributary confluences on the right, slightly perched on a well-vegetated low bench.

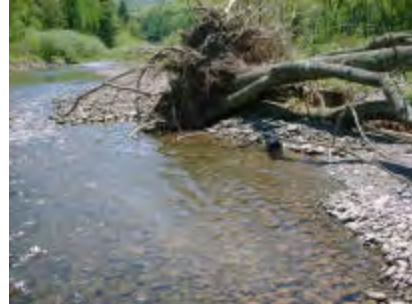
**Woody debris, in channel**

Woody debris was observed throughout the reach, both in the channel and on the floodplain, left. Unnamed tributaries enter from the right and left over well-vegetated, well-connected low benches. The right tributary has a significant drainage (0.6 mi.<sup>2</sup>), which includes recently developed residential subdivision; stormwater impacts upstream in this tributary should be investigated, both in terms of hydrology and water quality. The left tributary is primarily flow from the overflow channel on the back of the bar, but also carries

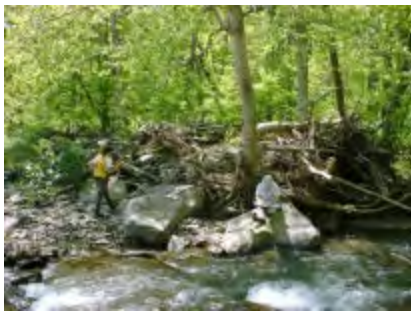
**Debris in trees on floodplain**

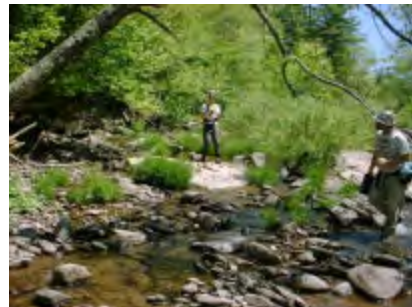
**Tributary confluence, right**

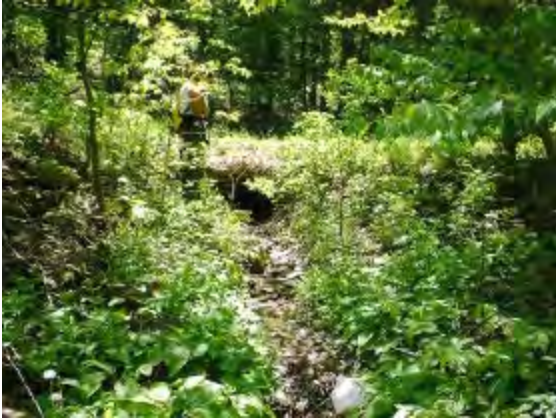
**Culvert, left**

A 24" culvert carrying road drainage enters from the left, with a stacked headwall in stable condition and good outfall protection. Just downstream, remnants of log and rock crib wall, still partly functional, protect the terrace bank on the right (see Insert F, Fig. 4.9.2).

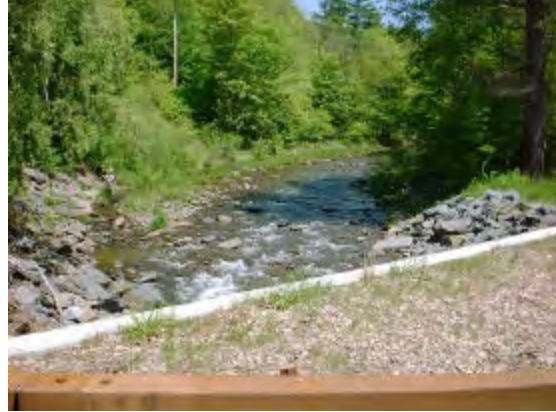
Looking upstream

While the relatively new Greene County Route 6 bridge (Insets A and E, Figure 4.9.2) passes bankfull flows readily, larger flows are constricted by the structure. Gravel deposits upstream of bridges are commonly caused by inadequate sizing of the bridge opening. An undersized bridge opening causes water to back up upstream of the bridge, reducing stream velocity, which results in sediment deposition. In high stage, the floodwater may seek conveyance through alternative paths, forming new channels around the bridge constriction, as appears to happen occasionally at this site. Additional *floodplain drainage*, using culverts set at the floodplain elevation under the east bridge approach, may help mitigate this problem. The upstream abutments are protected by formed concrete wingwalls and rip-rap on both the right and left.

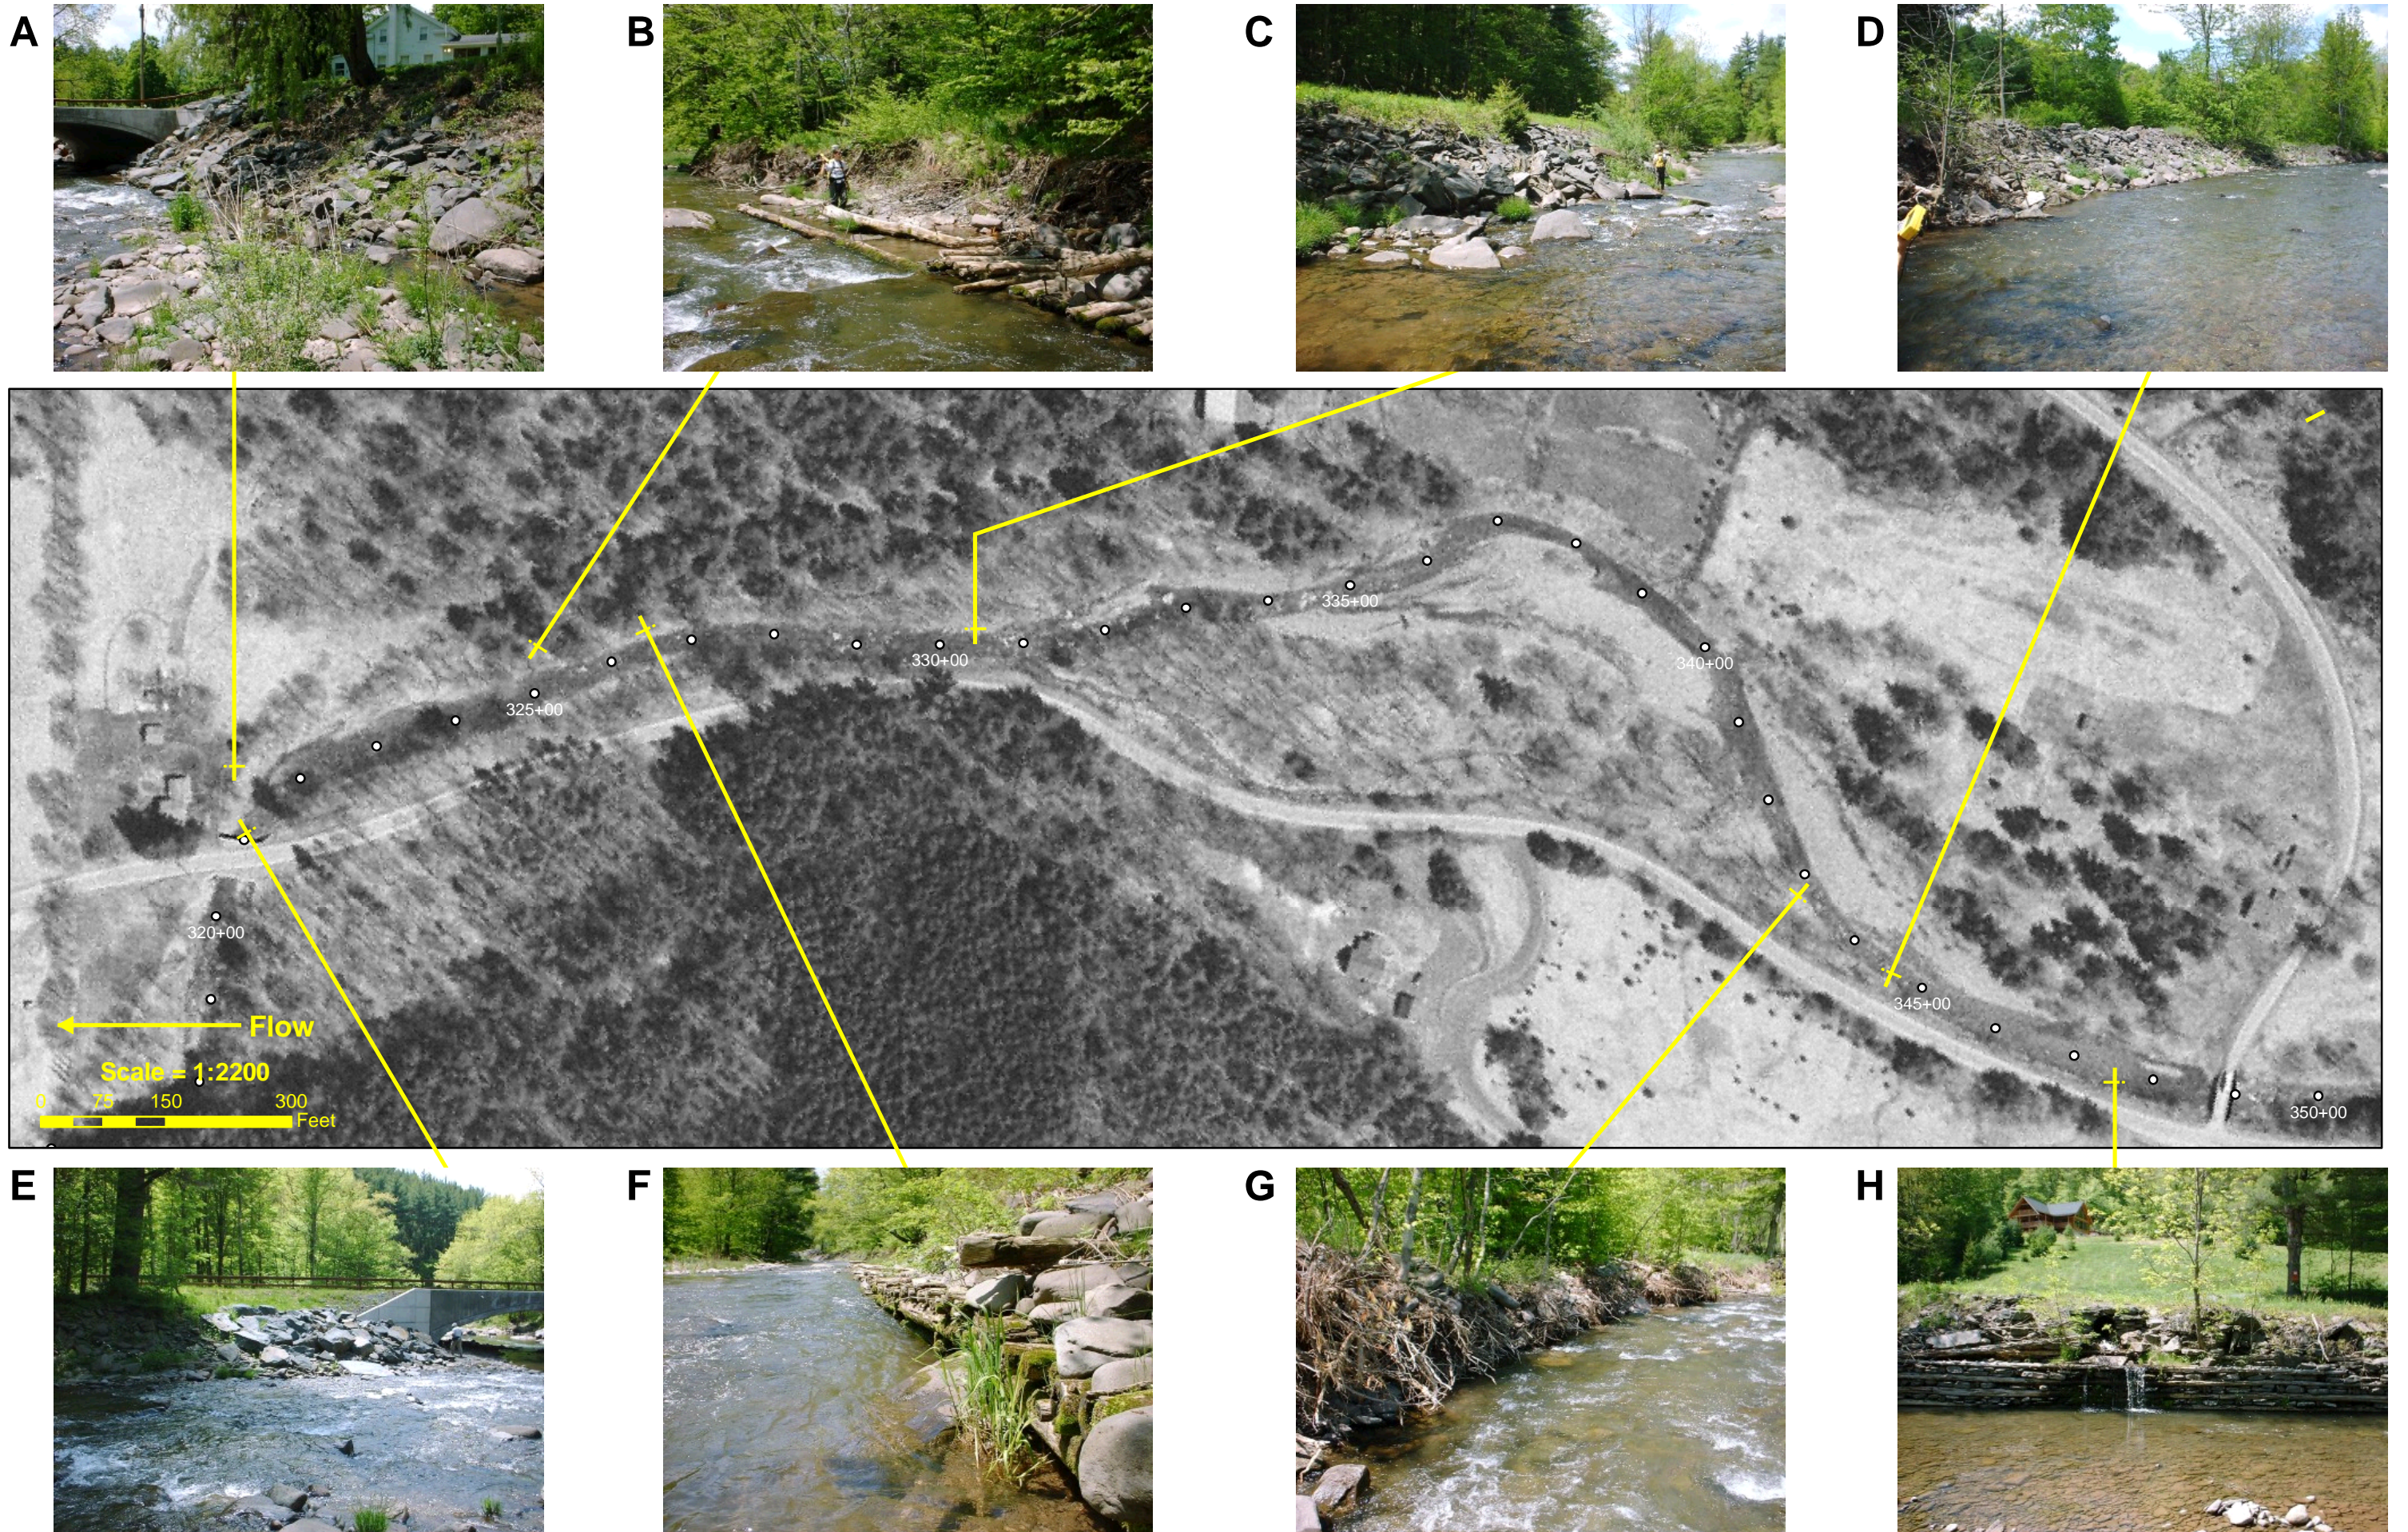
Figure 4.9.2 Management Unit 9 - 2004 aerial photography

A small unnamed tributary enters, left, through a perched 24” culvert under the road, with a stacked rock headwall in good repair and good outfall protection (see Insert H, Fig. 4.9.2). Downstream of the tributary the cribbing transitions to dumped rip-rap over failing cribwall, with no apparent toe protection, and then to material apparently sidecast during channel grading (Inset D, Figure 4.9.2). There is no significant riparian buffer between the channel and the road.

As the channel bends right, it becomes overwidened as a result of downstream aggradation and a significant drop in channel slope (see Insert D, G, Fig. 4.9.2). The result is 153 ft. of bank cutting on a low, well-rooted terrace at the outside of the meander bend, left (Inset G, Figure 4.9.2). Channel grading has likely exacerbated the overwide conditions here, but the point bar on the right appears to be vegetating with willows which may serve to narrow the channel,

Proceeding downstream, a 115 ft. section of the terrace bank is experiencing minor erosion at the downstream end of the log cribbing on the right. This erosion is exacerbated, if not directly caused, by streambed aggradation resulting from backwater at the bridge downstream (Inset B, Figure 4.9.2). The site was not significant enough to be monumented as a Bank Erosion Monitoring Site. A small stand of Japanese knotweed was observed on the left bank.

Recommendations for this site include interplanting the revetment with ecologically appropriate trees and shrubs to improve buffer function and bank stability. A monumented cross-section (Station 34647) documents this B3c reach, with entrenchment increasing, but channel slope dropping to 0.8%.

and an improvement of the riparian buffer on the right mitigates the erosion. As a result, the problem does not appear severe, and *passive restoration*, or letting the channel reestablish its own equilibrium, is recommended for this site, and for the reach in general. The site was not monumented as a Bank Erosion Monitoring Site.
