# West Kill Management Unit 12

## Management Unit 12

Between Station 26957 and Station 23489

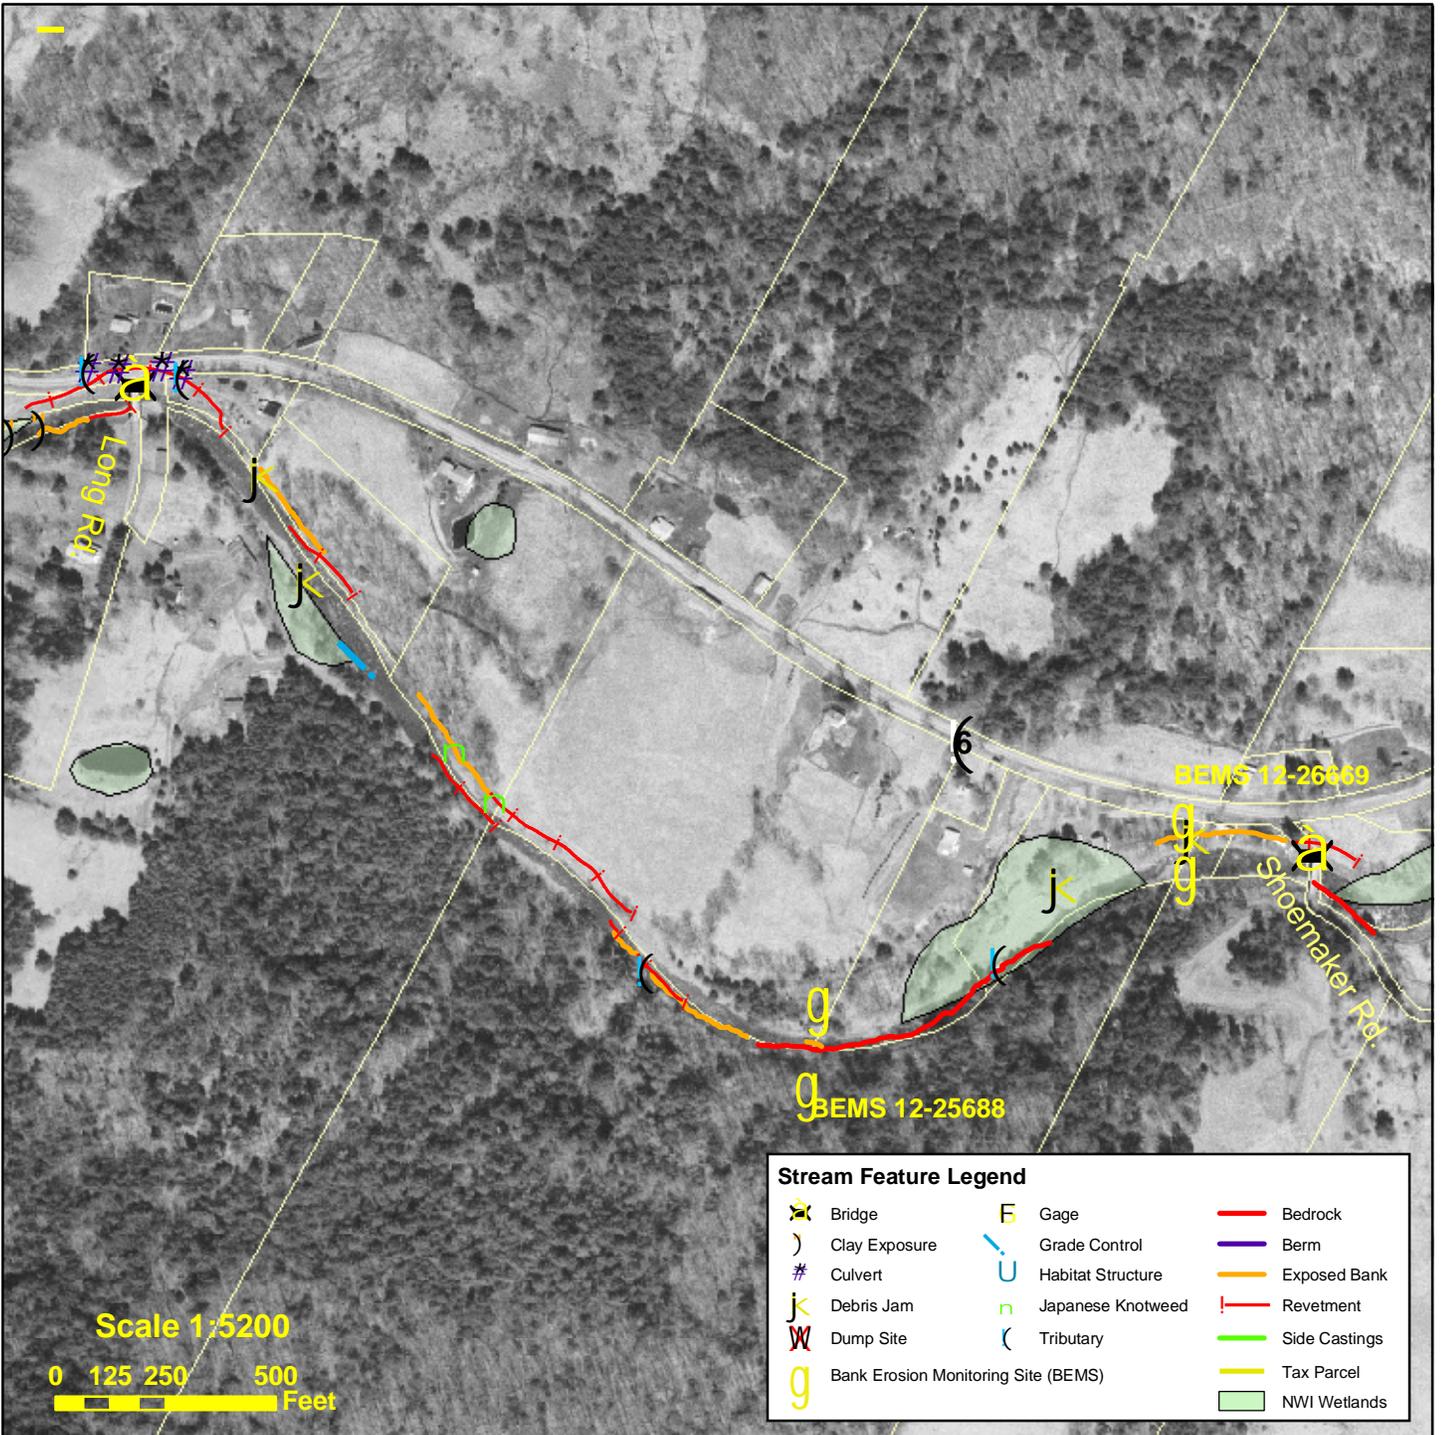
Figure 4.12.1 2004 aerial photography with stream feature inventory and tax parcels

The 2004 stream feature inventory revealed that 35% (1230 ft.) of the stream exhibited signs of active erosion along 3468 ft. of total channel length (Fig. 4.12.1). Revetment has

been installed on a remarkably high 39% (1355 ft.) of the stream length. No berms were identified in this management unit at the time of the stream feature inventory.

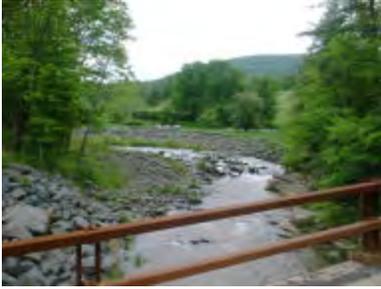
**Shoemaker Road bridge, looking upstream**

The Shoemaker Road bridge marks the start of Management Unit #12 (MU12). Data collected upon completion of the demonstration project revealed a 457 ft. reach of B3c stream type. The channel is moderately *entrenched*, or somewhat confined within the stream banks during high flood events. The channel slope is 1.7 % and the bed material is dominated by cobble.

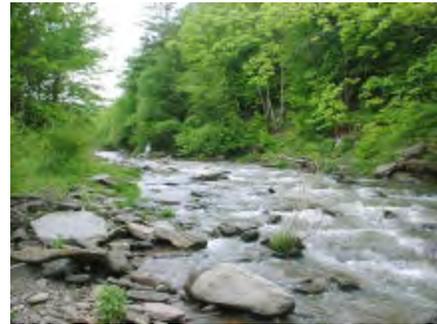
**Bedrock, looking upstream**

A 232 ft. length of bedrock begins at the classification cross-section, lining the left bank and portions of the bed in this reach. The bedrock offers partial grade control to the channel, inhibiting the migration of headcuts through upstream portions of the Management Unit.

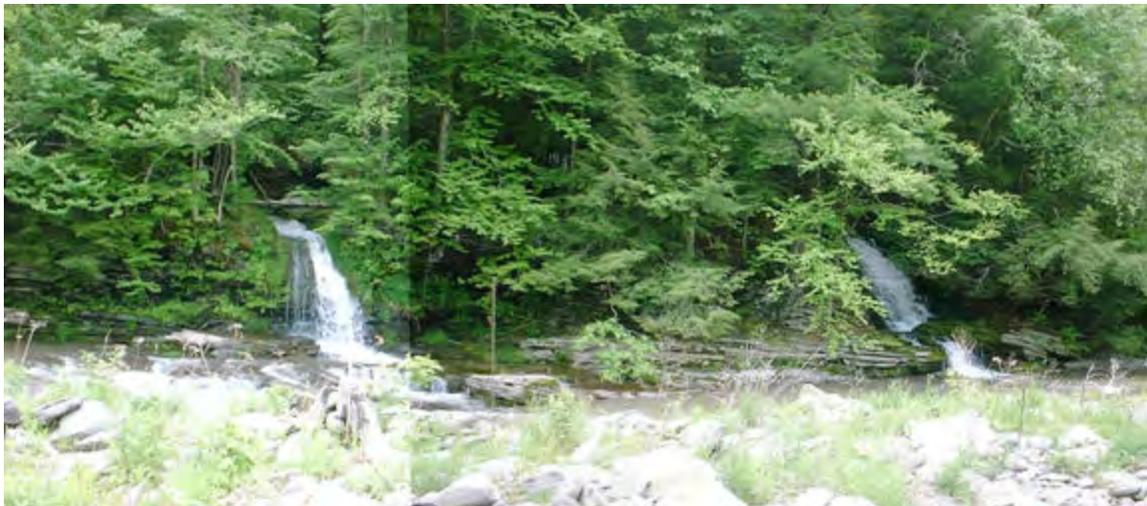
**Bennett Brook confluence, left**

Bennett Brook, split into two threads at its mouth, is seen here cascading over the bedrock ledges on the left bank to join the West Kill. This large tributary delivers flow

and sediment from a 1.0 mi<sup>2</sup> catchment, and despite its perched confluence, is very stable due in part to its bedrock grade control.

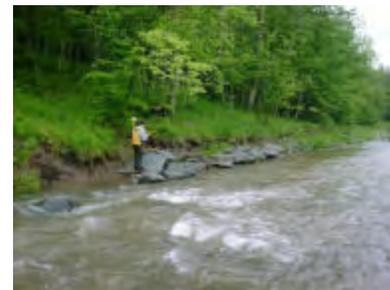
**Rip-rap, left**

A short section of rip-rap is found immediately downstream of the erosion. It appears that this rip-rap is a remnant of a once contiguous installation that unified this and the rip-rap located just upstream.

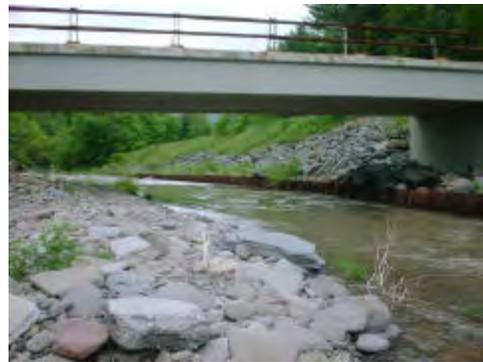
**Rip-rap, downstream of bridge**

rapped upper banks. The treatment extends both up and downstream of the bridge, and appears fairly new and in good condition. Riparian vegetation, however, is non-existent. Recommendations here include interplanting of the rip-rap, using ecologically appropriate tree and shrub species. The vegetative treatments will enhance the function of the riparian buffer, and improve fish habitat in this reach.

As the channel makes a sharp bend to the left on its approach to the Long Road Bridge, the right bank is heavily armored with a sheet pile toe and rip-

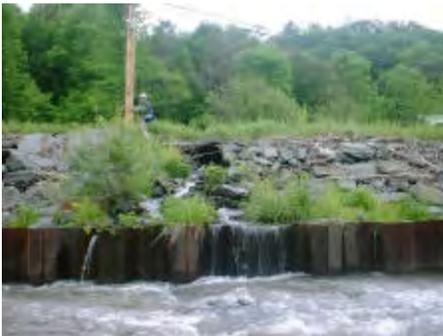
**Tributary culvert**

Two culverts convey drainage under County Route 6, and outfall onto the riprap (see Inset A, Fig. 4.12.2). One of the culverts conveys road drainage, and the other conveys an unnamed tributary. The culverts are perched, but have ample outfall protection.

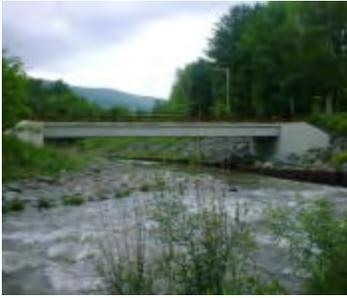
The Long Road bridge marks the downstream limit of Management Unit 12. This bridge appears new and is in excellent condition. The span of this bridge is adequate to pass relatively high flows without channel constriction, but the channel meander creates form roughness resulting in significant backwatering (see Inset E, Fig. 4.12.2).

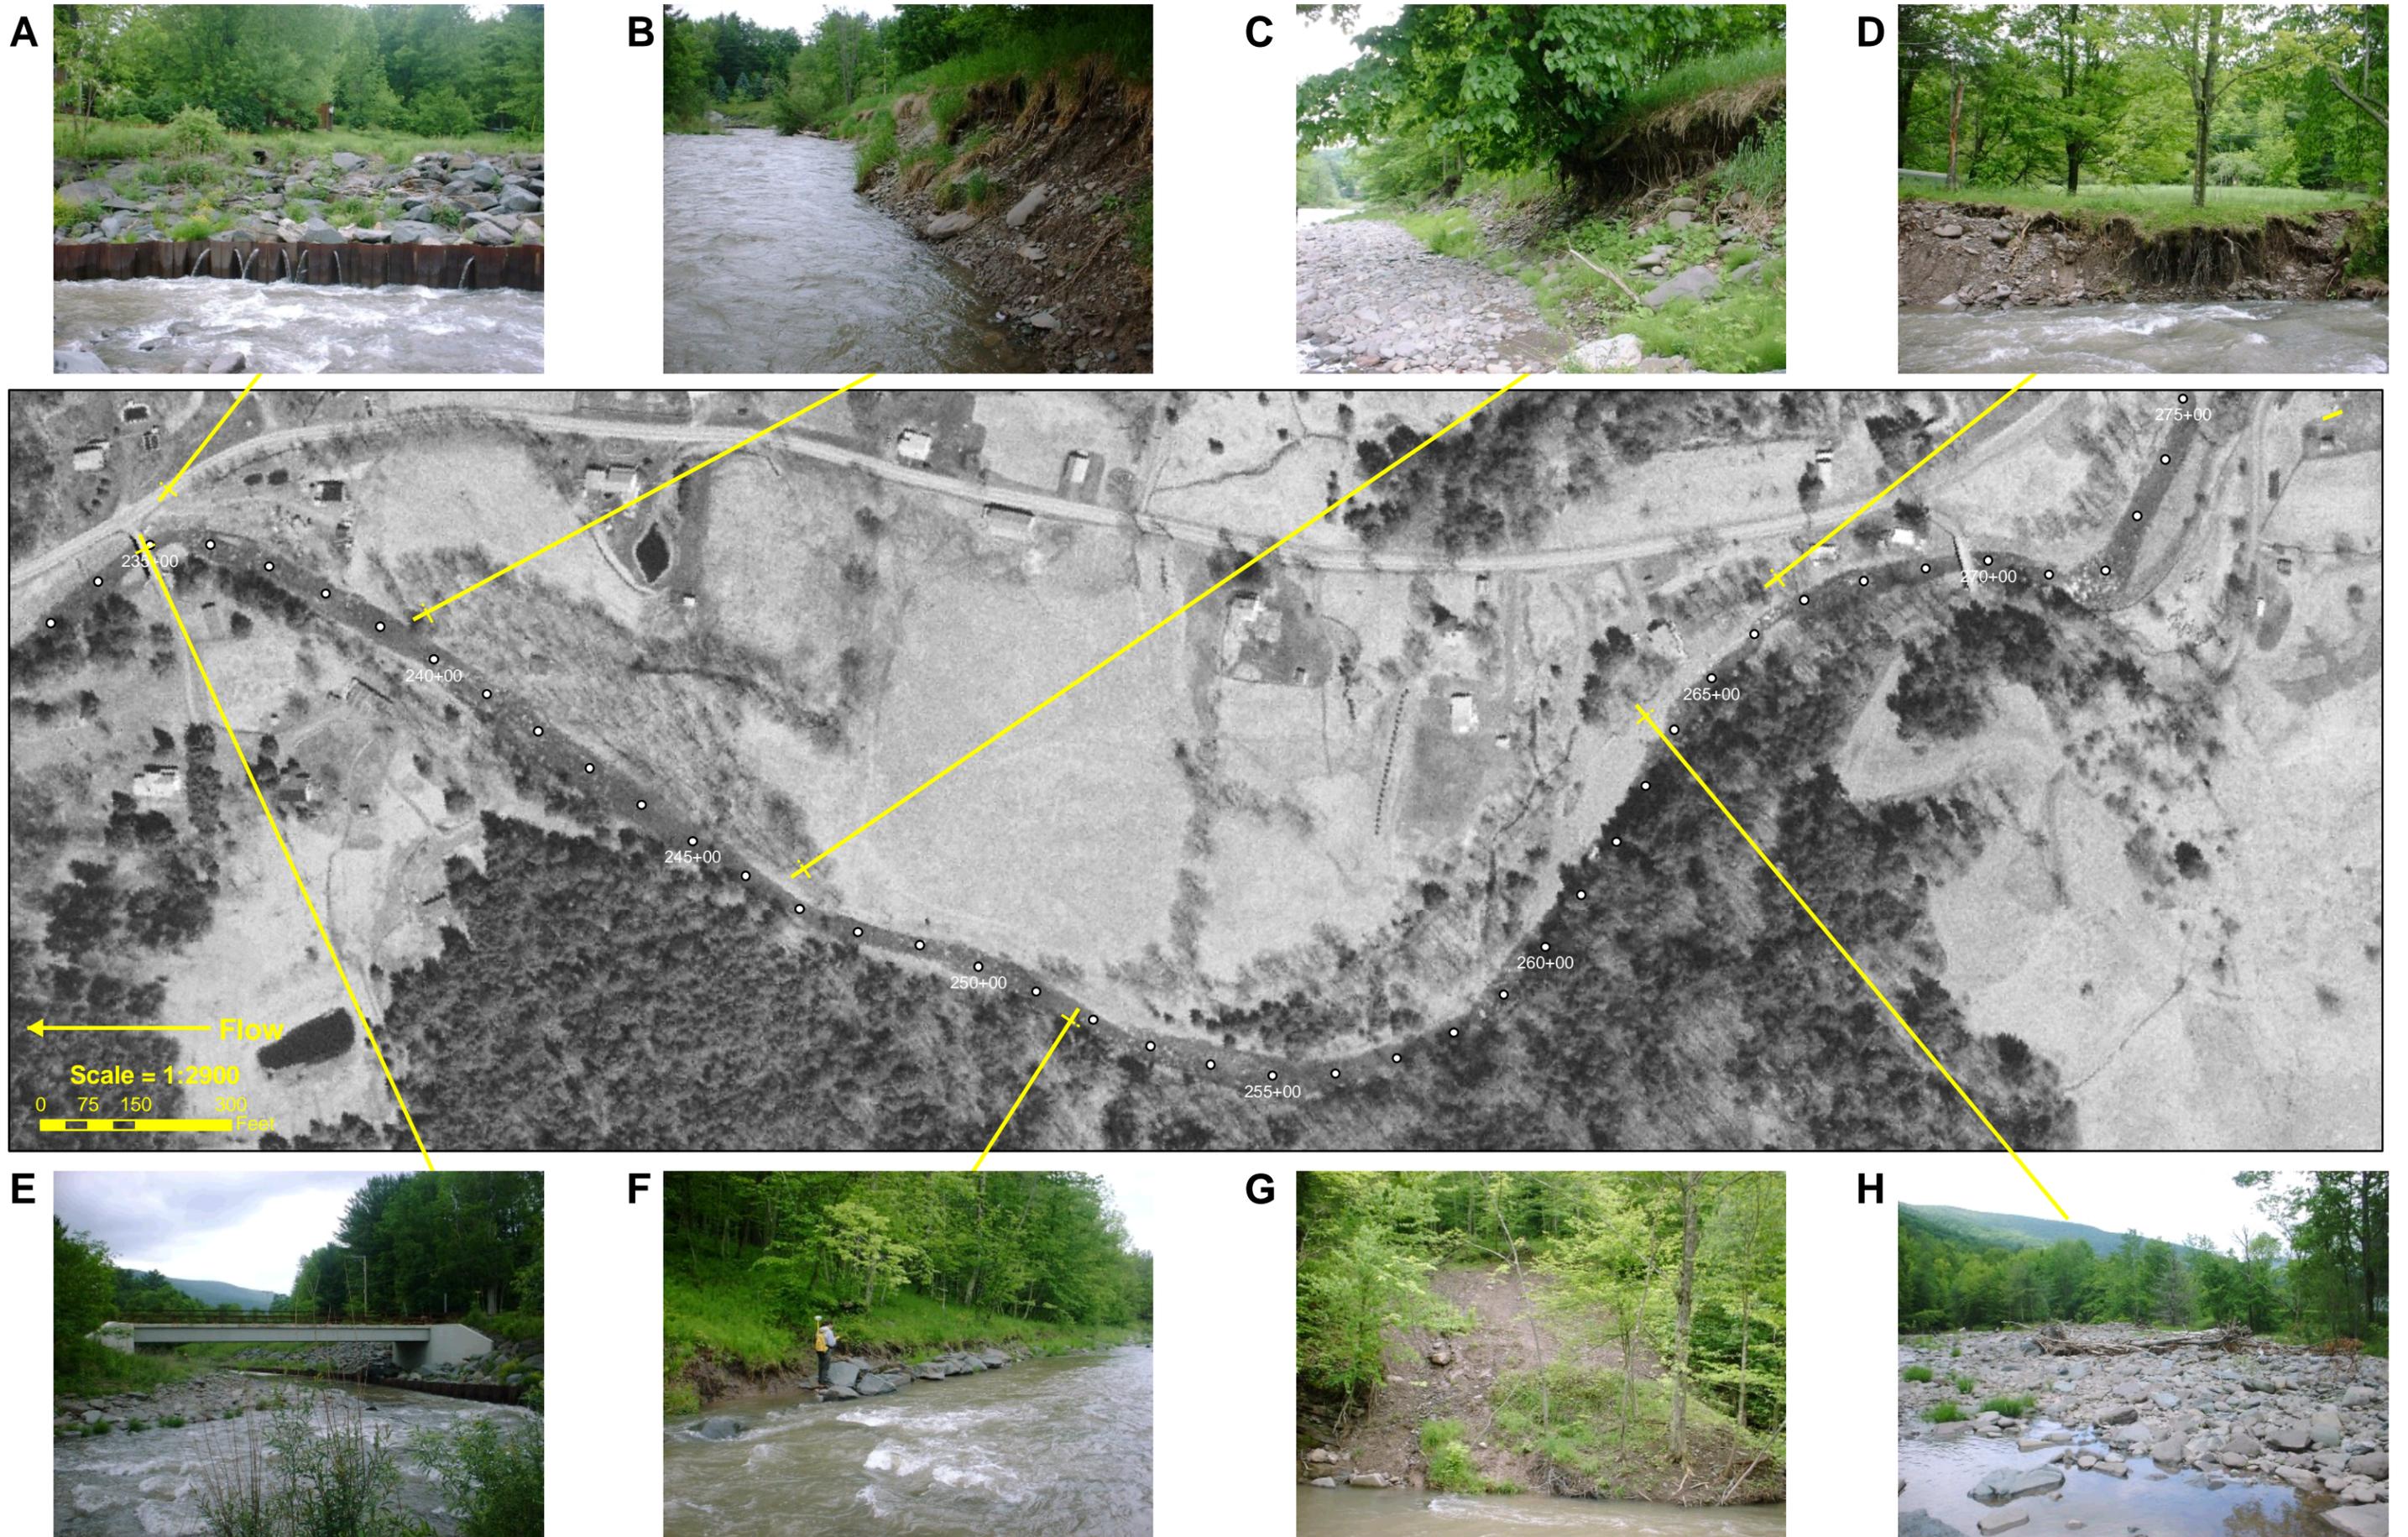
Figure 4.12.2 Management Unit 12 - 2004 aerial photography

The erosion at the downstream end of the rip-rap appears to be exacerbated by the flow obstruction created by the damaged rip-rap (see Inset B, Fig. 4.12.2). To monitor the erosion of this streambank it will be added to the BEMS sites. The toe of this erosion is composed of clay rich glacial till, posing a threat to water
