West Kill Management Unit 13

Management Unit 13
Between Station 23489 and Station 20415

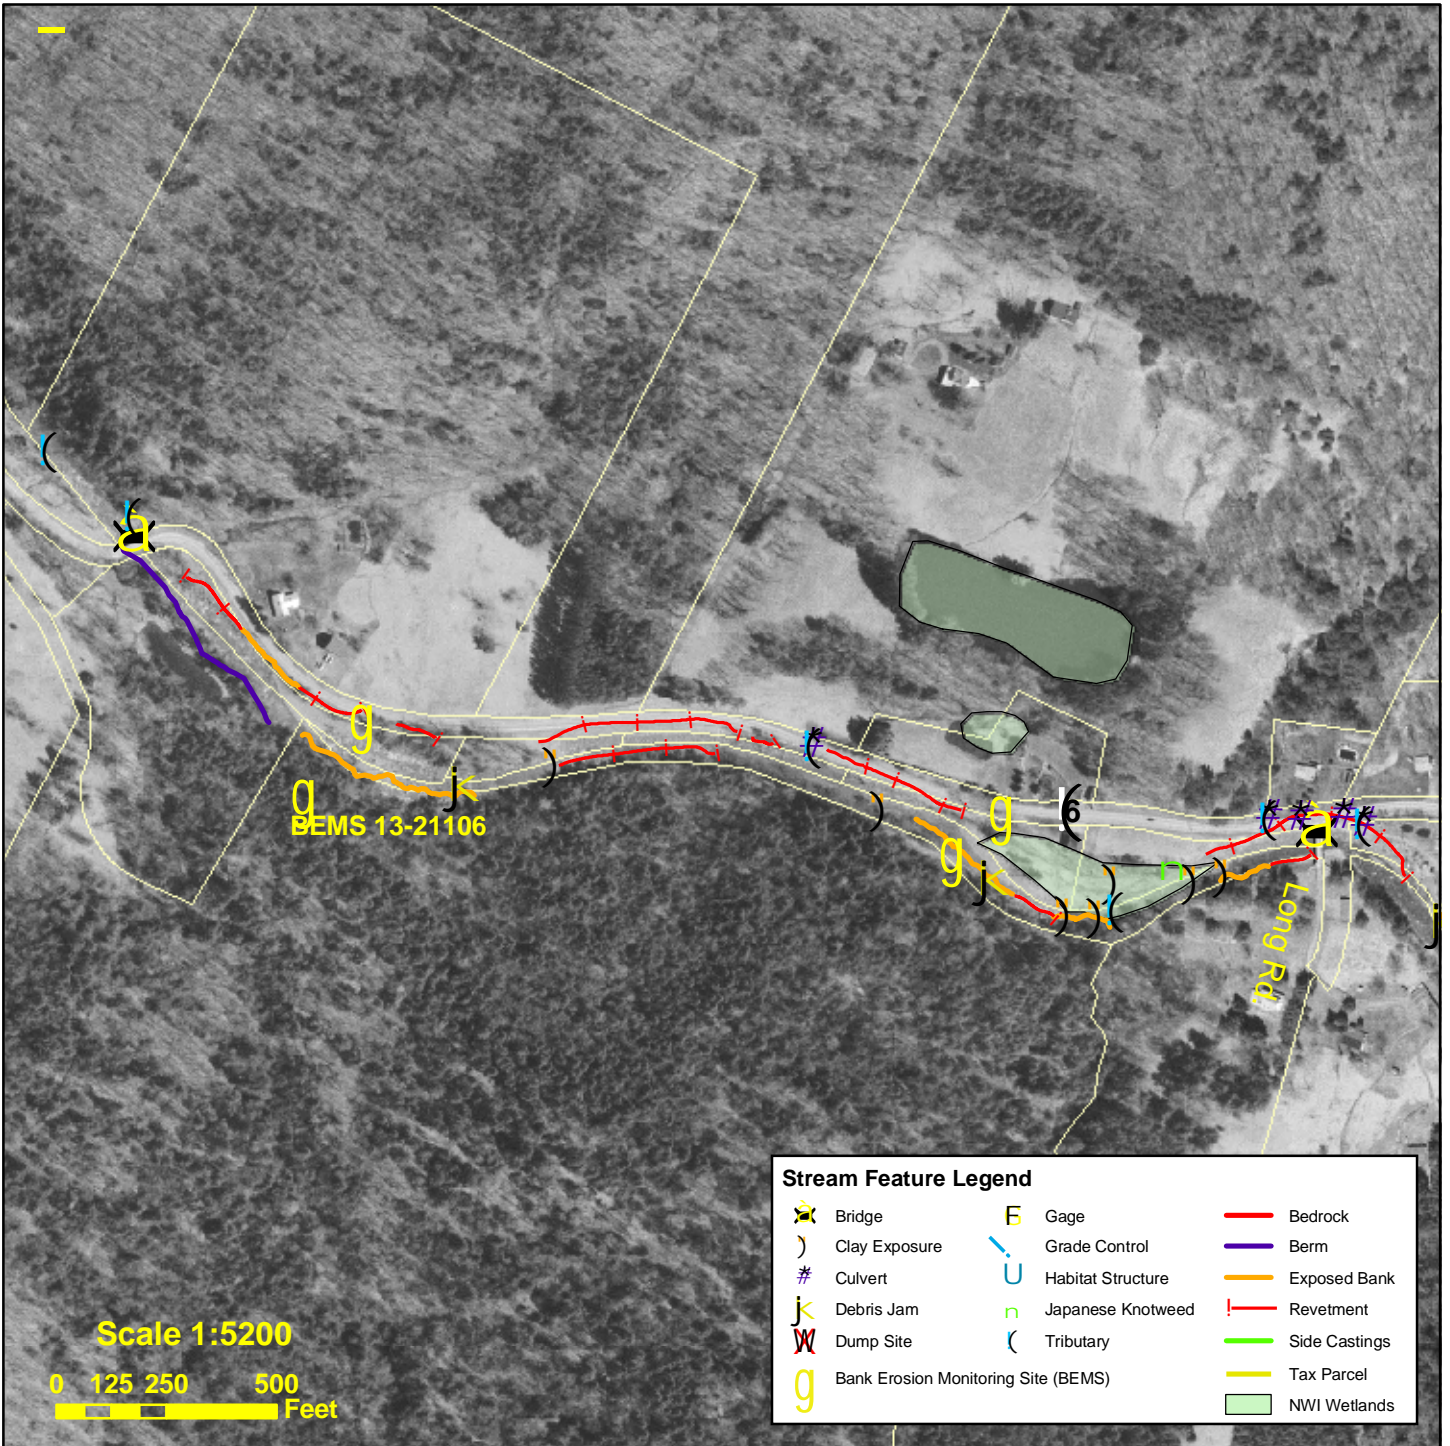
Figure 4.13.1 2004 aerial photography with stream feature inventory and tax parcels

The 2004 stream feature inventory revealed that 40% (1231 ft.) of the stream exhibited signs of active erosion along 3074 ft. of total channel length (Fig. 4.13.1). Revetment has been installed on a remarkably large 66% (2039 ft.) of the stream length. One berm, measuring 542 feet, was identified in this management unit at the time of the stream feature inventory.

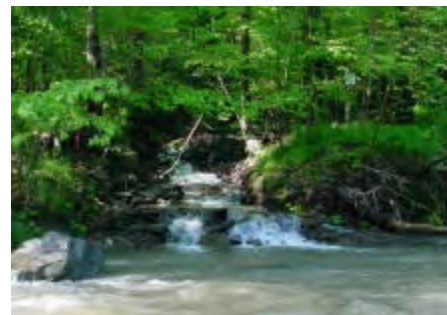
Newton Brook confluence, left

Just before the channel bends to the right, Newton Brook joins the West Kill from the left. The tributary drains 0.5 mi² and has a quite steep, yet stable, approach through a well-forested floodplain.

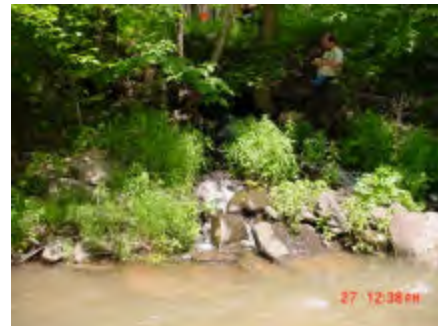
Tributary, right

An unnamed tributary, culverted under Greene County Route 6, joins the West Kill from the right near station 22200. The tributary drains a pond on a residential area north of the road. Although the tributary is somewhat perched, the natural rock appears to provide adequate stabilization.

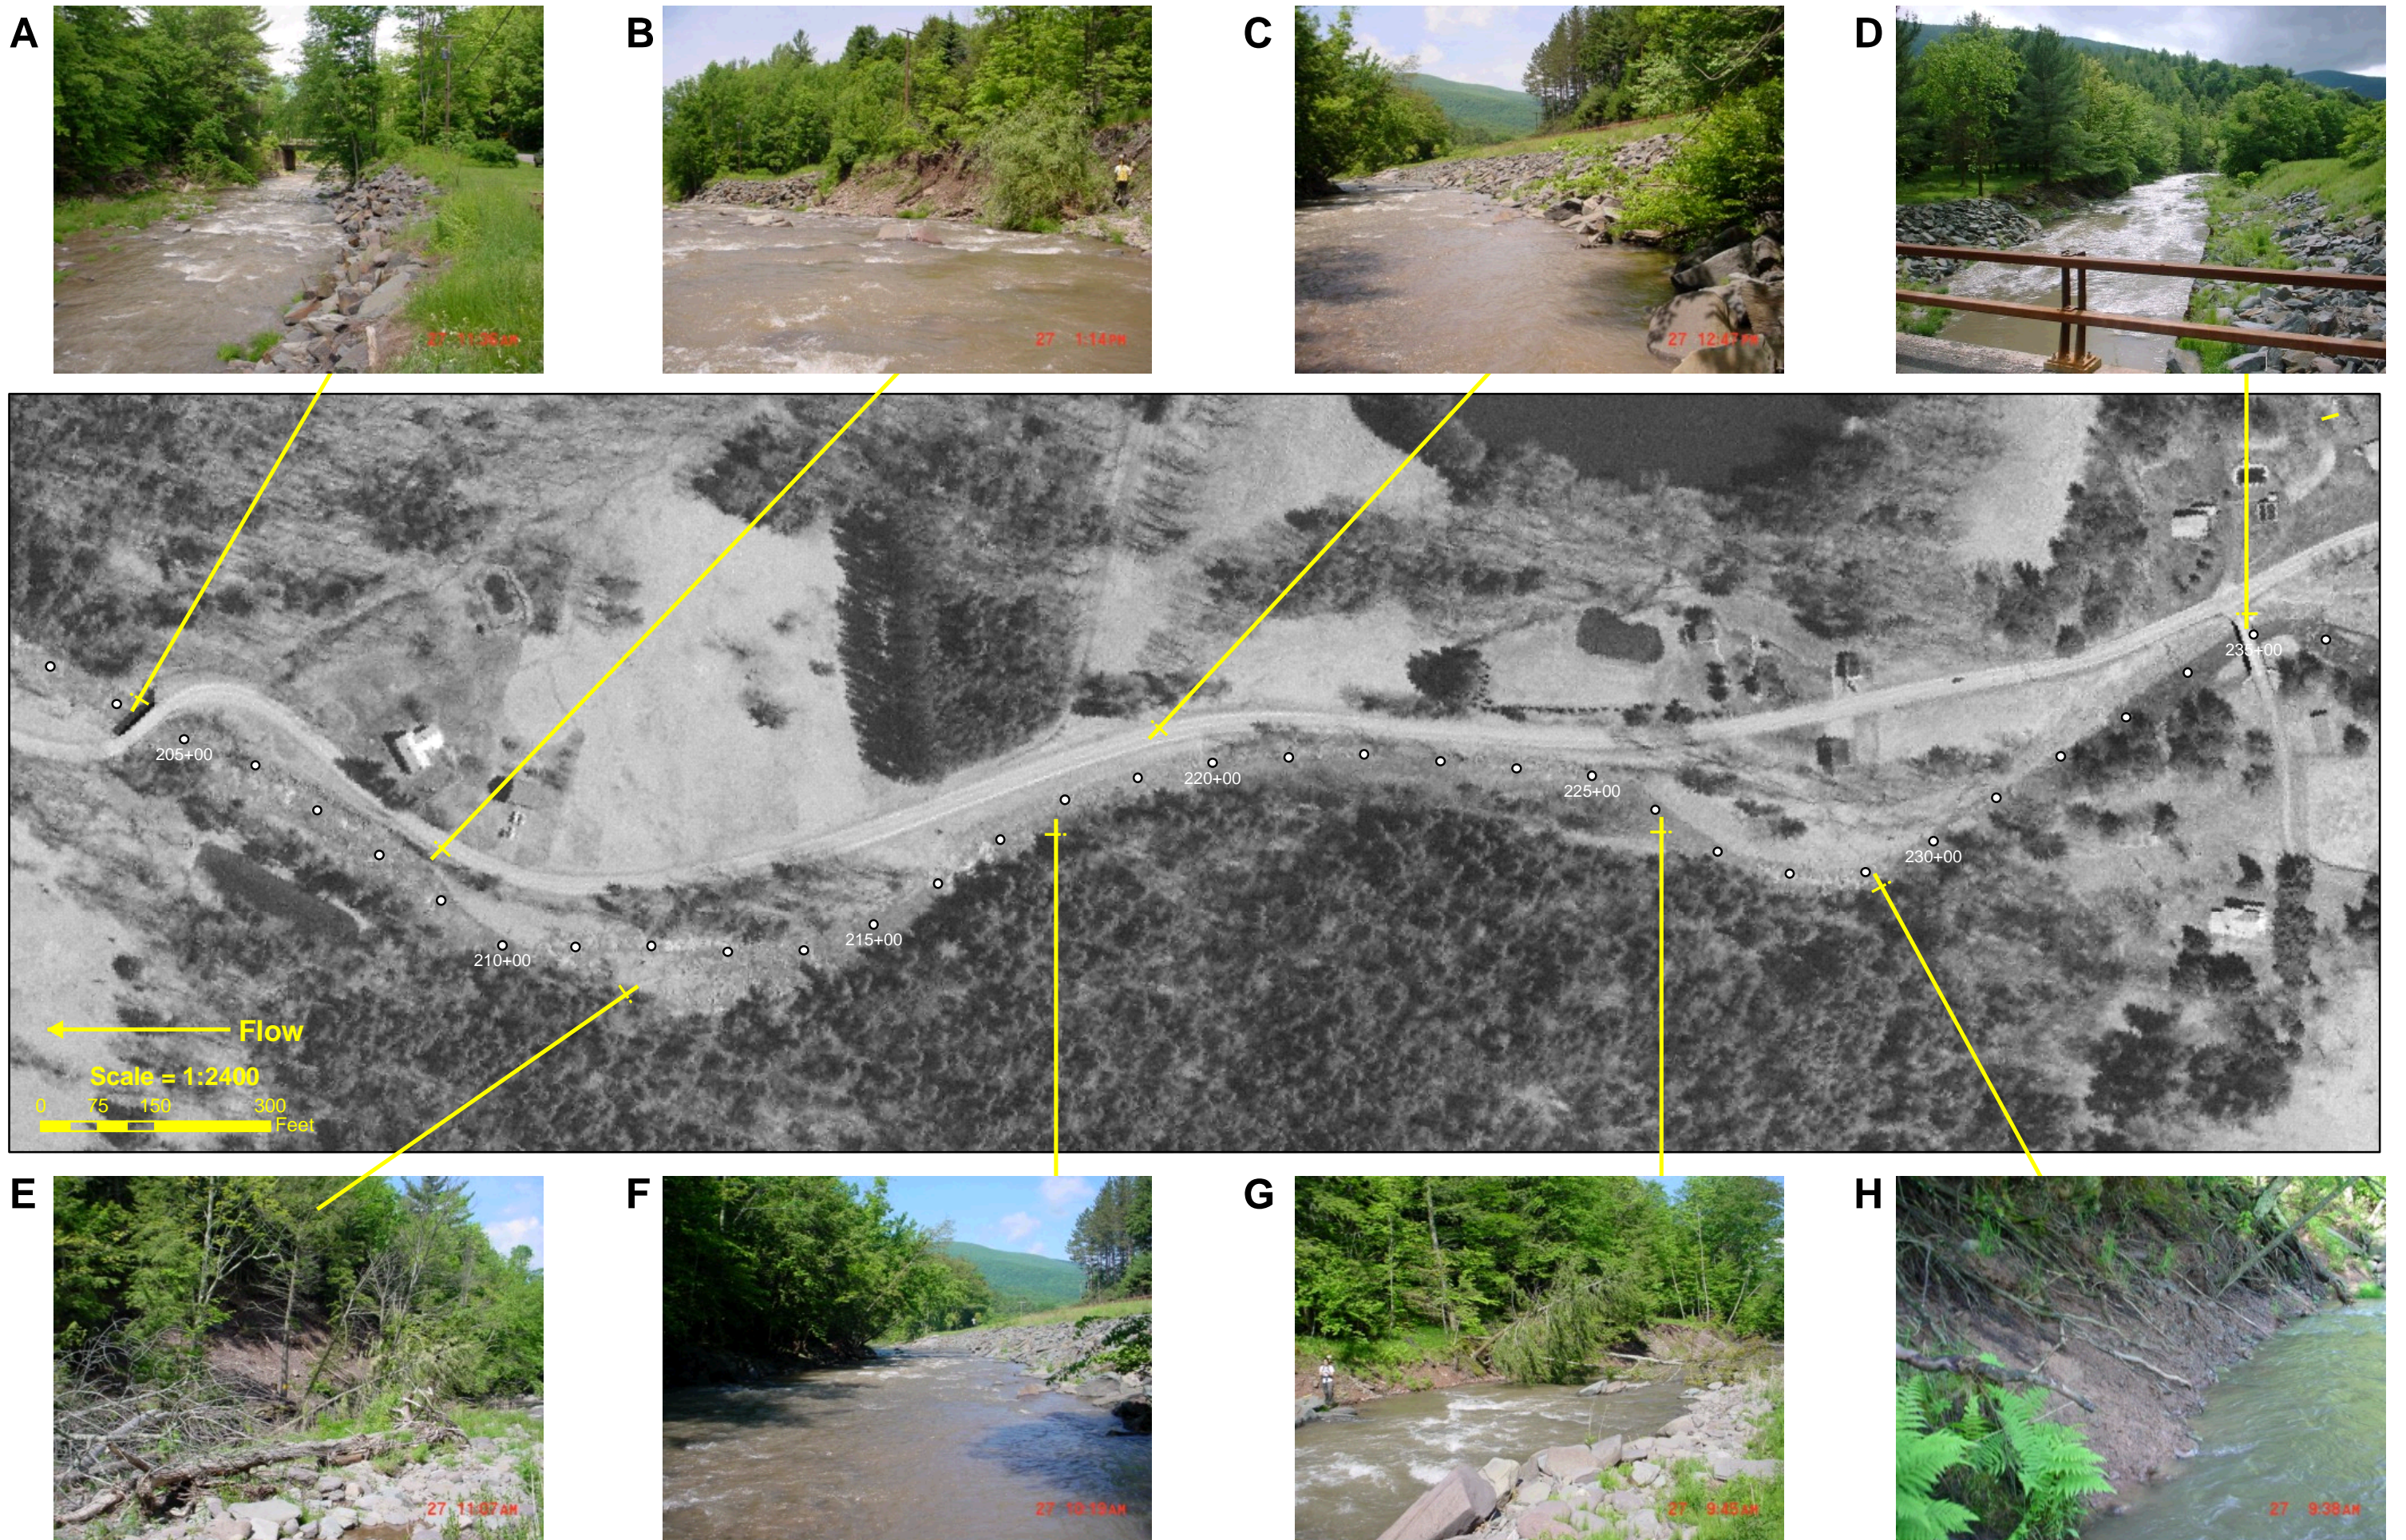
Figure 4.13.2 Management Unit 13 - 2004 aerial photography

Damage to County Route 6 in 1996 and 1999 prompted rip-rapping of the entire channel cross-section along 450 ft. of the West Kill (Inset C, Fig. 4.13.2). The resulting channel has a reduced channel width and slope, and increased roughness, all contributing to a backwater condition in the reach immediately upstream. As a result, flow depths through the treatment during high flows were significantly increased, triggering a headcut at the outfall of the treatment. As the headcut migrates with future flow events, it is likely to destabilize the project, and threaten Greene County Route 6 once again. The coarse rock material used to line the channel also resulted in subsurface flow through the treatment during dry periods, forming a migration barrier and virtually eliminating aquatic habitat. Recommendations for this area include restoration of appropriate channel dimensions and slope, while not compromising the integrity of the structural measures installed to stabilize the adjacent roadway. Finer material should be applied to the channel to fill voids in the coarse rip-rap, and to promote surface flow through the treatment during low flows. Interplanting of the rip-rapped road embankment to enhance the longevity, aesthetic quality, habitat value and buffering capacity of the treatment is recommended.

Along the outside of a bend back to the right, 474 ft. of extreme bank failure (see Inset E, Fig. 4.13.2) has been monumented as a Bank Erosion Monitoring Site (BEMS Station 13-21106). In a prioritization of twenty-one BEMS sites throughout the West Kill watershed (see Section 3.3, Watershed Inventory and Assessment), this site ranked High Priority, and rated as the second most severe erosion site in the West Kill watershed. The *thalweg*, or deepest part of the stream channel flows up against the glacial terrace here. The hillslope is being undermined by toe erosion, leaving large sections of the high bank unvegetated. The *exposed ice contact deposits* and *lacustrine* soils have a high silt and clay content, contributing sediment through both *wet and dry ravel* and yielding a significant suspended sediment load during high

Along the outside of a bend back to the right, 474 ft. of extreme bank failure (see Inset E, Fig. 4.13.2) has been monumented as a Bank Erosion Monitoring Site (BEMS Station 13-21106). In a prioritization of twenty-one BEMS sites throughout the West Kill watershed (see Section 3.3, Watershed Inventory and Assessment), this site ranked High Priority, and rated as the second most severe erosion site in the West Kill watershed. The

flows. The high volume of clay inputs into the stream from this site are a water quality concern, increasing *turbidity*, degrading fish habitat, and acting as a carrier for other pollutants and pathogens.

Full restoration is recommended for this site. This would likely involve establishment of a well-vegetated bench on the right with rock vanes to direct stream flows away from the left bank, and revegetation of the bank face. Geotechnical assessment, in-depth survey and design would be required to plan a stream restoration project at
