# West Kill Management Unit 14

## Management Unit 14

Between Station 20415 and Station 18646

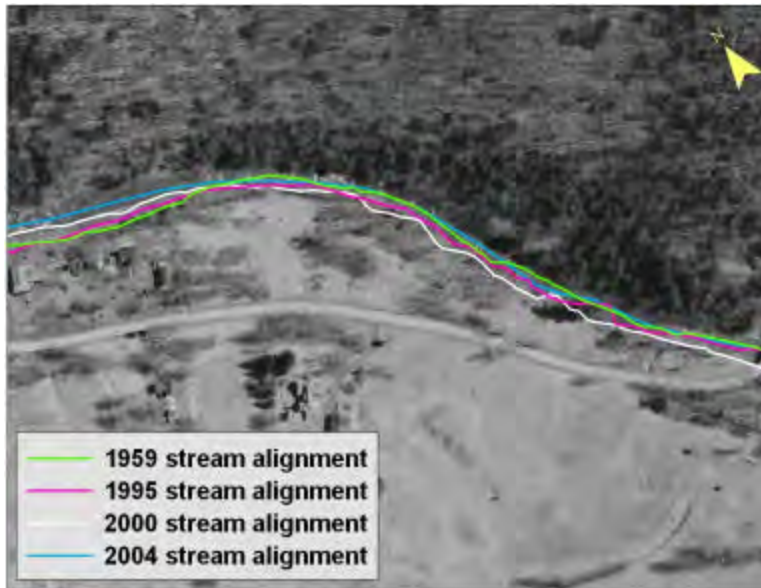
Historic Stream Channel Alignments in MU14

As seen from the historical stream alignments, the channel alignment has remained fairly consistent over the years. Minimal lateral channel adjustments are detectable from the aerial assessment. Vertical channel adjustments, however, cannot be assessed from aerial photography, and cannot be ruled out on the basis of the lateral stability evident from the historical channel alignments.

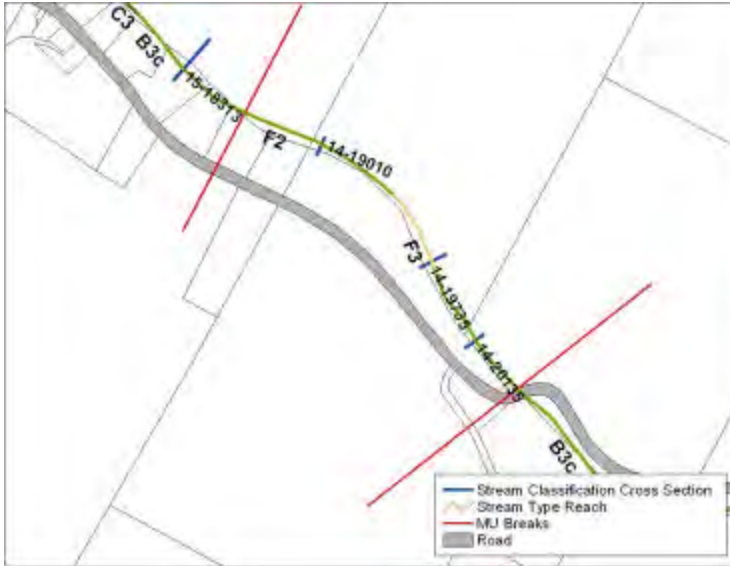
**Cross-sections and Rosgen stream types in Management Unit 14**

Management Unit #14 begins with a 615 ft. reach of B3c stream type. The channel is moderately *entrenched*, or confined within the stream banks during high flood events. The channel slope is a very flat 0.7 % and the bed material is dominated by cobble.

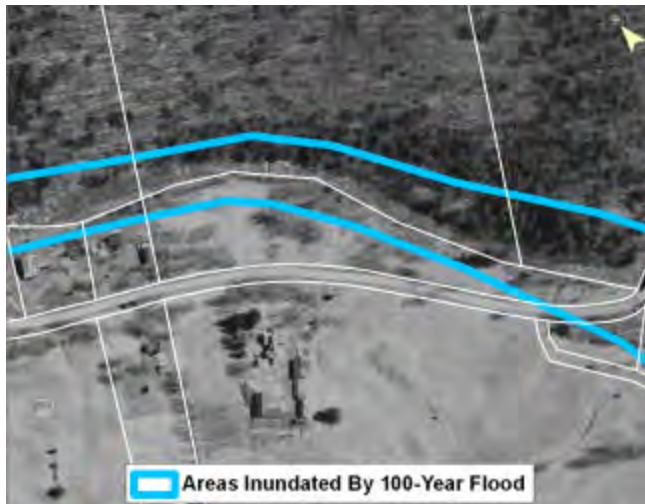
**100-year floodplain boundary in Management Unit 14**

As part of its National Flood Insurance Program (NFIP), the Federal Emergency Management Agency (FEMA) performs hydrologic and hydraulic studies to produce Flood Insurance Rate Maps (FIRM), which identify areas prone to flooding. The NYS DEC Bureau of Flood Protection is currently developing new floodplain maps for the West Kill on the basis of recent surveys. These maps should be completed for the West Kill watershed in 2006.

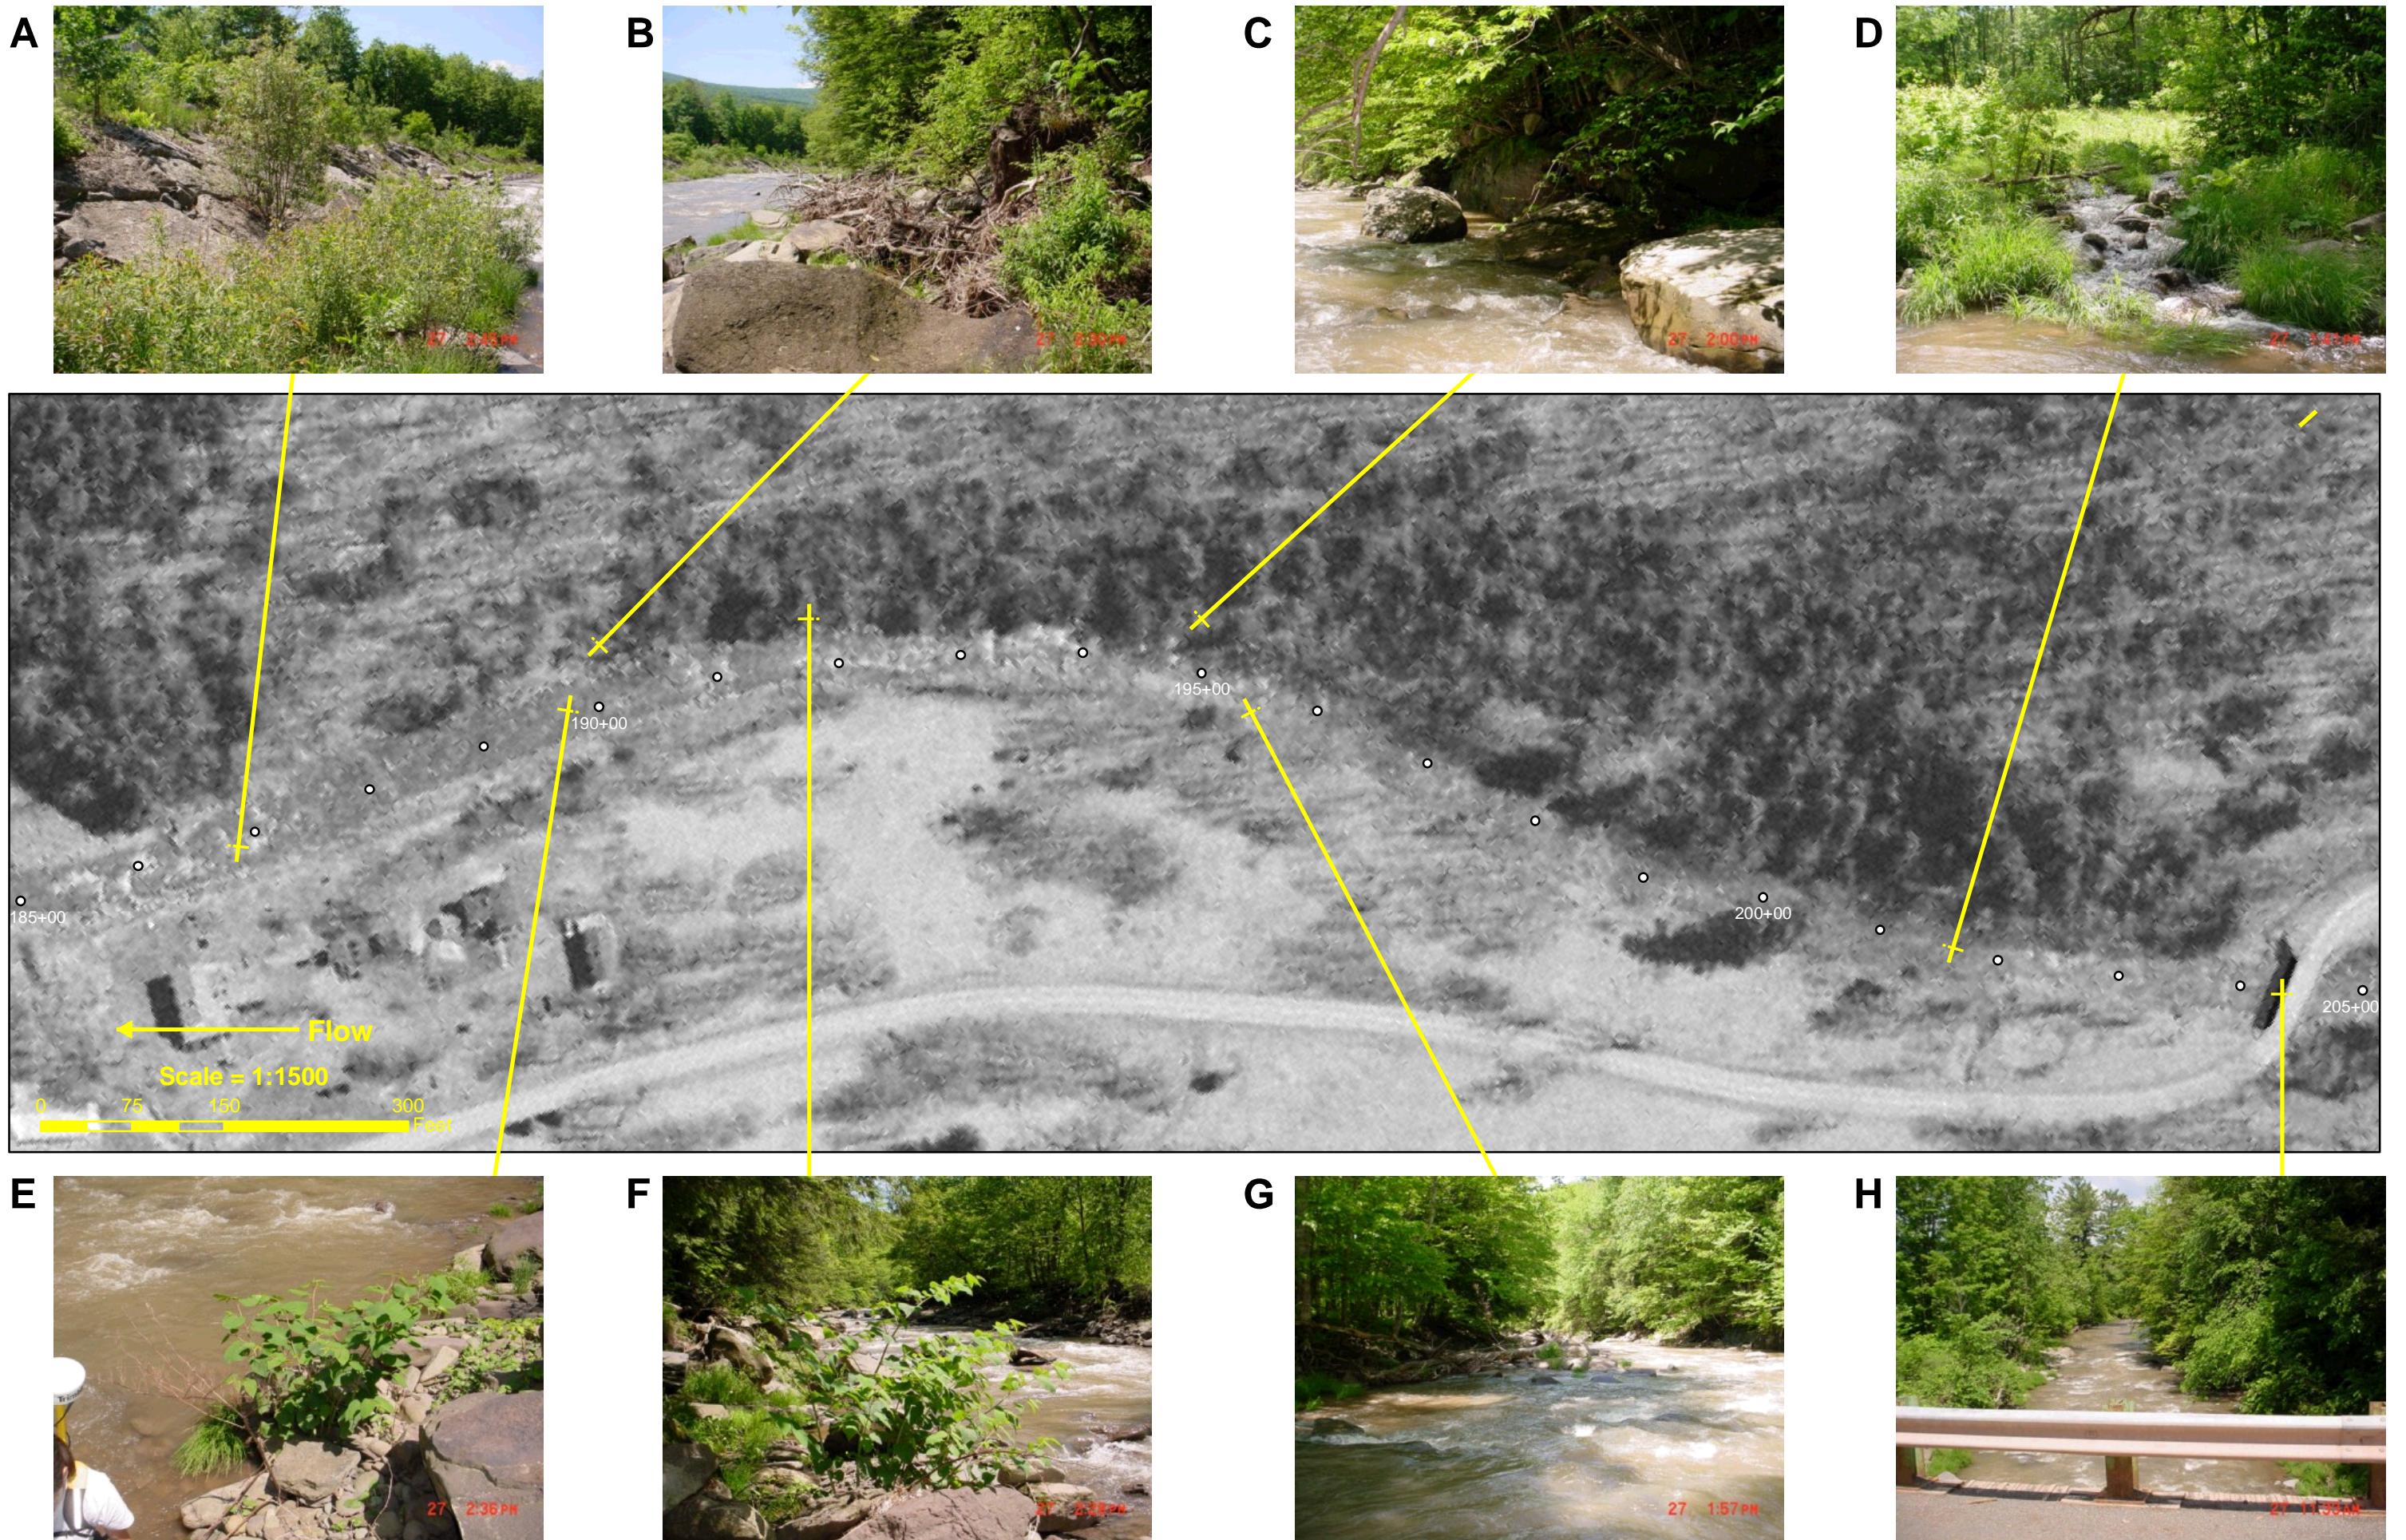
Figure 4.14.2 Management Unit 14 - 2004 aerial photography

Greene County Route 6 bridge (Inset H, Fig. 4.14.2) marks the upstream end of Management Unit 14. The bridge is old, but in fair condition. The span of this bridge is inadequate to convey bankfull flows without flow constriction and backwater. The bridge has no rock scour protection and significant abutment scour is evident. Increased water surface elevations upstream of this bridge have resulted in flooding

A debris jam (Inset G, Fig. 4.14.2) is observed on the left bank near station 19550. The jam is clear of the low flow channel, creating an obstruction only during high flows.

of the hamlet during larger flood events, which flank the bridge to the south. This bridge is scheduled for replacement in 2006, and coordination with Greene County Highway Department is recommended to ensure application of appropriate channel dimensions to the bridge design. The bridge design should be evaluated from a hydraulic perspective to determine the impact it will have on flooding in the hamlet.
